AMAN HOUSE

STATE OF CONSERVATION REPORT

Heritage Cell - Department of Architecture and Planning,
NED University of Engineering and Technology, Karachi.

FEBRUARY – APRIL 2016

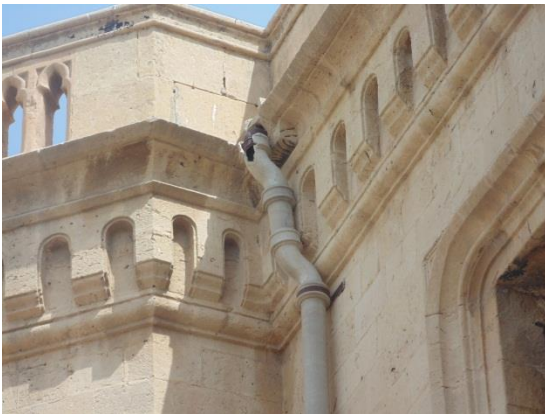
1. RISING DAMPNESS:

Rising damp is usually easy to recognize. It is given the name because it is caused by moisture being drawn up through the wall from the damp ground below. This is referred to as capillary action. The reason that it does not go higher than about a metre, is

causes observed for Rising damp at different locations of Aman house are plants and trees growing too close to the house. The problem with these is that moisture and rain gets trapped, with little airflow behind to help dry off the moisture when the weather is reasonable. Another factor cause's rising damp observed during survey are Water leaking into the property from outside, e.g. leaking roof or defective guttering and drainpipes, or inside the property from leaking plumbing pipes / fixtures, such as around the bathroom fixtures and water supply pipes causing dampness.
