BUILDING OWNER: HASAN ALI SOOMRO
617 OFF WAGNO GATE LANE
ENLISTMENT NUMBER: 2012-UC1/37

SAFDAR AHMED RESIDENCE

TIBATI HAVELI

BUILDING OWNER: Ahmed Ali Mangi
117 Suigar Lane/off
Hathi Gate Lane
Enlistment number:
2012-UC2/529

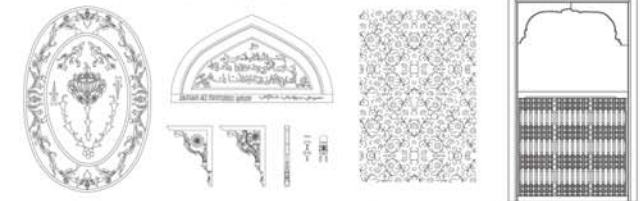
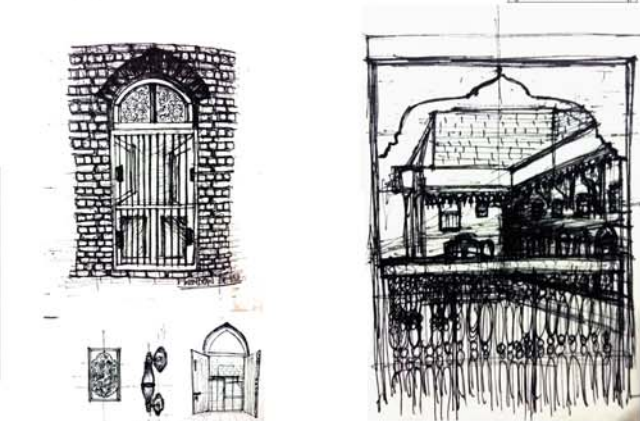
DETAIL BLOWUPS

SUGGESTIONS:
Lack of maintenance due to several reasons such as termite infestation which in turn has caused structural issues in various parts of the house.
Cleanliness to better the environment and decluttering is suggested.

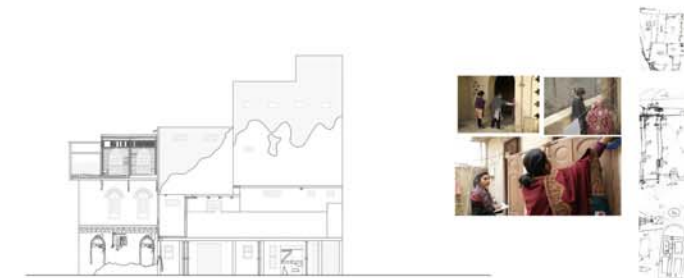
- 1.The lack of maintenance of the property.
 - 2.The current condition reflects the partial collapse of different spaces is facing threats of complete collapse of the structure.
- Just be owned as the representative of the remains of history unlike the many historic buildings because negligible consideration, it should be taken care of.
- is not possible to preserve the complete property, its elements can be used through the process of partition.

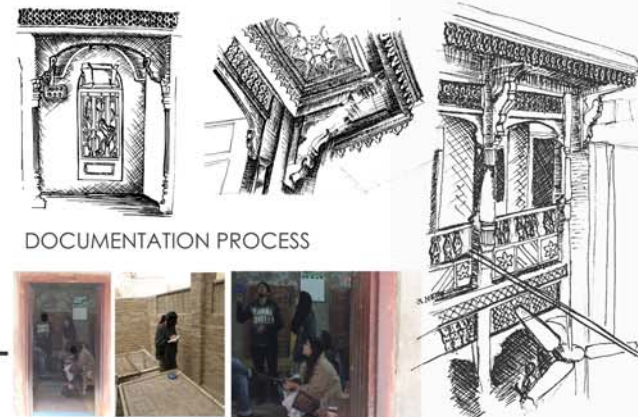
DETAIL BLOWUPS

The intricate wooden facade is currently in a derelict state and may crack under the load. Hence it is in dire need of reinforcement while the wooden facade could act as a frame. The lack of maintenance has engendered a termite infestation and hence needs to be controlled.
