Condition Assessment of Heritage Buildings - Karachi Declared as “Dangerous”

JUNE 2018

Structural Consultant

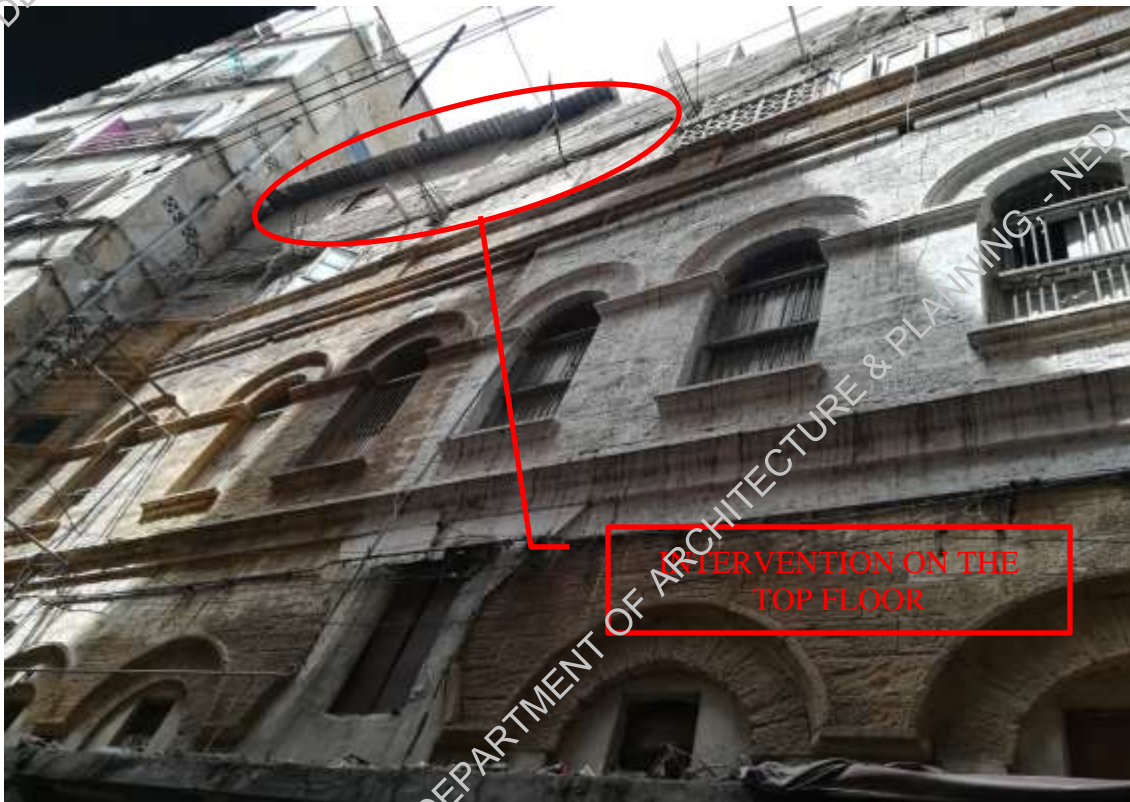
- On front façade, loose stone masonry can be noticed at a few locations and cracks were noticed on the first floor.
- Wide cracks were visible on front facade.

Plate-1: Front Façade- loose stone masonry can be noted at few places. Additional floor on top is also visible

- In existing condition, building structure is not stable and is susceptible to failure/collapse.
- Extensive strengthening is required to make the structure stable. Strengthening measures to be done with careful methodology which will include propping of existing walls/floors before proceeding with any strengthening technique.
- Interventions should be removed such as the additional floor on top and extra floor finishes where present, to decrease the dead load on existing walls,
- Strengthening techniques can be adopted, including but not limited to;
 - a. Pointing of mortar in existing stone masonry joints,
 - b. Application of mesh plaster
 - c. Introducing internal mild steel frame within the building to secure the occupants from fatal damages

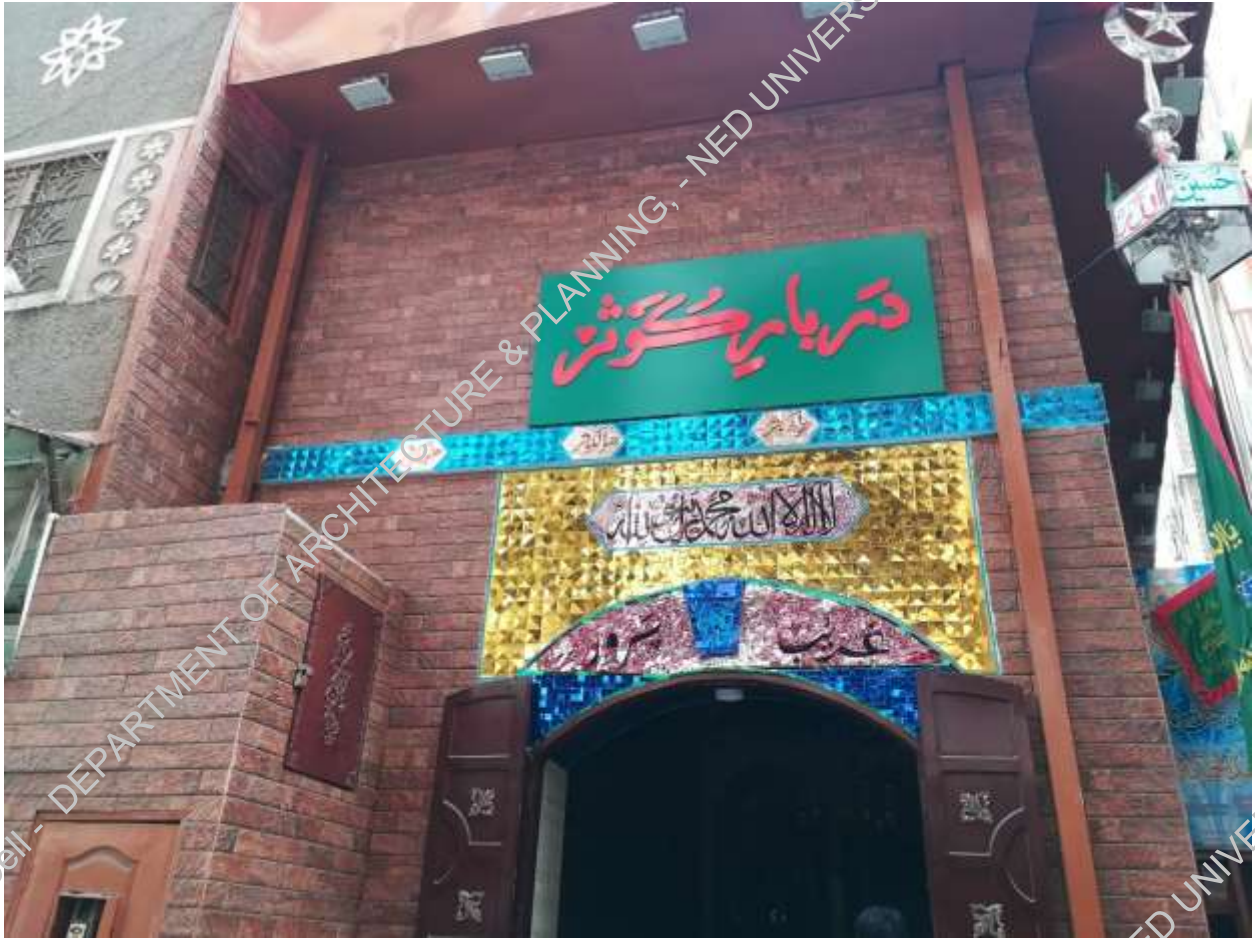
Plate-1: Front Façade- proper tiling works

- In existing condition, building structure appears to be in good condition.
- However, it is suspected that the mortar used for pointing and repair is cement mortar which is not good for stone integration in long run, hence it is recommended to guide the occupants/user of building to get the repair of building done with lime mortar.

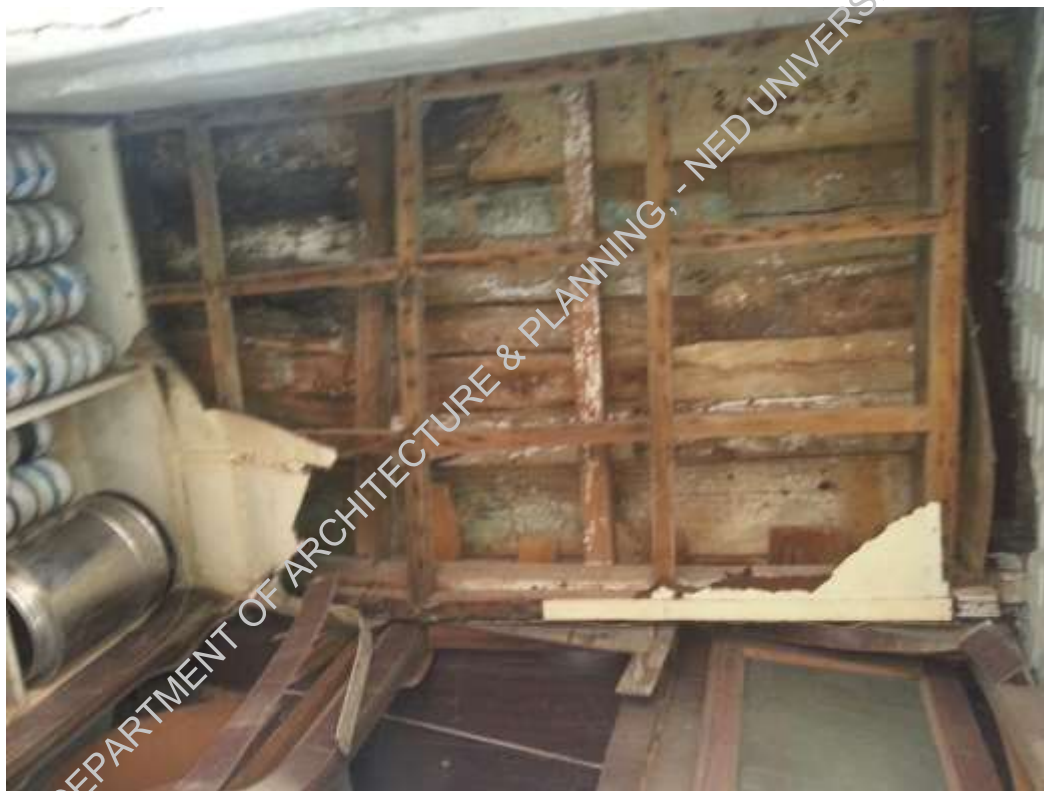
- Building could be observed from outside only.
- Internal floors have been collapsed. Refer Plate-3.
- Timber beam and wooden slab is in bad condition. Refer Plate-1 to 4.

*Plate-4: slab in
bad condition,*

- In existing condition, building structure is not stable and is susceptible to failure/collapse.
- Extensive strengthening is required to make the structure stable. Strengthening measures to be done with careful methodology which will include propping of existing walls/floors before proceeding with any strengthening technique.
- Interventions should be removed such as the additional floor on top and extra floor finishes where present, to decrease the dead load on existing walls,
- Strengthening techniques can be adopted, including but not limited to;
 - a. Pointing of mortar in existing stone masonry joints,
 - b. Application of mesh plaster
 - c. Introducing internal mild steel frame within the building to secure the occupants from fatal damages.

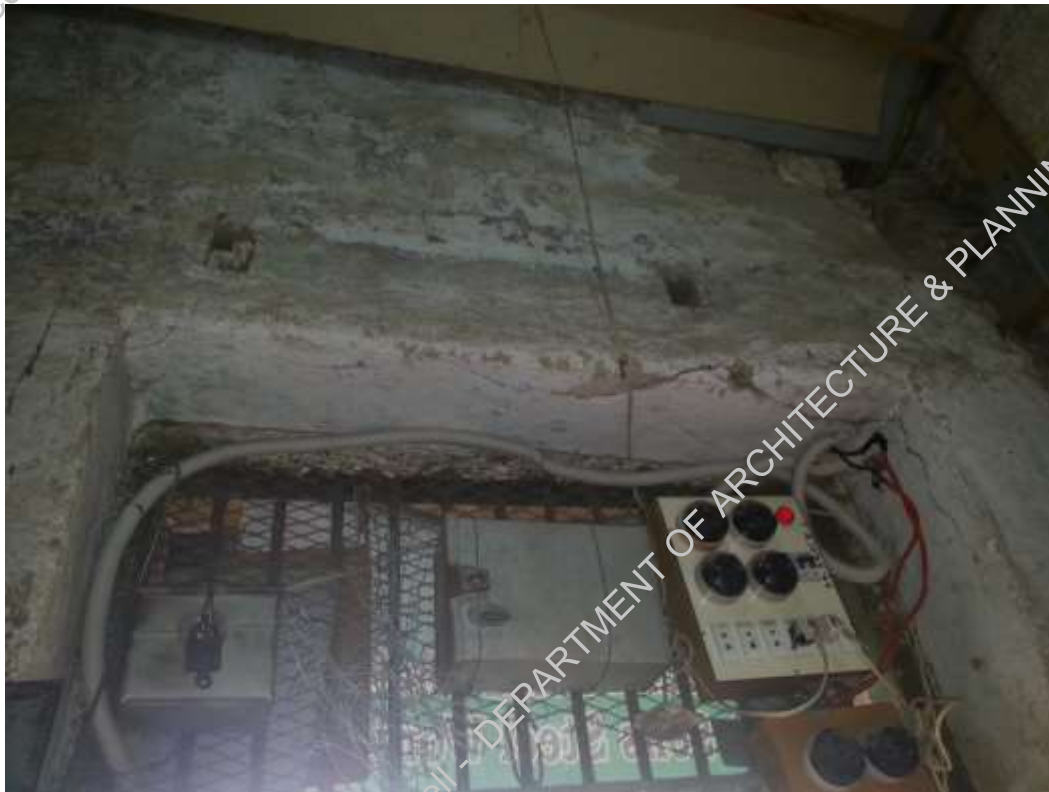
*Plate-5:
Concrete
construction, in
bad condition*

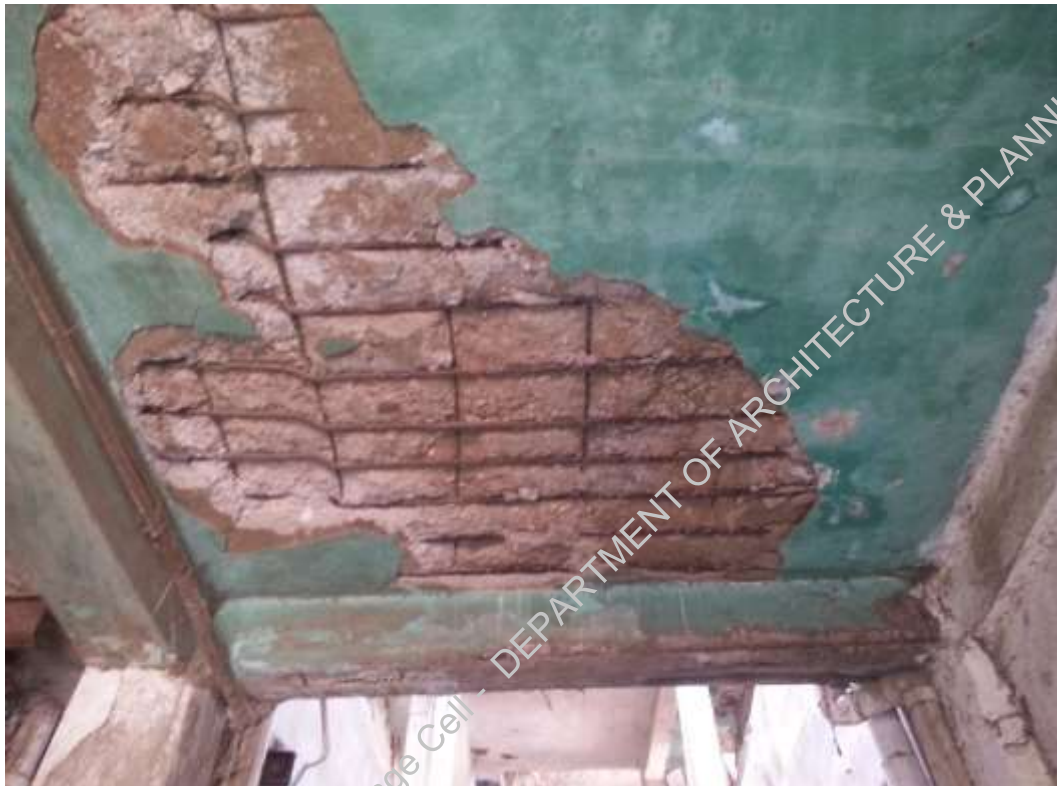
- In most of areas, reinforced concrete floor laid later on, was found in bad condition with concrete cover fallen off. Refer Plate-4, 5, 6 & 7.
- In central courtyard, Reinforced concrete construction, which was done later-on, was found in bad shape. (Refer Plate 8 and 9)

*Plate-4:
reinforced
concrete slab in
bad condition,
concrete cover
has fallen off.*

- In existing condition, building structure is not stable and is susceptible to failure/collapse.
- Extensive strengthening is required to make the structure stable. Strengthening measures to be done with careful methodology which will include propping of existing walls/floors before proceeding with any strengthening technique.
- Interventions should be removed such as the additional floor on top and extra floor finishes where present, to decrease the dead load on existing walls,
- Strengthening techniques can be adopted, including but not limited to;
 - a. Pointing of mortar in existing stone masonry joints,
 - b. Application of mesh plaster
 - c. Introducing internal mild steel frame within the building to secure the occupants from fatal damages.

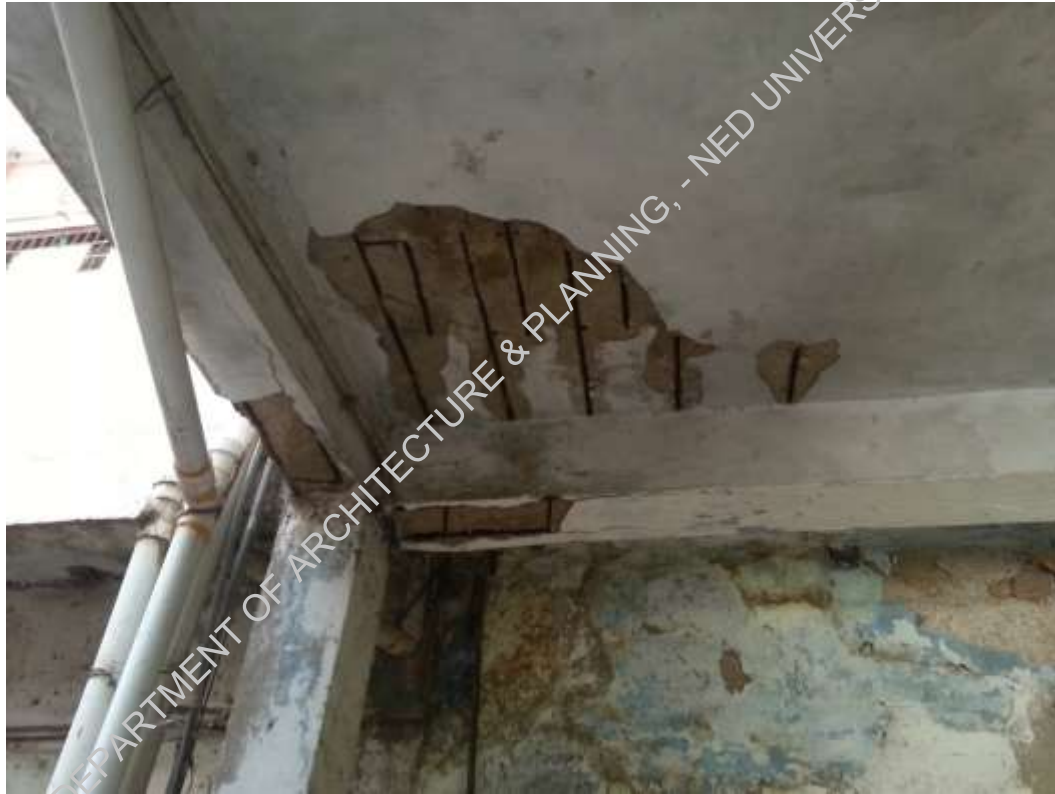
*Plate-5:
Concrete
construction
done later on,
in bad
condition*

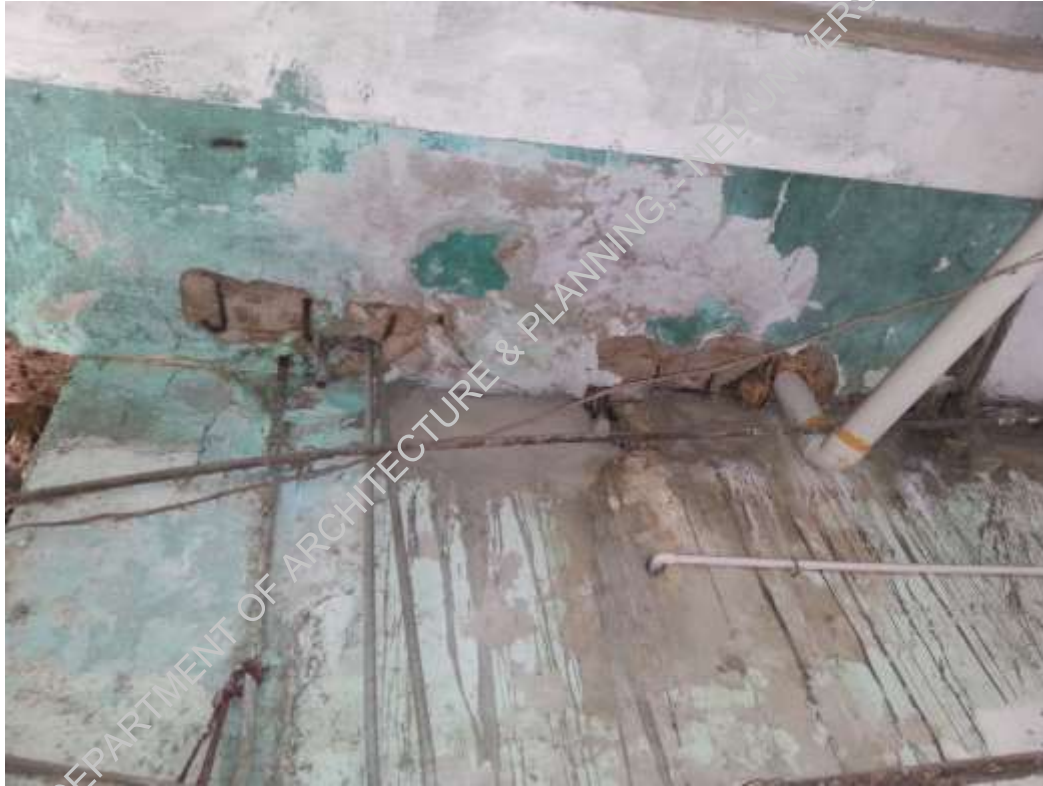
Plate-7: Bad condition of roof slab due to punctures and seepage from plumbing lines

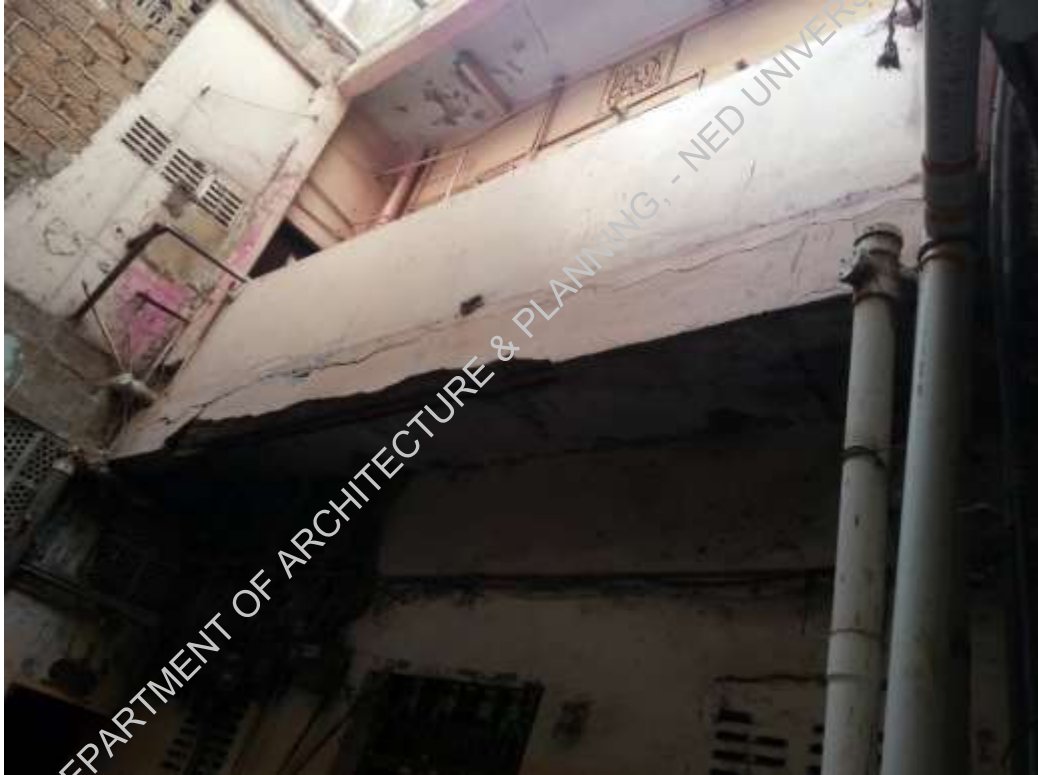
Plate-9: Bad condition of reinforced concrete construction of central court

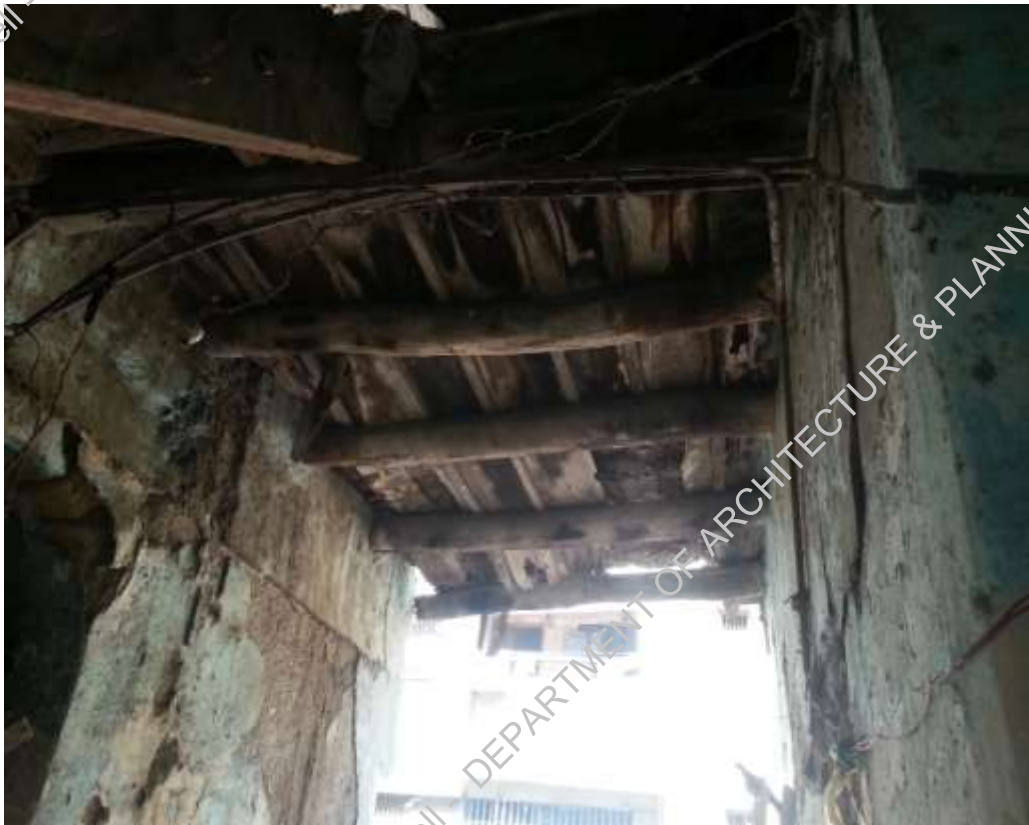
Plate-10: Bad condition of original timber flooring and walls at ground floor

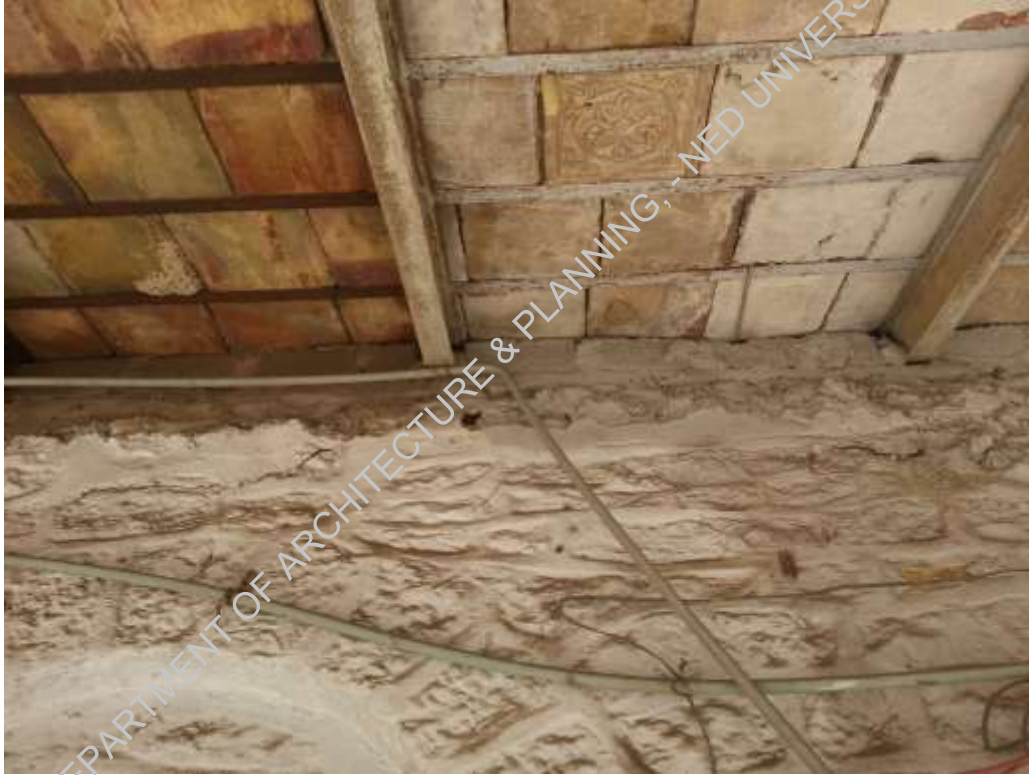
*Plate-12:
condition of
original roof*

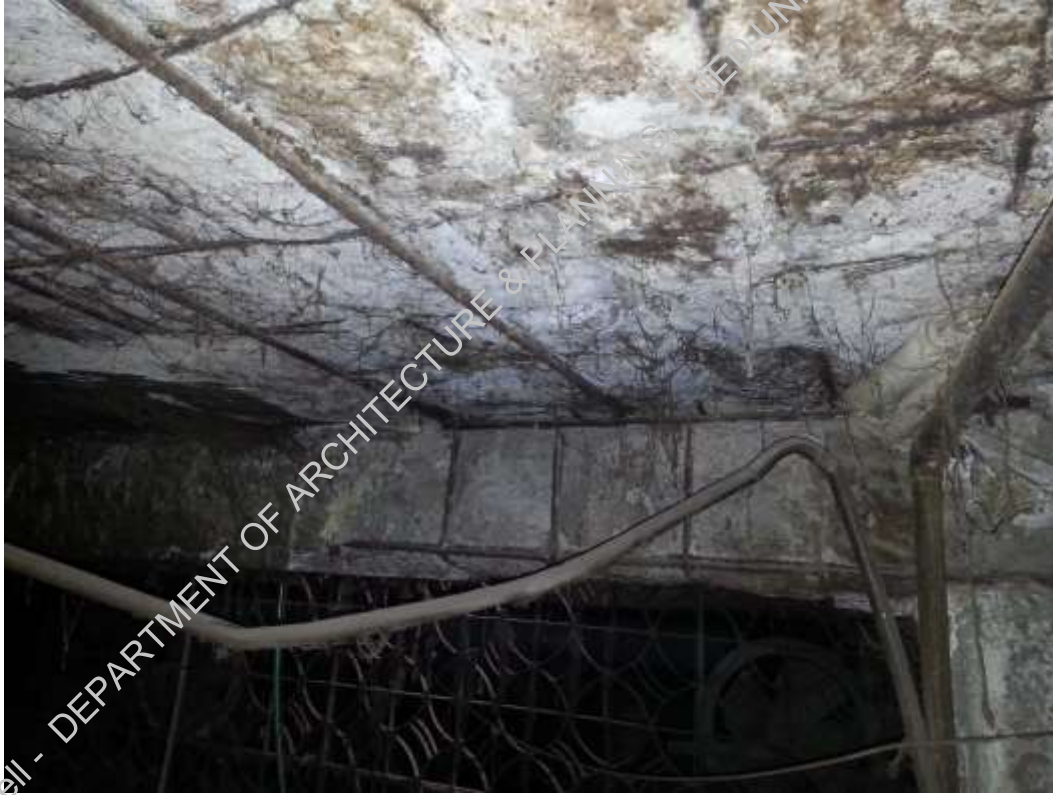
*Plate-5:
Concrete
construction
done later on,
in bad
condition,
concrete cover
has fallen off.*

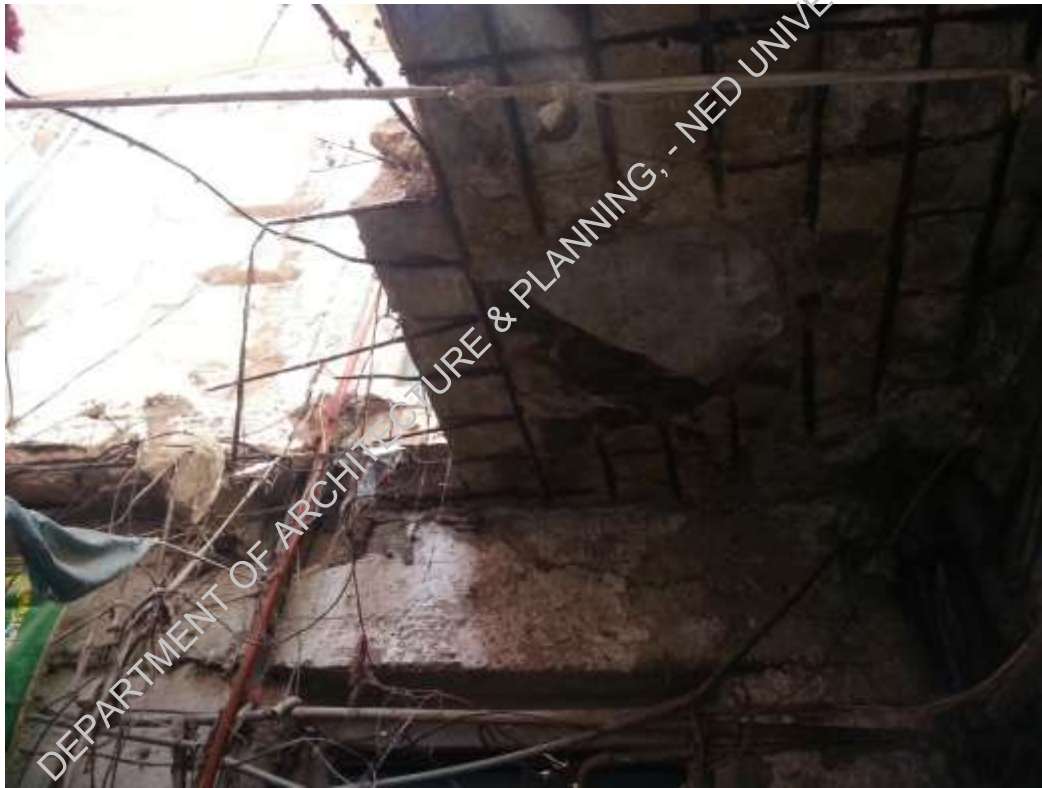
Plate-7: Bad condition of roof slab due to seepage from plumbing lines

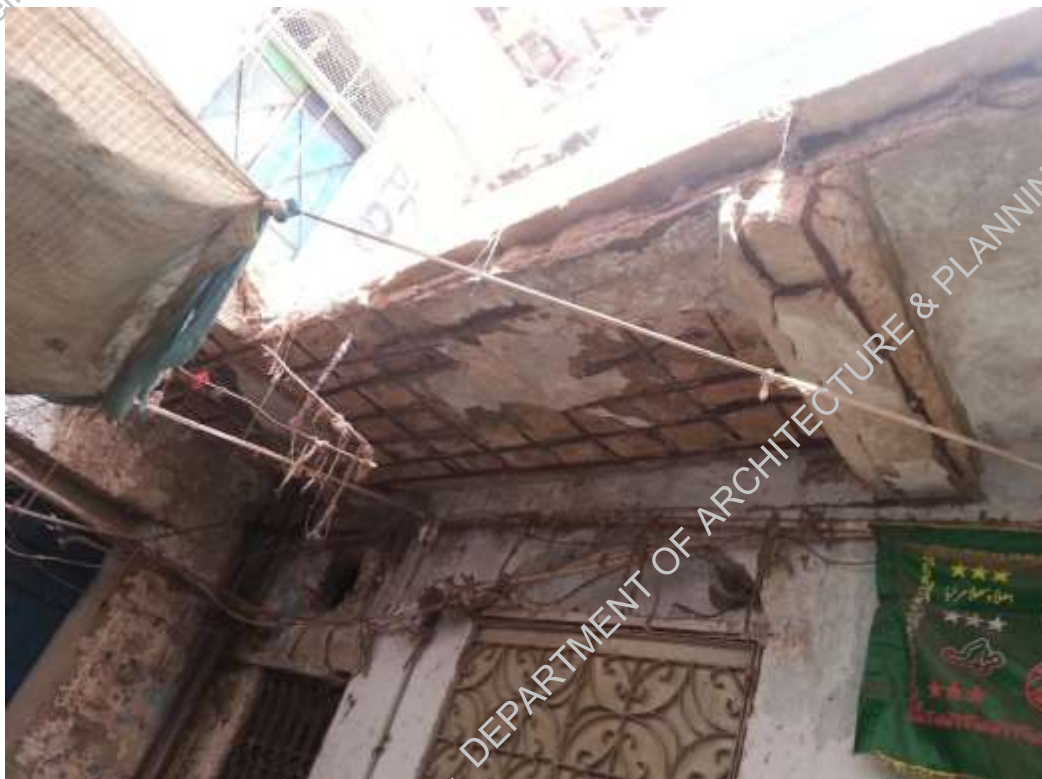
Plate-8: Projection plaster being fallen off

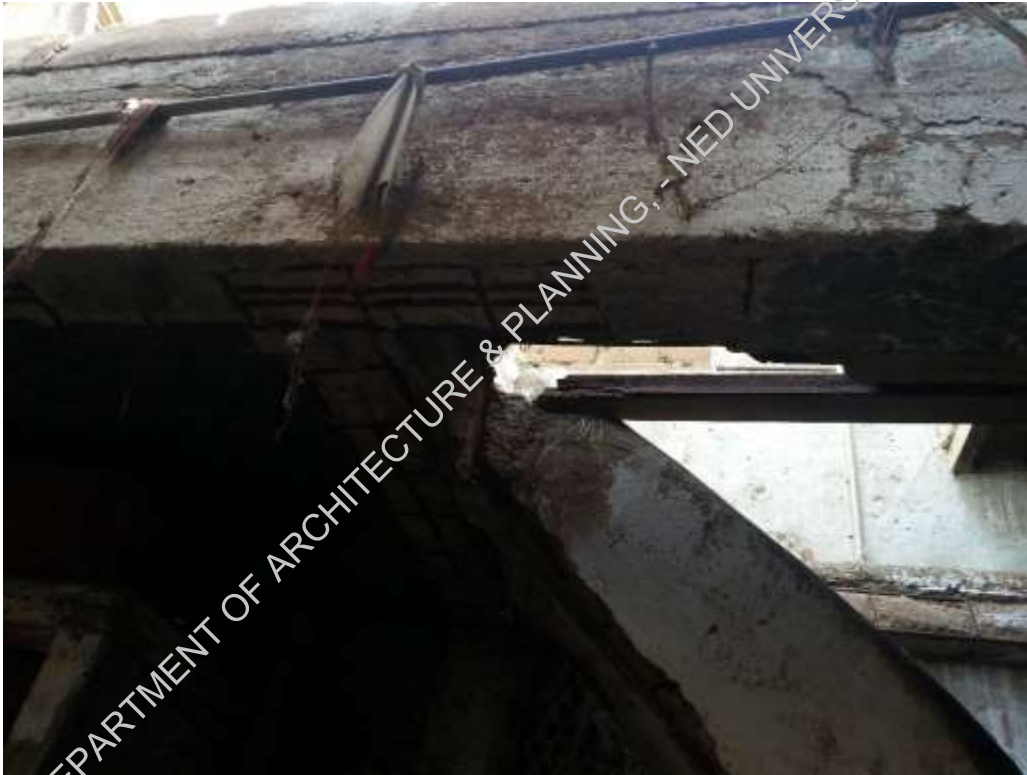
*Plate-9: Stair in
Bad condition*

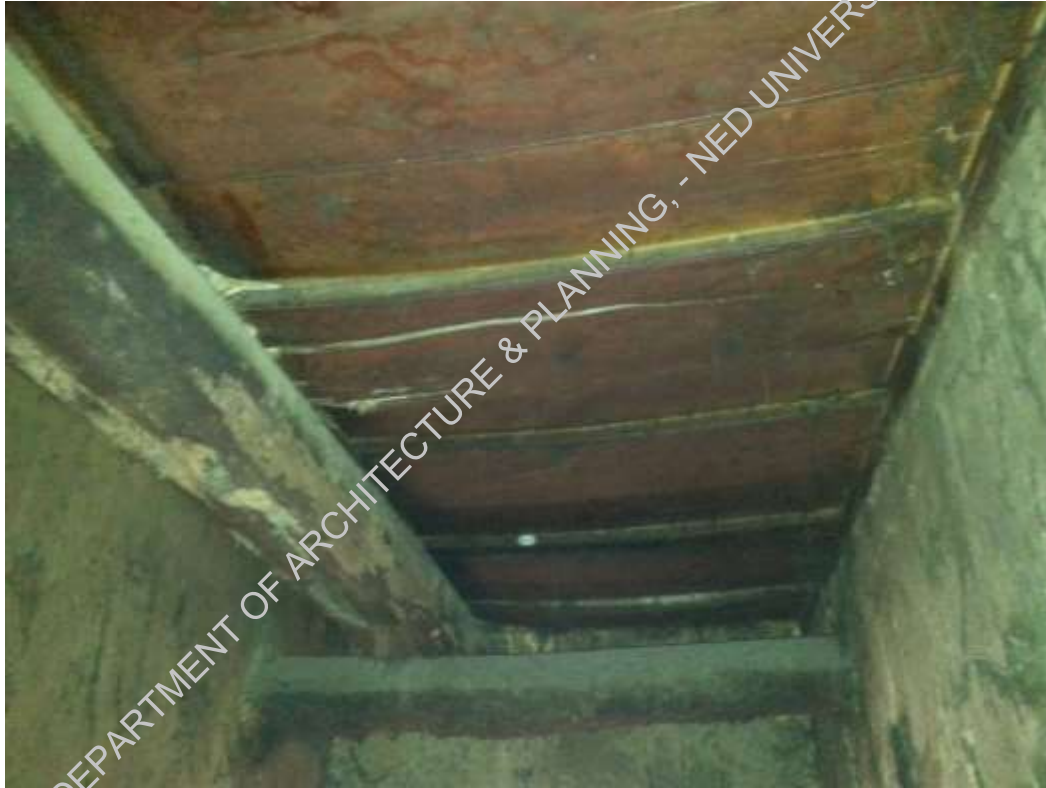
*Plate-4:
Condition of
wooden deck*

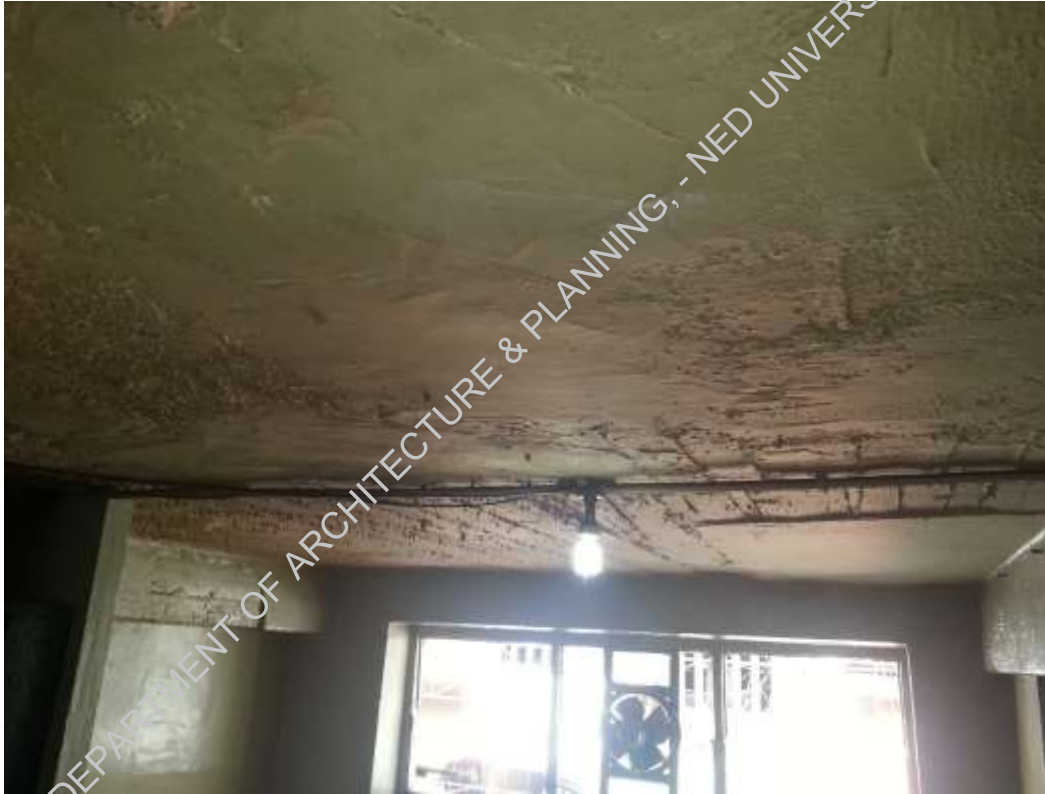
*Plate-3:
reinforced
concrete slab
condition,*

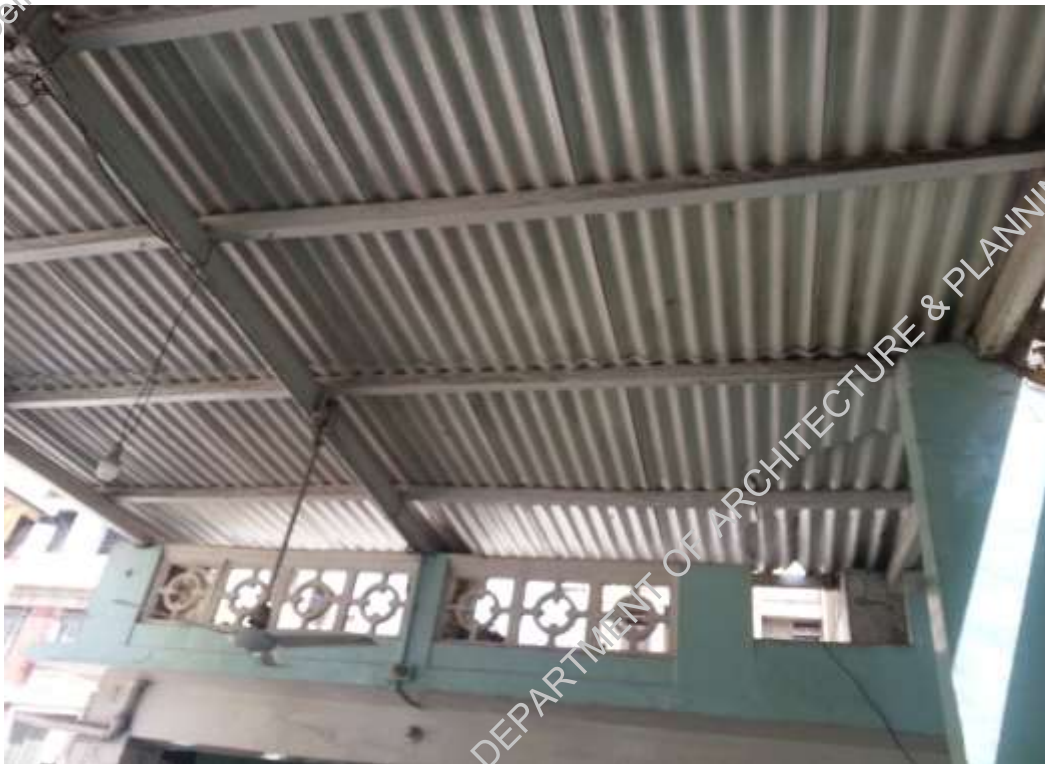
*Plate-4:
Temporary roof
above*

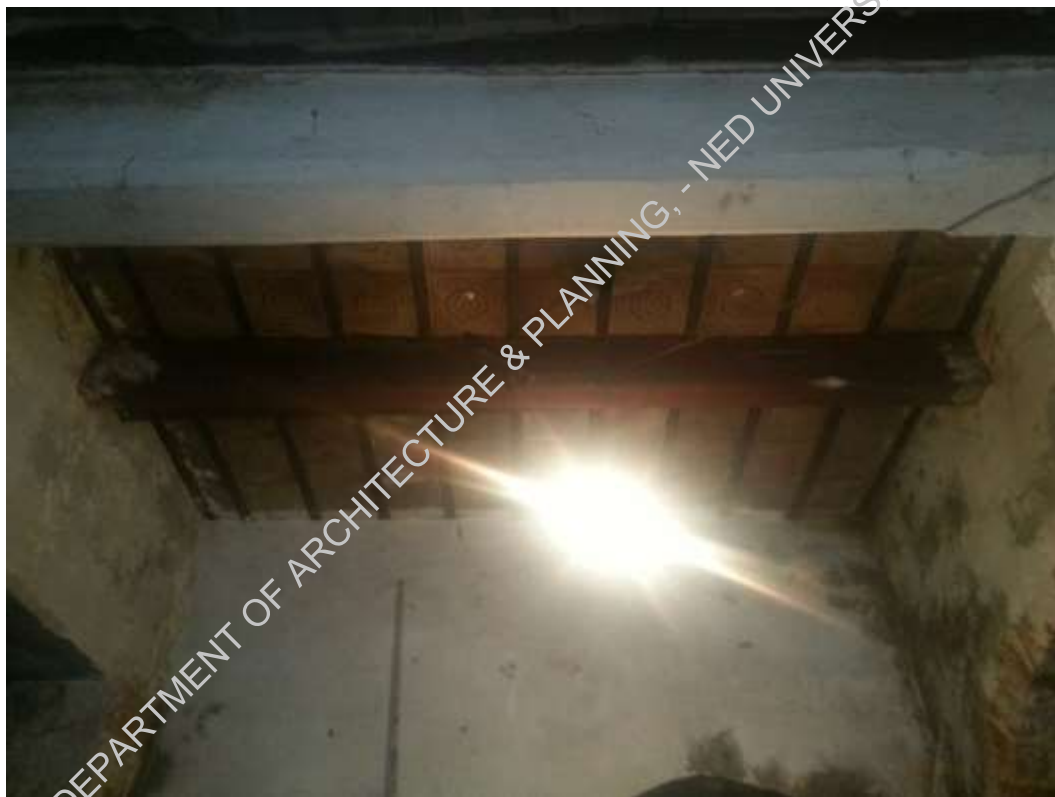
*Plate-5:
Original timber
beam intact*

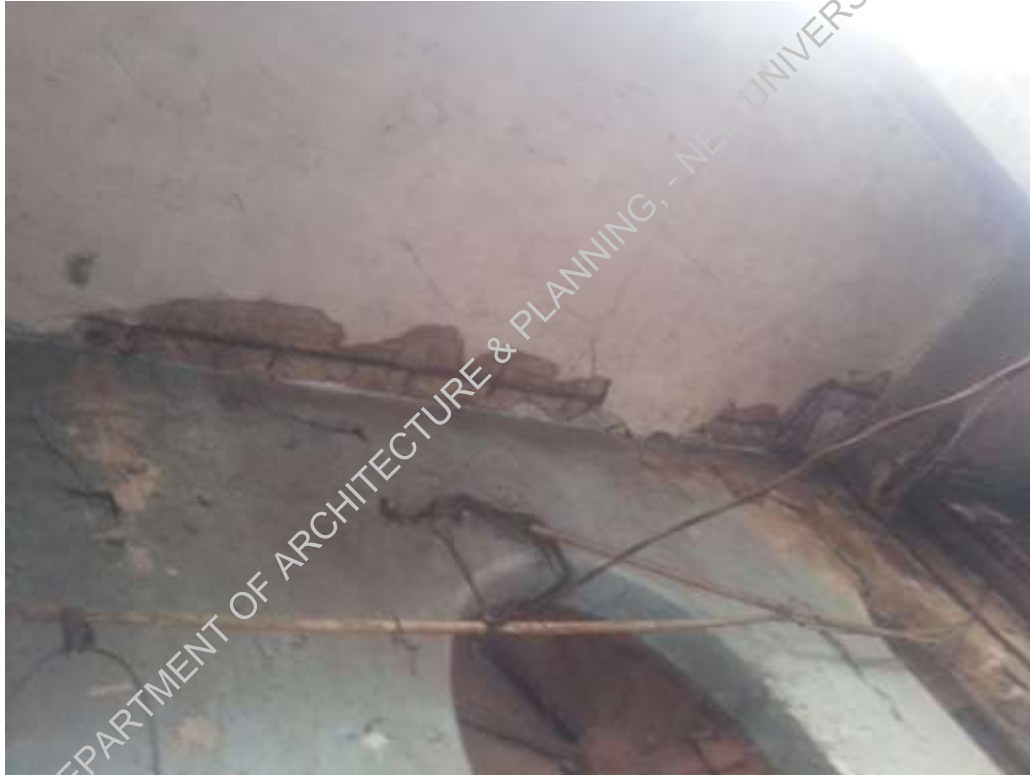
Plate-9: Bad condition of reinforced concrete construction of central court

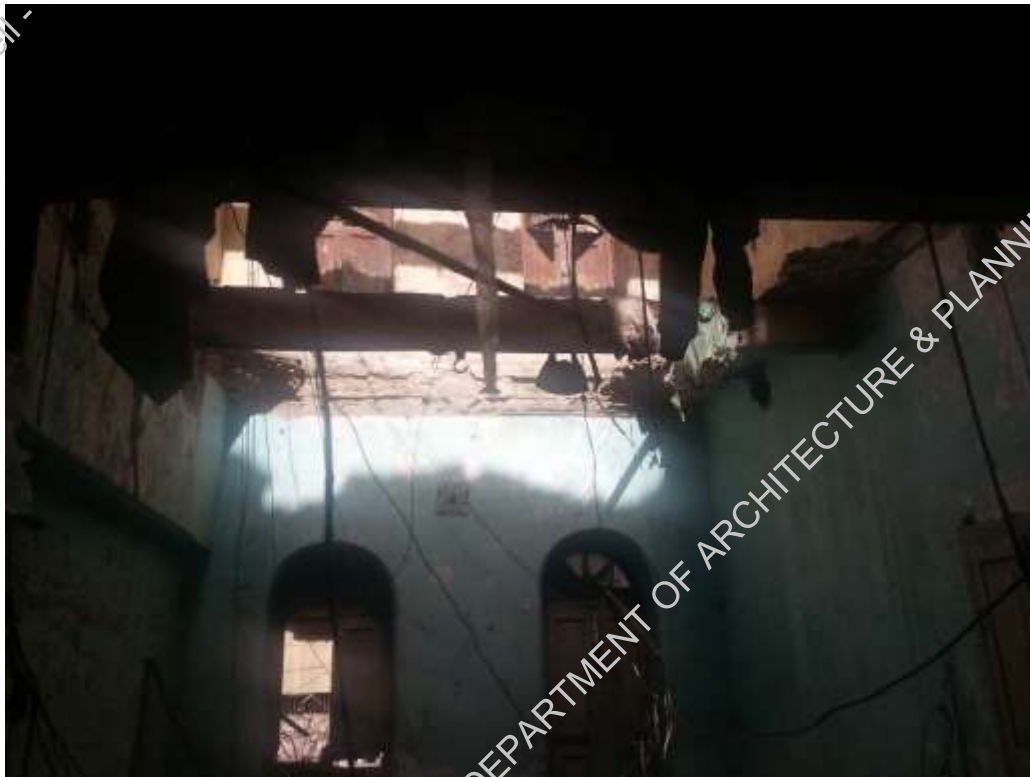
Plate-10: collapsed slab at 2nd floor

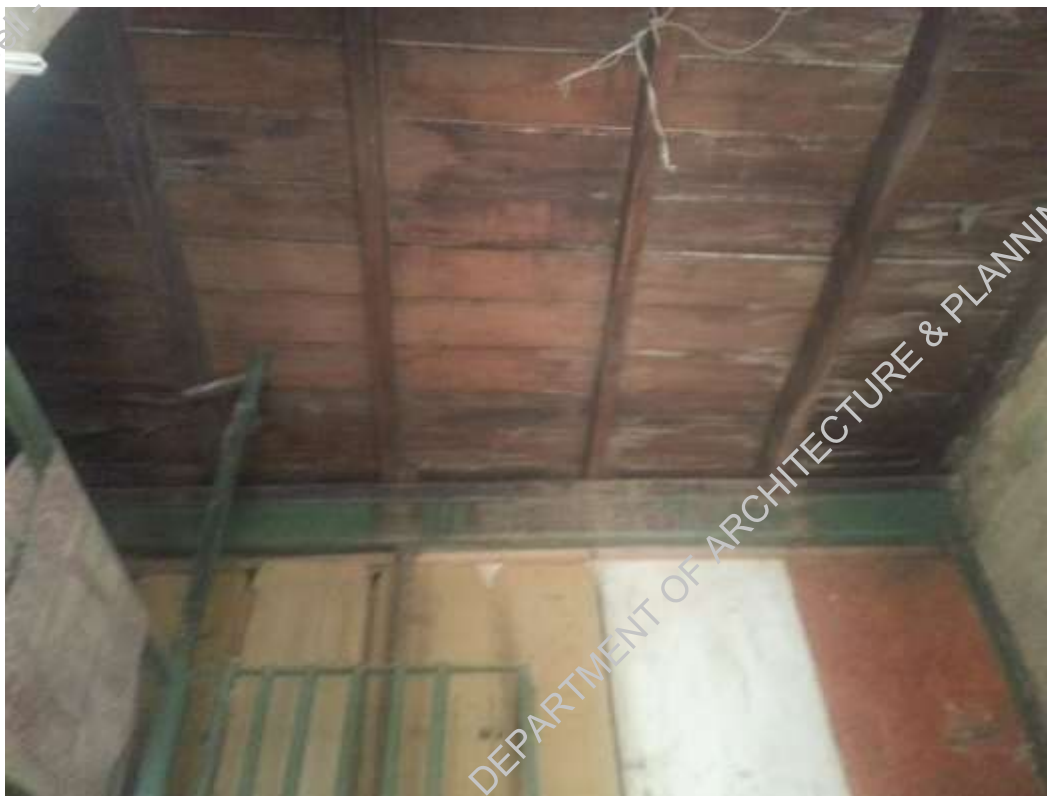
*Plate-5:
condition of
wooden slab at
ground floor*

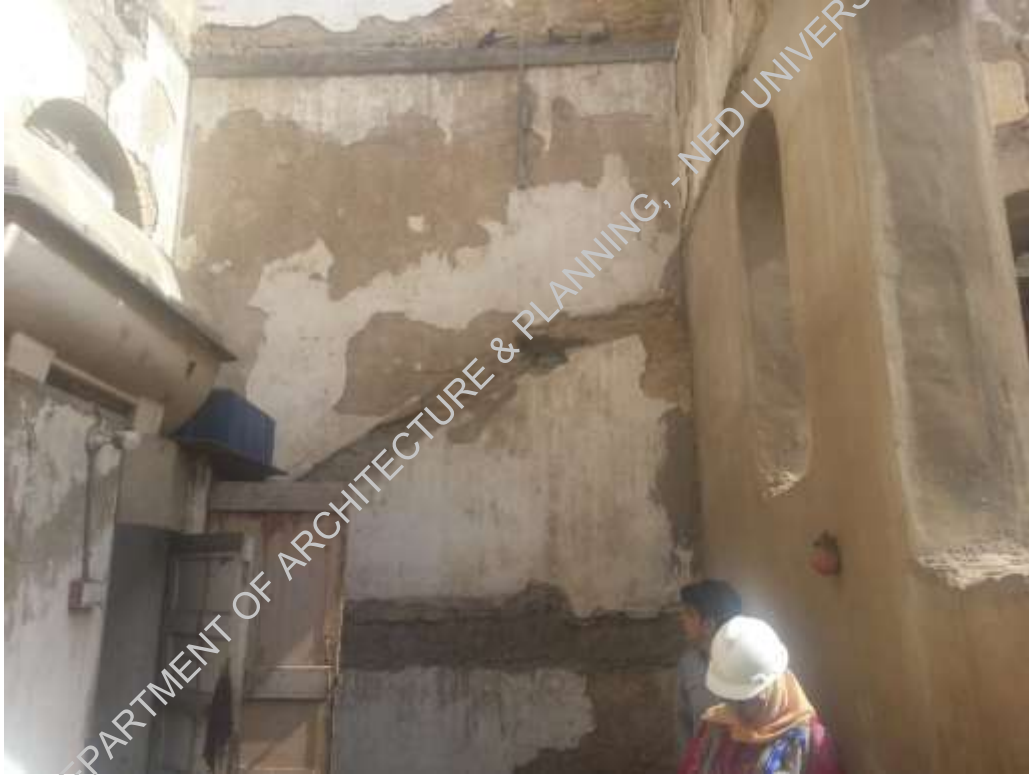
Plate-10: stair removed

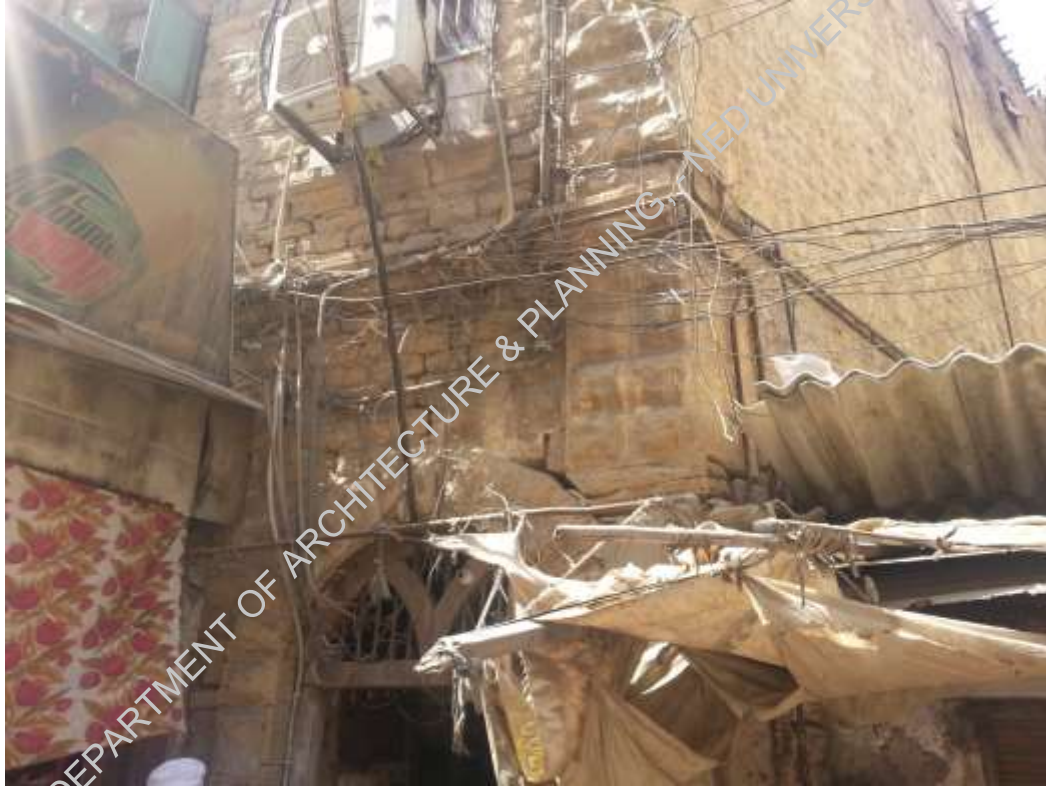
*Plate-4: vertical
cracks observed*

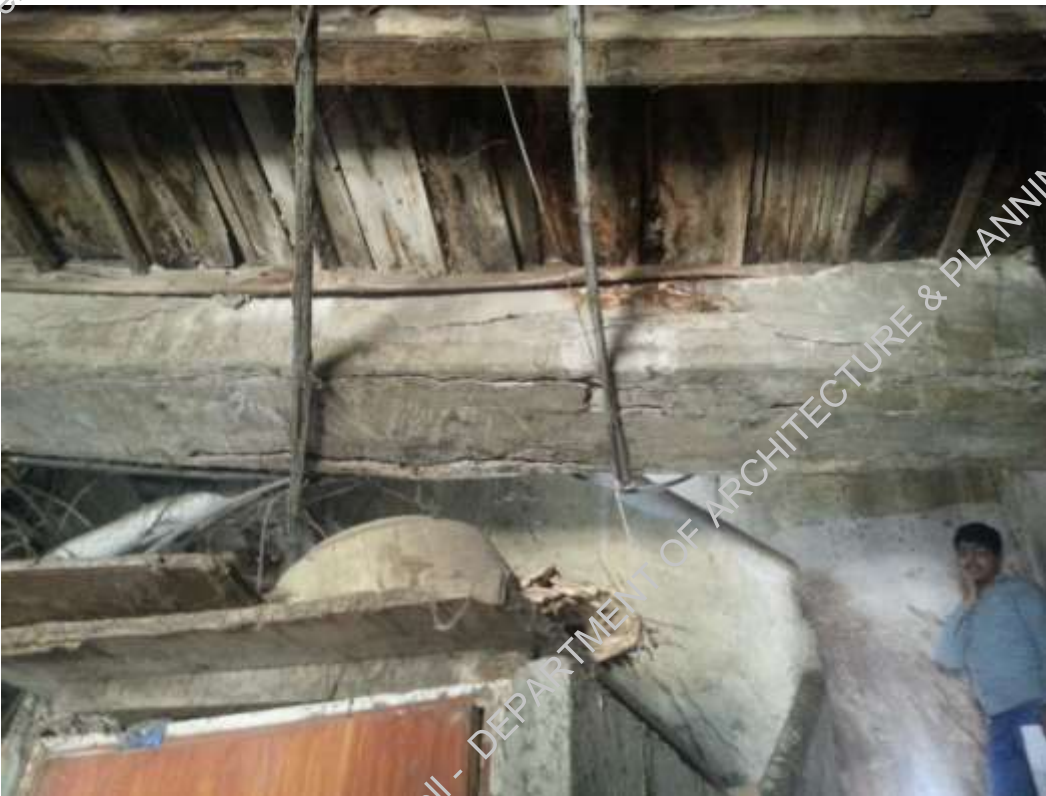
*Plate-5:
Concrete
construction
beam deflecting*

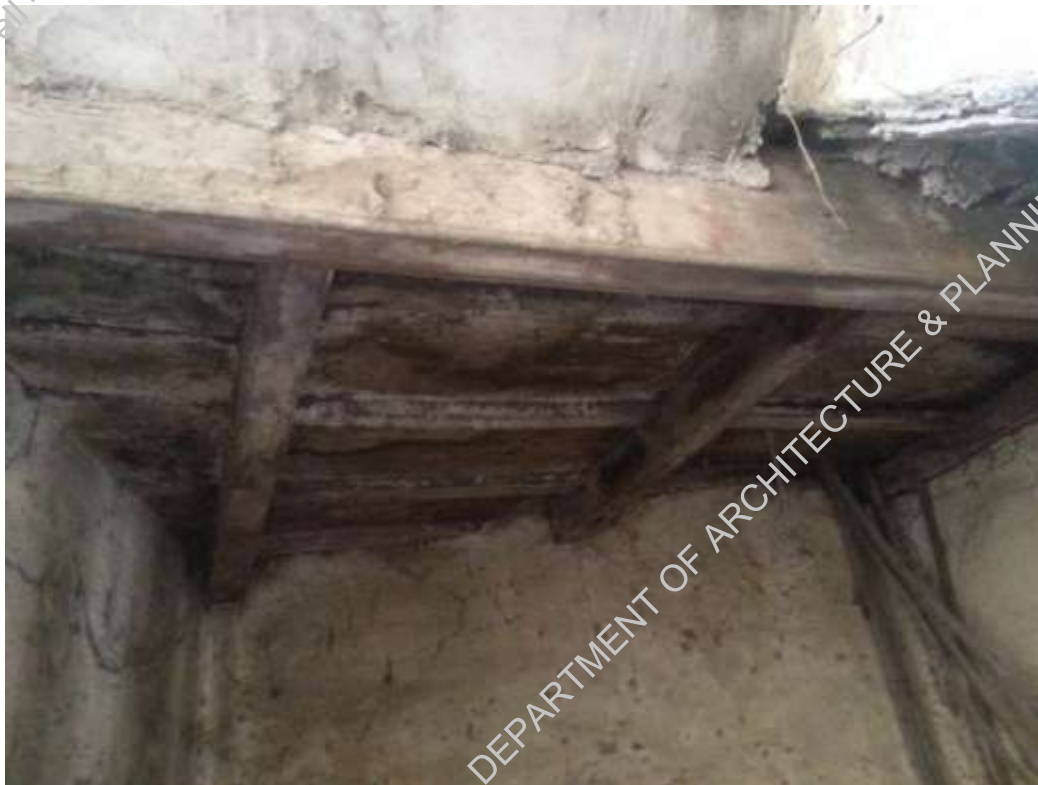
*Plate-7: Bad
condition of
timber slab due
seepage from.*

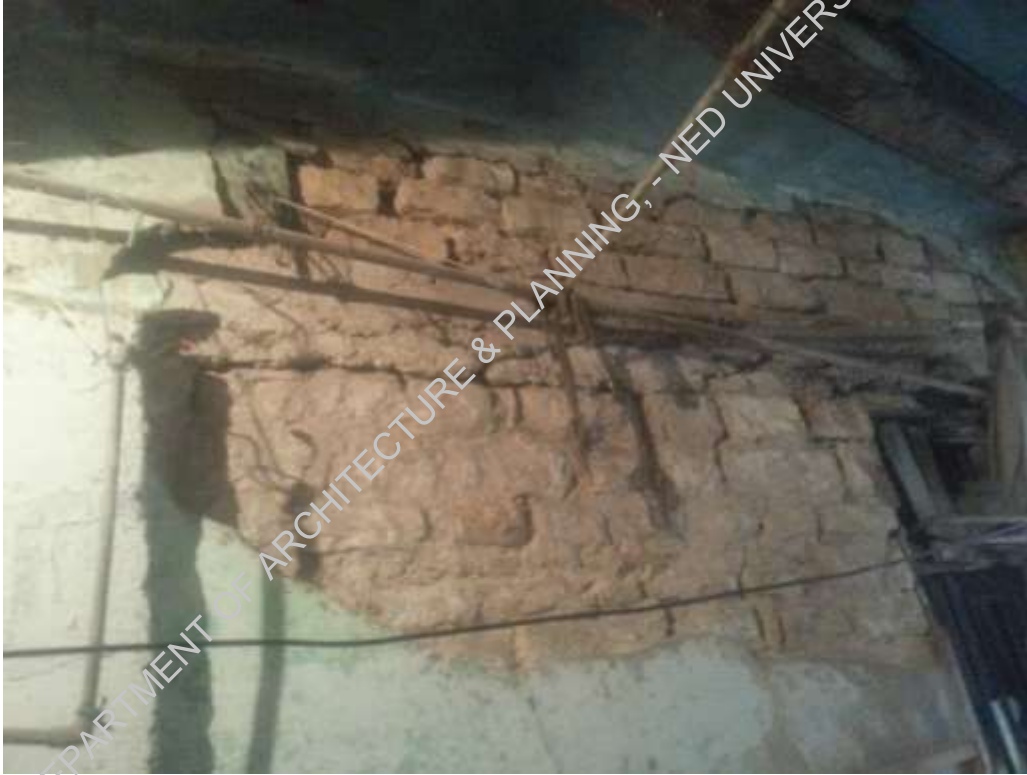
Plate-10: bad condition of masonry wall
