Condition Assessment of Heritage Buildings - Karachi Declared as “Dangerous”

JUNE 2018

Structural Consultant

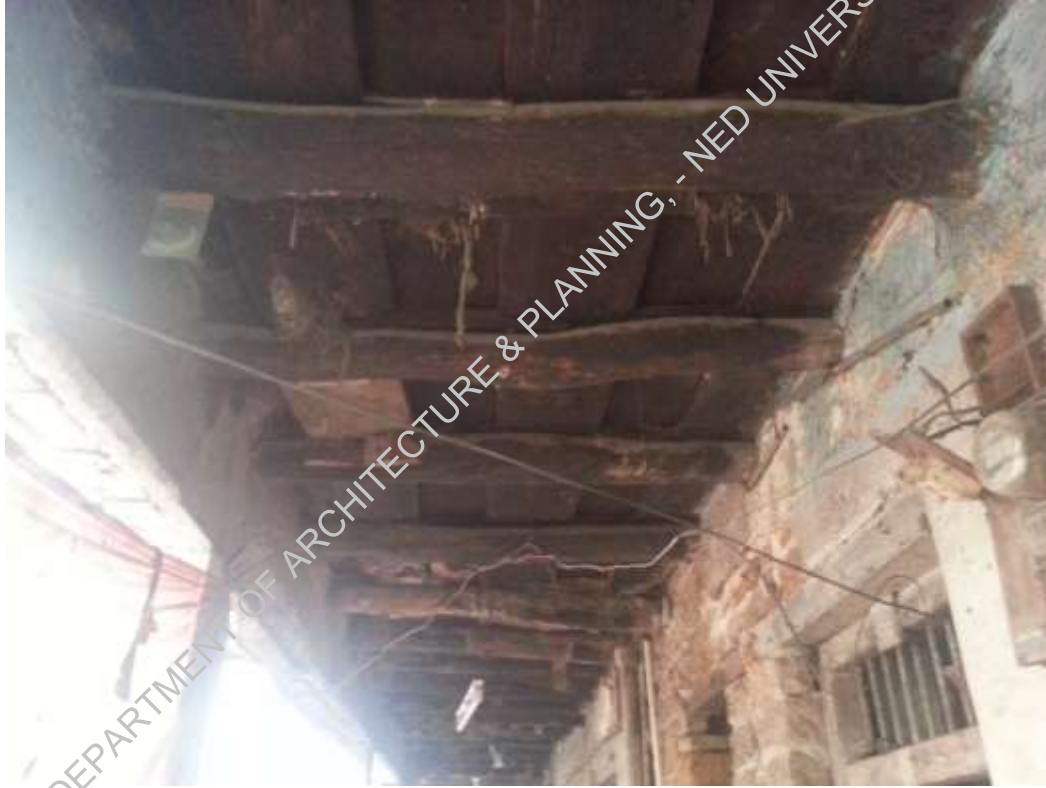
*Plate-4:
original deck in
bad condition,*

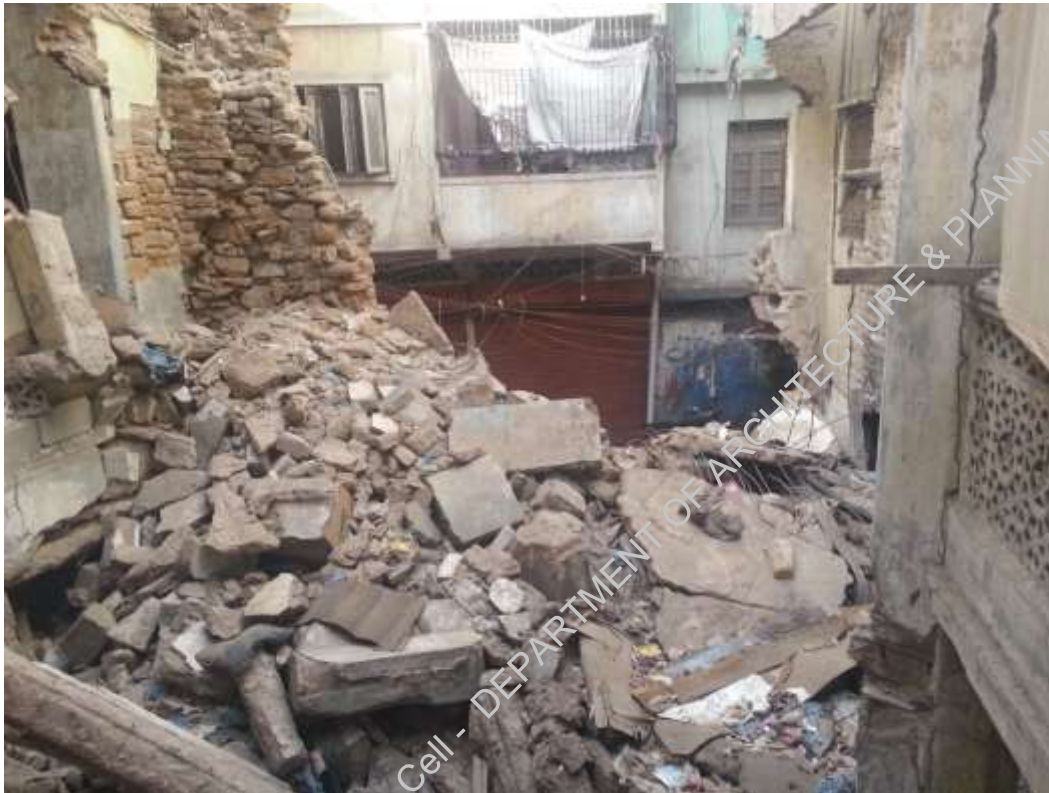
*Plate-5:
Concrete
construction
collapsed*

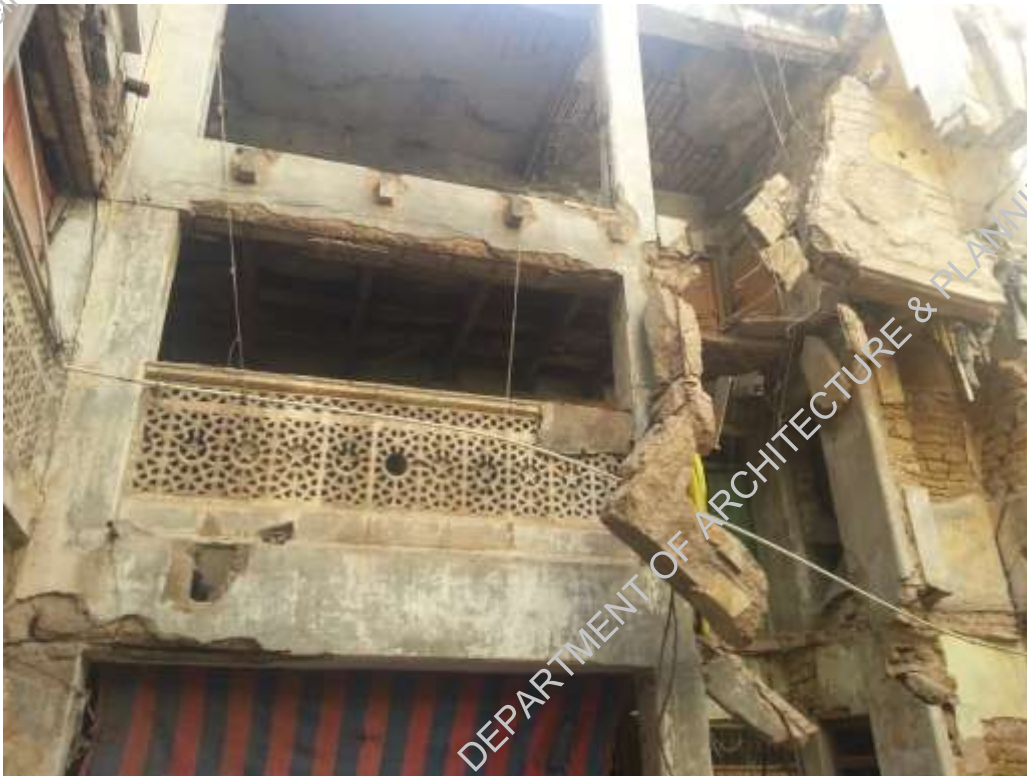
Plate-9: collapsed area

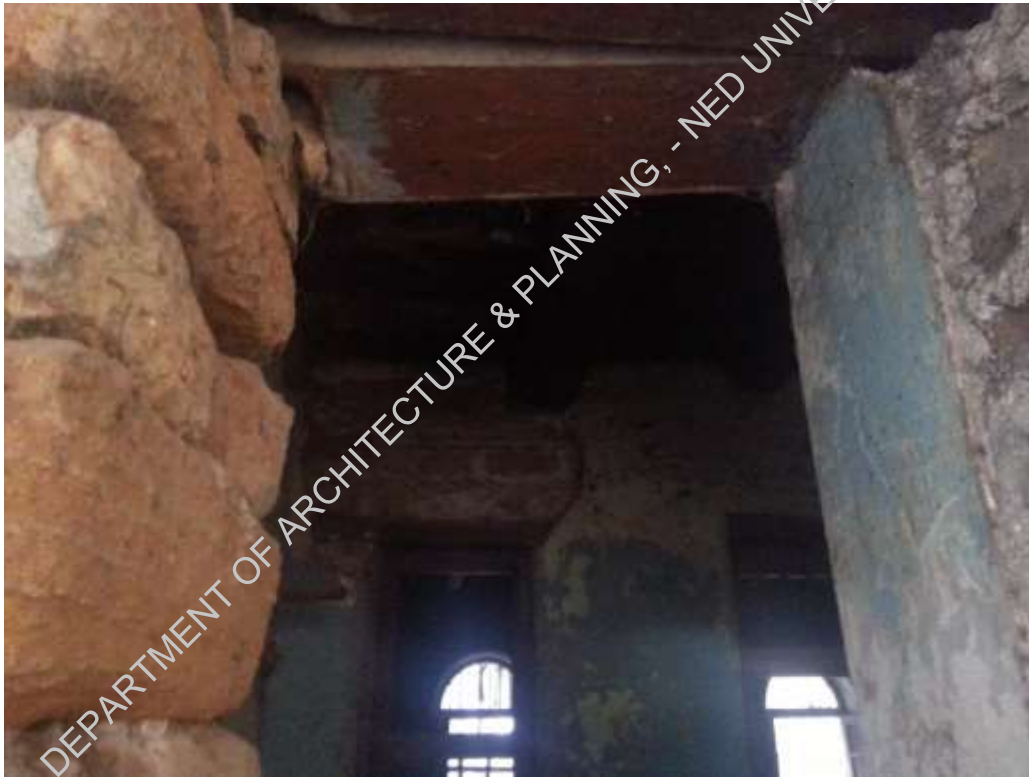
Plate-10: Bad condition of original timber slab

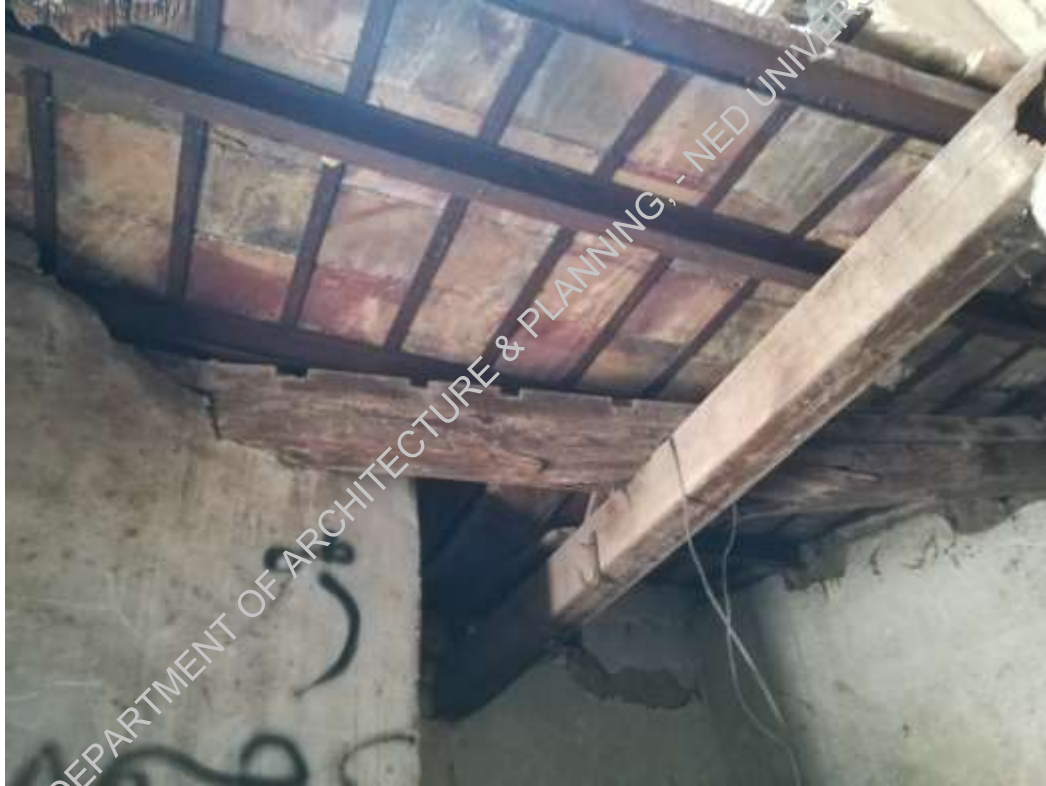
Plate-4: timber slab in bad condition,

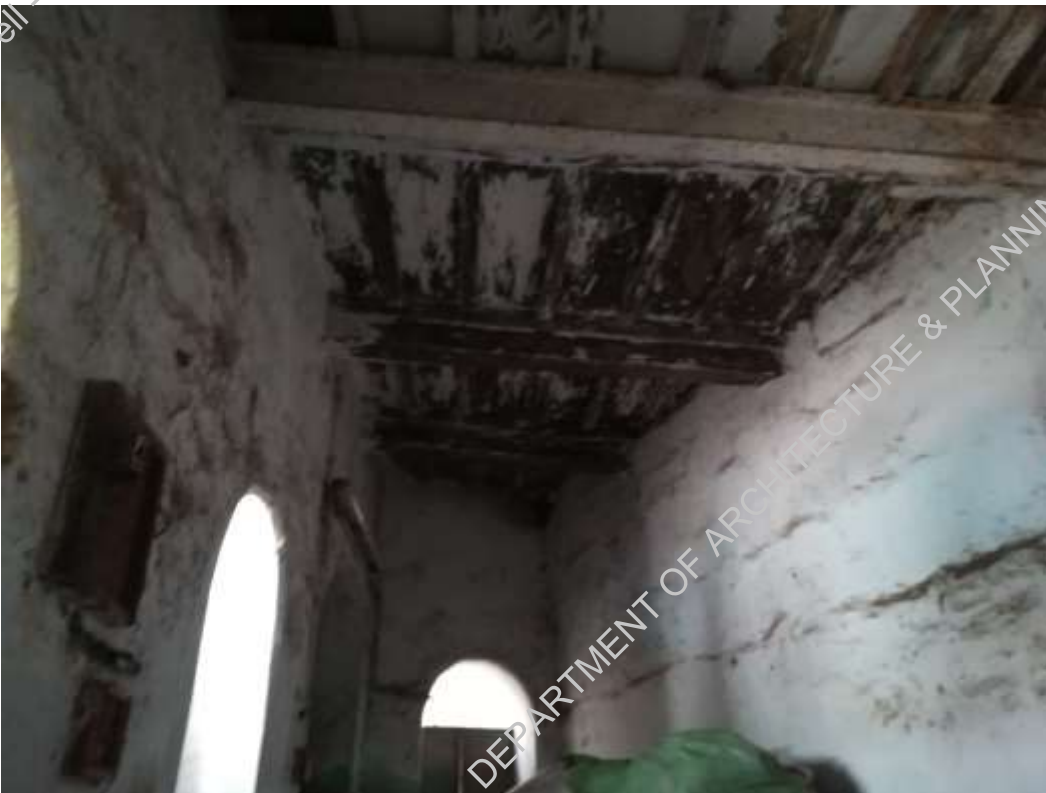
Plate-5: steel girders installed to support existing slab

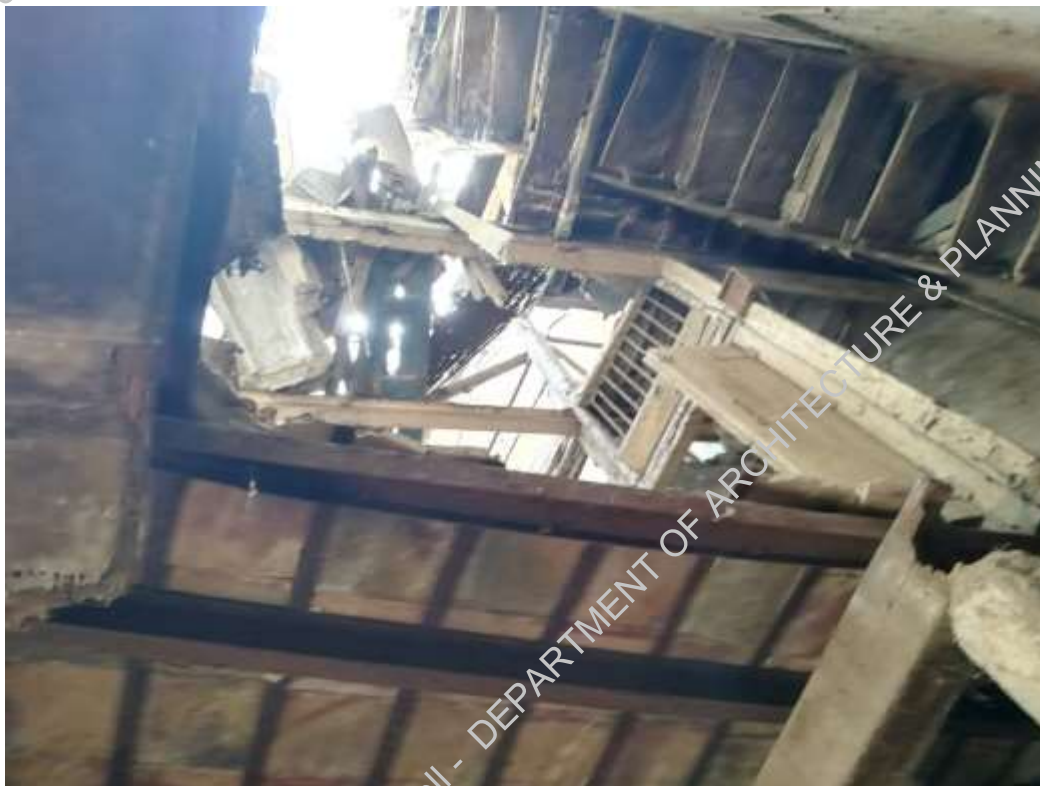
*Plate-7: slab
and stair
collapsed*

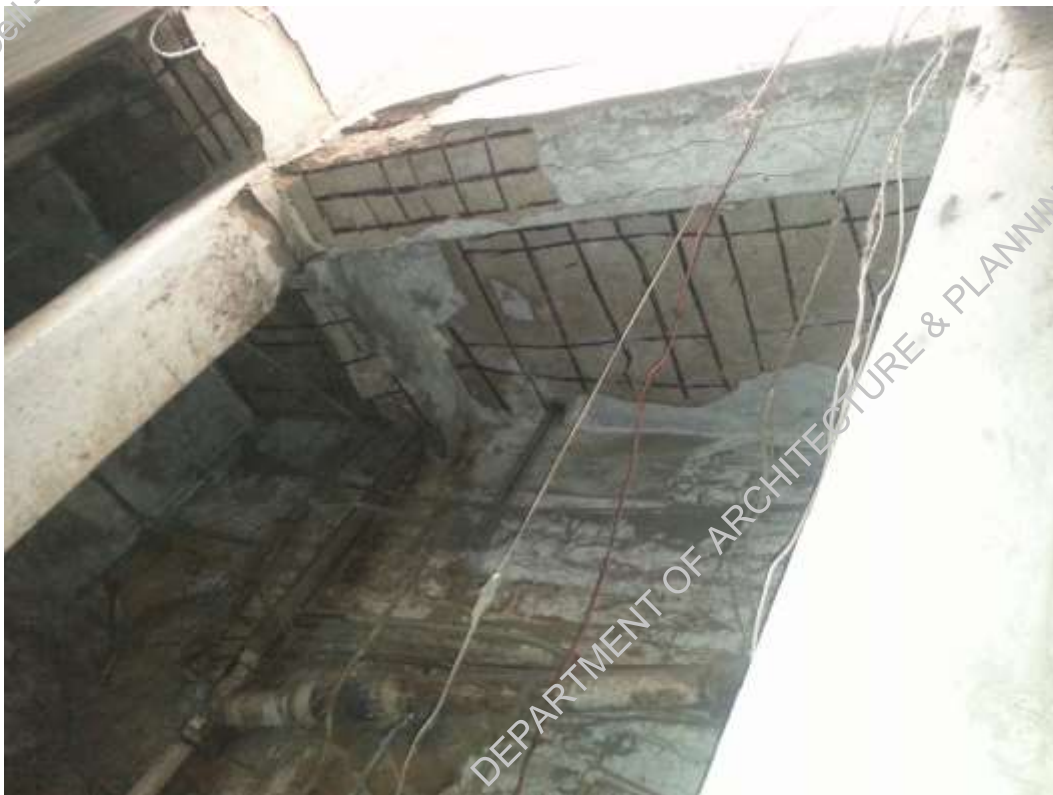
Plate-5: Concrete construction done later on, in bad condition

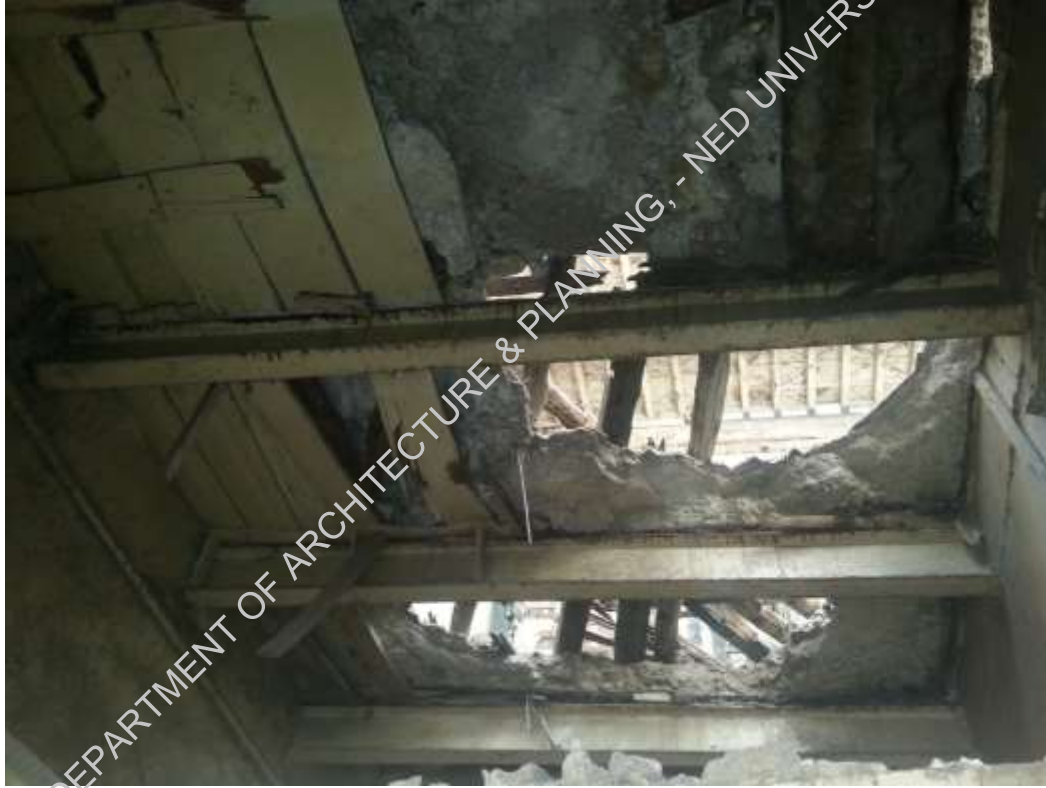
Plate-4: slab collapsed

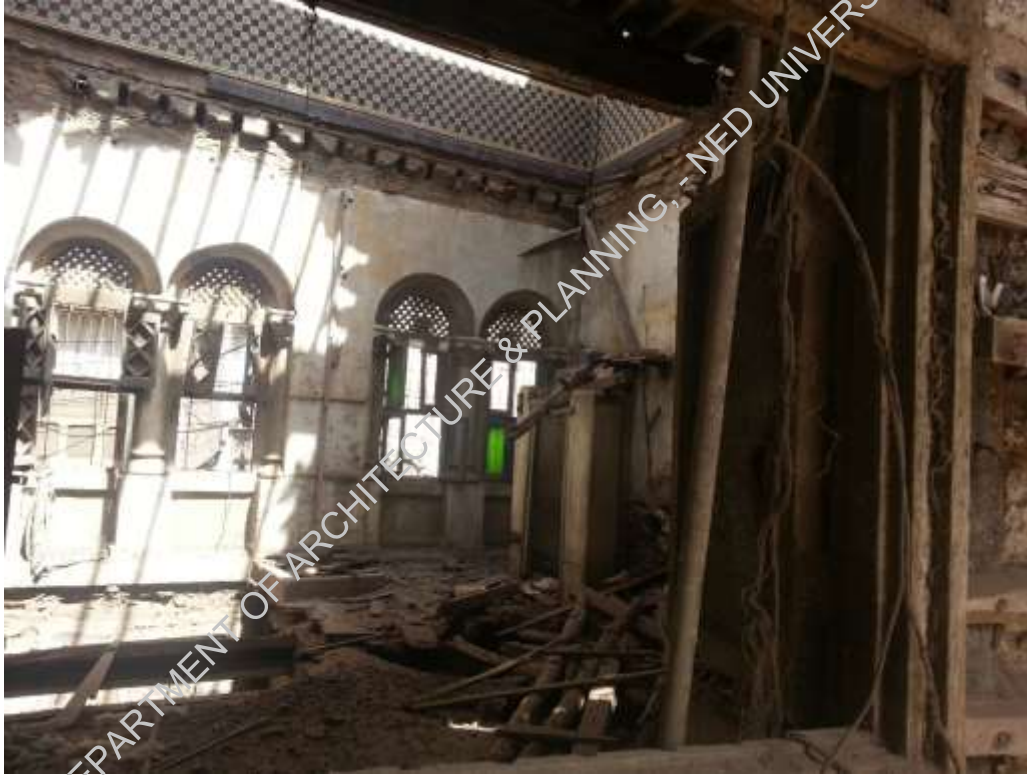
Plate-10: slab collapsed

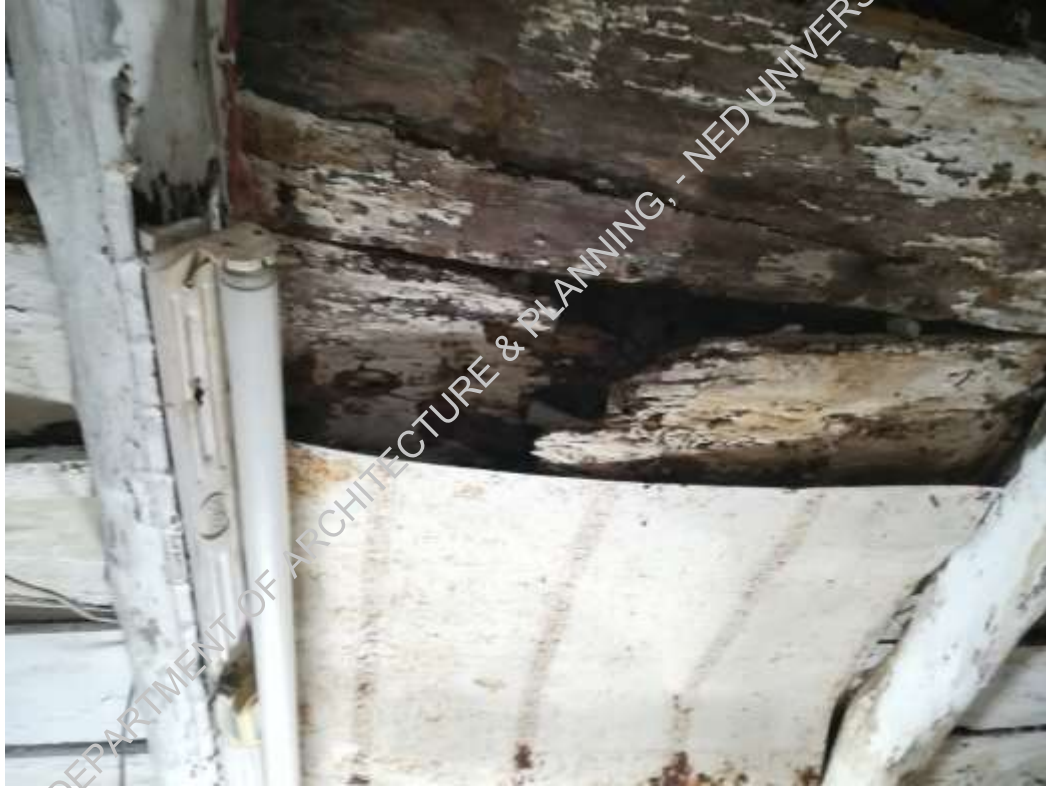
Plate-4: timber slab in bad condition,

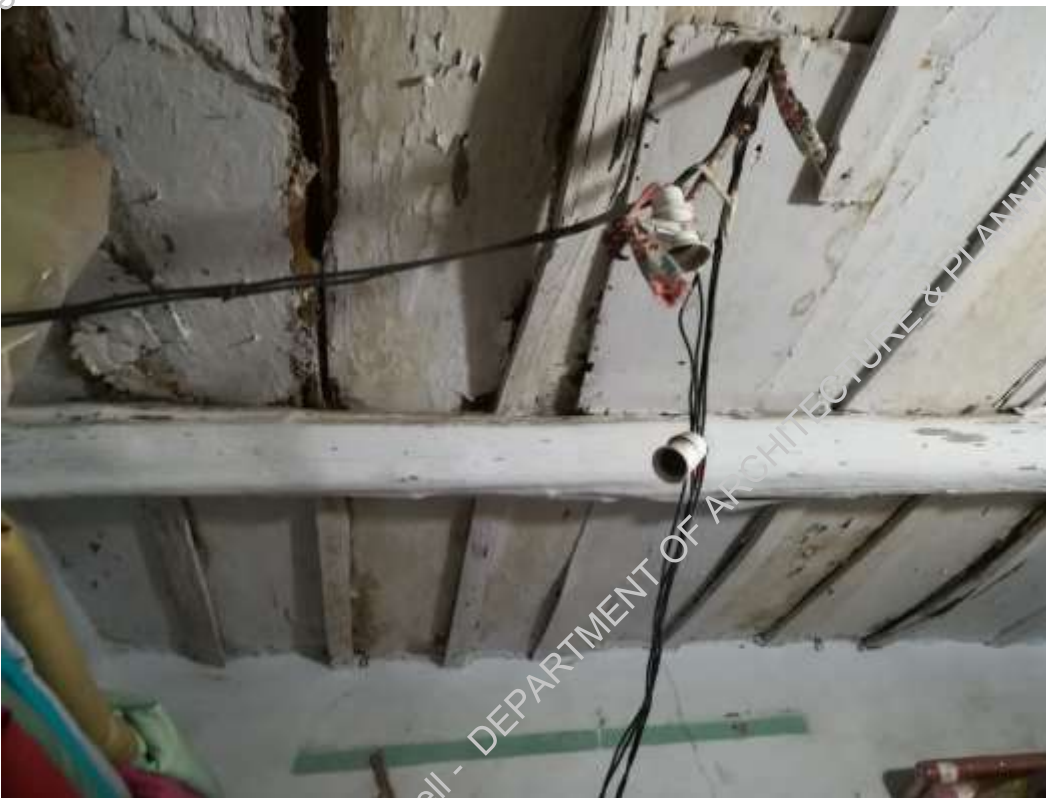
Plate-5: slab deflecting

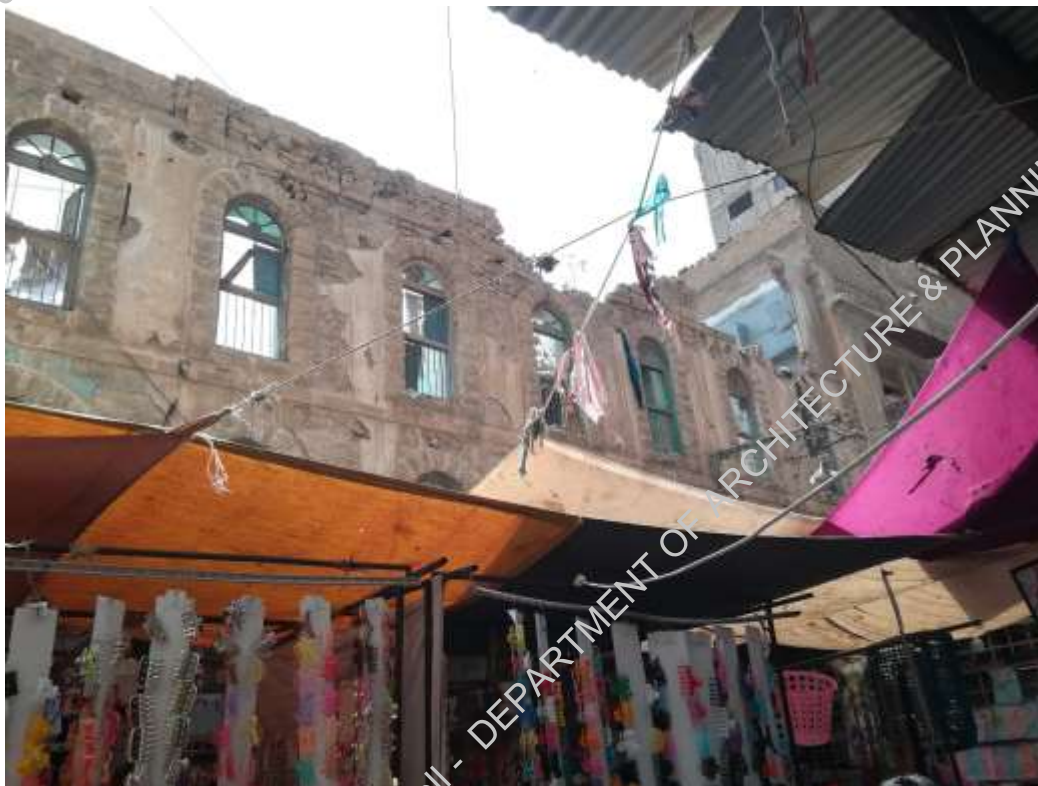
*Plate-7:
masonry
collapsed*

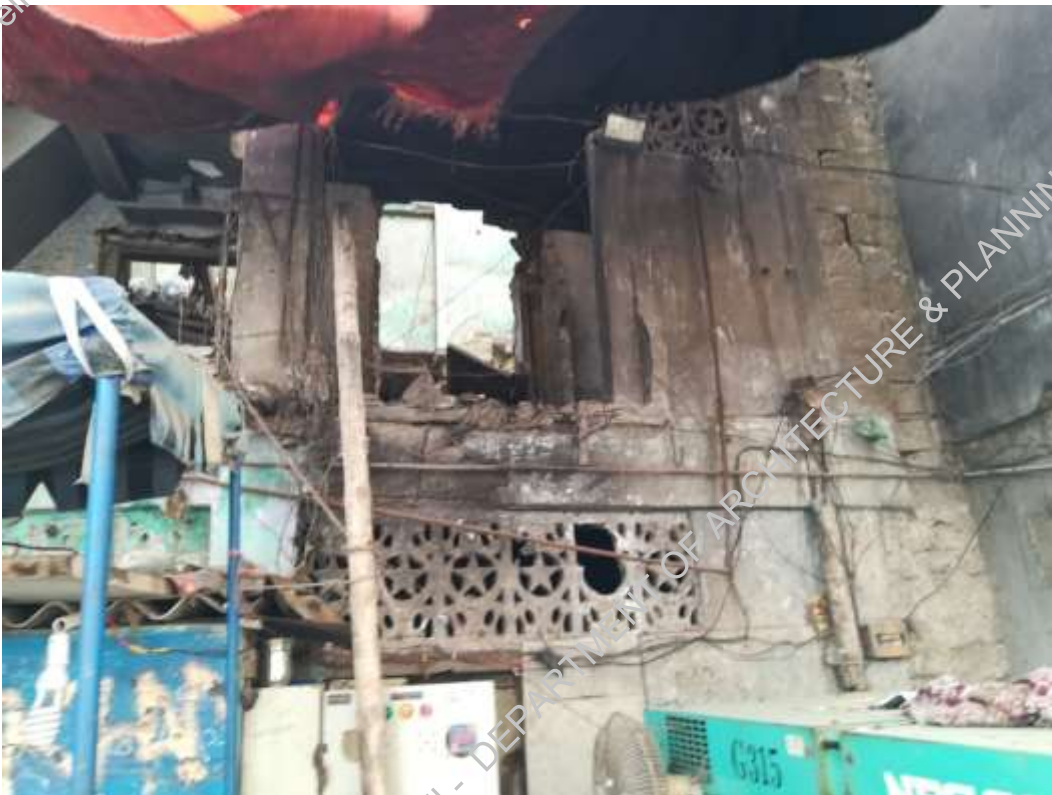
*Plate-5:
Concrete
construction
done later on,
in bad
condition*

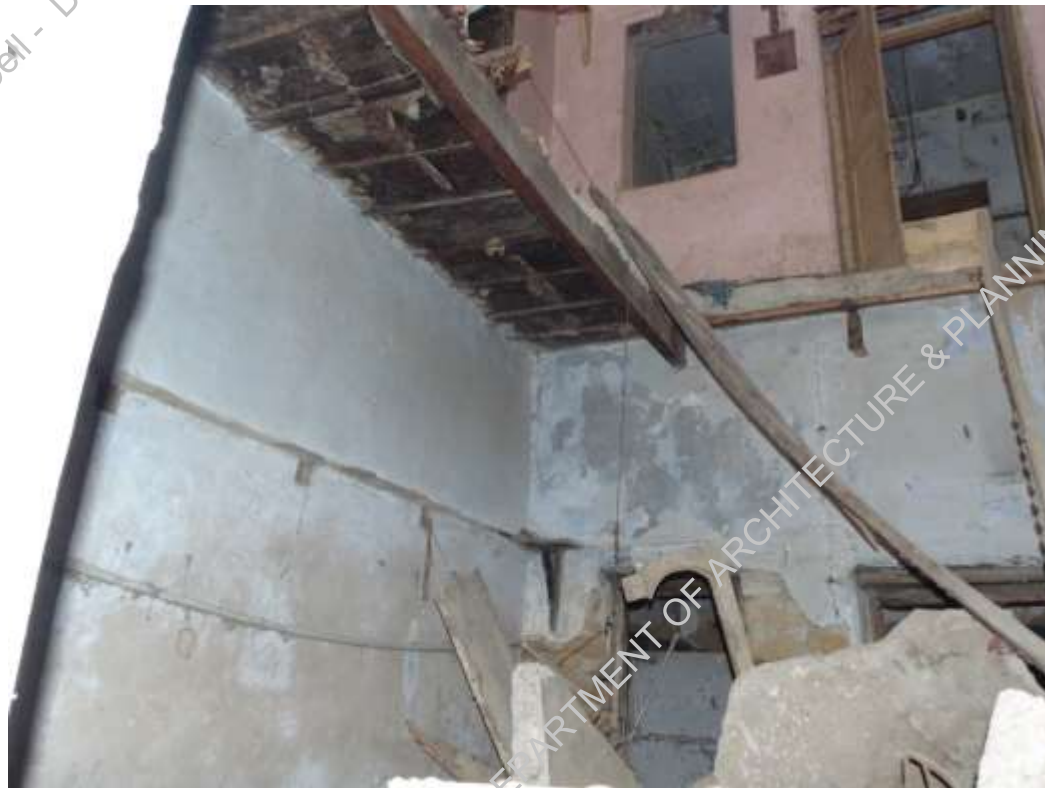
Plate-7: Bad condition of roof slab due to punctures and seepage from plumbing lines

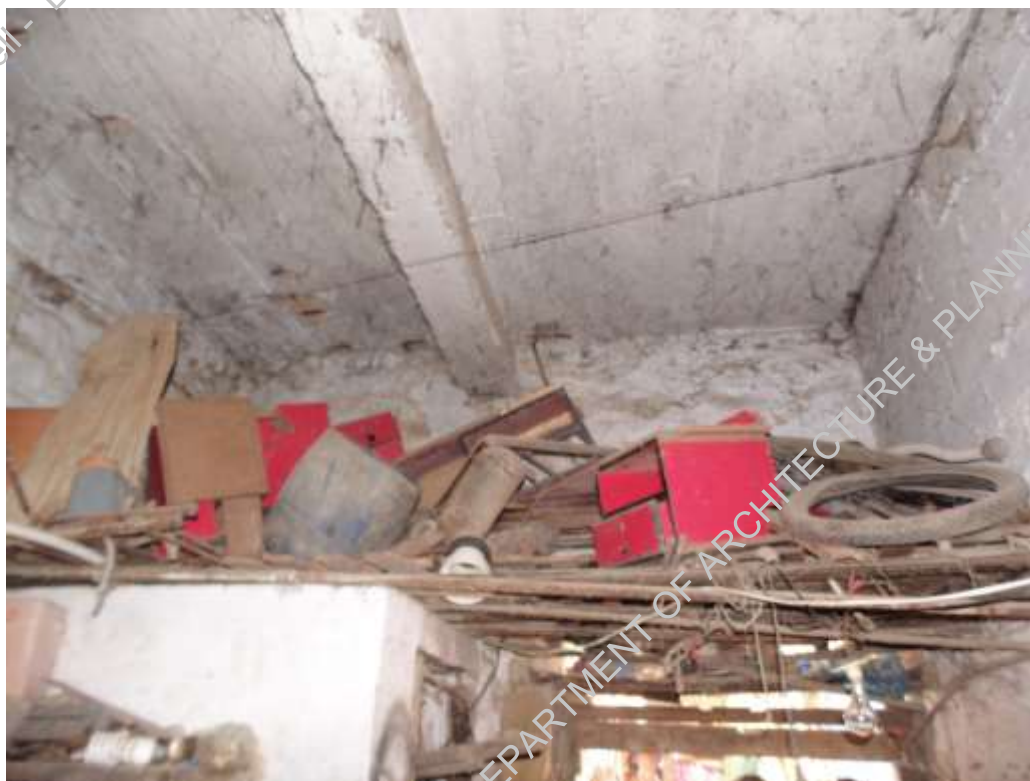
Plate-9: Bad condition of reinforced concrete construction of central court

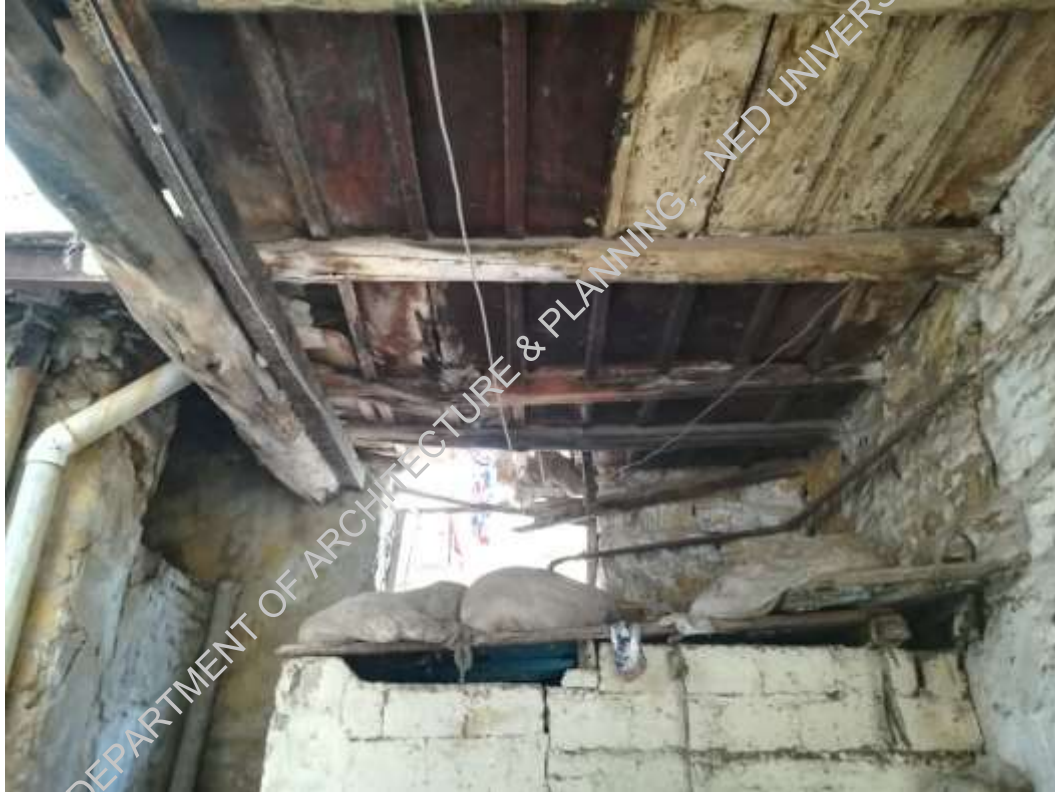
Plate-4: Bad condition of original timber flooring and walls

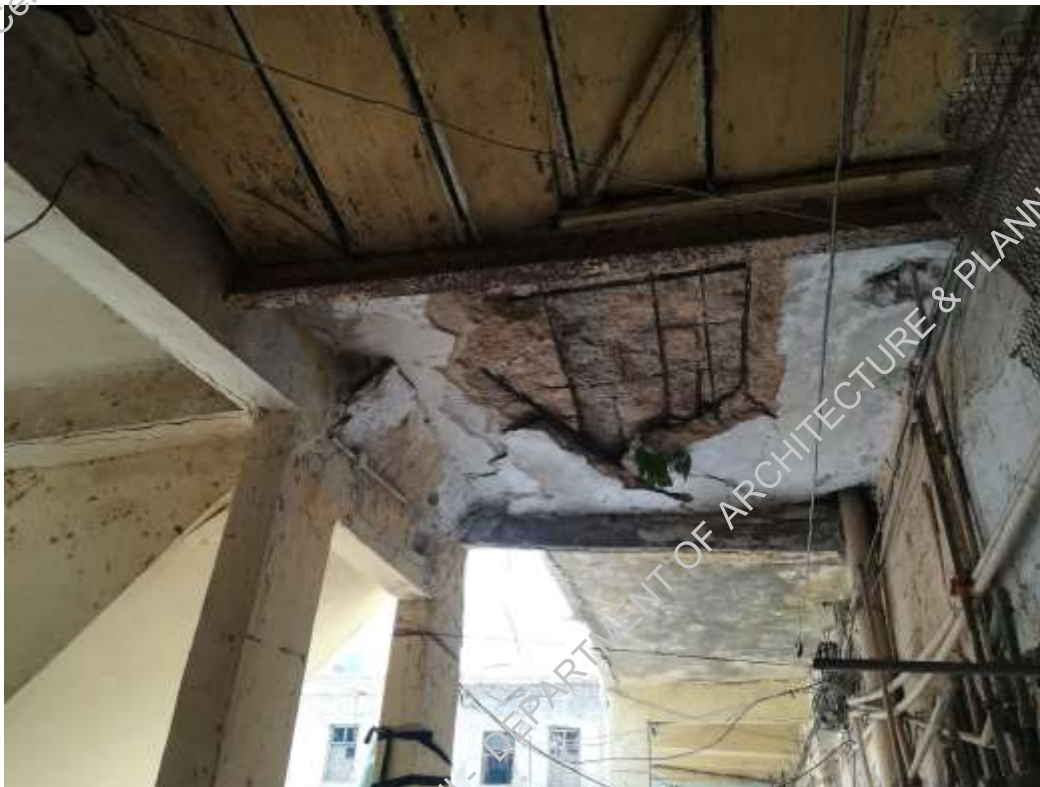
Plate-5: Concrete construction done later on, in bad condition

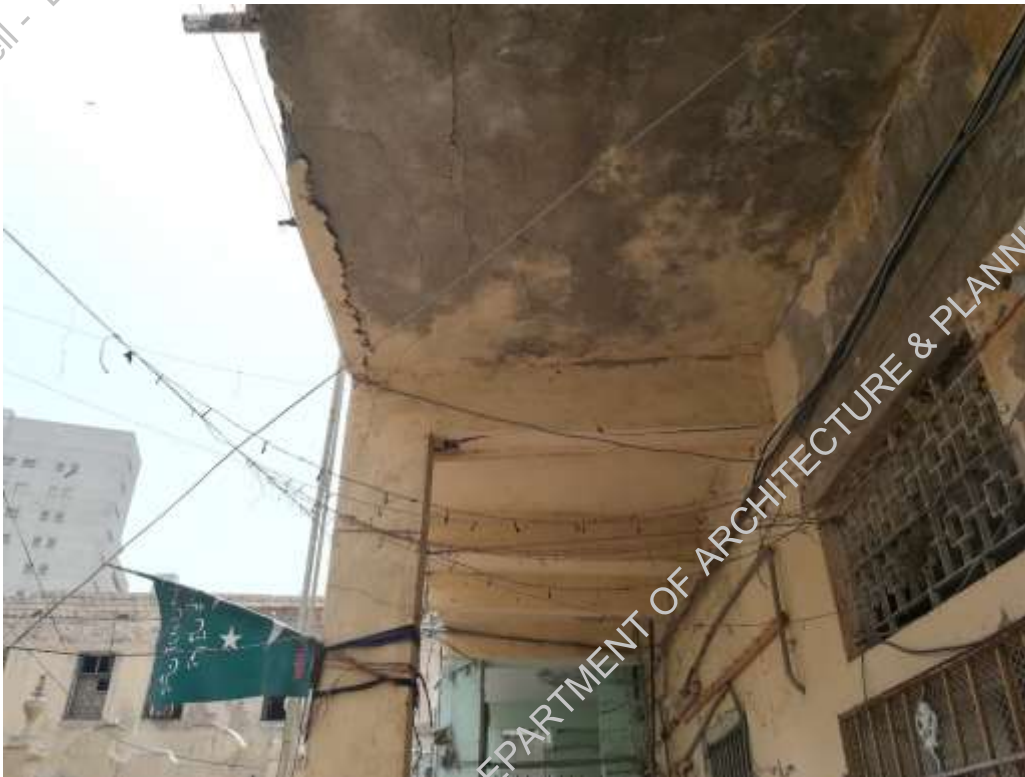
Plate-7: Bad condition of reinforced concrete construction of central court

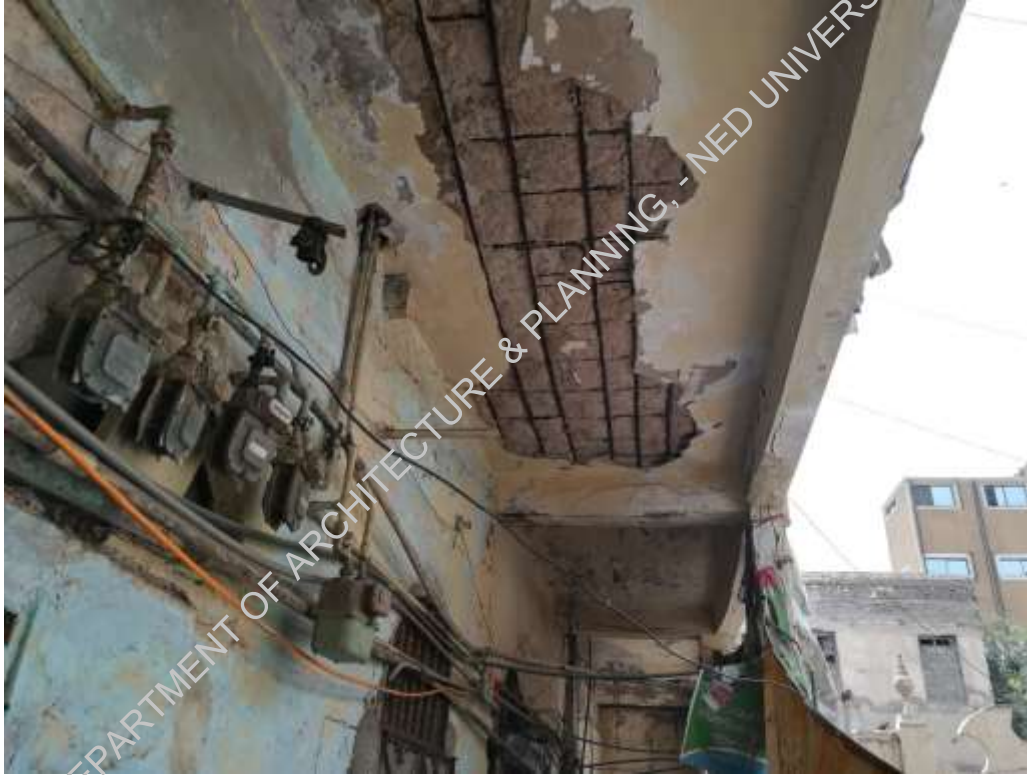
*Plate-8:
reinforced
concrete slab in
bad condition,
concrete cover
has fallen off.*

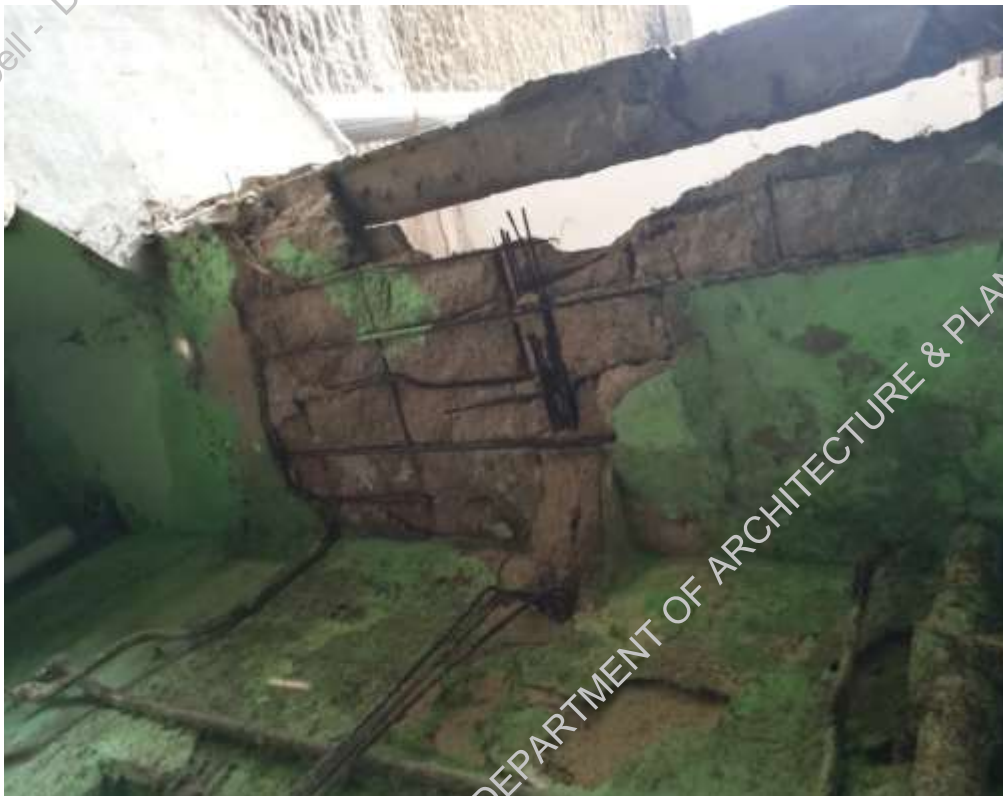
Plate-5: Concrete construction done later on, in bad condition

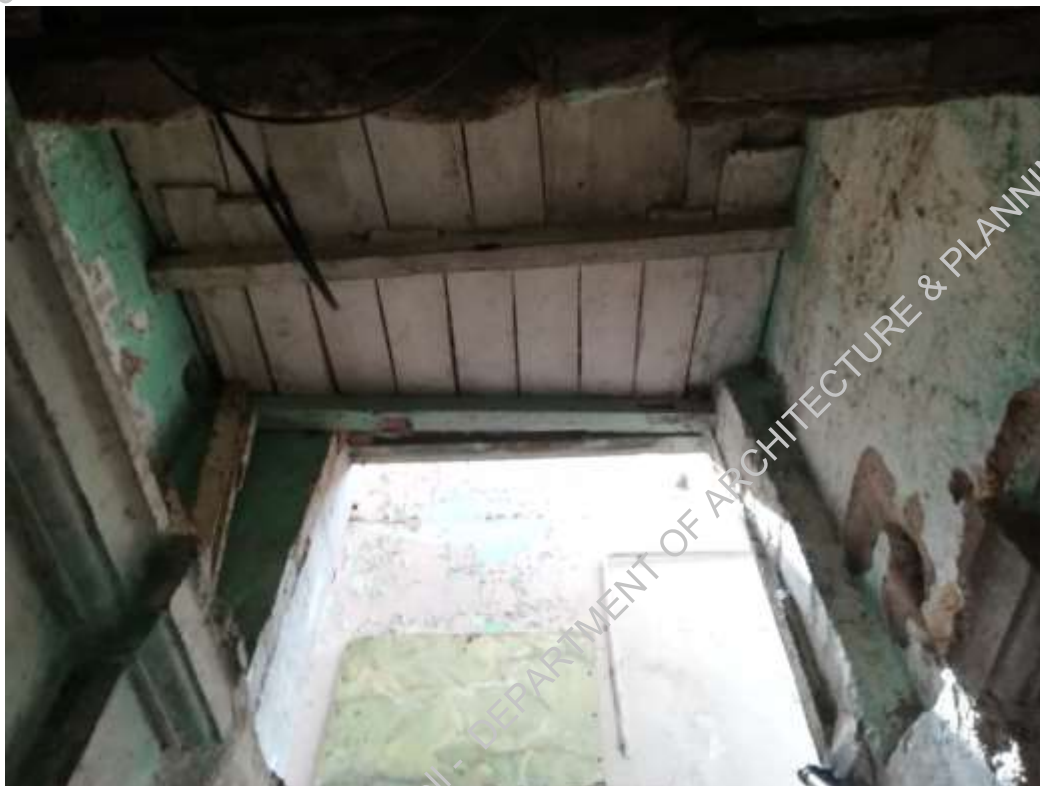
Plate-7: Bad condition of roof slab due to punctures and seepage from plumbing lines

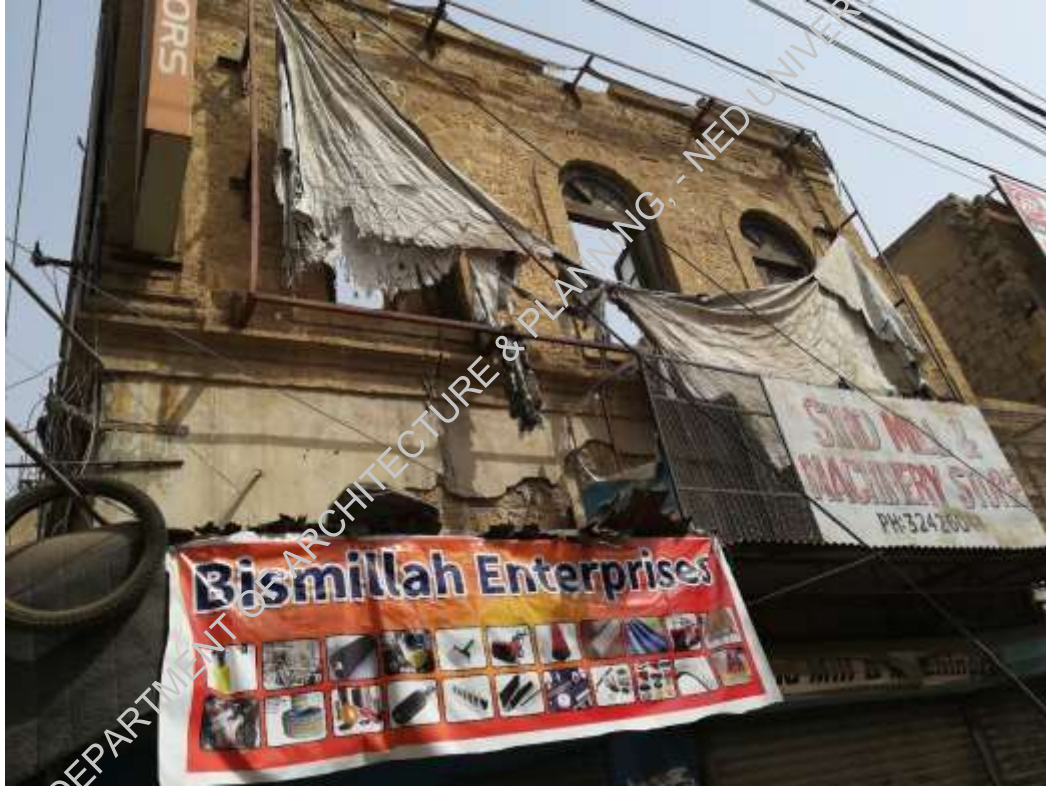
*Plate-4:
masonry wall is
damaged due to
intervention of
structural steel
for bill board*

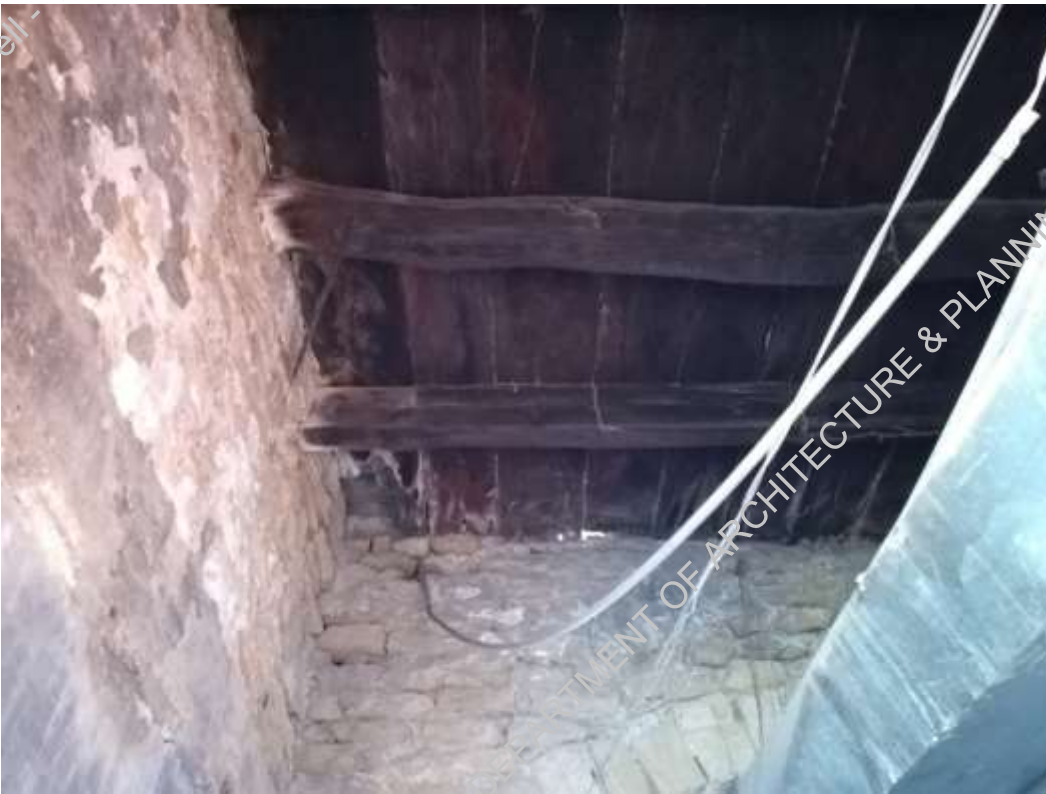
*Plate-5: Bad
condition of
original timber
flooring and
walls at ground
floor*

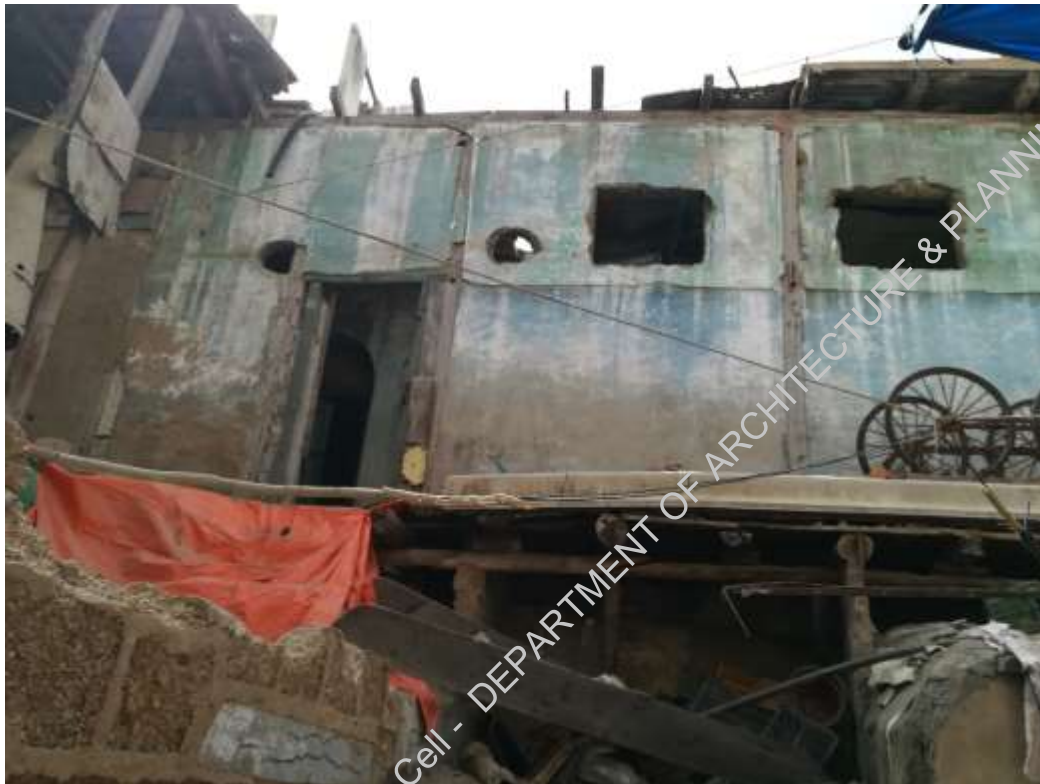
Plate-7: intervention at the back

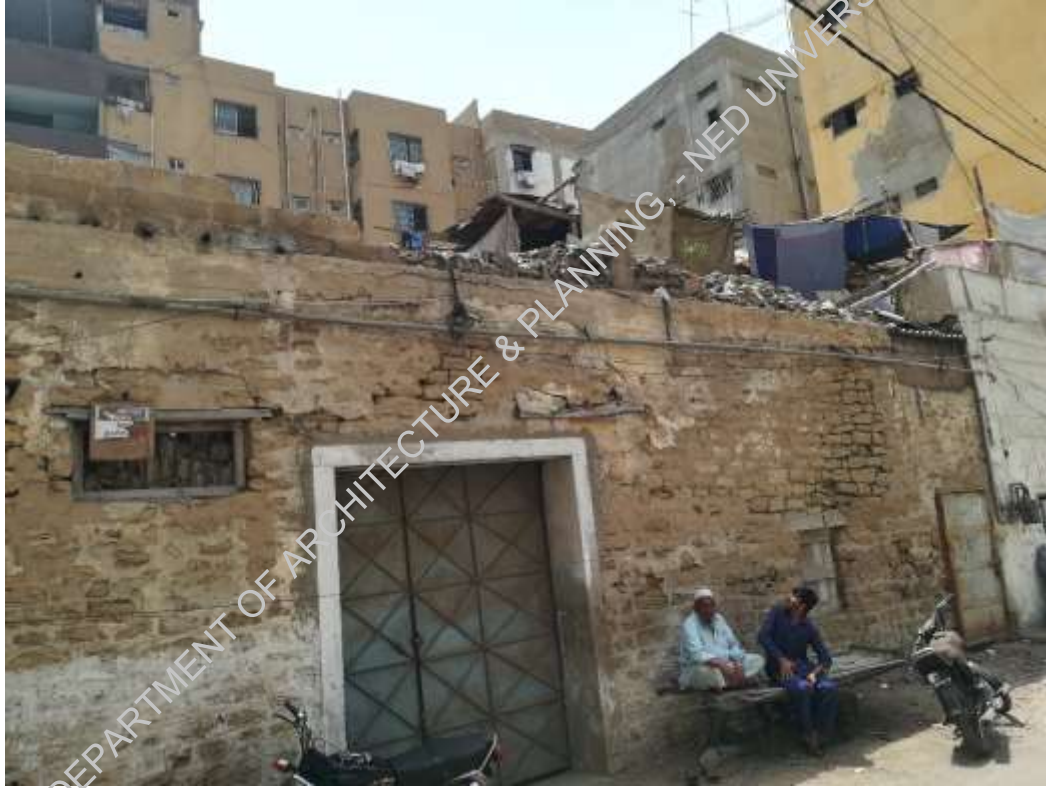
Plate-4: Loose stone masonry is visible

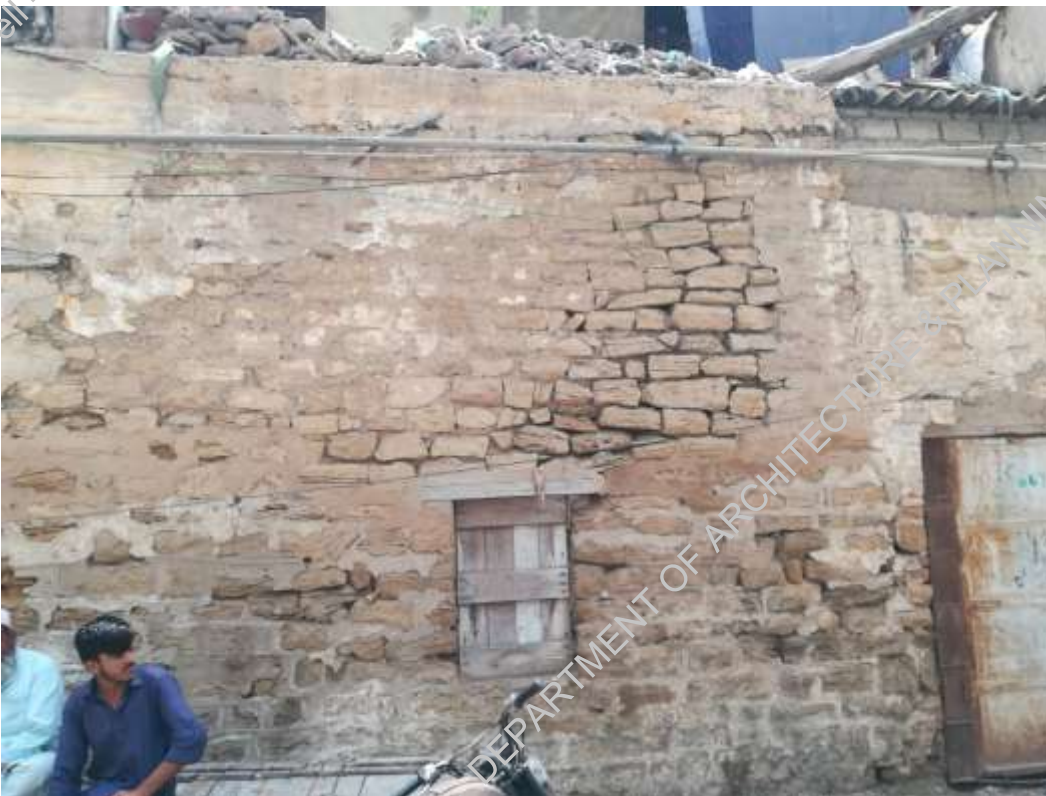
Plate-5: Loose stone masonry is visible

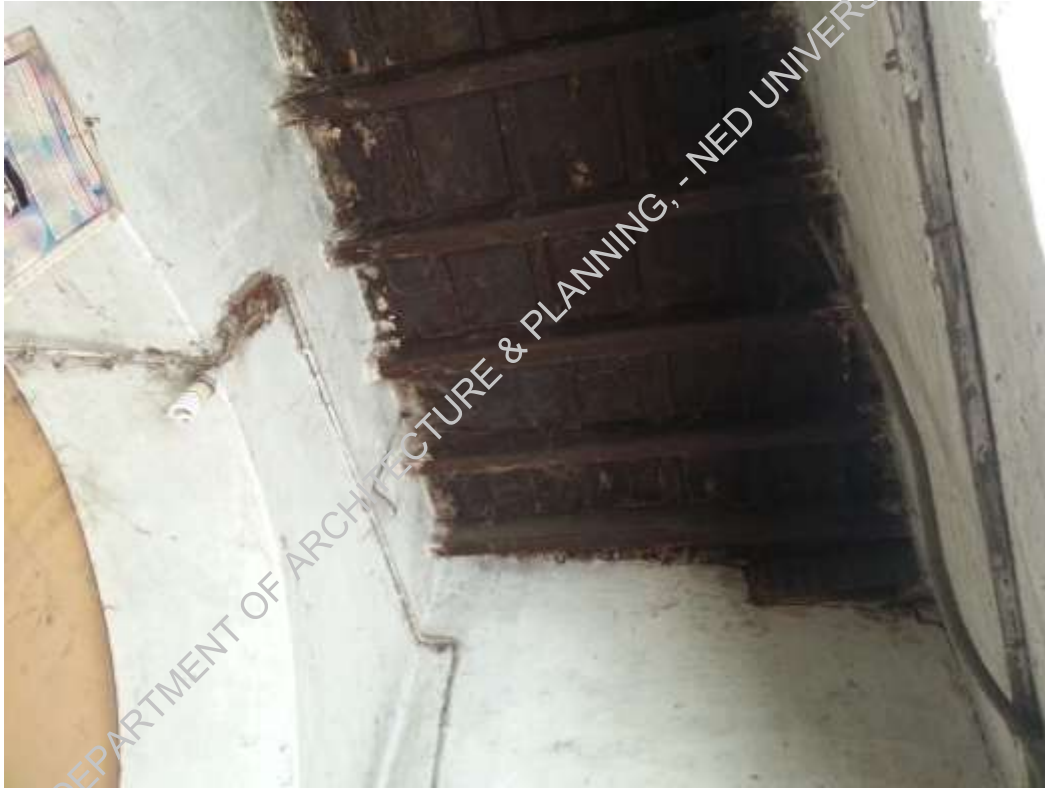
Plate-4: timber slab is in good condition,
