Condition Assessment of Heritage Buildings - Karachi Declared as “Dangerous”

JUNE 2018

Structural Consultant

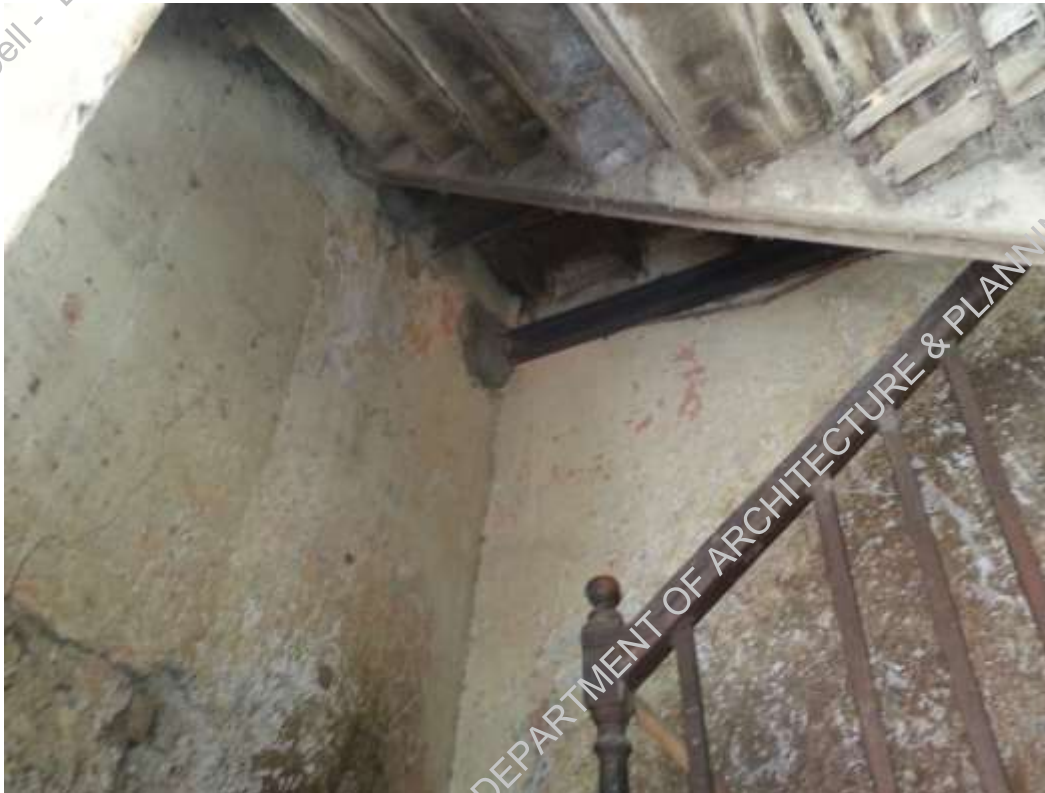
Plate-5: stair is inaccessible

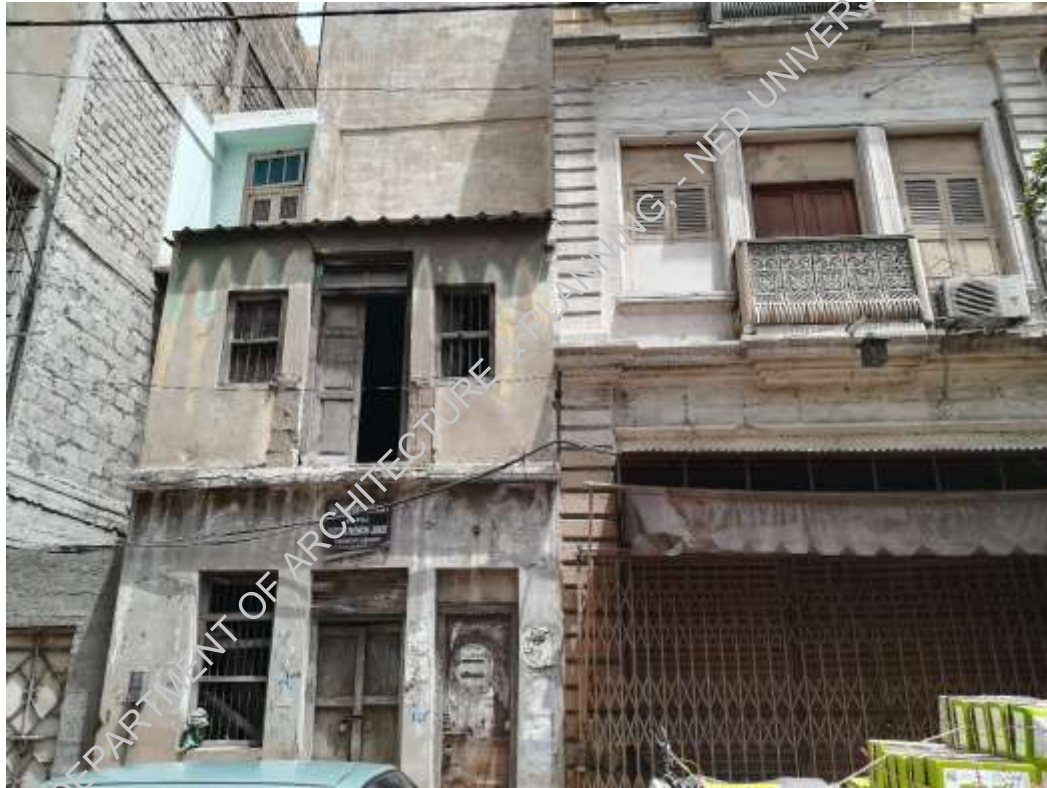
*Plate-4:
projection in
their original
condition intact*

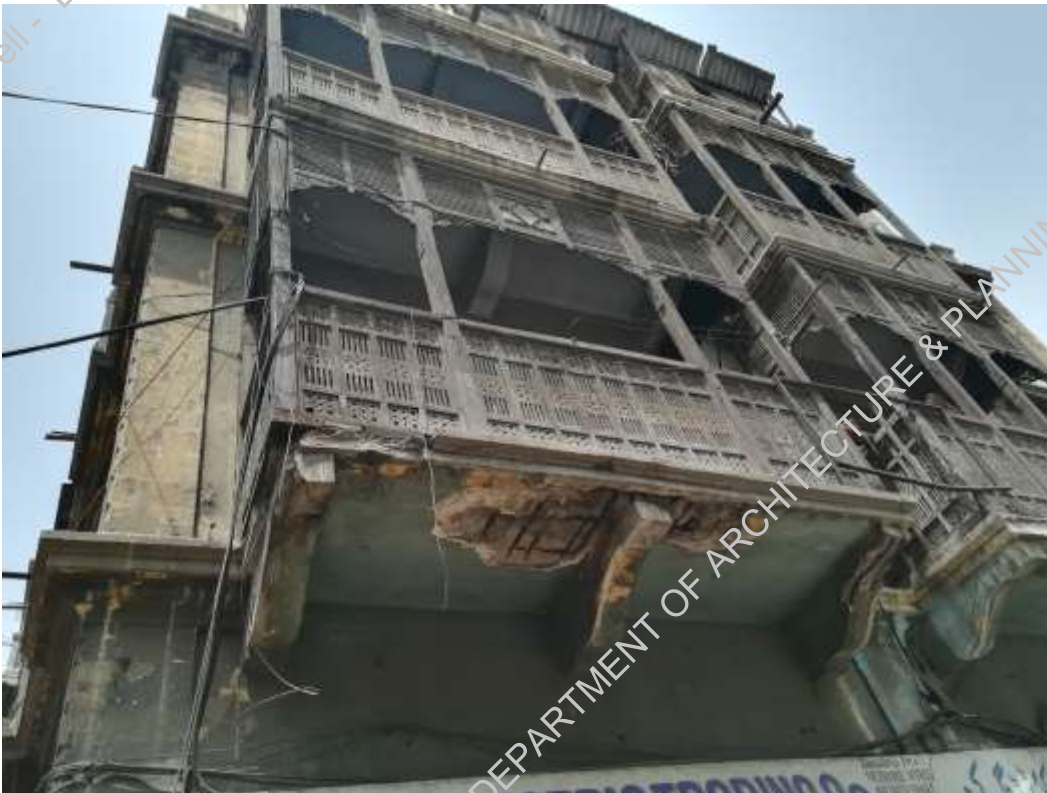
*Plate-5: plaster
fallen off due to
lack of
maintenance*

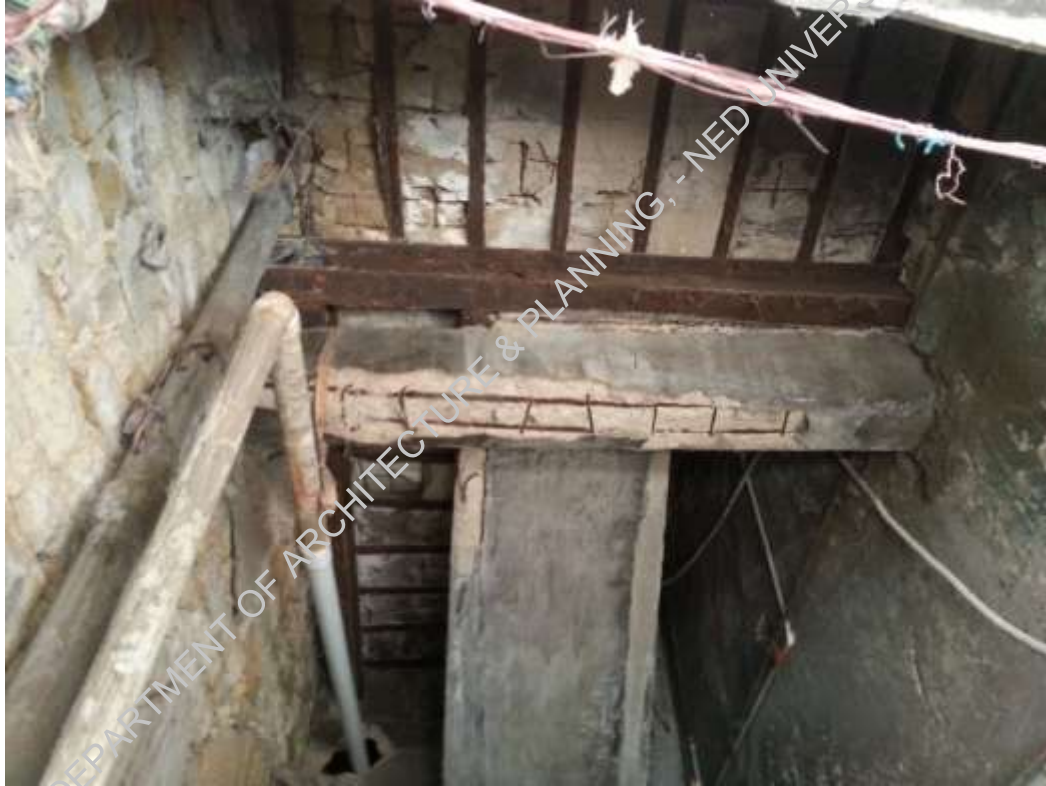
*Plate-4:
reinforced
concrete slab in
bad condition,
concrete cover
has fallen off. It
has be
strengthened
still in very bad
condition*

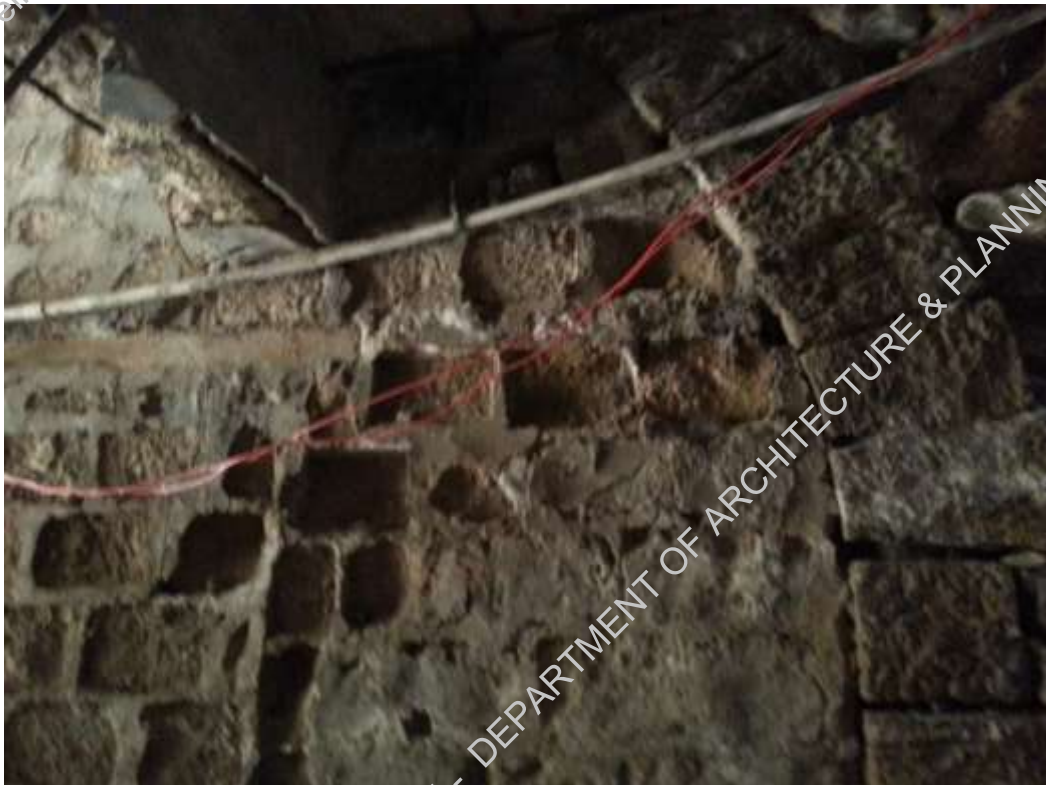
*Plate-5:
deteriorated
stone and
mortar*

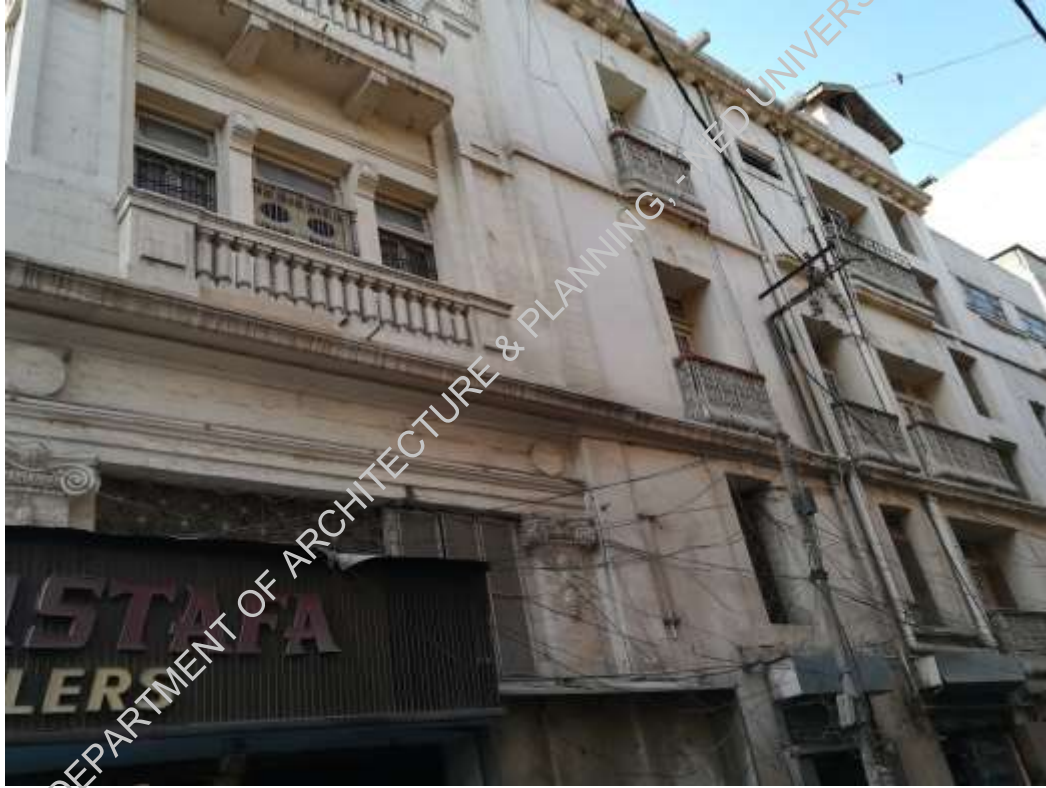
*Plate-4:
structure in
good condition*

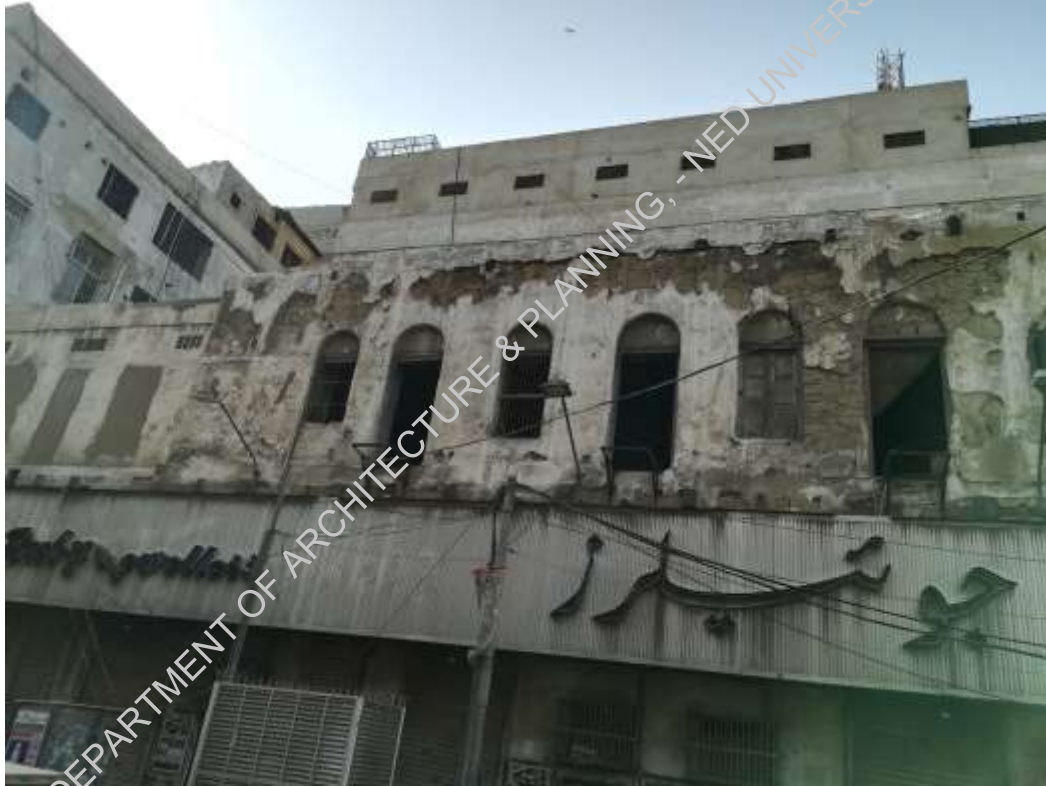
*Plate-4:
reinforced
concrete slab in
bad condition,
concrete cover
has fallen off.
Plaster been
weathered.*

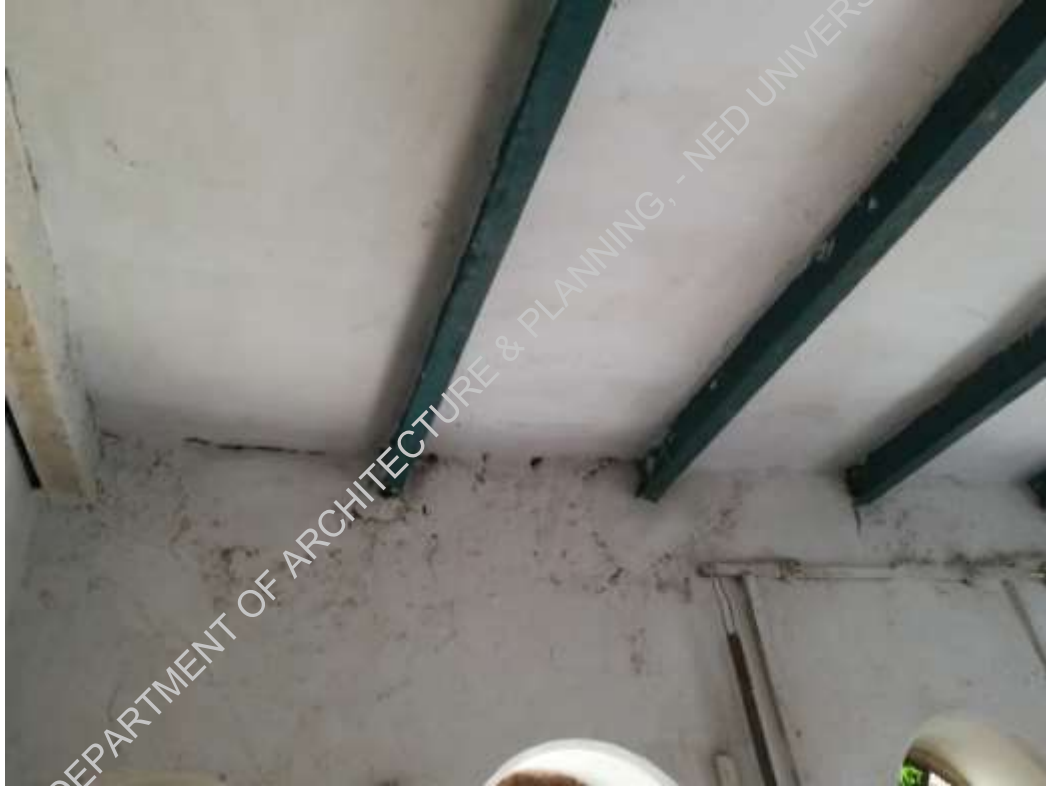
*Plate-4:
reinforced
concrete slab in
good condition,*

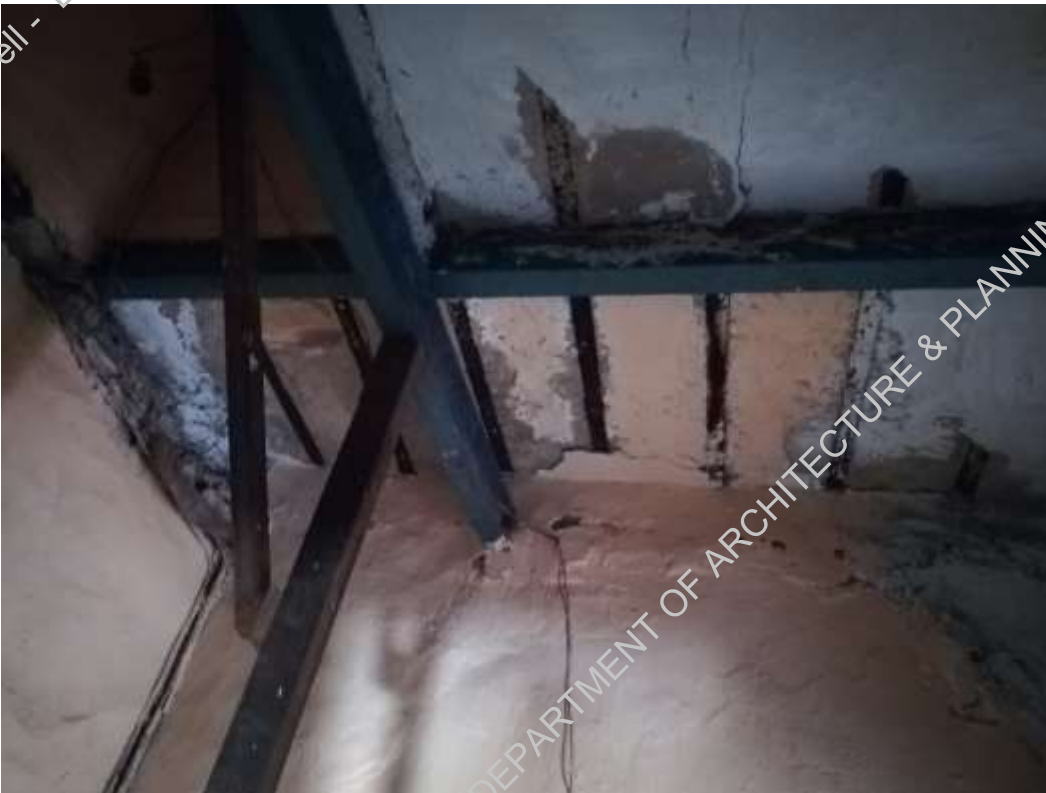
*Plate-5:
Concrete
construction
done later on,*

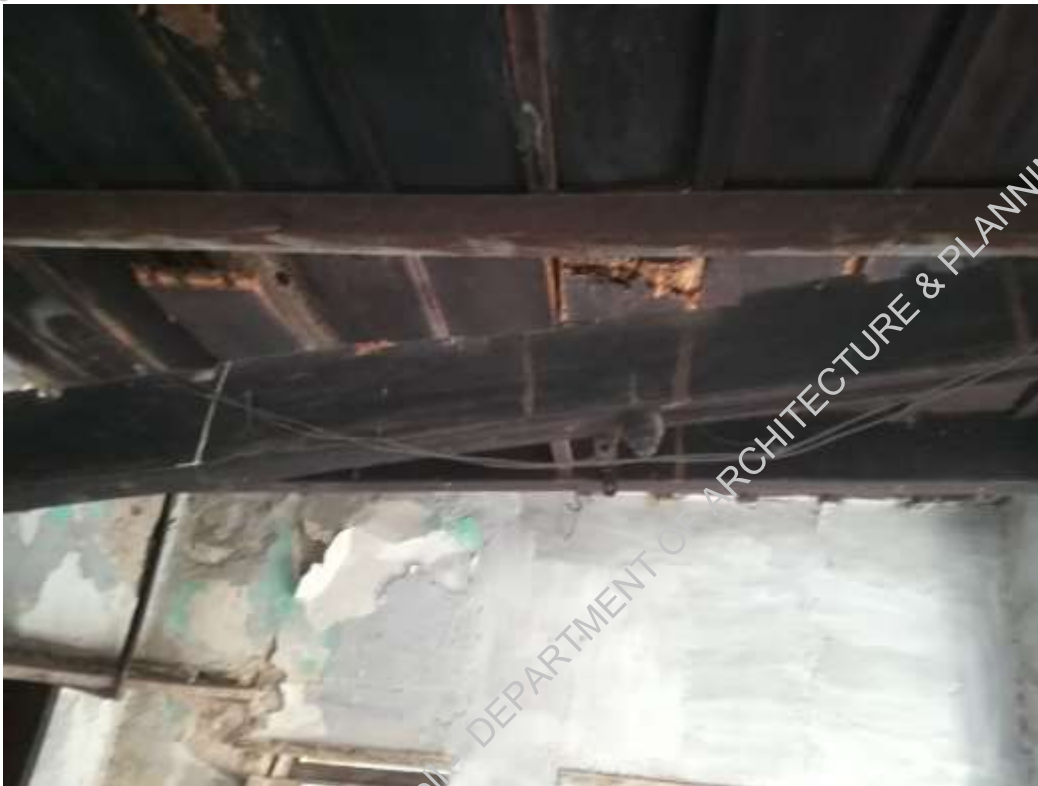
*Plate-7: Bad
condition of
timber deck*

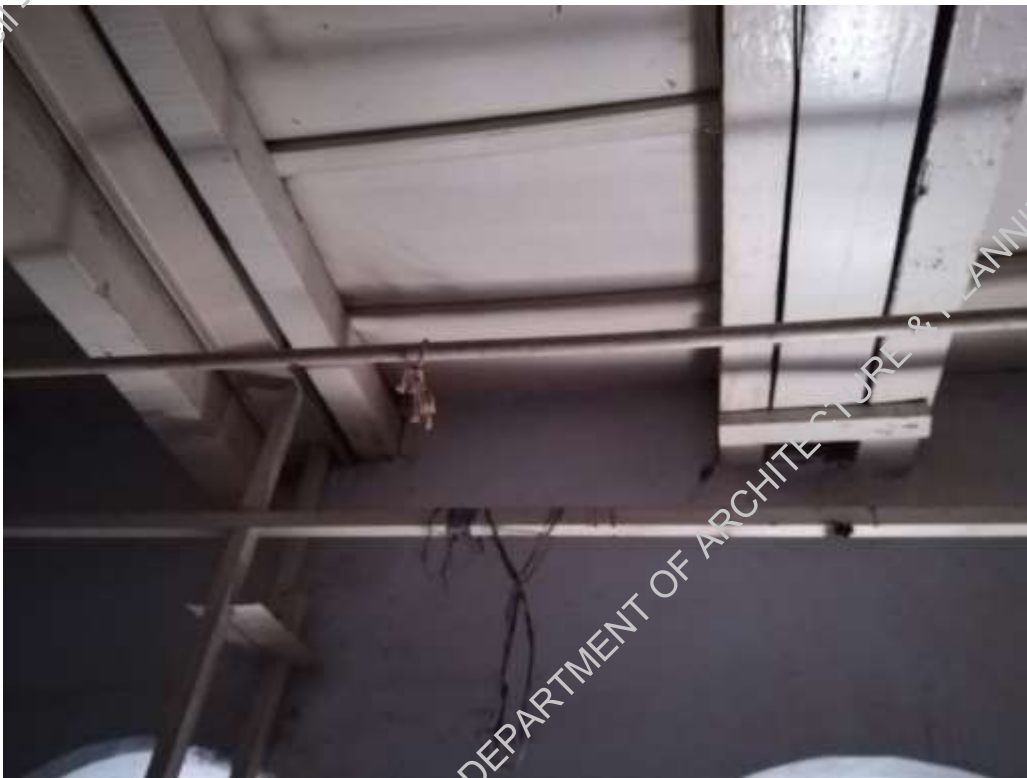
*Plate-9: Bad
condition
reinforced
concrete
construction*

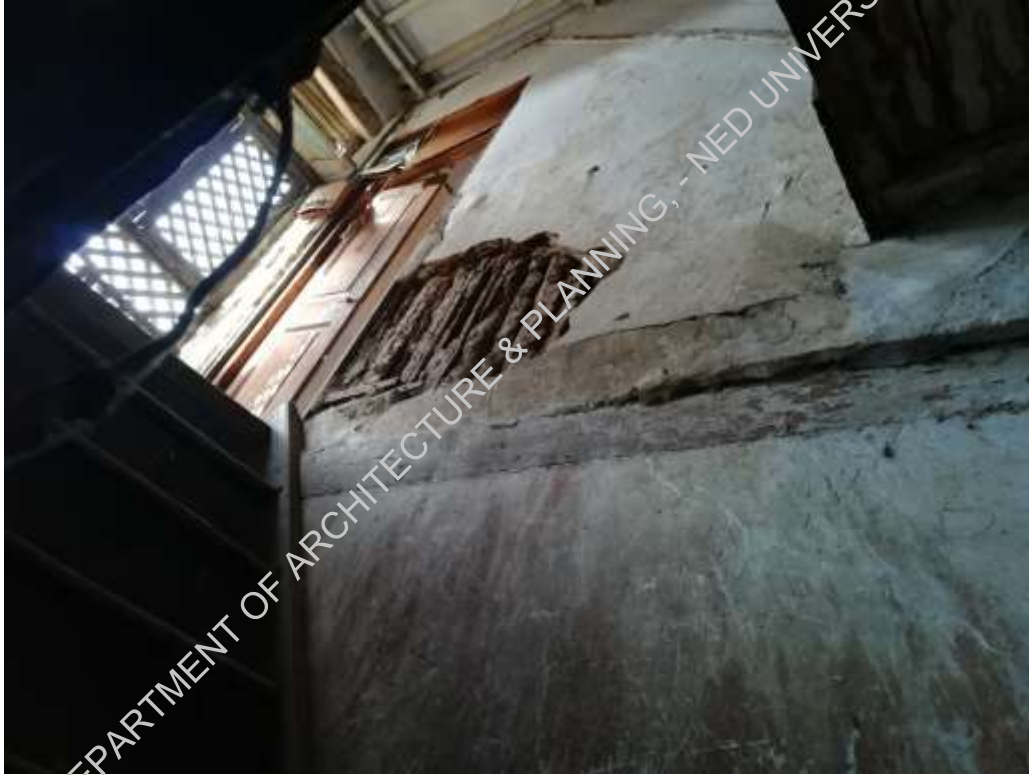
*Plate-10: loose
stone masonry*
