## **HAMDARD MATAB BUILDING**

### **Renovation, Restoration and Repair Work**

*Heritage Cell - Department of Architecture and Planning,  
N.E.D. University of Engineering and Technology, Karachi*

**November 2011**

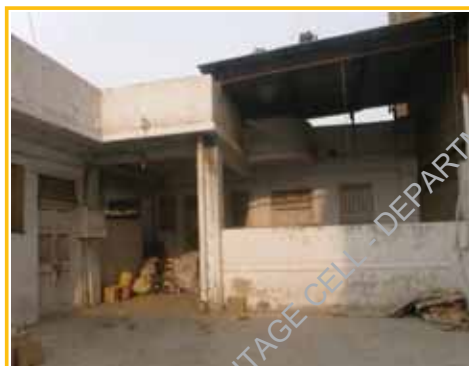
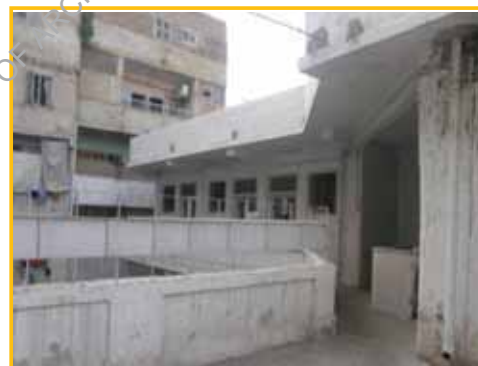
Most of the spaces on second floor are being used as storage areas. The three rooms facing courtyard use to have a pathology lab which was closed in 2004. These rooms used as servant quarters for some time but now are not used. It is observed that this floor has been under utilized state. Some areas on the floor have accumulated debris, which need to be removed. The cemented area, which is open to sky, indicated seepage stains at different locations. This pointed towards the fact that flat roof of the area has improper surface water drainage. (Refer drawing: iii)

**Almost completely underutilized floor**

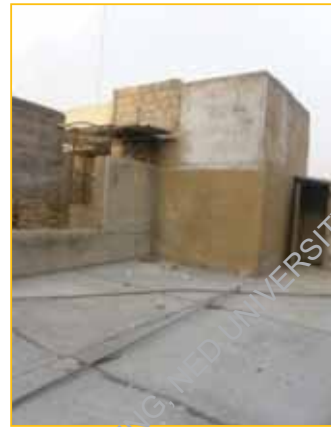
The roof is accessible through a wooden staircase. The roof has exposed plumbing lines running all over its floor and also has piles of debris at different locations which need to be removed. There is no water tank at this floor. The water is supplied, to the building, by fibre glass water tanks which are placed over the roof top of second floor toilet block. On roof, water seepage stains are also observed, indicating the fact of improper surface water drainage and poor condition of screeding at different locations. Parallel to this it is also found that there are seepage stains at the side boundary wall which is due to the overflowing problem of adjacent building's tank. For drainage purposes pipelines are used instead of water spouts, in fact all of water spouts are choked. (Refer drawing: iv)

**Exposed drainage lines, water tank of adjacent building is also seen**

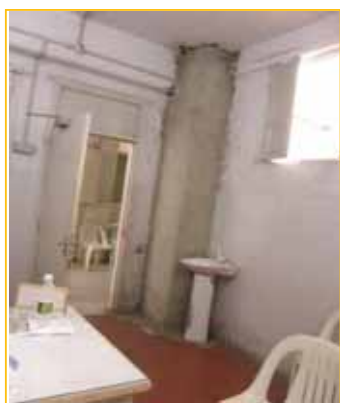
The present status of structure indicates that the load bearing structure is comparatively, in a better state than that of R.C.C frame structure. No major structural faults are observed on masonry walls, having plaster and paint finish. There are however, some patches of plaster repairs at a few places. For a detailed structural analysis it is recommended that it should be viewed by a structural engineer. In areas of building, which are made up of R.C.C frame structure, as a general remedy it is advised that consolidation and repair treatments are done to all damages R.C.C elements. This would include chiselling of damaged c.c. cover, treating the eroding bars with chemicals, applying surface bonding chemicals and then applying repair plaster/c.c. covering. Some cracks are noted in few of beams, columns, walls and cantilevered balconies. One column, at ground and first floor is completely repaired, as it was heavily deteriorated due to increasing cracks and damages on its surface. These will have to be tested in detail for durability, by a structural consultant and repaired/reinforced according to his recommendations.

**Repaired column**

The building needs some structural repairs according to the state of deterioration it is in at present. A couple of beams columns and slabs are in a heavily deteriorated state. These will have to be tested in detail for durability, by a structural consultant and repaired/reinforced according to his recommendations.

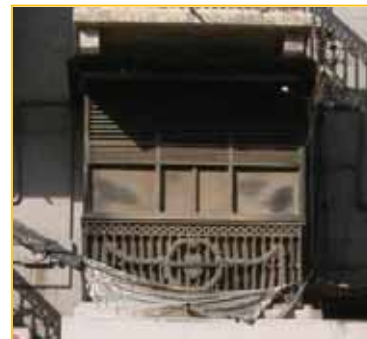
**Alterations in Balconies:** As mentioned earlier that there exist three cantilevered balconies on each of the first and second floors, making the total of six balconies altogether. Out of the three cantilevered balconies of first floor, central balcony has been completely closed by using asbestos sheets and wooden louvers. This balcony is accessible from inside room; which once was the room of Hakim Said and now is in use of the senior consultant. This balcony also served as the washroom for some time after the death of Hakim Said, but now it has been in no use. From interior it is still in very dilapidated state. (Refer drawing: xi)

**Balcony of first floor**

The balconies are the most outstanding element of the facade of Hamdard Matab building. It is suggested that all balconies be restored to their original form. Closed balconies should be opened and utilized as balconies; so that the building could be viewed in its original totality. The temporary sheets should be removed to bring the balconies back to their original condition. The wrought iron bars and hand rails should be scrapped and cleaned, repaired for any damaged segments and finally painted and polished.

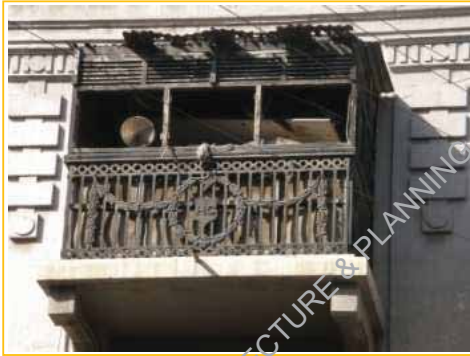
Similarly out of the three cantilevered balconies of second floor, left corner balcony has been closed by using asbestos sheet and is been used as storage room. Also addition of asbestos sheet is observed on the centre balcony on second floor as temporary covering. (Refer drawing: xi)

Left corner balcony on second floor

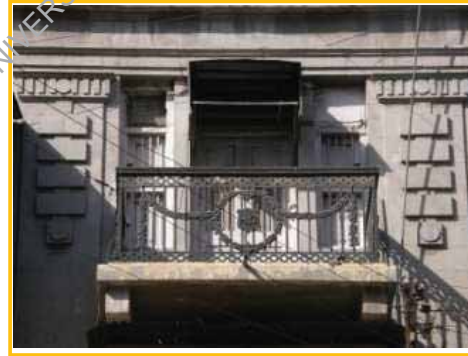
Centre balcony on second floor

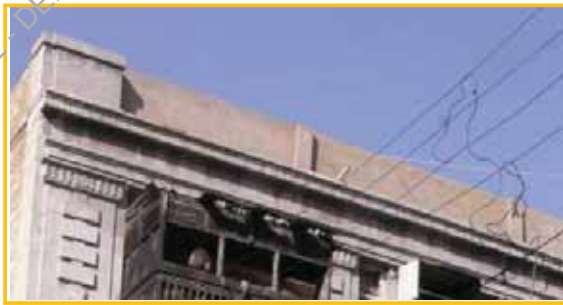
**Parapet wall on roof:** The original parapet wall at the roof level has been completely replaced by masonry parapet wall finished with plaster. Although traces of original parapet wall still exists at the interior of the building. (Refer drawing: xi)

Replaced parapet wall

The new parapet constructed using C.C blocks needs to be removed and the original form of parapet should be restored using the original patterned blocks. For this purpose existing evidence found in the courtyard facing parapets of the building, should be used to replicate the original motif in its right proportion and detail.

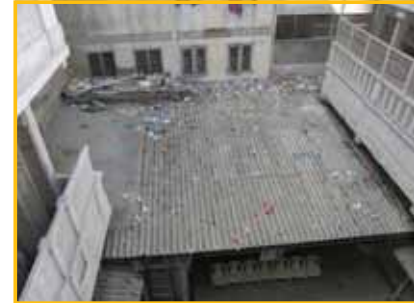
More than 50% of the courtyard is covered with asbestos sheets creating a covered waiting area. The adjacent apartments on the back create problem of garbage dumping onto asbestos sheets covering the waiting area. The back lane which was once the open lane, has converted into storage area, by covering it through asbestos sheets.

Asbestos shed over waiting area

Presently the waiting area of ground floor has asbestos covering, which makes the space non-utilizable in monsoon season. Also the continuous disposal of garbage from adjacent buildings, create unhygienic conditions in the area. For this reason it is proposed that asbestos covering should be removed from the waiting area; and proposed solutions for controlling the garbage nuisance from adjacent buildings are recommended for an option.

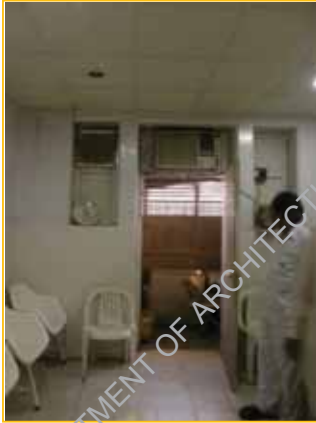
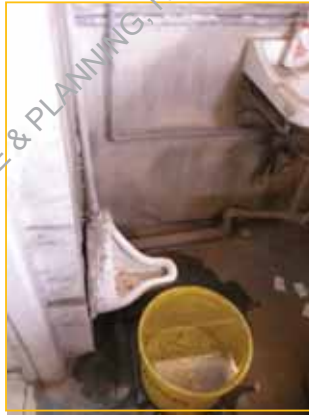
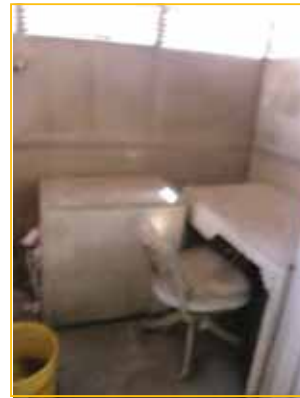
as water washes over surfaces and now creates puddles over cantilevered balcony's floor. Due to the absence of proper drainage of standing water from the floor, seepage occurs through the slab, damaging the construction materials. Later added washbasins along with their exposed drainage lines have also observed, giving unpleasant visual of building's interior facades. The proper duct spaces are not in use also. The original flooring has been replaced or covered, using red acrylic tiles and ceramic tiles. Finishes seems to be in very dilapidated state. (Refer drawing: xiii)

Access into the Balcony of Hakim Sahib's and existing condition of the said space

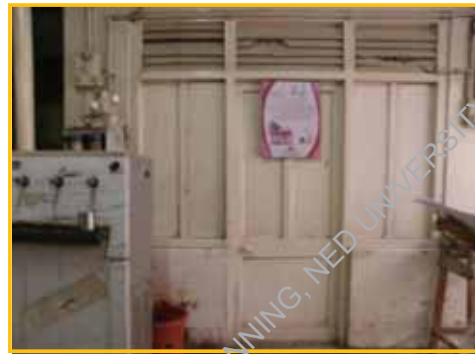
**Damaged ventilator at ground floor**

The existing doors and windows are made of wood; they need to be cleaned and repaired where necessary. Some ventilators are made of cement jalis or wooden louvers; they require maintenance works. All broken wooden louvers and jalis will be replaced with same kind of material and colour. The wood work will be cleaned/scrapped of all paint layers and polished will clear varnish.

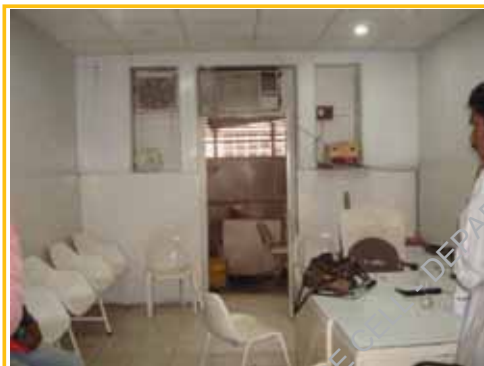
**Alteration of windows and ventilators of  
Hakim Said's room**

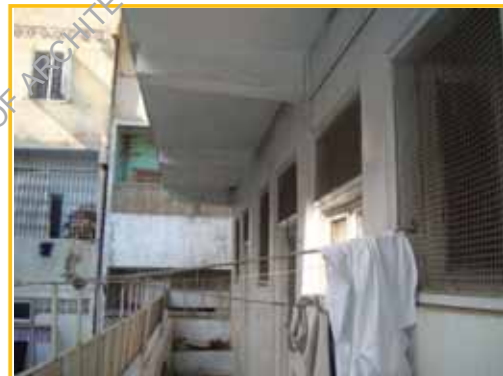
**Installation of net, replacing timber  
windows of hall on second floor**

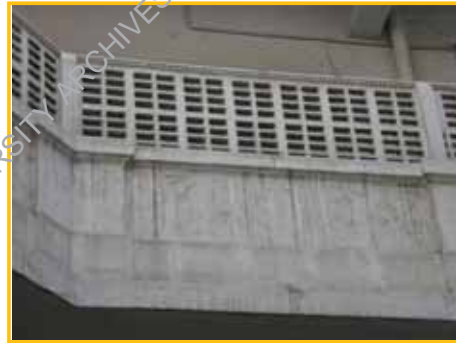
In all the floors, parapet walls running at interior of the building have a typical block pattern. These pattern blocks were, later on filled with cement infill or mortar. The traces of such block pattern still found at different locations inside the building.

**Altered interior parapet which still have traces of original design**

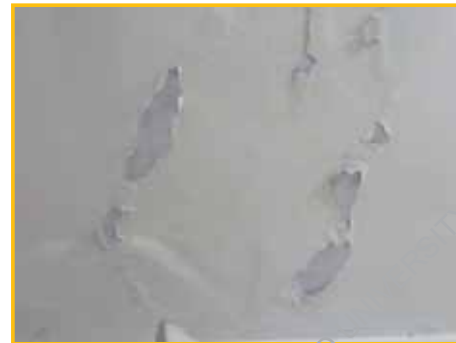
The finished look of Hamdard Matab is not appealing at all from the interior. Seepage stains, peeled off paint and non plastered walls has given patchy appearance to the walls of the building generally. For overcoming the problem prime focus should be given for removing the seepage stains. Only after that the plaster has been repaired. Before applying the new coat of paint the previous layers of paint, accumulated over the years will be thoroughly scrapped.

**Peeled off Ceiling Paint**

After the plaster has been repaired, the walls will be painted. Before applying the new coat of paint, the previous layer of paint, accumulated over the years will be thoroughly scrapped.

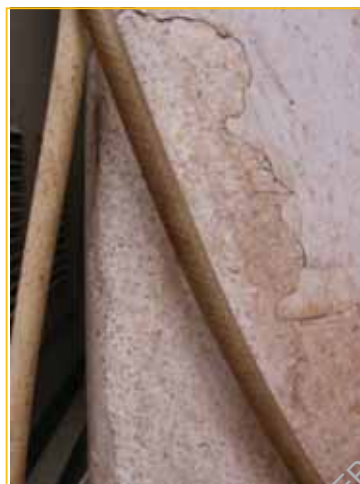
**Patchy look; original mosaic dado have been covered under paint surface**

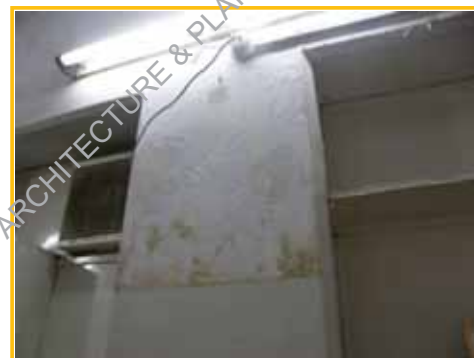
**Internal wall Paint**

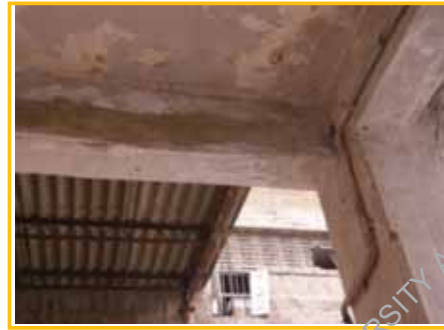
Cracks have been observed in different areas of all floors. There are two kinds of cracks in the building; one on structural elements and the other on masonry wall. The affected areas include the projection areas of the toilet blocks, walls, columns and beams etc. The reason of developing cracks in the building is water penetration from different sources. The major source had been the faulty drainage pipes running within the building haphazardly. Another reason includes standing rainwater on floors at various locations, which finally seeps through.

**Cracks and Seepage stains on roof slab**

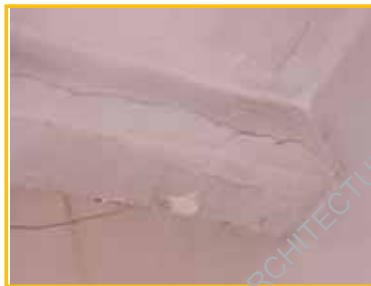
**Cracks in beam**

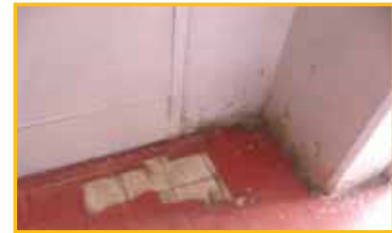
In terms of flooring, most of the original flooring has either been replaced or covered with another flooring type. The overlay flooring has damaged at various locations; reflecting the traces of original flooring underneath. In such cases repairing of flooring is required for giving finished look to the interiors. In addition to it pattern flooring area required proper maintenance and upkeep, in order to remain intact for longer time period. Also certain tiles of entrance lobby and waiting area, of ground floor, required replacement for overcoming the un-tidy look of the passage.

**Tiled floor underneath Vinyl tiles**

Flooring of the building is at present in a poor state of maintenance. The original flooring is replaced with vinyl tiles at various places. In addition to this some portions of the floor are also damaged and would require repairing. Patterned flooring on the first floor, needs to be clean and polished. In places where original flooring is still present underneath the new flooring; it is recommended to remove new flooring from these areas and after analysing the situation, old flooring should be restored.
