# DOCUMENTATION AND CONSERVATION REPORT

## Karachi Port Trust (KPT) Head Office Building

### STATE OF CONSERVATION REPORT

Prepared by: Heritage Cell, Department of Architecture & Planning  
NED University of Engineering & Technology, Karachi

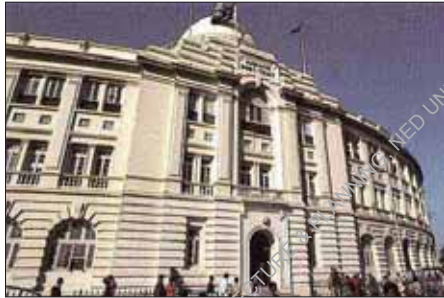
**Alterations in the Building Exterior.** There have been substantial amounts of repairs done to the building façade, evident from stone surface treatments being used. These repairs include application of paint coat, sand blasting, plastering (color crete) and marble cladding. An off white paint coat was also applied which was removed in 2007 by using sand blasting technique. Sand blasting is an abrasive treatment for cleaning stone surfaces.

Figure 37. KPT Building Coated With an Off White Paint Coat

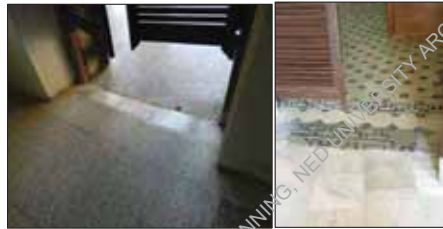
Continuous flooring of spaces with borders all around; indicates the wholeness of a room. As part of the original scheme, all floors of the building were having pigmented c.c. flooring with black and white border tiles. Later, flooring of various spaces was replaced with cemented flooring, marble tiles, vinyl tiles and ceramic tiles. The replacement of flooring has usually undertaken with reference to the function of that space. Vinyl flooring in computer section has applied on the previous pigmented flooring to minimize the noise level. Pigmented cc flooring has

also been repaired with usual application of cemented flooring.

Figure 46 (a, b, c, d, e). Altered Floorings

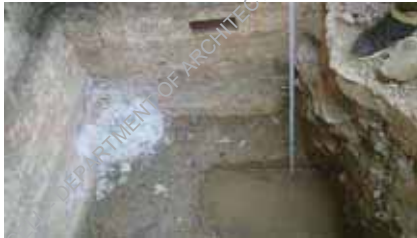
**Sub-Soil Water Intrusion.** In the field survey, the conservation team found that subsoil water and hedges along the building periphery, facing internal courtyard, were the main causes for water intrusion into the building walls. Underground water can cause massive damage to the heritage buildings. The moisture remaining within floor and walls cause serious problems that may eventually wear the building away if untreated as the KPT building is in close vicinity with the coastal lines of Arabian Sea.

Figure 40. A pit excavated to identify Plinth Foundation Depth and Water Level

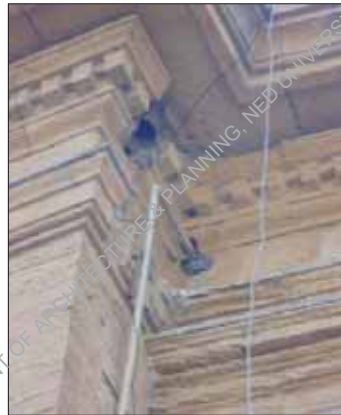
manhole enclosed with sewerage pipes and raised gutters. This portion also does not get direct sunlight. For these reason stains of moisture penetration and microbial growths were observed.

Figure 56. Inappropriate Plumbing Services on Front Façade

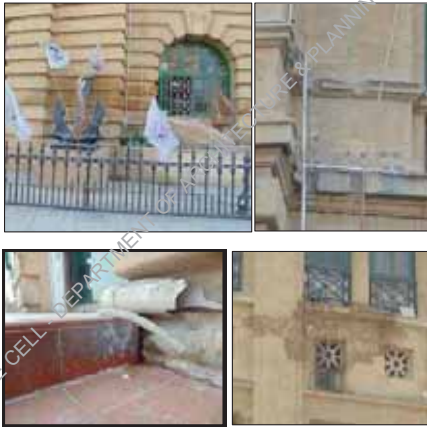
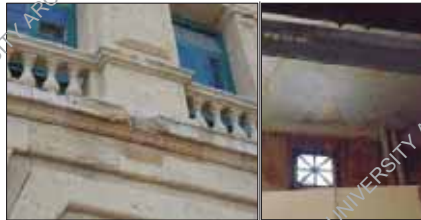
to overcome the water intrusion problem and hiding the decaying surface. This further worsened the situation, by acceleration and raising the water above 9 ft. height. Measures should be taken up to stop the water rising in the masonry or else this problem may become more severe

Figure 57 (a, b, c, d, e, f). Dampness due to faulty plumbing

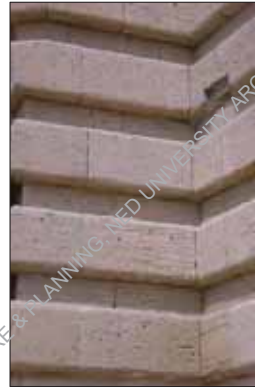
masonry.<sup>2</sup> It removes the hard exterior surface of stone and leaves a negative impression on visual character of the building. Sand blasting causes severe damage to the fabric of the building by increasing roughness of the surface, and destroying details and textures of the stone. This also causes an increase of stone porosity which accelerates the water absorption rate and rapidly deteriorates the stone surfaces. As the porosity and surface roughness increases, the corrosion process takes place deeper inside.

Figure 59. Damaged Stone Surface

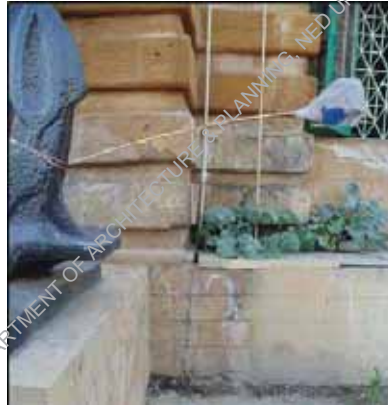
absence of sunlight. The area where there is a continuous leakage of sewerage pipes promotes microbial growths. On the building front façade, outside the pension cell there was a drainage manhole. Microbial growths and weeds were evident due to moisture content of drain pipes and lack of exposure to direct sunlight. At the building's rear side water dripping off from an AC unit caused fungal growth.

Figure 65. Macro biological Growth due to Faulty Plumbing Services

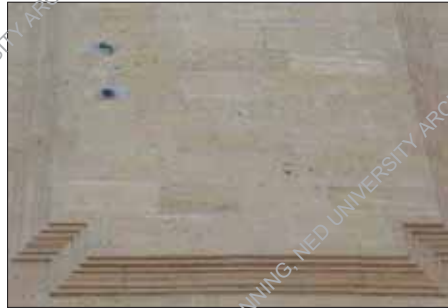
Figure 71. Cement Mortar Grouting in Holes Drilled for Some Installations

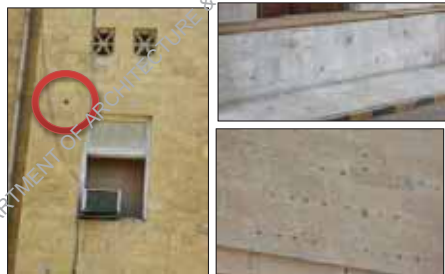
At various locations on the building surface, unnecessary holes or cavities are observed. Some untreated cavities and many small holes (probably created due to sand blasting) were found on the building front façade. Few filled cavities were found on the front façade and rear side where there is a water tank on the roof top. It could be anticipated that few holes were made purposely for some installations but later it was filled up. In an effort to fill the cavities, cement grouting has been identified which is not in compatibility with aesthetical and physical properties of the stone.

Figure 72 (a, b, c). Holes and Cavities at Various Locations

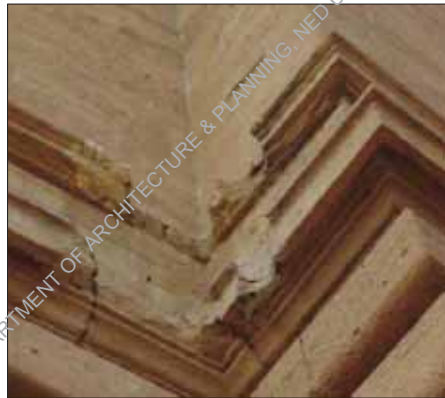
Since the building is classical but less ornamental and due to the timely maintenance and upkeep there are not many exposed significant architectural features which have been damaged or disintegrated except for the decorative cornices which are damaged or disintegrated at some locations. The mode of damage may be due to cracking or crazing of the stone due to natural weathering process caused by intense heating of direct solar radiations or vibrations induced by surrounding urban context. However, some cornices are broken due to some technological installations. In a close observation of the front facade, it was found that cornices were damaged and disintegrated at several locations. Some damages are untreated and at numerous locations inappropriate repairs have been made with cement mortar. These repairs are aesthetically unpleasing; therefore, it is required to remove these repairing. On the front façade of the building there are few windows with broken glass which is visually unpleasing. Some windows were damaged while installations of exhaust fans and air coolers.

Figure 73 (a, b). Broken Cornices

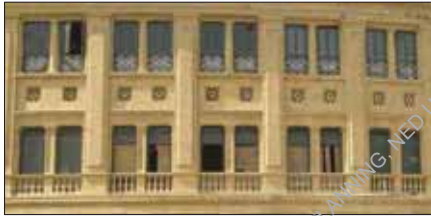
Figure 74. Affected Windows of Front Facade

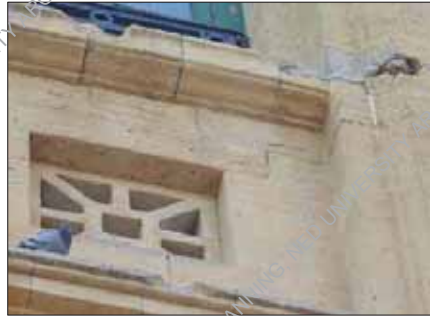
Figure 76. Inappropriate Repairs of Damaged Cornices

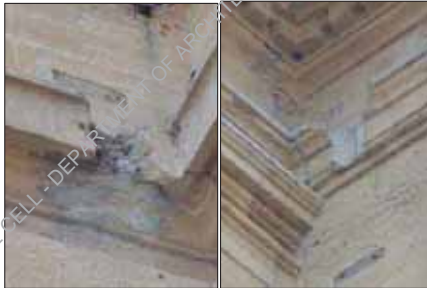
Figure 75 (a, b). Inappropriate Repairs of Damaged Cornices

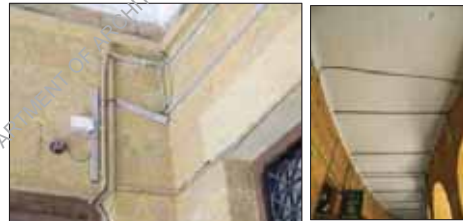
Inappropriate electric wiring has caused damage to the stone walls, since they were clipped with iron nails. With the passage of time, all along the internal arcade exposed wirings and fittings have been added haphazardly. Exposed electric wiring and broken fittings were identified in several rooms. On the front façade dangling wires are affecting aesthetics of the building façade.

Figure 80 (a, b, c). Exposed Faulty Electric Wiring inside Corridor

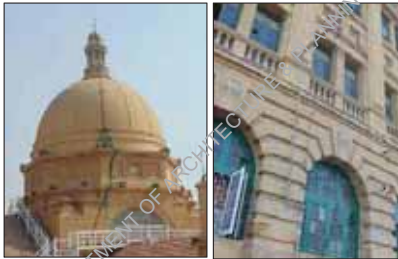
Black stains of wires apparent on the dome and few other locations of front and rare façade impart unpleasing visual impact. These mesh of wires need to be planed and reassembled in a proper way without affecting the building's aesthetics.

Figure 81 (a, b). Exposed Electric Wires on Dome & Front Facade

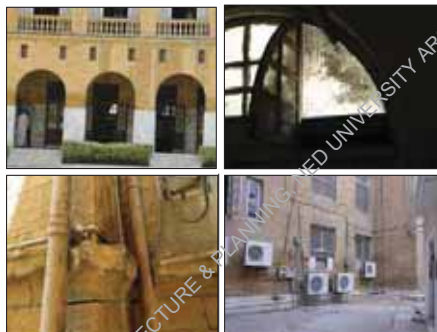
Dust accumulation and spider webs on walls was also found in several rooms of ground floor level.

Figure 86 (a, b, c, d). Dirt Accumulation and soiling of various surfaces

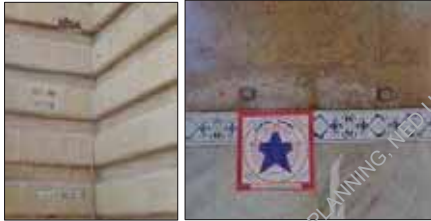
Wooden insertions have been identified at several locations, both inside the corridor of building and outside as well i.e. on the façade surfaces. It is required to take out these unnecessary insertions and fill the cavities with appropriate mixture as suitable with stone composition.

Figure 87 (a, b). Wooden Insertions in Slope

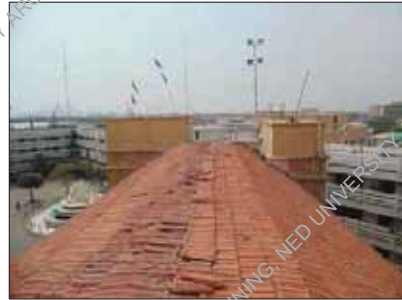
*Mangalore* tiles of the pitched roof, accumulated with dust, needs cleaning. This can be done by simple washing with high pressure low volume distilled water. At some locations, tiles are broken which needs to be replaced with new tiles of same design, pattern and color, however, there should be a mark of date indicating the year of repair.

Figure 88. Broken Roof Tiles

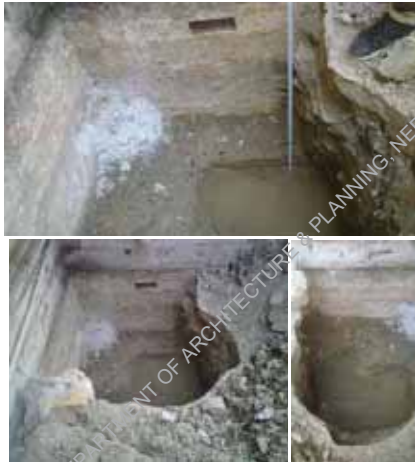
Figure 90 (a, b, c). Excavated Pit along Building Periphery

be achieved by excavation of a water trench (French Drain), all along the building periphery, to provide a channel for the water to evaporate and prevent further penetration into the building foundations and walls after application of appropriate water proof coating. It should be covered up with perforated iron grills to prevent the solid wastes for causing blockage.

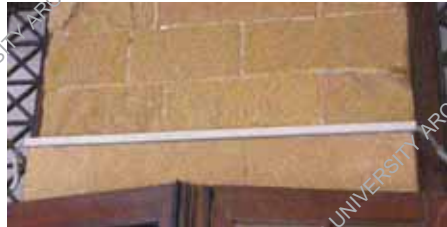
To hide the deteriorated stone surface another attempt was made by stone veneering process, as test sample in a small portion, inside the corridor of ground floor level. As per conservation principles this method is not recommended since original material has to be restored and preserved in the original state.

Figure 92: Stone Veneering as Sample Test
