**KILLARNEY HOTEL :  
A PROPOSAL FOR RESTORATION**

**Anila Naeem,**  
*Associate Professor, Department of Architecture and Planning,  
NED University of Engineering and Technology, Karachi.*

**June 2004**

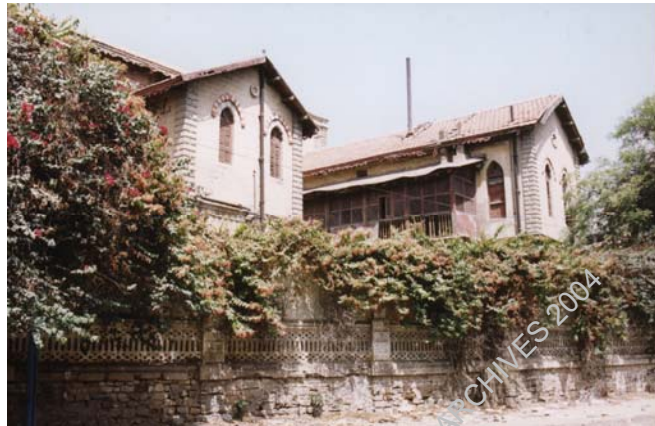
In the case of Killarney Hotel the original boundary wall was low with a distinct design of the period of its construction. But this wall has now been altered by raising its height with block masonry. This has caused a complete blocking of the view of the building from the street. As this building is an important historic building it is felt that its impact on the street

and visual link with the surrounding should be revived. However, the need for higher boundary for security purposes cannot be denied. Thus an architectural solution will be sought thorough which the original character of the low boundary wall will be retained, but in addition a higher barrier is achieved that allows visual connection but restrains unauthorized access.

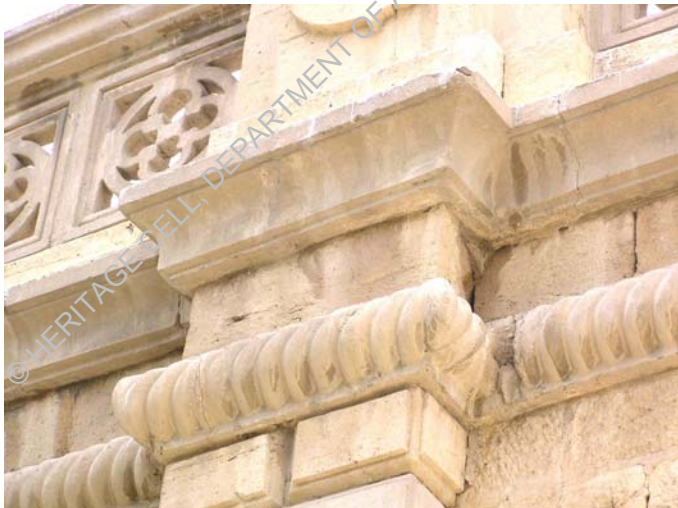
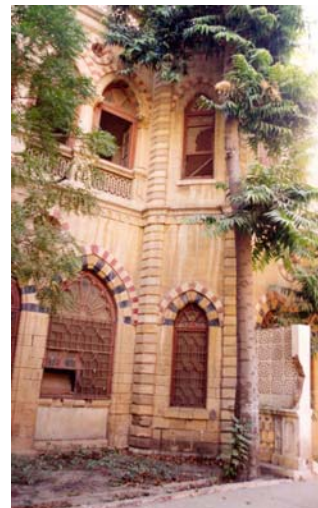
Besides general soiling due to consolidation of atmospheric dust, various locations of the building façade also show another form of stone deterioration i.e. the black crust formation. This is a combination of run off bio-film, dried pigeon droppings and dust accumulation, seen on vertical surfaces where rainfall striking on damaged horizontal surfaces, produces a run off film down the wall. When dry this film turns into black crust adhering to the stone. The black crust is most likely to cause excessive weathering of the stone during humid climatic conditions, when water content in air is very high. Black crust is seen on the building façade mostly under windowsills, cornices and other shaded areas under projections.

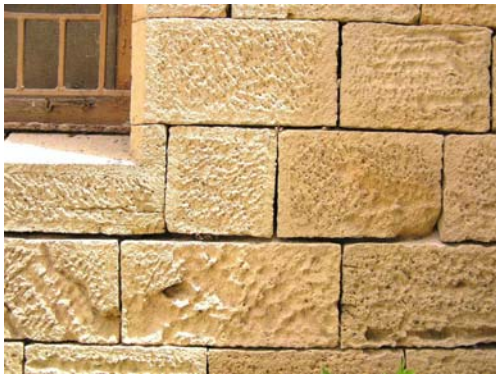
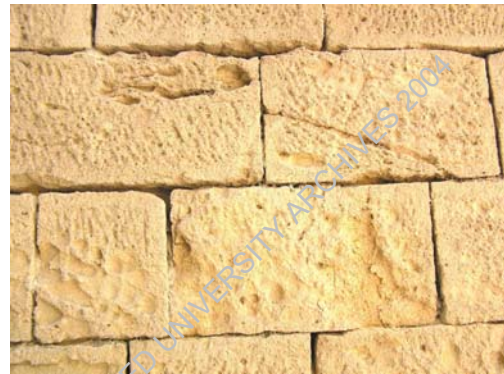
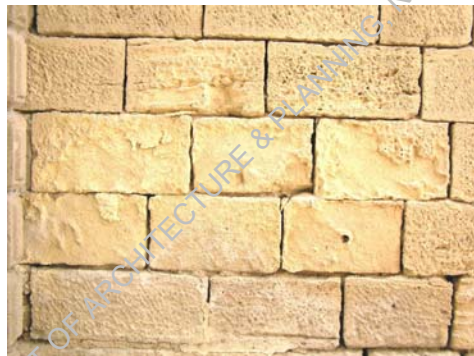
The limestone used in the construction of this building seems to be of a poor quality, as it shows severe weathering in various locations. These weathering forms are termed as alveolar weathering and pitting, where large or small holes appear on the stone surface. These are caused by the rapid de-evaporation of moisture from the surface due to windy weather. In non-homogenous stones this type of weather is more severe.

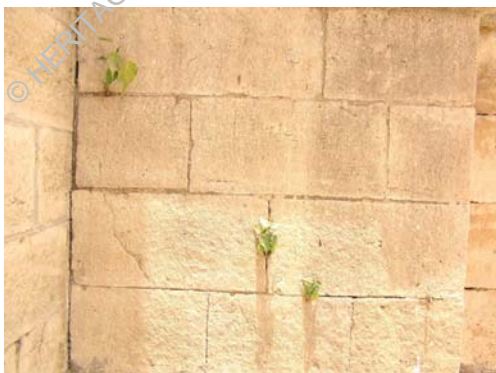
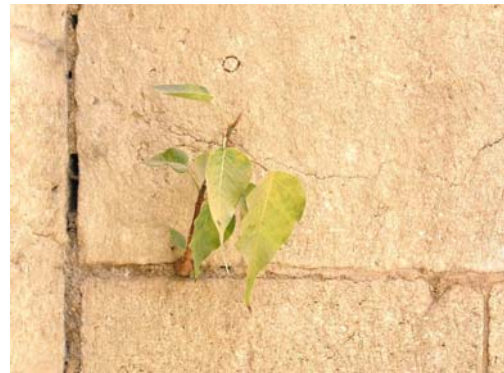
The stone is of a very porous quality, thus has higher water absorption and retention capacity. Due to trapped moisture inside the stone, macro biological growth is seen on vertical surfaces. To achieve a reduced water absorption a water repellent coat on the surface of stone at the end of cleaning procedure can prove to be effective.

On the North and East facades some areas of stone also have pulverization and disintegration. These areas of stone need to be identified and some consolidation treatment need to be applied to them.

Prior to any cleaning procedure all the different forms of stone deterioration need to be carefully mapped and then each areas treated separately for its specific deterioration type. In the first stage of cleaning all dry and loose dirt particles will have to be brushed off with wire brush, carefully ensuring that no loose particles of the stone itself are lost in the procedure. Such loose or detached pieces of stone should first be consolidated and repaired only then the general cleaning and washing should proceed. General washing of the entire façade will have to be done with mild soap and distilled water. Only after this initial cleaning, the more stubbornly adhering dirt patches, such as black crust formations etc. will be treated. For a detailed, recommended process of stone façade cleaning, please refer to “**Appendix I**” of this report.

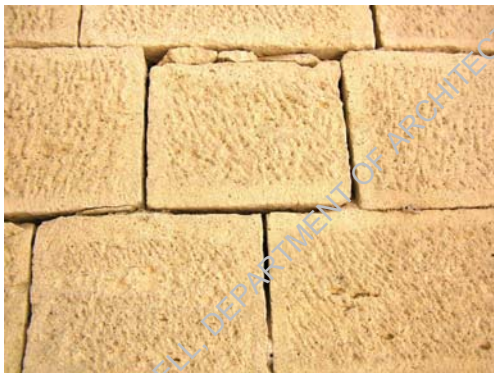
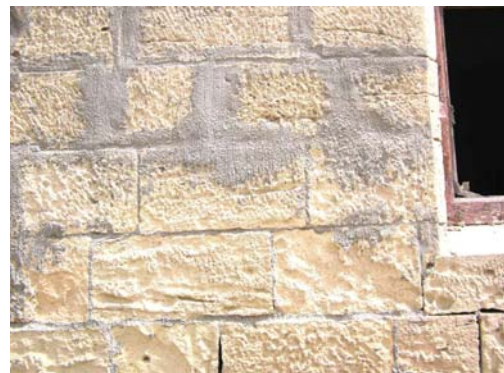
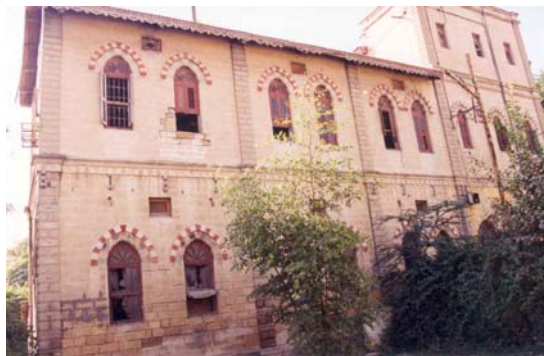
The lower parts of the masonry where rising damp has caused severe damages the mortar joints have opened up. In some places on the north façade it was observed that the stone masonry joints have been repaired with cement mortar. Generally this mortar is adhering tightly with the masonry, but due to the bad workmanship of these repairs it is advisable to carefully chisel these out and repair these joints with lime mortar.

The entire building facades should be inspected closely for any damaged or open mortar joints, before the cleaning of stone is started. Any loose mortar should be brushed off, and the larger gaps and open joints should be temporarily filled with lime mortar. Later these joints should be finished with fine lime mortar of approved finish color & quality.

This problem is most evident and severe at the base of the stone masonry on the ground floor level. See “**Appendix II**” of this report for preparation of lime mortar.

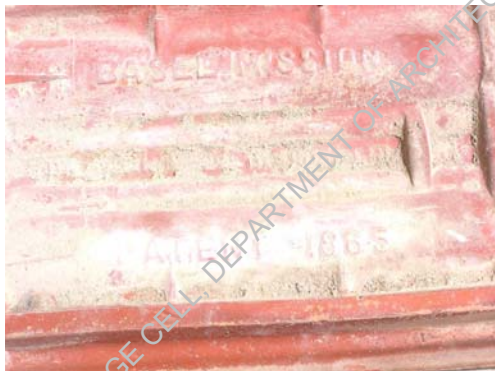
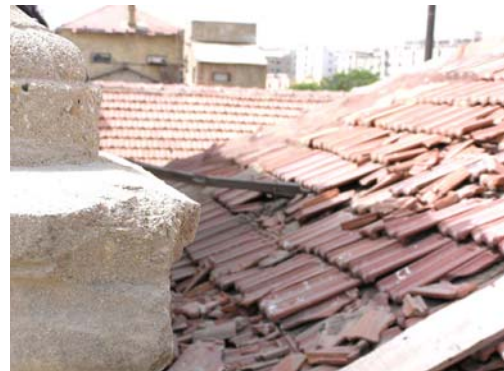
The entire roofing of the building has timber trusses made of teak wood. A general inspection shows that it is in a sound and stable condition with no signs of structural collapse. However, at the stage of implementation a detailed inspection will be carried out and each timber section will be closely inspected for any signs of damage, structural failure or termite attack. Based on this inspection decision for any replacement or consolidation will be undertaken.

A detailed inspection of the entire roof will also be done for all damaged and dislodged tiles. The broken tiles will be replaced with new ones. The ‘Khaprail tiles used in the roofs of this building are patent marked as “BASLL MISSION – PATMENT 1865”. It can be tried to look for the same tiles in the market of reused building materials, where debris of demolished stone buildings is sold. It might be possible to get the same patent marked tiles for the replacement of the broken or missing pieces.

Installations for the proper drainage of roof slopes, need to be implemented, at the base of the valleys, so that all the rainwater is carried down through these pipes, instead of washing over the facade surfaces. The drained water should be channeled off the site, through drainage system or subsoil drainage trench.

In order to make the trussed roofs waterproof all joints of purlins should be sealed with a water proofing material. In addition an appropriate insulation detail needs to be worked out for the entire roofing.

The timber structural elements are at present soiled with dust accumulation and bird droppings. After a detailed examination of the roofing timber, it would be thoroughly cleaned and treated for termite proofing. Finally these will be polished with clear lacquer polish. (Refer to “**Appendix IV**” of this report for the recommended detailed process for cleaning of timber).

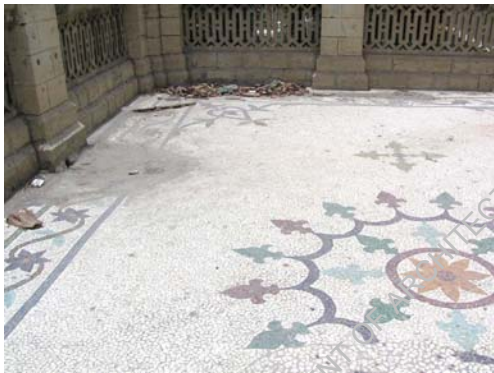
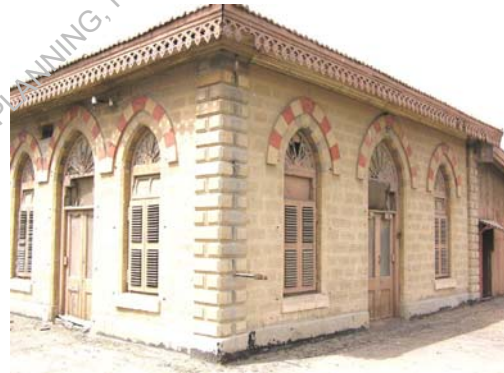
The parts of building having flat areas such as the terrace on the second floor and the balcony on the first floor, show evidence of improper surface water drainage. Due to this the rainwater stands on these surfaces and seeps through, damaging the structural members underneath.

In order to eliminate the problem of standing water on these surfaces proper slopes need to be worked out to ensure complete draining off of water. The second floor terrace at present has badly laid bitumen flooring which needs to be taken out and proper insulation treatment with properly worked out slopes and surface finish need to be done in this entire area.

Working out slopes for the first floor balcony will however be a bit difficult as it has the original mosaic floor which should not be damaged at any cost during the process.

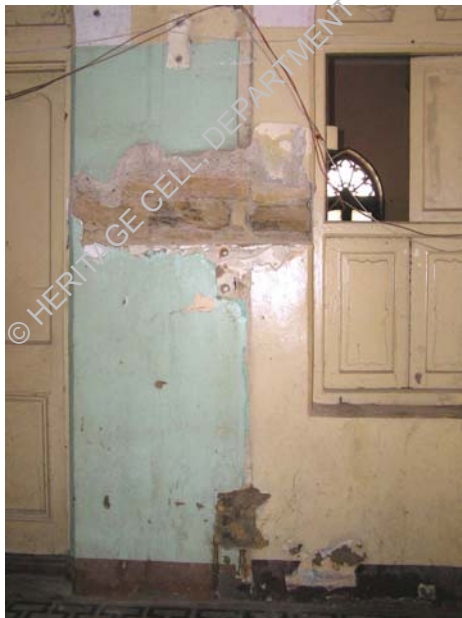
A band of severely damaged and deteriorated stone, along the entire base of the masonry on the exterior surfaces and a similar belt of damaged plaster along the interior wall surfaces on ground floor, endorse the fact that the ground water table is high in the area. The water table level being higher than that of the old stone foundations, is the cause of rising damp, through capillary action, into the building masonry. The problems caused due to high water table are further aggravated by seasonal changes and fluctuations in its level.

Before doing any repair work on the masonry, first the problem of rising damp should be eradicated. For this purpose the water table around the building has to be stabilized. In order to achieve a stable water table a trench can be dug around the building, which is as deep as the foundation. Along this trench perforated PVC pipes should be laid in such a manner that they maintain a gradient which allows drainage of excess ground water. This drained water can either be collected in a pit and then pumped to the nearest drainage hole or if the site conditions allow, it can be directly drained off into the nearest drainage line utilizing the natural gradient. For details of this treatment refer to “**APPENDIX IV**” of this report.

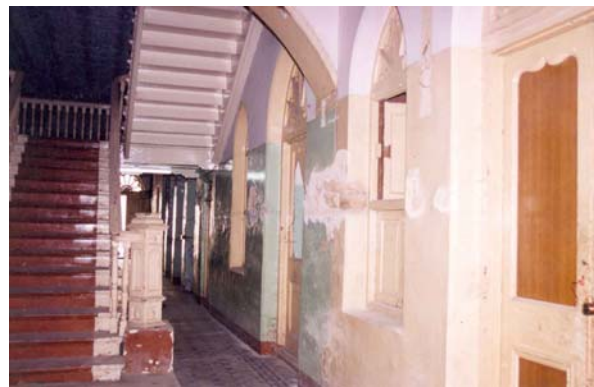
Along the interior walls it is seen that at some point in the life of the building an attempt has already been made to repair and prevent further damages caused by rising damp to the stone masonry. This earlier attempt done with a very superficial approach has caused further damage to

the stone masonry. In this earlier attempt the lower portion of the stone masonry inside the building has been re-plastered with cement plaster. Cement plaster being very strong and dense did not allow evaporation of the rising dampness, thus increasing the level of rising damp above the height of the repaired portion and damaging the band of lime mortar above it. Thus at present the damage caused by the rising damp is observed at a level as high as approximately 5'; above the level of the cement plaster band. It is advised that this entire band of cement plaster is chiseled out completely and new lime plaster is applied only after proper treatments for cutting off the rising damp are implemented and substantial time is allowed for the drying of the wet masonry.

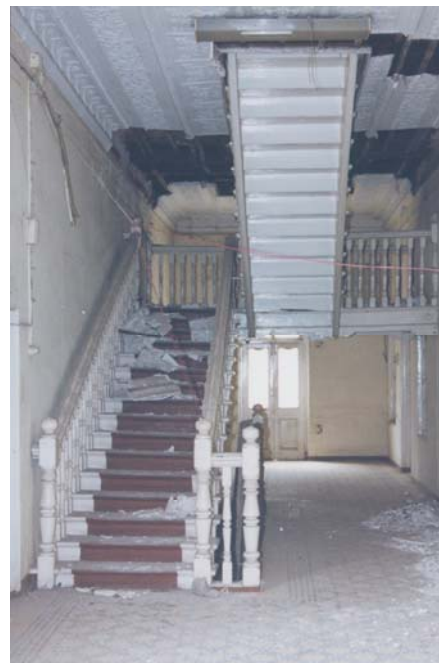
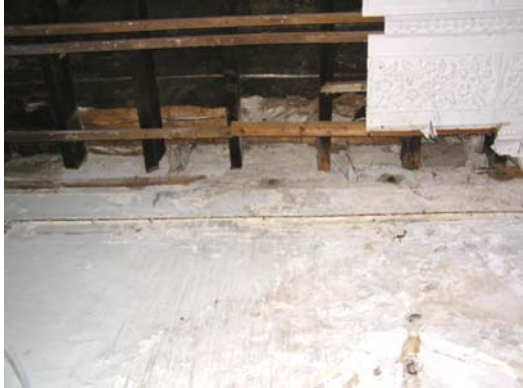
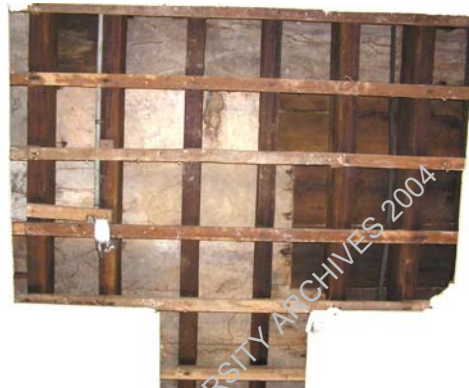
The entire building has a false ceiling of ‘plaster of paris’ panels. This false ceiling apparently was added at a later stage in the building’s life. At places where some panels have fallen off, the original timber trusses of the roof become visible. It is at these locations where the timber used for the framework of the false ceiling is also visible. It is quite obvious that the timber used for fixing the false ceiling is of very poor and cheap quality. This

frame has been attached directly to the roofing trusses, thus giving an additional load on them, which they are not designed to cater. Due to the cheap quality of wood used in the

false ceiling framework, it has been attacked by termite. This has also made the teak wood of the trusses vulnerable to termite attack. It is strongly recommended that this entire false ceiling, with its entire framework, is removed at the earliest to avoid further damage to the roof trusses. This would enable exposing the interesting trussed roofing, which is a strong feature of the building fabric, visible from the inside.

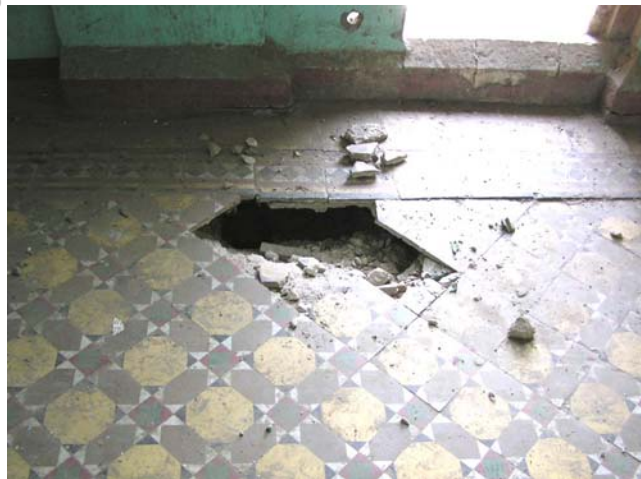
Flooring of almost the entire building is done with cement concrete (c.c.) tiles, except for the first floor balcony and the second floor verandah that have mosaic floor. On the ground level the floors have settled at various locations and need to be re-laid evenly. On the first and the second floors also, due to sagging of a few timber beams the floors have uneven levels. At one or two locations, due to damaged timber beams the flooring has collapsed. But this is only at localized spots, and the cause of such failure seems to be water penetration at these specific locations, which has caused decay and rotting of the timber beams leading to collapse of floor only in that location.

Since the flooring material almost all over the building is c.c. tiles it will be easy and cost effective to take out the entire flooring, level out the sub floor or in the upper levels provide

a better sub-floor, and re-lay the same tiles again in the same sequence. This procedure will give possibility for treating the sub-floor on ground level with a water proofing layer also. Special care needs to be taken while taking out the c.c. tiles so that they are not damaged during the process. They would also be carefully numbered to allow their reinstalling at exactly the same location.

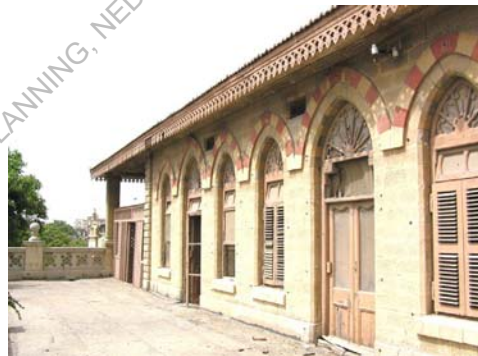
The existing doors, windows and ventilators of all the buildings, are made of timber, with glass panes. Quite a few glass panes are broken and will have to be replaced.

The frames of doors and windows have been painted and repainted over the years. This accumulated layer of paint should be scraped completely, to the extent that the original color and texture of wood is exposed. This cleaned wood will then be polished with clear lacquer polish.

In addition to this there are a few windows that have wooden louvered panels on the exterior. These will also be restored where missing and repaired where broken, then cleaned and polished.

In some of the doors and windows the broken glass panels have been replaced with plywood which should be removed and new glass panels (either of colored or textured glass) installed in their place.
