DOCUMENTATION & CONSERVATION REPORT

Edulji Dinshaw Building - Lady Dufferin Hospital

STATE OF CONSERVATION REPORT

Prepared by: Heritage Cell, Department of Architecture & Planning
NED University of Engineering & Technology, Karachi

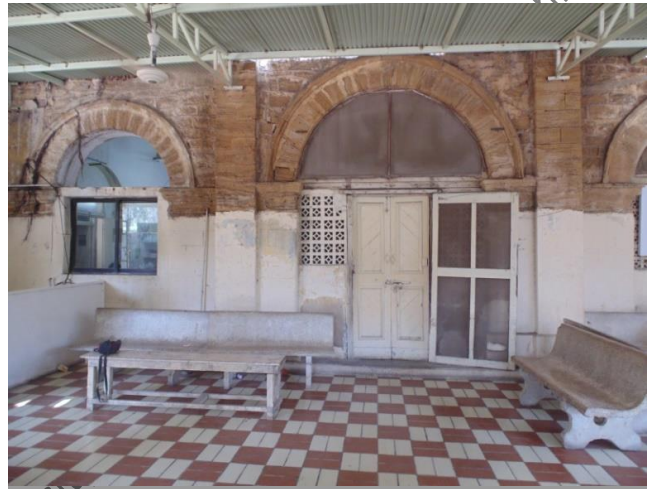
The north-east elevation and corner of EDB is presently completely obscured by the extensions forming visibly impactful alterations to original structure. Here three small spaces are added at ground floor level, having access from outside; serving as extension of Women's OPD wing. The front elevation at this corner is also partially obscured at ground floor level due to the asbestos covered waiting area outside Women's OPD (**Figure 24**). The south-west elevation is also completely obscured by a G+1 structure, used as family planning wing. This is internally linked with EDB at first floor level through connecting steps. The extensions at both ends are RCC structures, with simple façade details; not conforming with or complimenting the original architectural character of the stone structure. Both of these ends as seen in an undated historic image (**Figure 25**) are single storey portions, having timber roof of hipped profile covered with terracotta (*khaprail*) tiles.

Figure-24 Covered Waiting Area at OPD Women Section

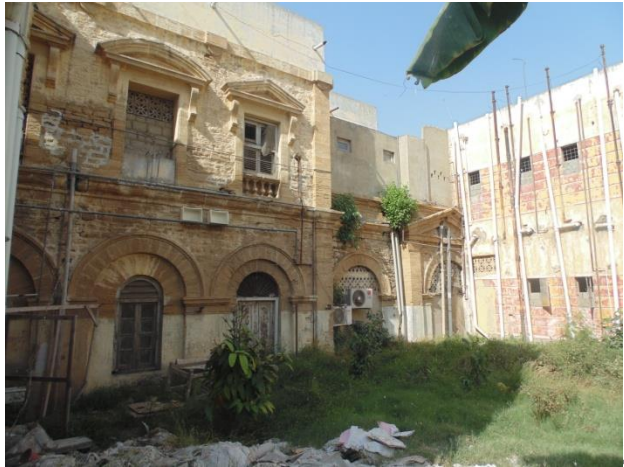
Figure-26 Extension Blocking Side Façade

All inappropriate alterations including material interventions for consolidation of disintegrating/damaged stone must be removed; wherever possible without causing damage to the original fabric. Foremost in this are the massive later additions or extensions built at the two ends of EDB completely obscuring the side elevations. These are presently in use for various activities; thus would require further deliberations with the hospital administration to develop a gradually phased out restoration scheme.

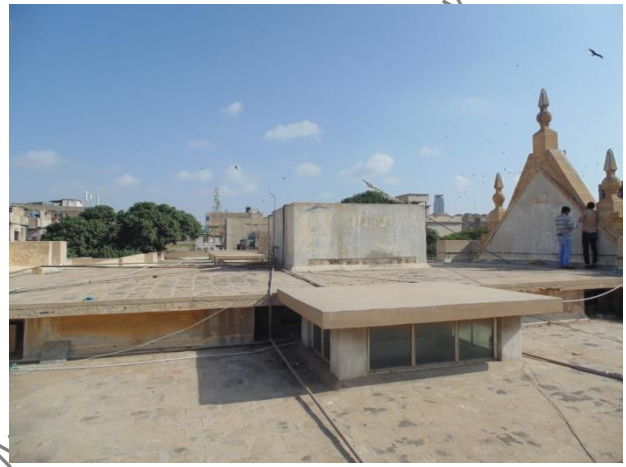
The entire roof profile has been completely altered as evident from the undated historic image indicating a timber pitched roof profile, finished with terracotta (*khaprail*) tiles. The original roofing is now completely replaced with RCC slabs, punched with ten protruding skylights that provide natural light to first floor spaces. The extensions at two ends of the building have also resulted in the loss of ornate gable detail at the two side façades of central two storey high portion of EDB (**Figure 26**). The pitched roof over the central gable is also replaced with a flat roof and an additional RCC water tank (**Figure 27**).

Figure-27 Gable Roof replaced with Flat Roof

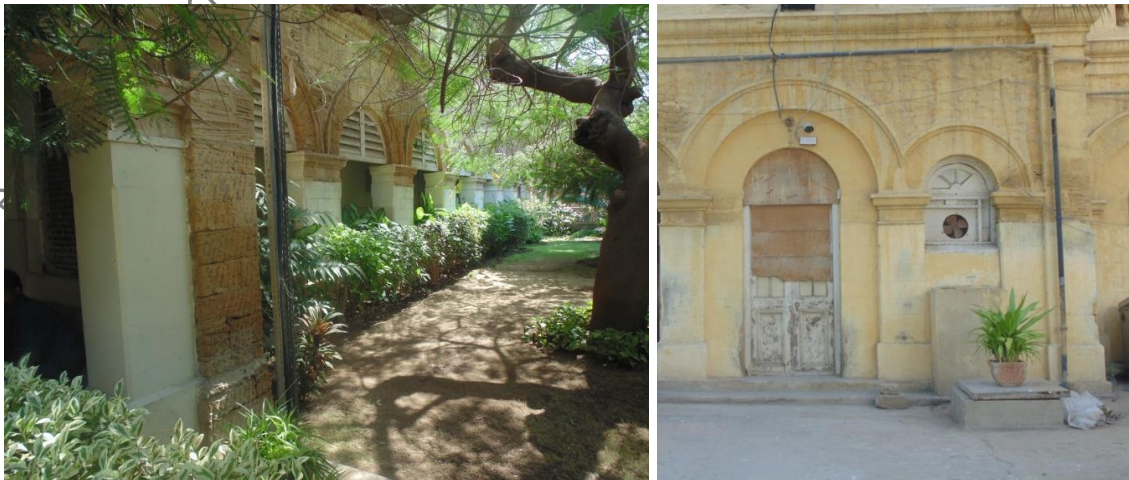
For the construction of EDB, Gizri limestone of yellow coloring has been used. The general condition of stone masonry and decorative architectural details are mostly well preserved. However, repair and maintenance interventions do indicate in-coherence with original materials. The stone masonry is at places altered with different surface treatments, such as plastering over with cement or color Grête, or tile cladding (**Figures 28**). These cosmetic surface treatments are

Figure-28 Surface Treatment in Stone

observed to be up to 7ft. height, apparently attempting to hide the deteriorated, discolored or damaged stone masonry at ground floor level, due to presence of moisture – either through rising dampness from underground water or leakages in plumbing installations.

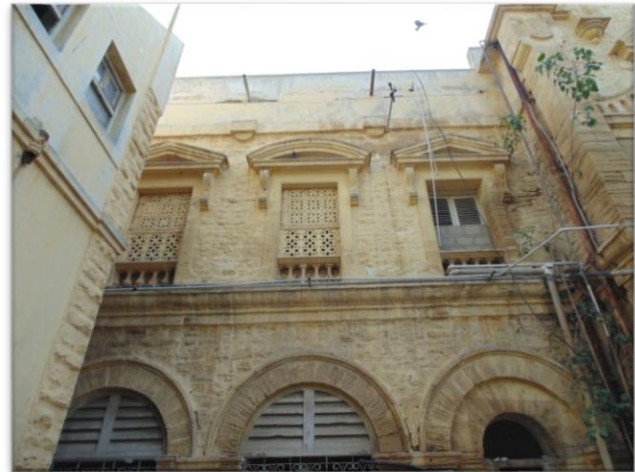
The original bottle shaped stone parapet at roof level, clearly visible in the undated historic image of EDB has been completely replaced with a simple masonry parapet wall. In addition to the replacement of original parapet at roof level, the parapets of openings along first floor corridor are also altered by adding c.c. *jali* to increase their height (**Figure 29**). In some of the openings there is a geometric patterned stone tracery, above which the c.c. *jalis* additionally added.

Figure-29 C.C. *Jali* Closing Corridor Openings

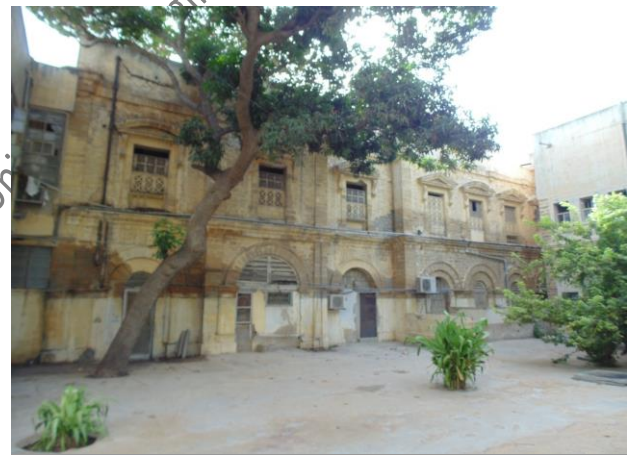
A few of the arched openings on ground floor, along front and back corridor are closed either with wooden trellis (*jaffry*) or simply with block masonry; particularly along back side corridor and near OPD in-charge room (**Figure 30**).

Figure-30 Openings Closed with Masonry

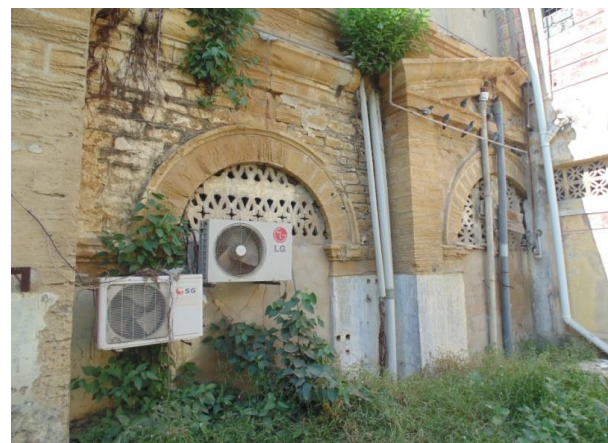
Some parts of the stone façade are defaced with exposed electrical wiring and insensitively installed drainage pipes at locations where toilets, washbasins, or other wet spaces are created. These do not only have a negative visual impact, but additionally been a cause of damage to building stone due to seepage and/or leakage of water, washing over or penetrating into the stone masonry. At some locations AC units are also installed on building façade (**Figure 31**) adding to the negative visual effect.

Figure-31 AC Unit Attached with Stone Wall

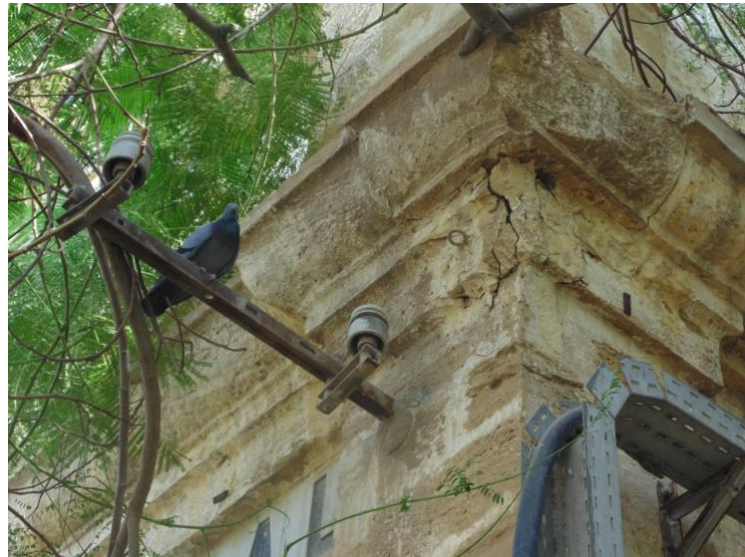
Electrical wiring clipped to the stone walls with iron nails also forms a visual eyesore, particularly along the arcaded corridor (and inside several rooms as well), where exposed wiring and fittings have been installed haphazardly (**Figure 32**). Some wiring is also carelessly dangling from façade affecting aesthetics of the façade (**Figure 33 a, b**).

Figure-32 Exposed Electrical Wiring

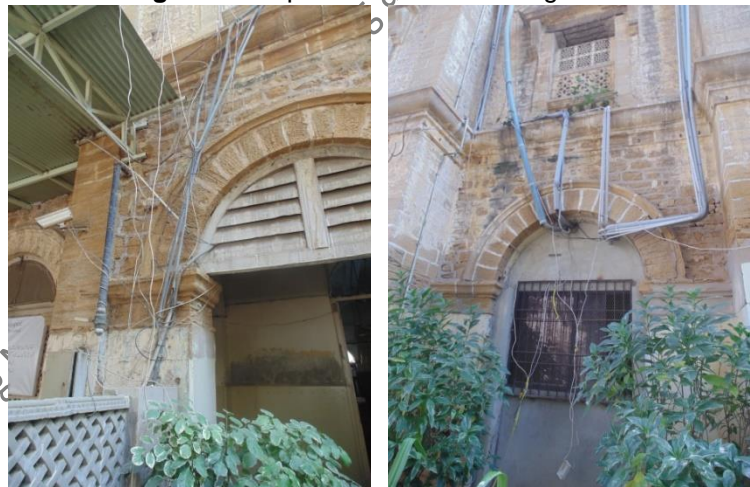
Figure-33 a, b Exposed Wiring on Façade

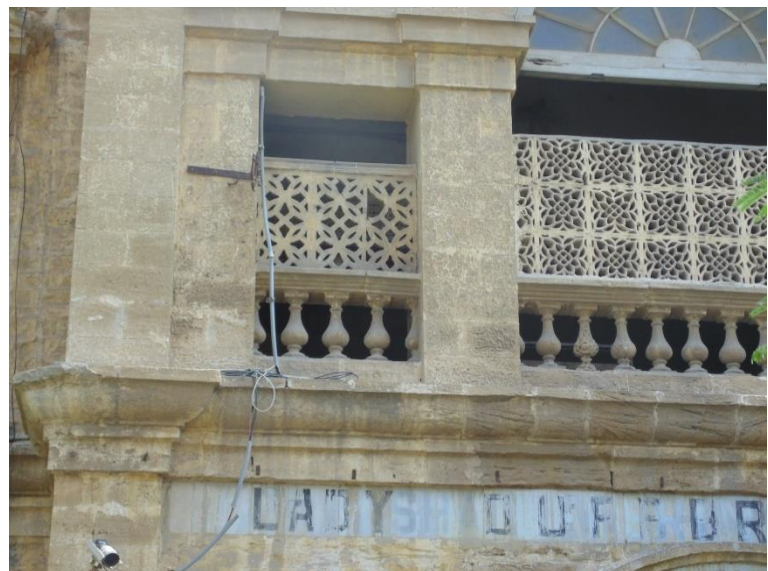
Iron clips, anchors or nails on front façade have also caused damage to stone walls, due to rusting and erosion of metal, leaving weeping rust stains causing discoloration of stone surface (**Figure 34**).

Figure-34 Iron Nails on Front Façade

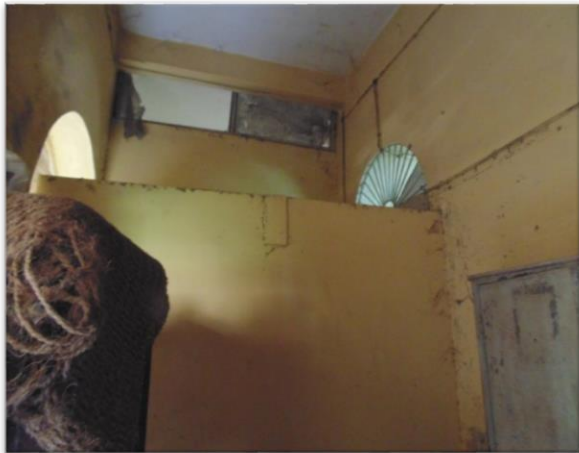
Several later added full height block masonry partition walls or wooded partitions are added in the original floor layout, to create subdivisions of spaces. This is particularly the case at ground floor level where the larger halls on two sides of entrance lobby are subdivided to create statistics department, store room and supervisor room in one hall; whereas the medical

Figure-35 Partition Wall Subdividing Spaces

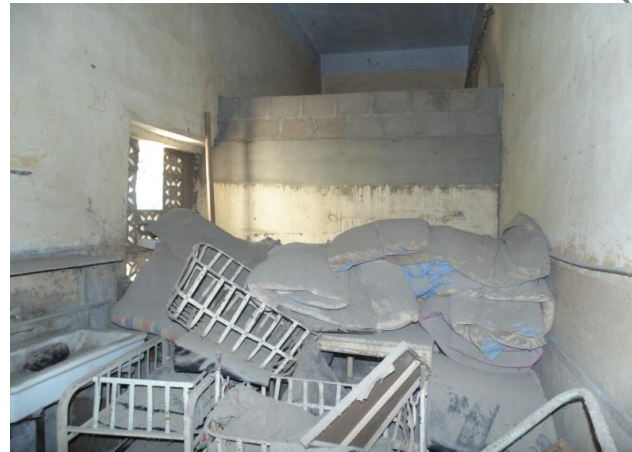
officer's rooms and infertility clinic along with its ancillary spaces in the other hall. The front and back side corridors also have partition walls at various locations creating small enclosed spaces for accommodating toilets, storage or other service areas (**Figure 35**). The first floor is less altered, having additional partition walls only at a few locations on back side corridor and only at one location in front corridor (**Figure 36**).

Figure -36 Partition Wall at Backside Corridor

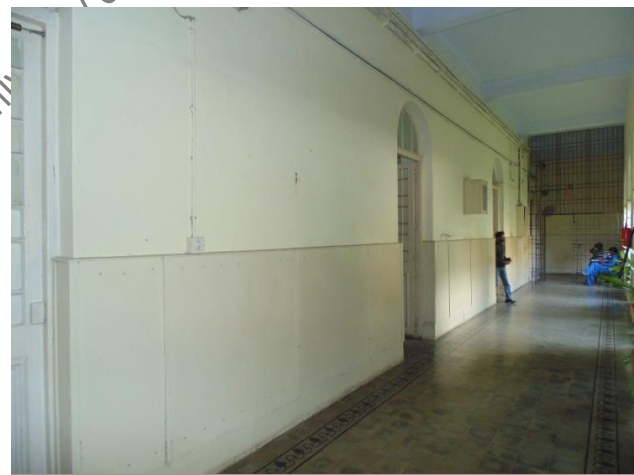
Walls of several rooms and corridors have 2-3 inches thick wooden panels' cladding up to 5ft height (**Figure 37**). Some of the rooms created by partitioning - including medical superintendent room, admin room and chief executive room have false ceiling, complete with ceiling lights - giving the look of a renovated interior (**Figure 38**).

Figure -37 Wooden Paneling and Cladding

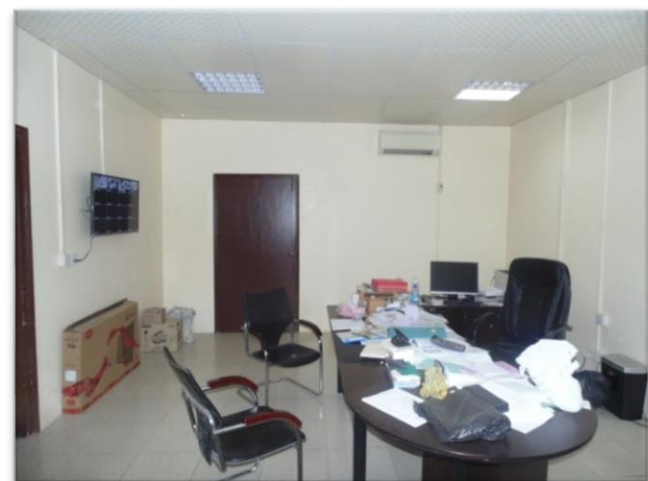
Figure-38 Renovated Interior with False Ceiling

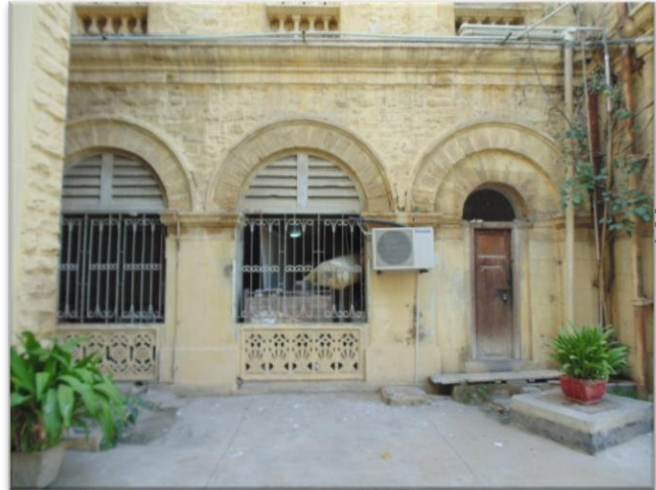
Besides some of the altered arched openings on the façade, a number of doors, windows and arched openings inside EDB premises are also altered by closing with block masonry or wooden boards/ partitions or shelves. Some of these closed openings also have AC units or exhaust fans installed in them. Some of these also have iron grills fixed on them (**Figure 39**).

Figure-39 Iron Grills on Windows

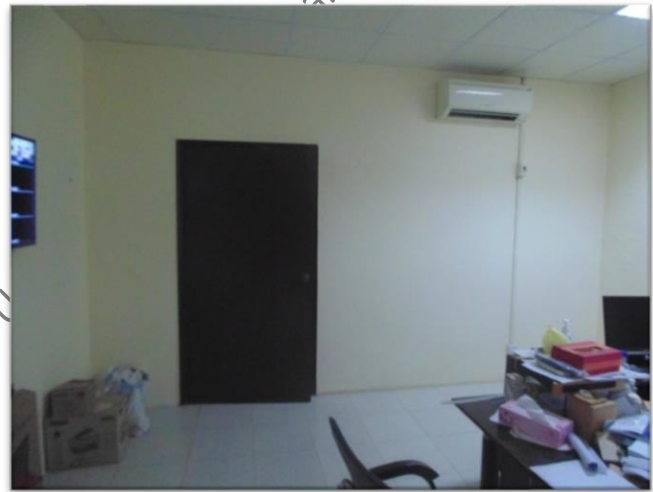
Figure-40 Addition of New Door

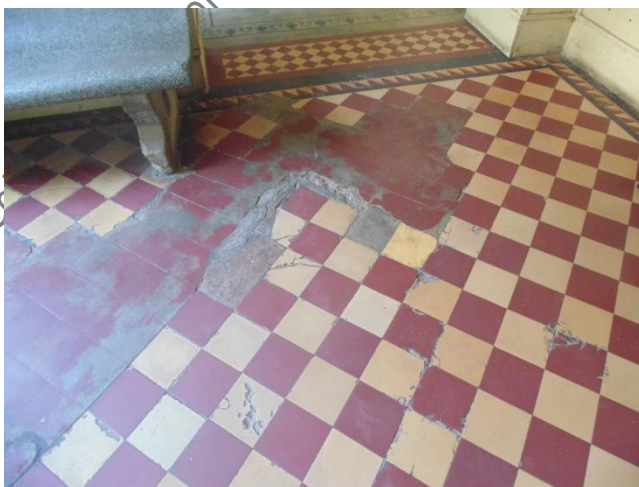
The original flooring of EDB's interior spaces is cc tiles, often with exquisite floral or geometric patterns or different colored pigmented tiles (Figures 42). Most of the spaces still retain their original flooring, except for the few administrative offices on ground floor where flooring is changed to glazed ceramic tiles. A few of the spaces still retaining their original flooring have some damaged portions that are inappropriately repaired with cement mortar. Due to lack of proper maintenance some areas of original flooring give a dulled and soiled appearance. The variety of original flooring patterns are documented in detail through flooring drawings. The above discussed alterations – additions or removals in original layout have taken place over the years to accommodate the growing needs, changing requirements and technological advancements that must have become necessary

Figure-42 Inappropriately Altered Geometric Patterns

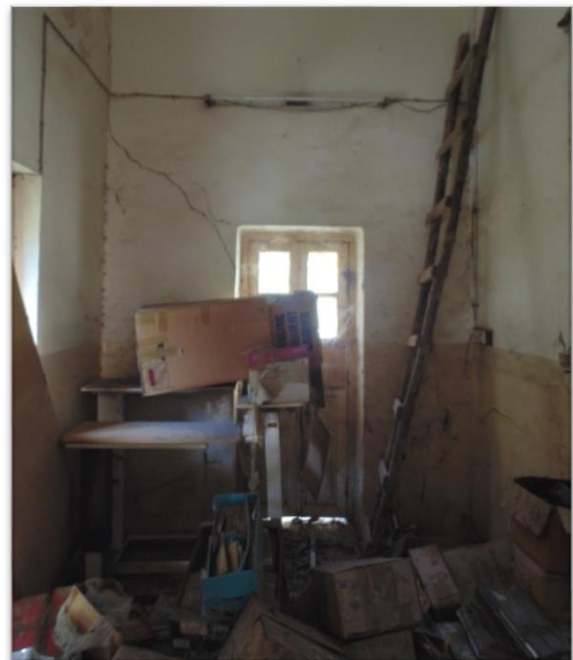
Figure-41 Door Blockage with Furniture

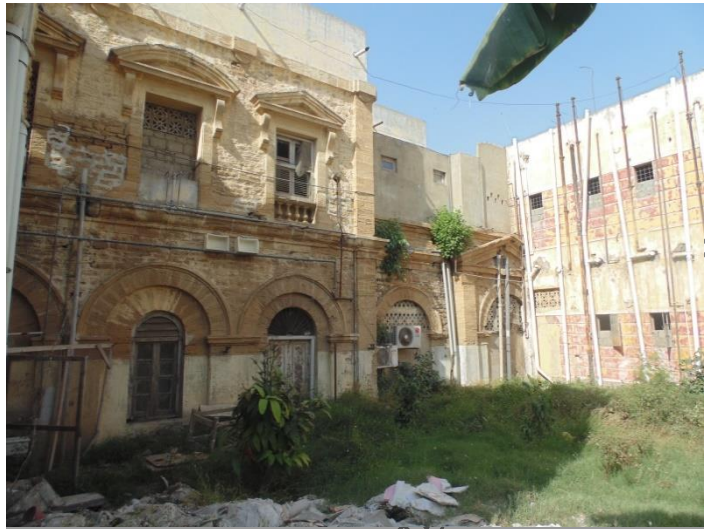
The lower part of stone masonry on front and rear façades shows the most advanced deterioration, in the form of scaling, back weathering due to loss of stone elements depending on stone structure and alveolar weathering. These forms of deterioration are caused by climatic factors, as well as penetration of moisture or water into the building material. Since Karachi is a semi-arid region there is little rainfall, however, being near to the sea there is a high percentage of humidity in the atmosphere, along with salt content. Besides the damaging effects of atmospheric moisture content, the stone of EDB is mostly damaged due to water penetration from leaking drainage pipes and AC drains. The close proximity of plantation on the front as

well as back side of the building is also another major source of water damage due to regular watering of plants (Figures 43).

Figure-43 Exposed Plumbing, Water Pipes and AC Units

The primary source of damage to stone masonry and other parts of the building is the water penetration through various sources including defective/ unmaintained plumbing and watering of plants. The first step would be to eliminate the sources of water intrusion. To achieve this objective all additional toilets and other service spaces having usage of water should be removed from the main building. If the decided usage requires any of such spaces these should be designed with proper details for plumbing and water drainage, both in terms of improved aesthetics as well as installation finesse.

The plantation placed very close to the building foundation needs to be relocated a little away from the building, with properly designed landscaping details, so that the watering process does not affect the building stone.

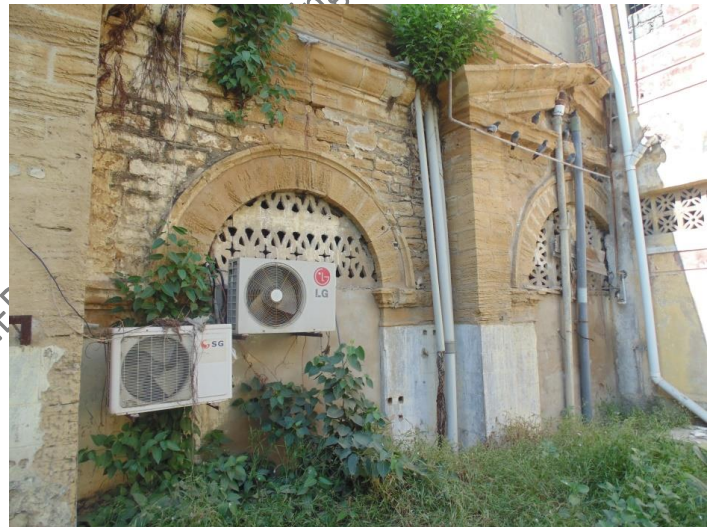
The stone façades have signs of soiling, apparent by a darkened color of stone, due to dust accumulation, particularly along horizontal ledges including cornices or moldings. Places where moisture is trapped for longer periods also have black crust formations i.e. a layer of microbiological growth (Figure 44).

Figure-44 Micro Biological Growths at the Rear Side of OPD

A thorough cleaning of overall stone façade is recommended. This would involve removal of accumulated paint layers, washing of soiled areas where dirt accumulation has resulted in change of stone coloring; particularly on cornices, balustrades, *jalīs*, windowsills or *chajjas*. The plinth base at rear side of the building also needs to be cleaned out from accumulating heaps of dirt.

A test patch is advised to ensure the right percentage of chemical concentration required to remove the adhering dirt. The first stage is to clean off dry and loose dirt particles using hard bristled brushes. A cautious approach needs to be taken to ensure that no loose particles of the stone are lost in the process. Any loose or detached pieces of stone, should be re-fixed or consolidated in place before the application of wet cleaning and washing procedures. Following dry cleaning process, the second step is to do a general washing of the entire stone surfaces with mild soap and distilled water. In the third stage cleaning procedure is applied for stubbornly adhering dirt patches and soiling. Poulticing (with ammonium bicarbonate solution) can be used for cleaning of areas with biofilm or black crust formations; whereas other types of stains such as beetle nut spits, rust stains from corroded iron, etc. would require treatments specific to these (refer Appendix I for more details).

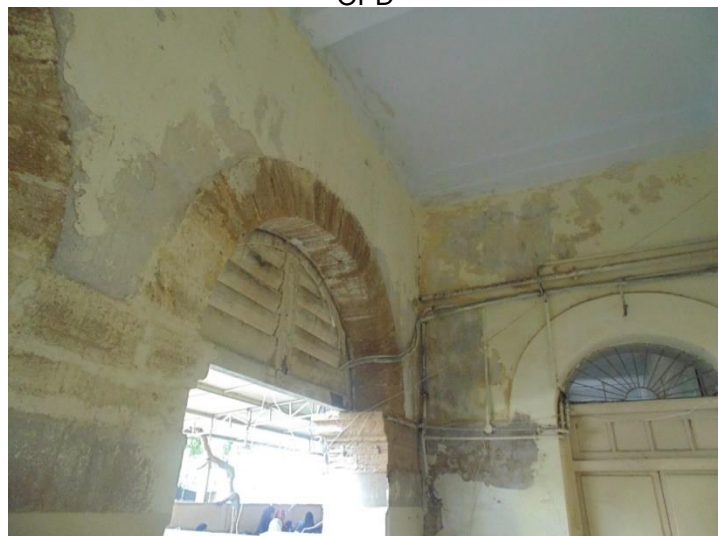
Moisture penetrating from a variety of external and internal sources has been a cause of damage to building stone. Besides natural sources such as the rain and ground water table, there are a number of internal sources, such as leaking plumbing pipes or AC drains. In EDB the pattern of moisture indicates localized sources of water penetration; rising damp is not much evident, however needs to check after removal of additional layers of cladding or covering materials on wall surfaces at ground floor level. In locations where cement plaster is applied the moisture stains have risen up to approx. 10ft height (Figure 45).

Figure-45 Moisture Stains Inside the Corridor

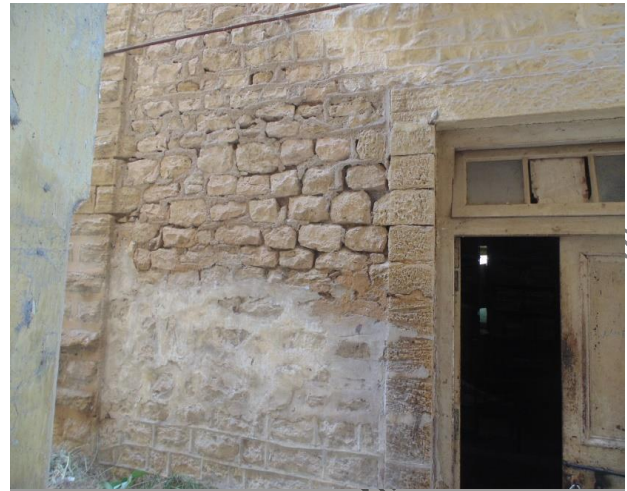
Many areas of stone masonry have deteriorated areas of mortar joints, where lime mortar sealing the masonry joints has disintegrated leaving open mortar joints that allow deeper penetration of rain water inside the masonry (**Figure 46**). Proper re-filling of these open mortar joints, using appropriate lime mortar, should be undertaken on an urgent basis to prevent further deterioration. A close visual inspection of stone masonry surfaces, also reveals that several open mortar joints have been repaired with cement mortar, however due to incompatibility of material the new mortar joints have again disintegrated (**Figure 47**).

Figure-46 Open Mortar Joints on Record Room Block

The front and rear façades of the building when closely inspected indicate few areas of open mortar joints, minor cracks or dislodged stone masonry blocks, and cavities/ holes drilled for some installations. These need to be re-fixed after investigating the reason for the damage and eradicating the cause. Initial mortar repairs must be done to seal all such openings before any cleaning of the entire façade is undertaken. These damages are not of severe nature thus can be rectified with simple interventions. It is recommended to use lime based fillers for the required repairs/ re-pointing of open mortar joints and minor cracks or gaps.

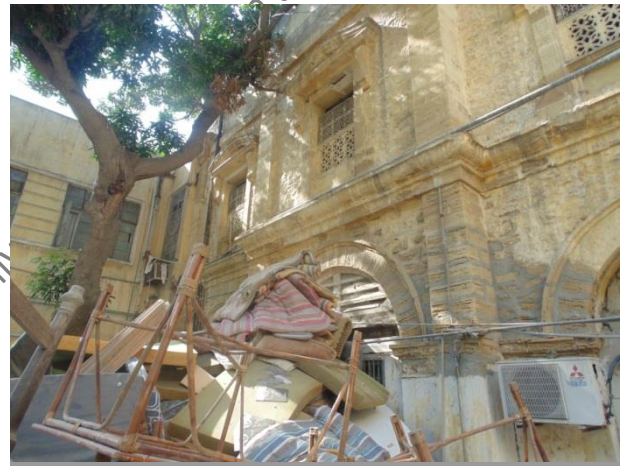
Figure-47 Mortar Joints Filled with Cement Plaster on Rear Façade

Mortar joints repaired with cement mortar fillings, and cement grouting applied for filling the cavities and holes at some locations during previous maintenance procedures, observed on both façades, should also be removed and repaired with appropriate lime based mortars. Generally all loose mortar shall be brushed off with hard brushes and the gaps or cracks shall be repaired with fine lime mortar of approved finish, color and quality (refer to Appendix II for details on preparation of lime mortar and suggested repairs).

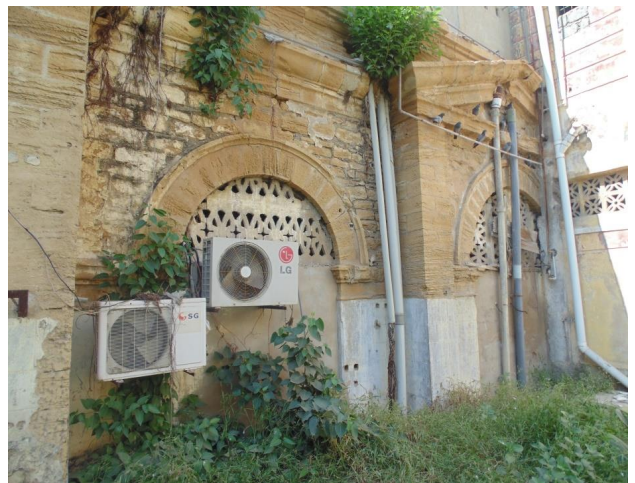
At locations where there is a constant presence of moisture, the growth of micro-biological film and higher plants such as weeds, tree plantlets, etc. is observed. On the rear façade, at the back of women's OPD there are more leaking drainage pipes thus more areas of damaged stone masonry (**Figure 48**).

Figure-48 Micro Biological Growths at the Rear Side

Due to constant presence of moisture at many locations on stone masonry there is both micro and macro biological growth; particularly on the back façade (rear side of Women's OPD wing) and the south-east end of front façade. The primary source of water penetration in these areas is leaking plumbing pipes. After removal or appropriate re-fixing of plumbing (if needed) the masonry should be allowed to dry off clearly. Only after the problematic source of water is rectified then cleaning of surfaces soiled by organic growth can be carried out, using mild chemical treatments. First attempt at cleaning can be done with simple brushing and scrubbing with dry bristle or soft wire. The surface can also be washed by jetting with high pressure, low-volume water lance to soften the crusts. Areas with more adhering crusts can be cleaned with paper pulp treatments using mild chemicals (refer Appendix I for details).

Higher plants (macro-biological growth) can be pulled out and their roots sprayed with an appropriate weed killer – to ensure complete eradication of roots that may encourage future growths. Once the roots are dead a thorough cleaning should be done to remove plant residue and any gaps or cavities created due to the removal of plant growth should be repaired/ filled with lime mortar.

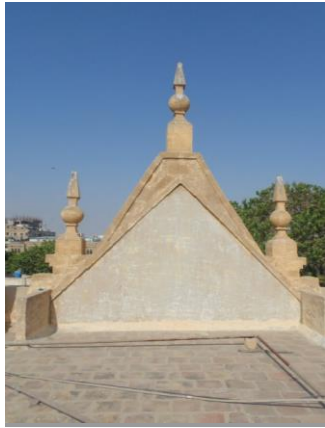
Due to presence of dense trees within the hospital complex there is a substantial presence of birds in the area which regularly perch on the building. Bird droppings are noticed on the outer surfaces of stone masonry particularly on the roof top on the acroterians (**Figure 49**). Activities of pigeons are also noticed inside the building at the ground and first floor corridor (**Figure 50**). Bird droppings are acidic and can cause damage to building materials if subject to prolonged exposure.

Figure 49 Birds Droppings at Acroterian

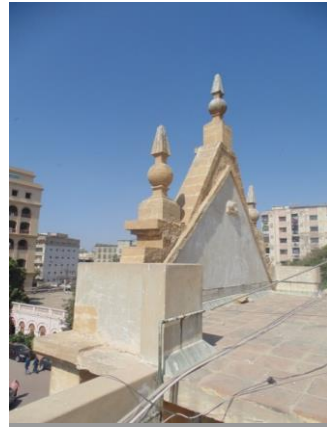
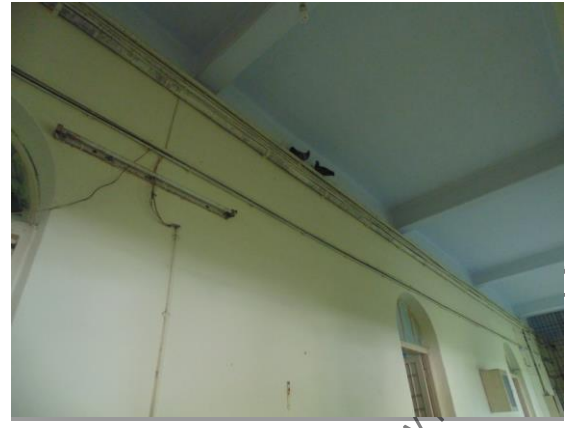
Figure 50 Pigeons Activity Inside the Corridor of Ground Floor

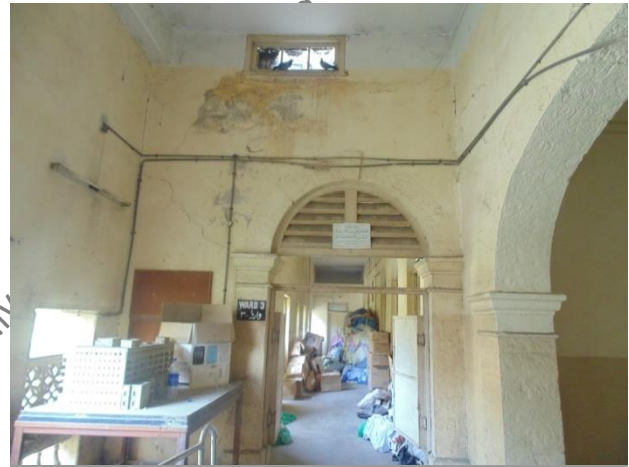
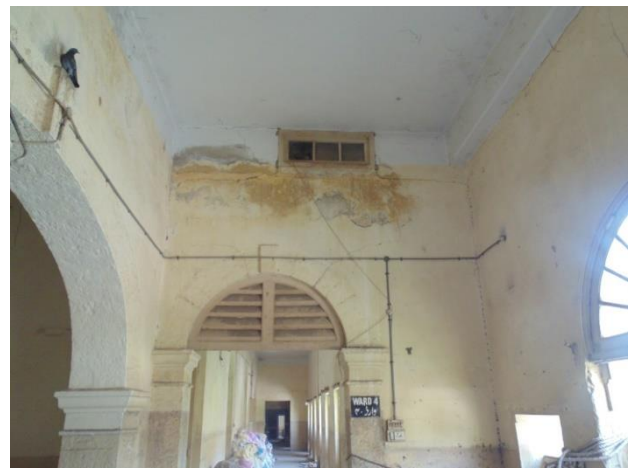
The condition of EDB is presently in very stable state, with no signs of any major structural failures. Only a few minor cracks in beams or walls were noticed in the corridor and at the linen section of first floor (**Figure 51**). These can easily be catered to with minor repairs and consolidation treatments.

Figure-51 Cracks on the Walls of First Floor Corridor
