NATIONAL FOODS LADIES CLUB: GUIDELINES FOR RESTORATION AND NEW EXTENSIONS

*Heritage Cell - Department of Architecture and Planning,
N.E.D. University of Engineering and Technology, Karachi.*

December 2010

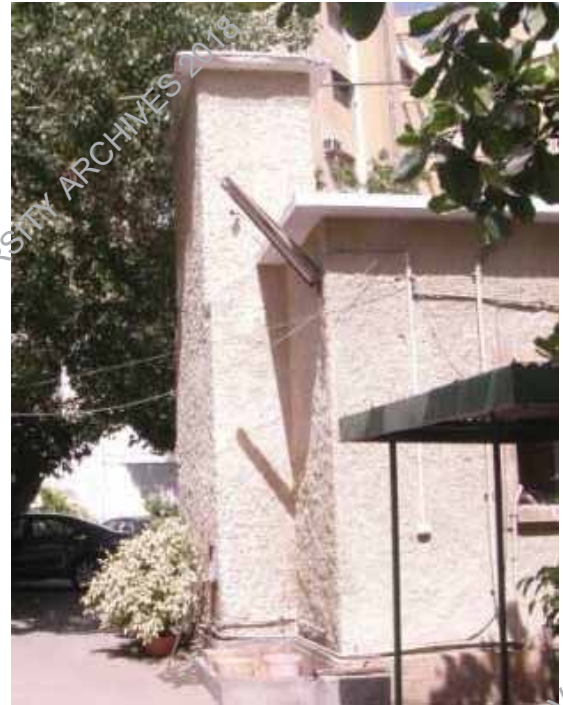
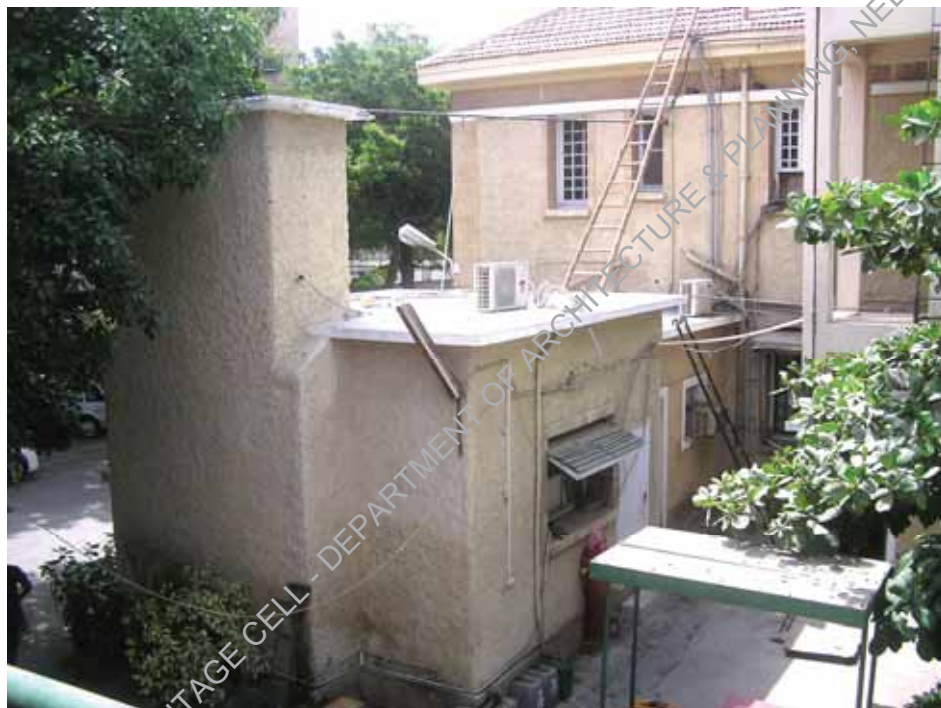
Chimney attached to the original kitchen space; placed on the north-eastern side of the main building.

The chimney located on the northern side of the building being an important architectural feature of the original layout and mass composition, is strongly recommended to be retained in the new design. Although the original use of the chimney is no longer valid due to the conversion of original kitchen space into an office and construction of separate kitchen area; yet retaining the chimney mass will ensure keeping intact significant evidence that gives important information on the original plan scheme and also preserves the original massing of the historic structure. Being a rare surviving sample of this architectural feature the chimney adds significant value to the building and adds to its parameters of merit.

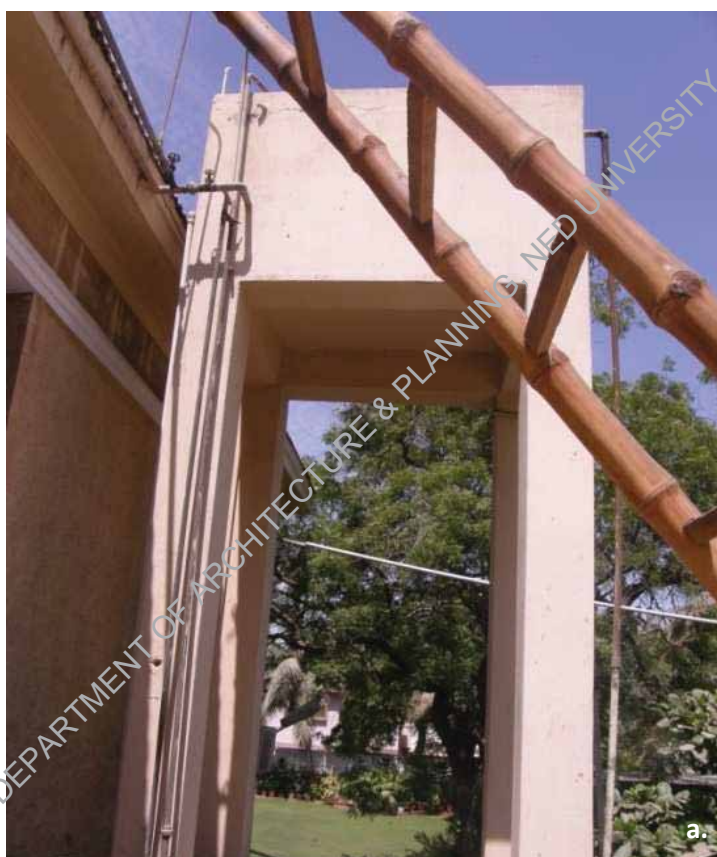
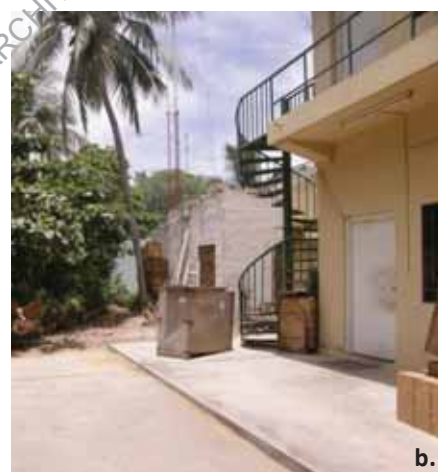
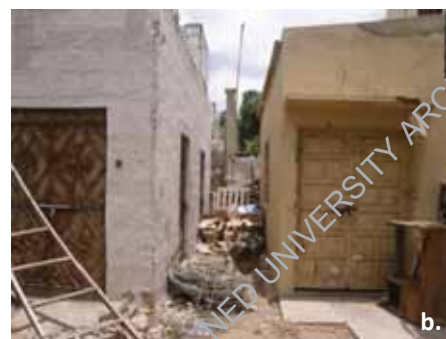
a. Later added over head tank tower on north-eastern side of the main building.
b. Blocks later attached to the out-house.

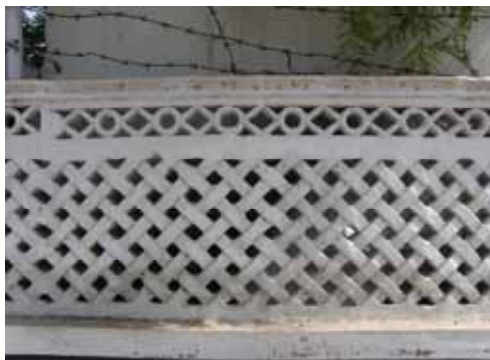
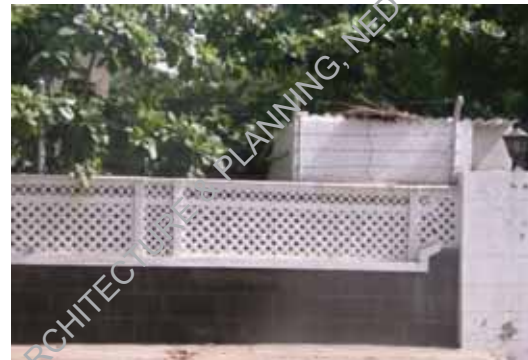
Different views of *namakpara* pattern of the boundary wall.

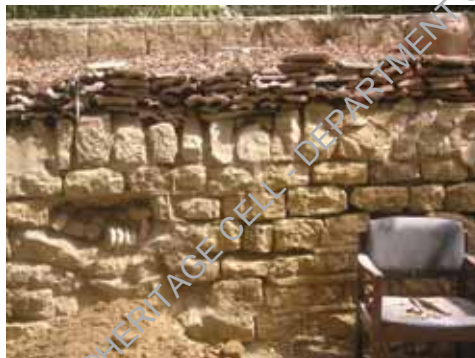
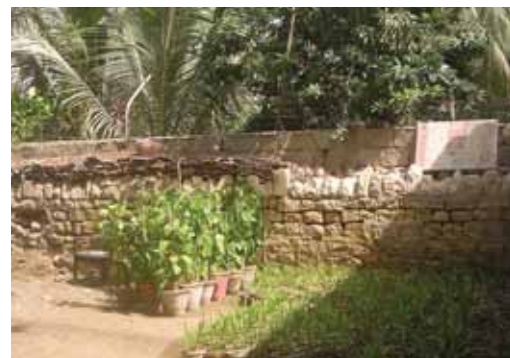
The remaining portion of the original boundary wall built of stone, on back side of the site.

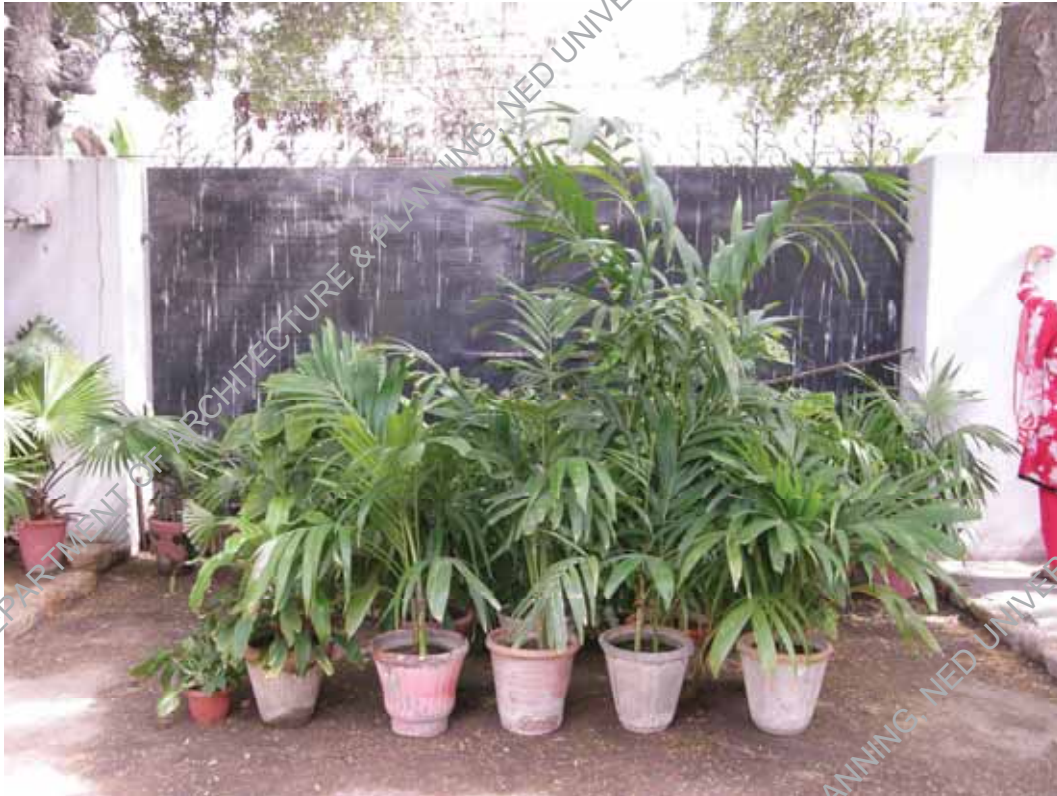
The plot has access only from the southern side. This side's boundary wall has two gates, but at present only the one on the western end is in use. The eastern end gate exists, but it is in disuse and kept permanently closed.

Second main gate: located on southern side of the site not being used.

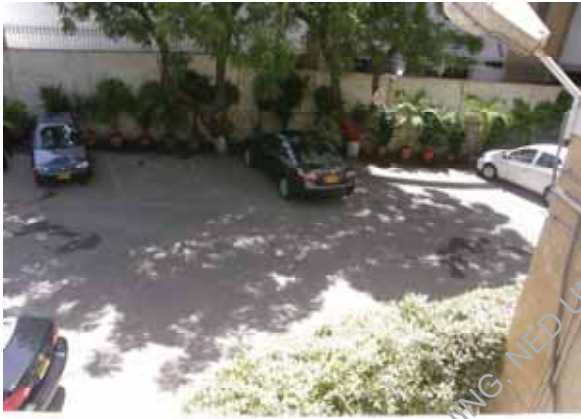
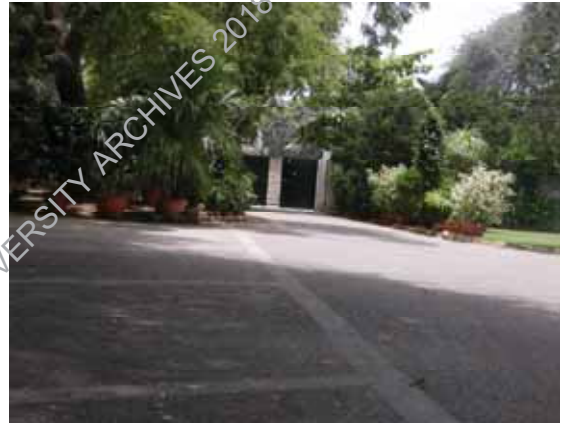
Pictures showing driveways covered with asphalt surfaces.

The driveways and circulation areas on of the site are at present covered with asphalted surface. This should be replaced with properly designed walkways. The hard pavements (preferably cc pavers) should be restricted to areas having vehicular circulation. The other areas should be designed with proper soft landscaping and terracotta tile pavements for pedestrian circulation.

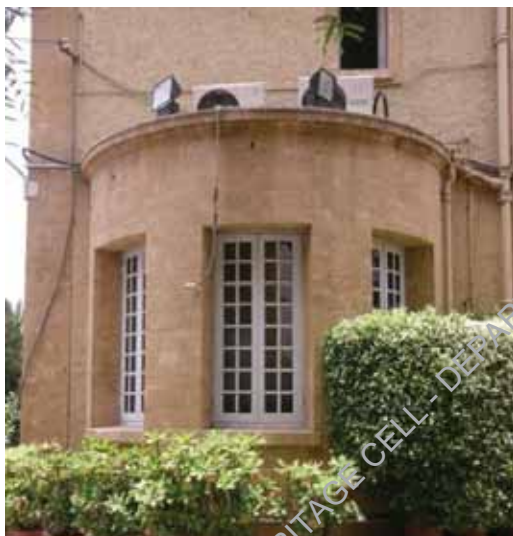
Semi circular niche on ground floor showing the original dressed stone masonry.

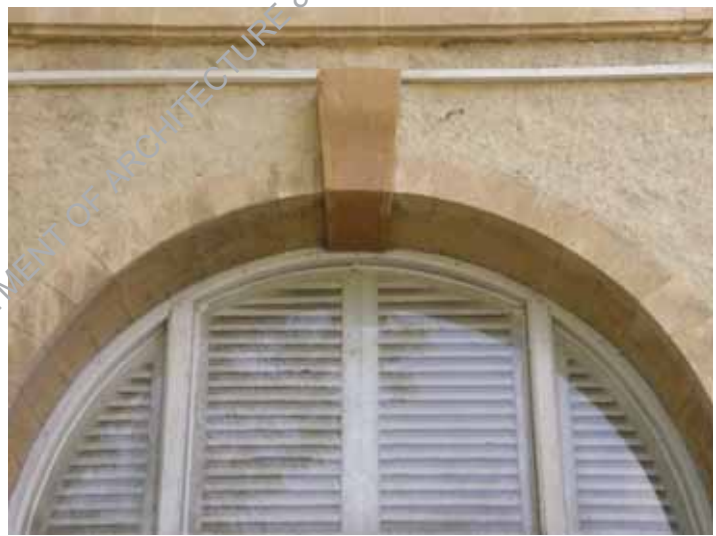
National Foods Ladies Club building is built with yellow limestone with finely dressed stone masonry surfaces. The original masonry surfaces of dressed stone are now externally covered with cement plaster having a *dana* texture surface. This *dana* plaster has been applied all over the building, on all sides four façades, except for the doors/windows framing details and the two semi circular niches in the ground floor rooms; seen on the eastern and southern façades respectively. These areas are the only remaining visible samples of the original stone masonry surface.

External surfaces covered with dana plaster

The *dana* plaster applied on all external surfaces of the stone masonry completely hides the original rich texture of dressed stone. An attempt should be made to restore the original surface texture by removing the *dana* plaster. Care should however, be taken to ensure that the removal of this later applied cement plaster layer does not damage the stone surfaces. A sample area at the rear of the building must be first tested for appropriate methods of plaster removal, carefully checking the acquired results before taking a final decision for its removal and the appropriate method/ technique with which it should be done.

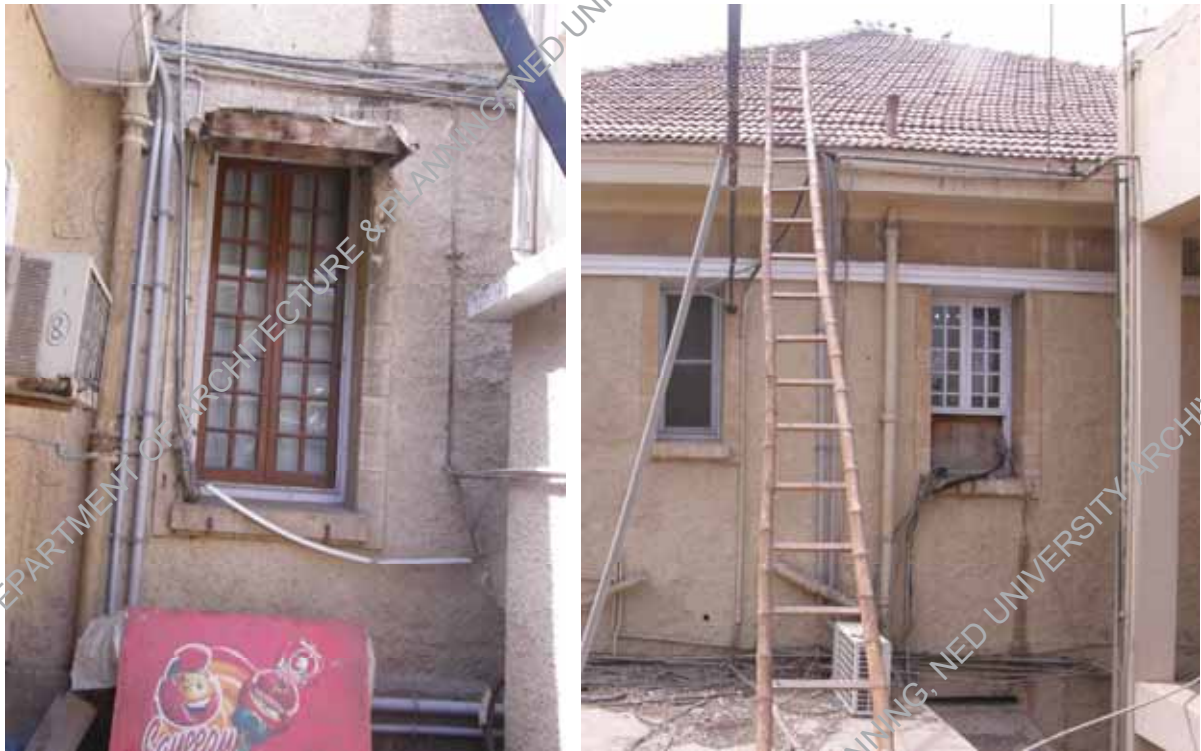
All the four elevations of the main bungalow are defaced by haphazardly installed electrical wiring and plumbing pipes. Huge light fixtures installed on the south-western and north-eastern corner of the building also create a visually disturbing impact on the façades.

Different views of northern façade showing haphazardly installed electrical wiring and plumbing pipe.

The external light fixtures on two corners of the building should also be replaced with more appropriate light fittings. It is recommended that instead of installing lights on the stone façades the building itself should be lit up in the evenings by using lights mounted on the ground or around the building.

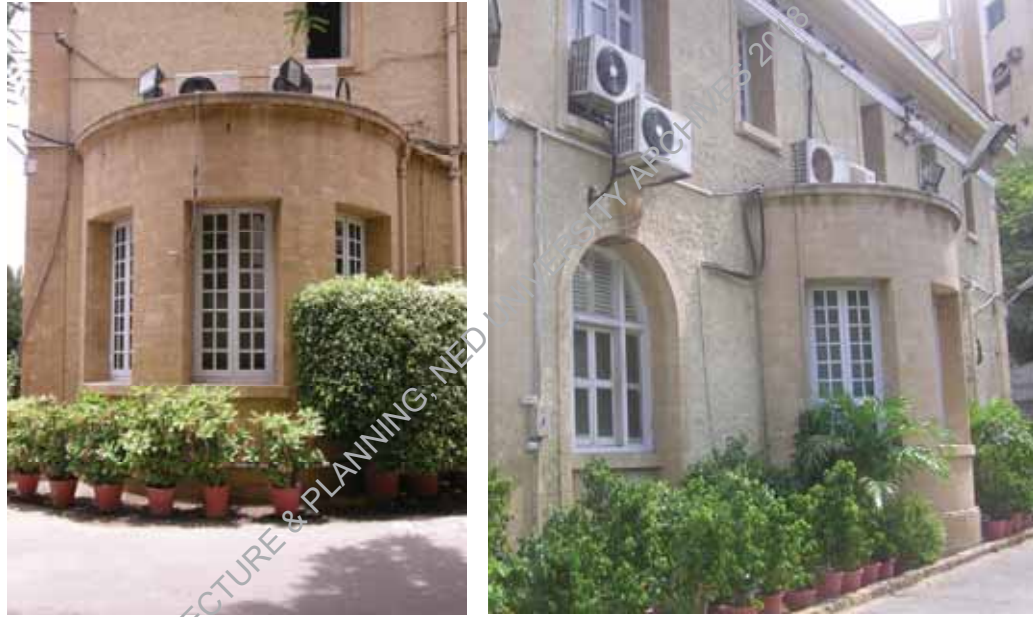
Haphazard placement of AC outdoor units on eastern and southern elevations respectively, creating an unpleasant visual effect.

This unplanned placement of ACs and their improperly fixed drain-pipes also cause problems of stains as water washes over surfaces and also creates puddles where cavities or improper drainage slopes exist. The presence of moisture causes micro and macro biological growth damaging the construction materials.

The most damaging alteration that the building has undergone in the past years is the installation of the air conditioning system. Since this is done in a piecemeal fashion, proper ducting for drainage as well as wiring has not been planned. As a result the entire building has been severely defaced and substantially damaged due to water penetration. A properly planned air conditioning program needs to be developed that keeps in consideration the future possibilities as well. The installation of the entire system should then be done according to the developed master plan. This should include proper locations for the ACs, their drainage ducts, and wiring conduits. It is recommended that the system should be worked out either on a central air conditioning program or uses split units. Window type units should not be used, as they are the major cause for the defacing of the building façades. Placement of the outdoor unit of the split AC should be done on the ground a little away from the building, making use of low height screening barriers that can be incorporated as an element within the outdoor landscaping plan. The drained water from ACs can be recycled and used for watering the plantation.

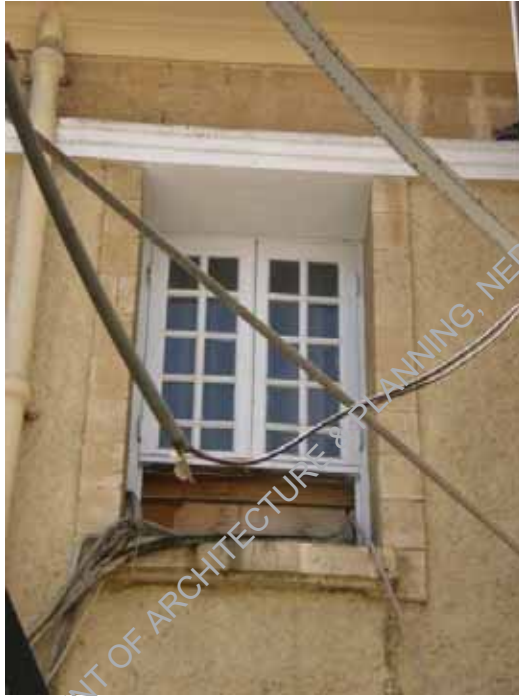
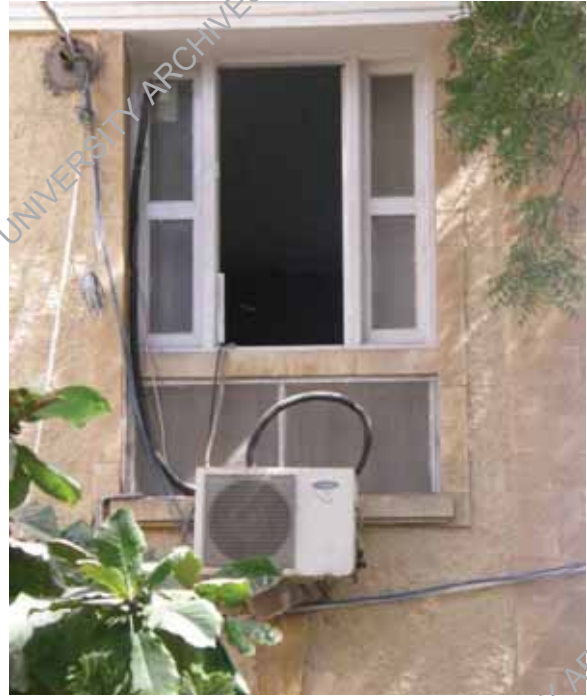
Examples of altered windows on first floor (northern side) of the main building.

In addition to this, wooden louvers of the semicircular arched windows on all sides of the verandah should also be repaired where broken, cleaned, polished and made functional. The alterations done to various windows should also be reverted and the necessary repairs to restore these to original state should be undertaken.

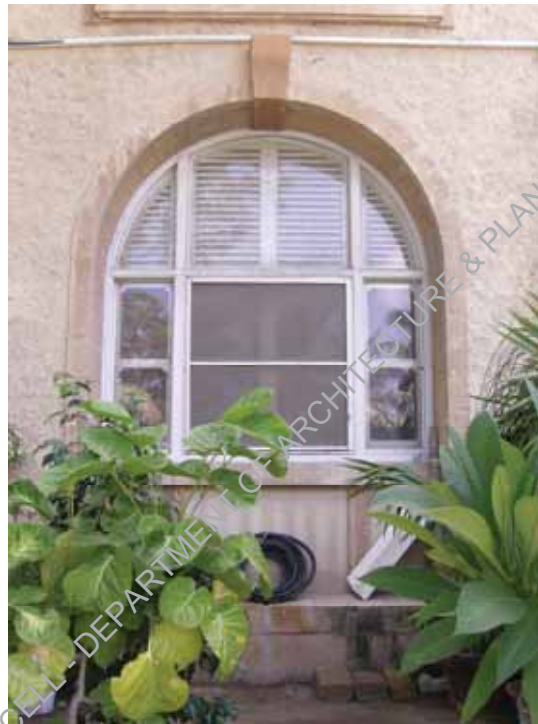
The window on western side of the building is being altered by filling the parapet with cement mortar and by adding the net frames.

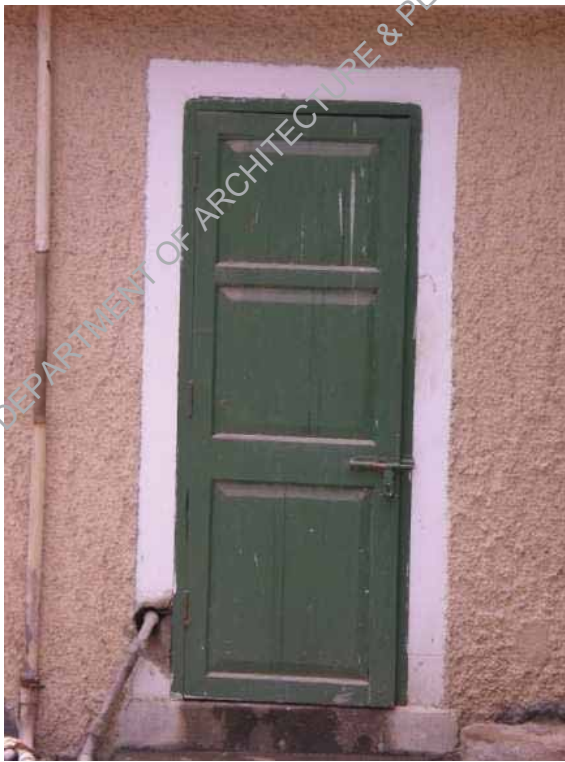
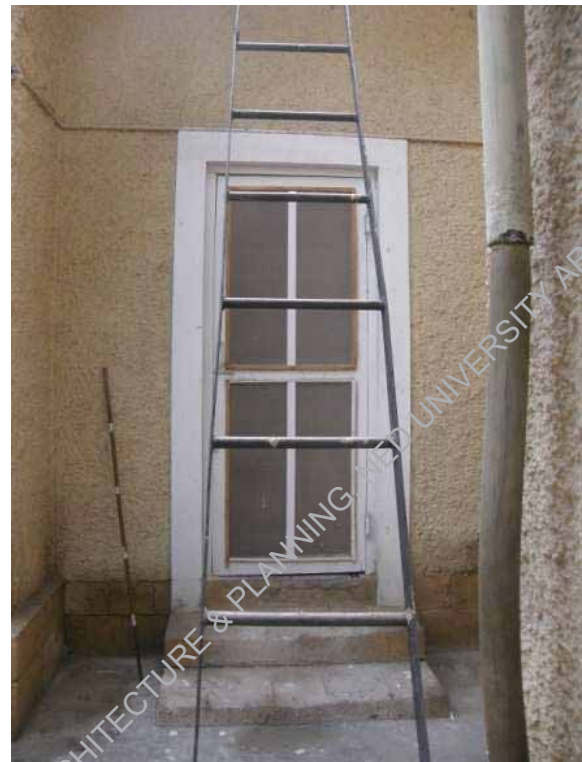
Temporarily closed doors on ground floor western side of the building.

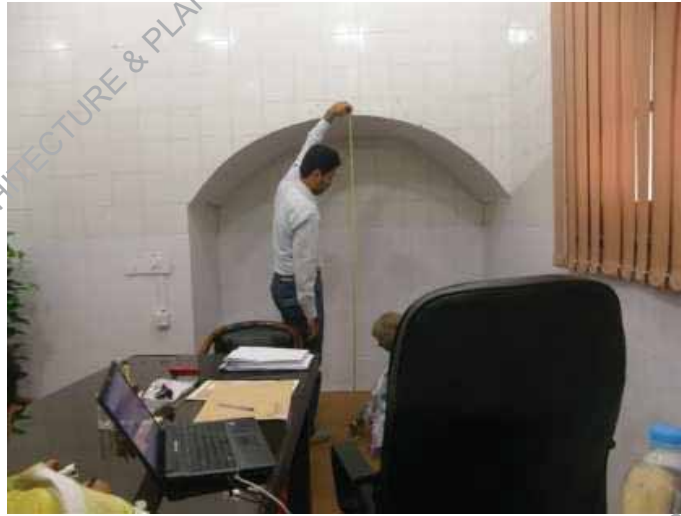
The extended wing on the northern side of the building was originally the kitchen and service areas. This is indicated by the existence of the original chimney structure. This kitchen space is presently converted into an office. The chimney has been sealed with block masonry from inside and turned into a decorative niche. A separately built structure (discussed in the section of later additions to the plot) now serves as the kitchen and staff dining area.

Kitchen converted into an office where the original chimney is sealed from inside.

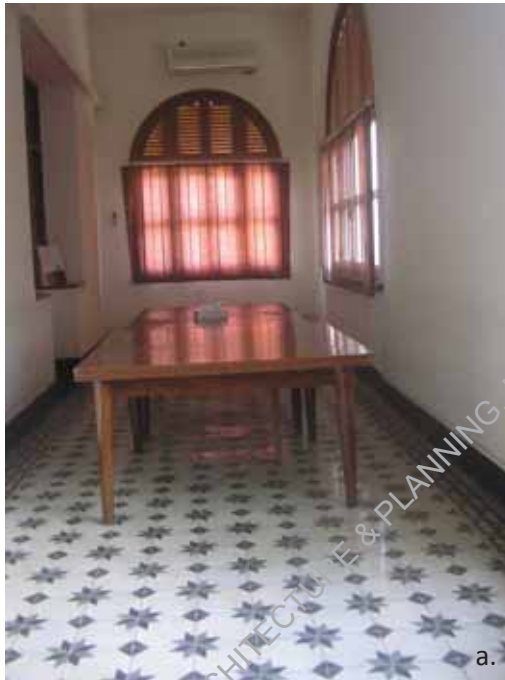
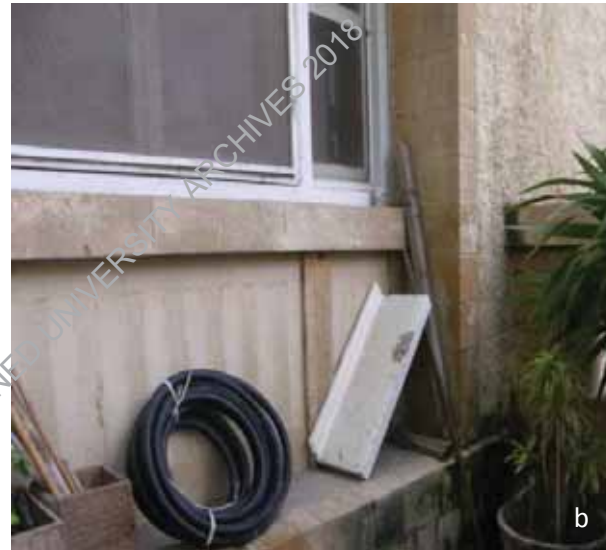
a. Interior view of the virandah converted into a closed space on western side of the building on ground floor.
b. Parapet wall being filled with cement mortar.

Both the verandahs have been converted into closed spaces probably to create an air conditioned environment. The stone parapets on both the floors have been filled in with cement mortar. On the external face of the first floor stone parapets netting is also fixed which creates an unsightly look on the exterior.

The stone parapet panels used in the openings of the verandah both on the ground as well as first floor have been closed by filling with cement mortar. This defaces the original design of these louvered style stone parapets, giving a negative impact of the exterior façades. All of these should be restored and brought back to their original shape. If for air conditioning purposes the space needs to be made airtight then plain glass panels can be fixed on the inner side of these parapets, so that the external appearance is not disturbed. In addition the netting fixed on the external side of these parapets on the first floor should also be removed.

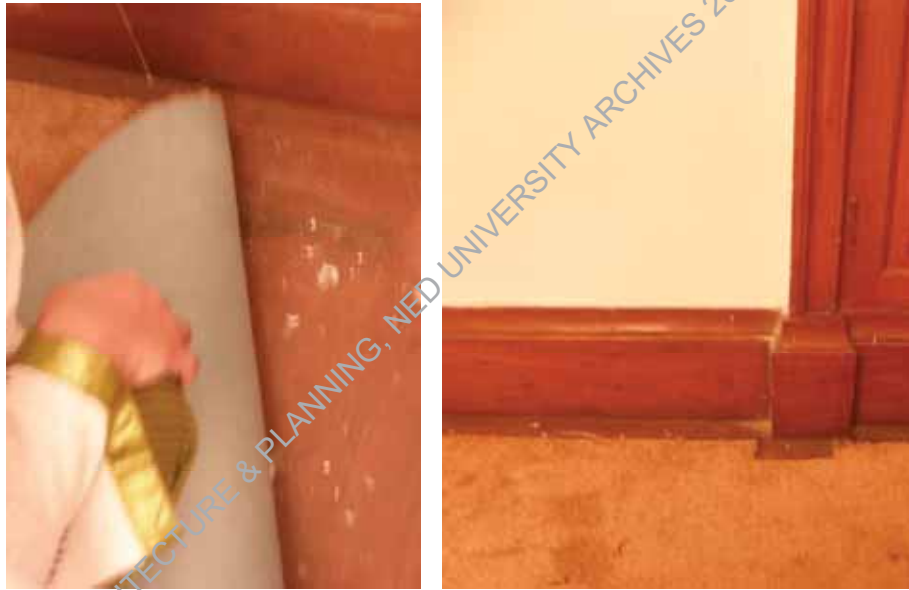
The original wooden flooring in the conference room on the ground floor has been covered with a carpet. Underneath the carpet the wooden planks of original floor can be seen. The wooden flooring is of a good quality, but has been stained with adhesive/ glue used for sticking the carpet. If properly polished this original floor has the potential of being restored completely.

The wooden flooring and skirting in conference room on ground floor, showing stains of carpet adhesive.

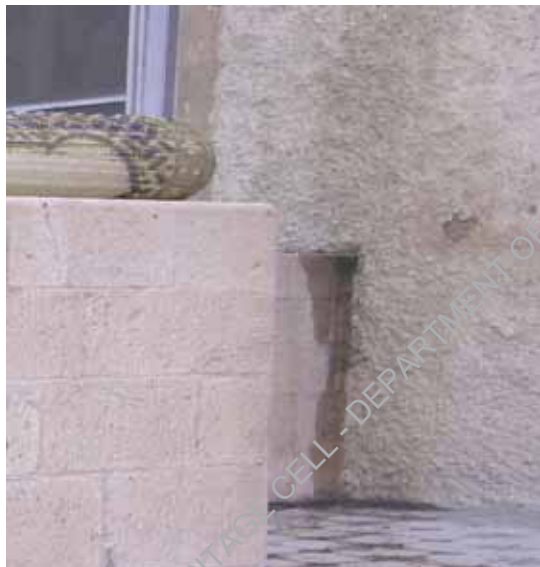
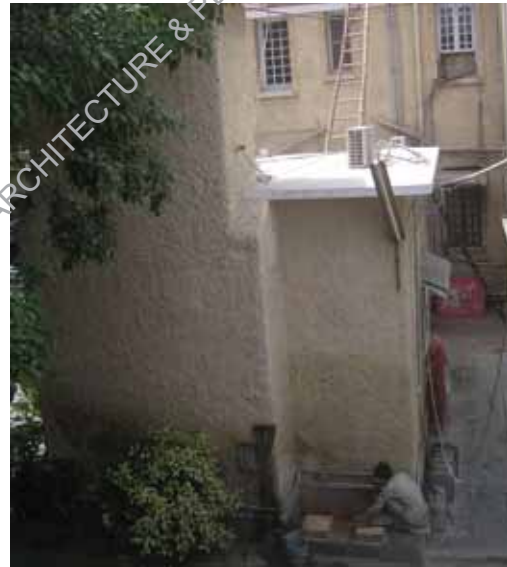
Moisture inside buildings penetrates either from the subsoil or from any other localized source inside the building. The National Foods Ladies Club building does not show any signs of rising damp from the ground, but at certain locations moisture stains have been observed on the external masonry surfaces. Three basic causes for these localized moisture stains at different locations are observed on the site.

- Watering of flower pots and beds placed too close to the building
- Leakage from drainage pipes in wet areas
- Water dripping from the drainage pipes of air conditioning units

Seepage and moisture stains due to localized water sources.

All of these causes are creating localized staining and micro/macro biological growth in masonry. Once these causes are eradicated through proper repairs/ installation of drainage pipes; and the removal of all plantations from the immediate vicinity of the structure, the damages done by the presence of water can then be treated after the affected parts of masonry are dried properly.

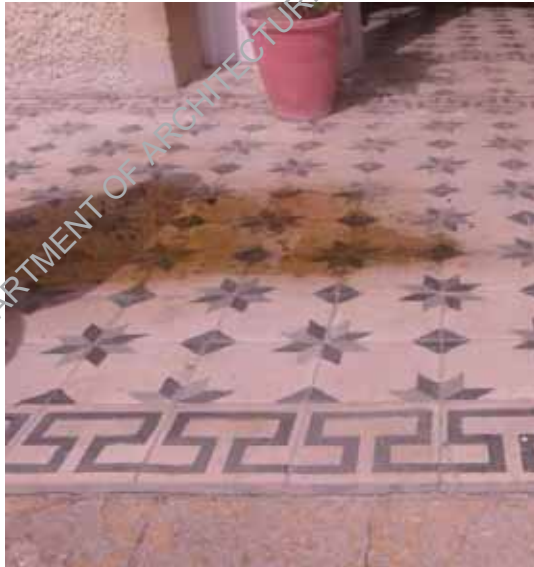
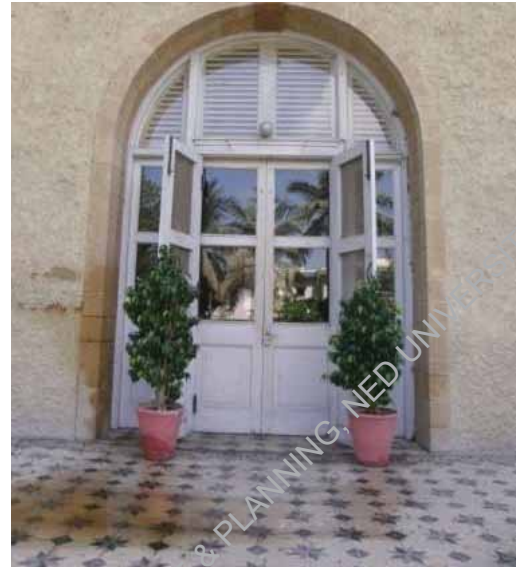
The problem of poor floor drainage slopes is also observed in some areas. This results in formation of water pools that are damaging to building materials; and in addition can cause accidents due to slipping. This problem is quite prominent at the front patio, where watering of potted plants results in frequent presence of water. A similar problem was observed in the toilet of chairman office on ground floor. The stagnating water causes its slow penetration into the sub-floor through mortar joints of tiles, damaging them in the process and eventually resulting in further sinking of the floor. Water penetration due to seepage into structural members can also result in erosion of steel reinforcements causing cracks in the RCC members.

Pictures showing faulty slopes in flooring of patio located on western side, causes frequent presence of water on it.

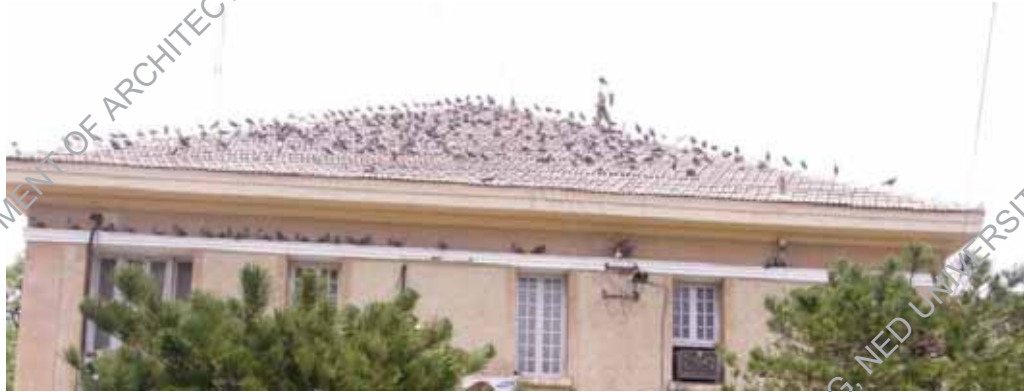
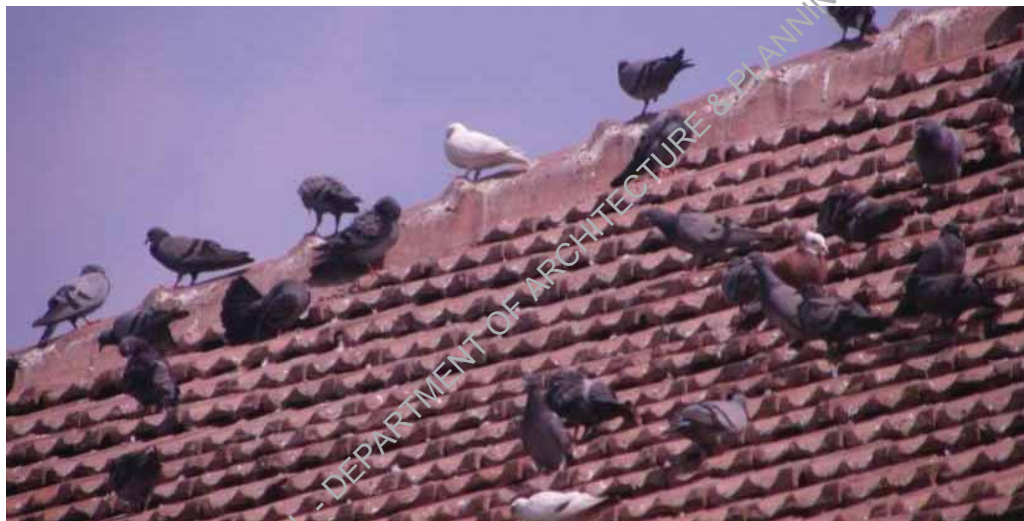
As the site of the club is surrounded by large trees, inhabited with hundreds of birds in them, the problem of bird droppings is quite severe. The most seriously affected areas are the roof top and cornice bands/ ledges. In locations this problem is so high that some areas of the façade are completely covered with white stains. These give an unsightly appearance to the building; and may also cause some damages to the stone because of their acidic content.

Red khuprail tiles, showing stains of bird's droppings.

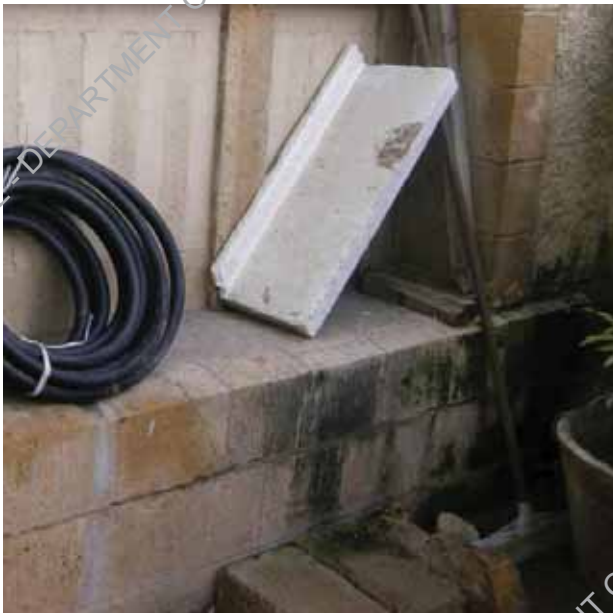
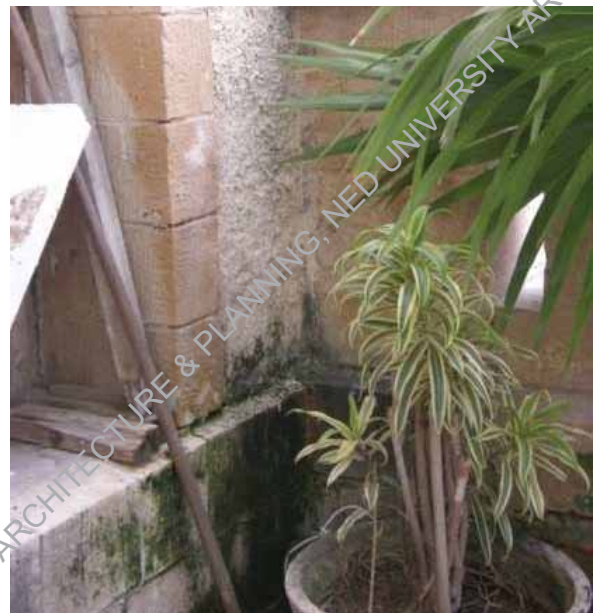
The problem of biological growth is very minor in the case of National Foods Ladies Club. Only small patches/ areas of stone masonry are affected by moisture; especially where flower pots are placed in very close proximity to the building or AC/ plumbing pipes are causing continuous wetting of stone. The moisture trapped in mortar joints or cavities in stone masonry results in promulgation of biological growth. Macro plant growth was observed only in one location, that is, the corner joints of the steps of patio. Measures should be taken to stop the water penetration into masonry, or else this problem become more severe.

Areas showing biological growths.

Macro plant growth can be killed by spraying with an appropriate weed killer. It is important to kill the roots and remove any humus which may encourage future growths. Any gaps or cavities created due to the removal of plant growth should be repaired/ filled with lime mortar (see appendix II).
