Residence No. **2**

Safdar Ahmed Awan Residence
SHK-UC2-0222 (Enlistment No. 2012-UC2/227)
6/ 362 Kotu Tabib Lane,
&
SHK-UC2-0221 (Enlistment No. 2012-UC2/226)
6/ 342 Kotu Tabib Lane/ Dallal's Lane,
UC2, Shikarpoor, Sindh

Reporting by:
Ar. Tania A. Soomro

State of Conservation - Damage Analysis:

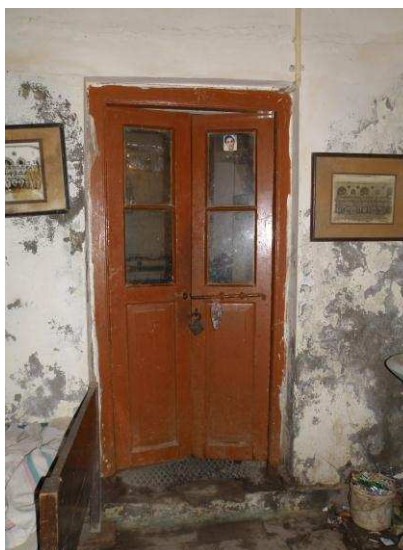
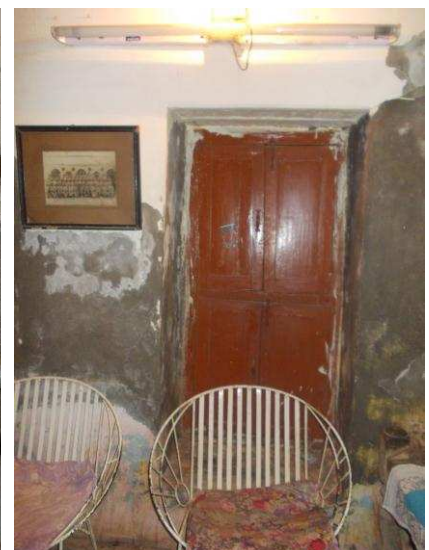
The problem of **rising damp** is observed to be severe on ground floor walls of UC2- 222 showing moisture penetration up to a height of over 5' to 6'. There problem is so severe that even efflorescence is observed on the walls. Thick layers of repair cement plaster applied on walls as a remedy, is perhaps the reason for the increasing level of water penetration.

Damage caused by rising dampness.

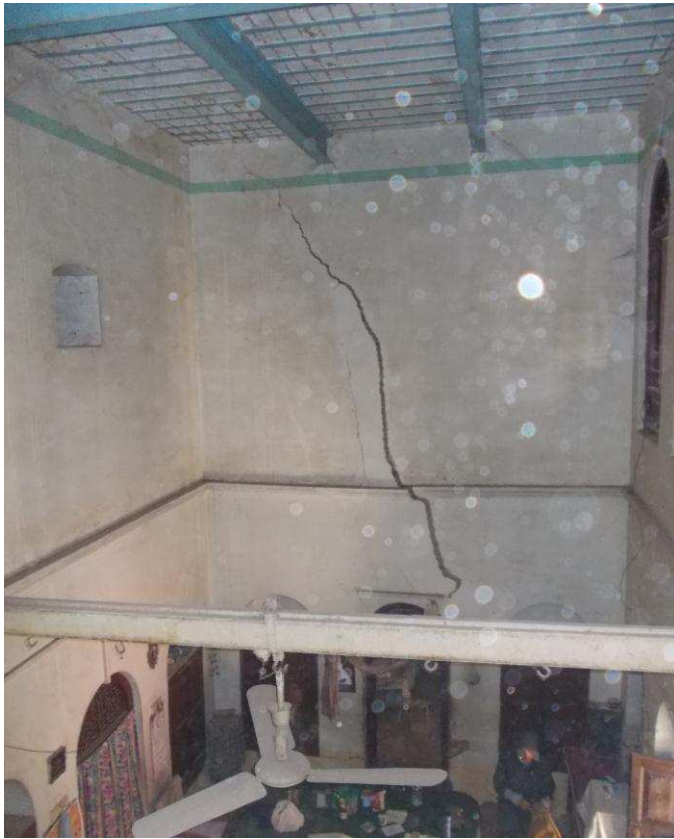
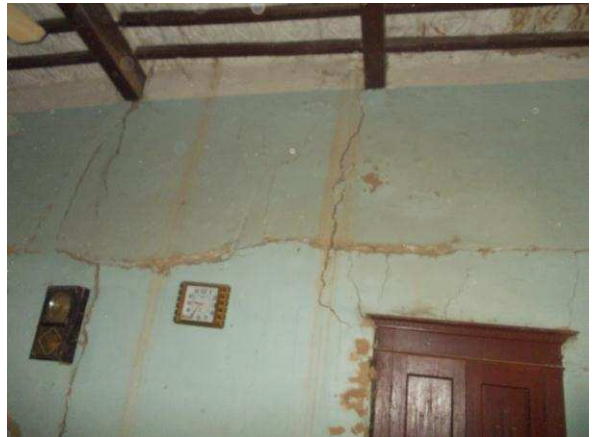
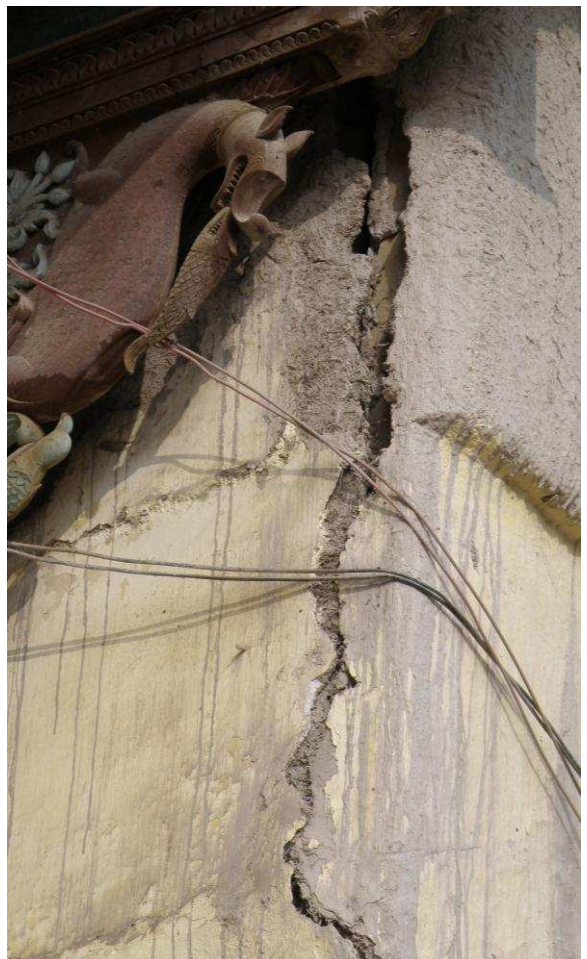
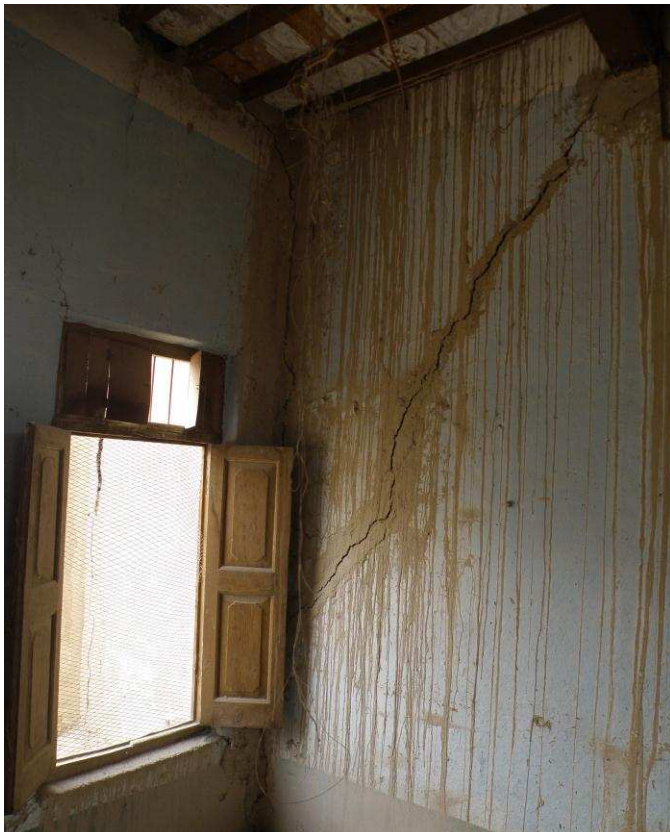
The first floor of building has deep cracks on its northern wall in the double heighted room. The crack goes through the depth of the wall and visible on the other side as well. The diagonal pattern of this crack indicates some sort of settlement at foundation. Proper monitoring of this must be done and remedial measures need to be taken on an urgent basis to prevent any structural collapse.

Images showing cracks in different areas of the property at various floor levels.

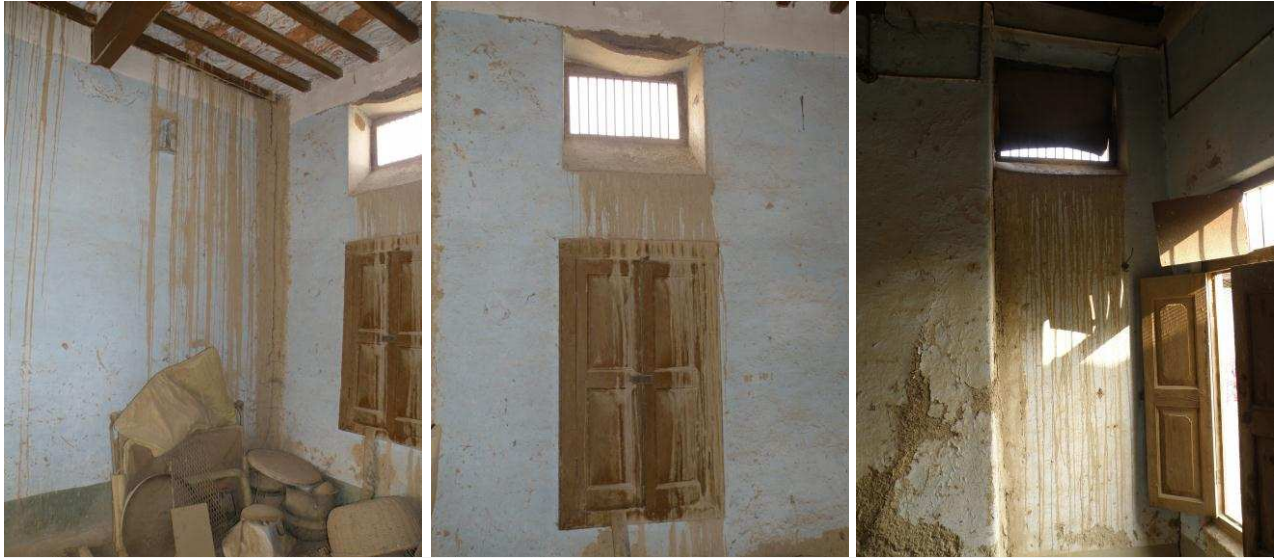
Images showing water coming from windows/ ventilators

Rain water penetration inside the building from different door/ window openings as well as the roof is indicated by water stains on the walls. Many ventilators/ windows the building do not have shutters thus rain water washes down the sill damaging the painted wall surfaces as well as the plaster.

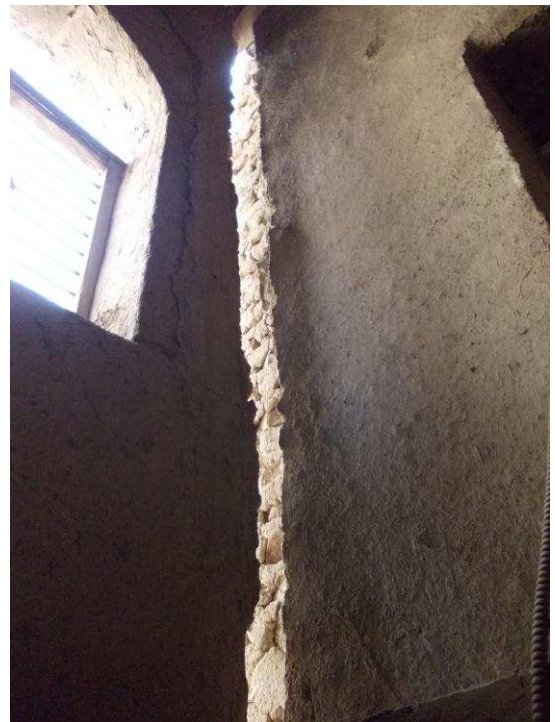
The weakened roof structure and apparent settlements in the buildings foundation has caused opening of the junction between two walls at one location. The overall condition in different sections of this property reflect a high state of deterioration requiring urgent and immediate action to first prevent further damage and then proceed to remedial measures that attempt to eliminate the root causes of ongoing deterioration. Only after these root causes are completely eliminated a proper restoration of the property should be undertaken.

Detached masonry wall causing a deep vertical opening.
