Residence No. **3**

Haji Sher Mohammad Tibati Haveli
SHK-UC2-0461 (Enlistment No. 2012-UC2/465)

20/ 189, 190 Off Daiki Lane No. 2
UC2, Shikarpoor, Sindh.

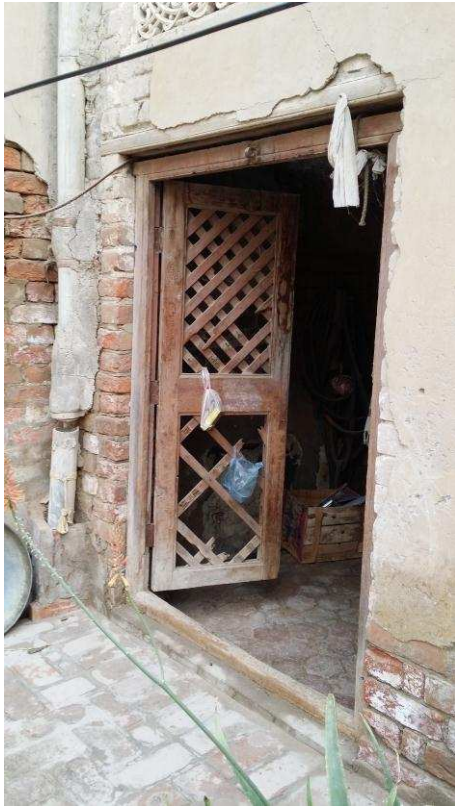
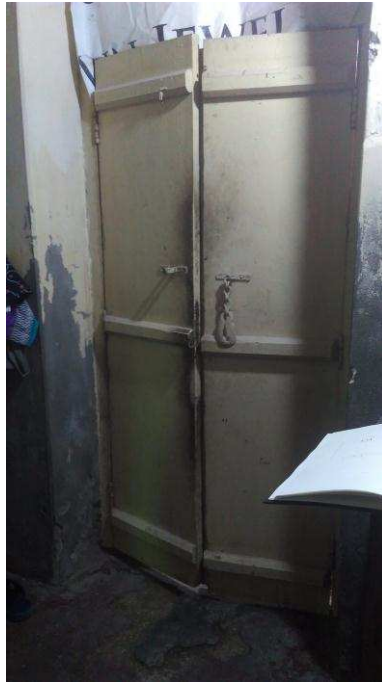
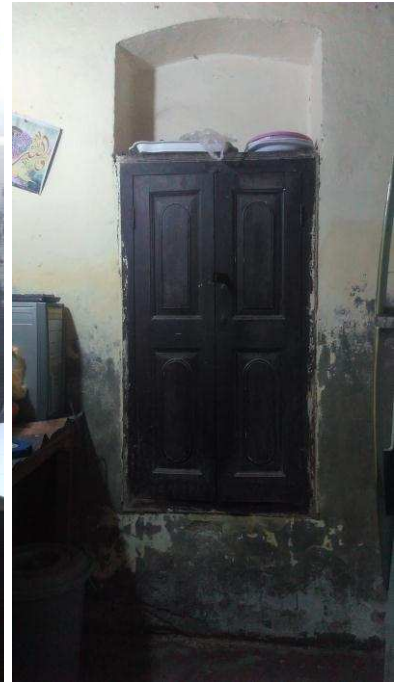
The most evident damage to the building is due to the rising dampness. Almost every room on ground floor has moisture stains and damage due to this issue. The moisture retention in walls has caused paint layer to peel off. This issue further leads to other damages such as the loss of bonding between the wall surfaces and plaster layer. Cracks have developed not only on the walls but also on fixed furnishings such as inbuilt cupboards. Rain water penetration from faulty roof joints is also observed causing further acceleration of issues such as detachment of plaster, peeling of paint layers and sagging of floors and roofs. Water seepage has weakened masonry joints in places causing bulging or detachment of walls.

Visible signs of rising dampness on ground floor walls

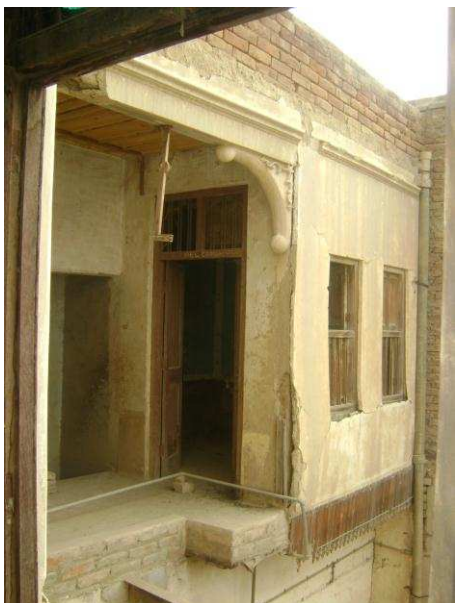
Detachment of plaster and loss of bonding between wall and plaster

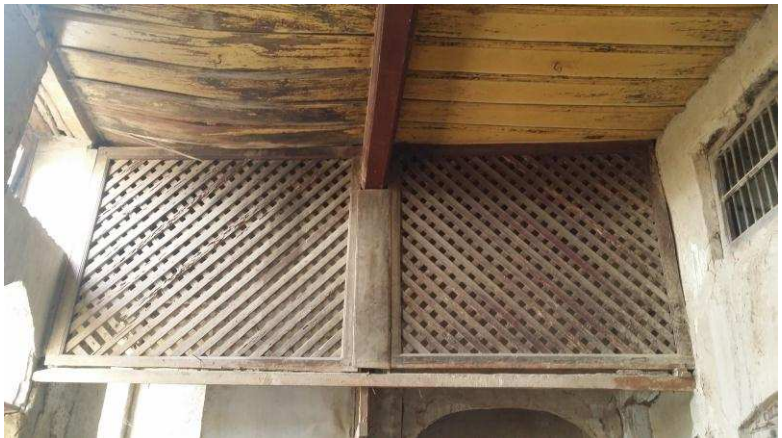
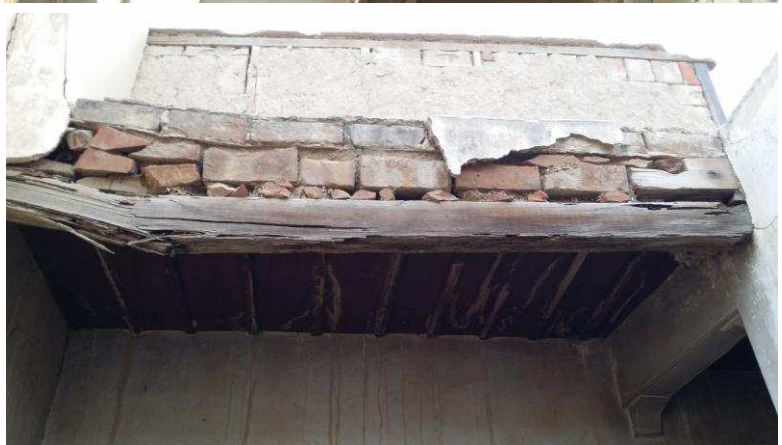
Sagging of ceiling and floor due to broken beams and timber planks.

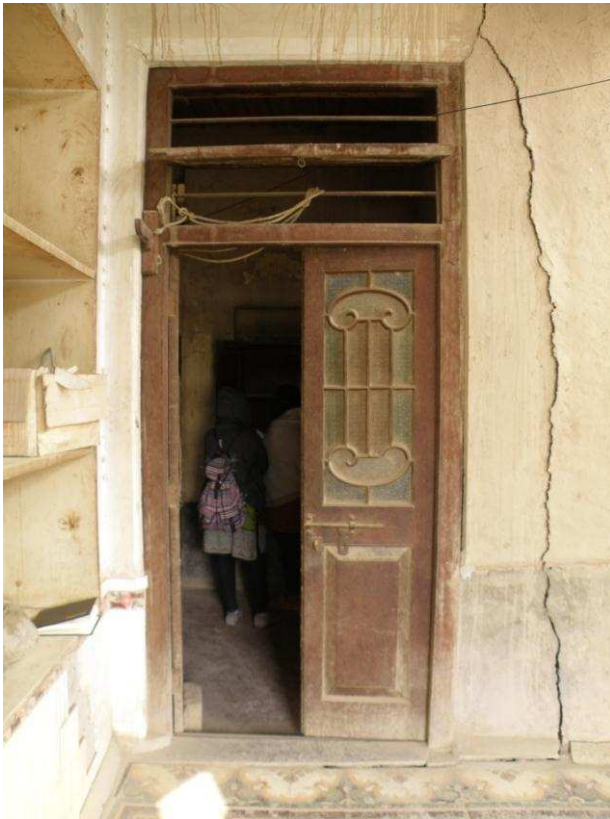
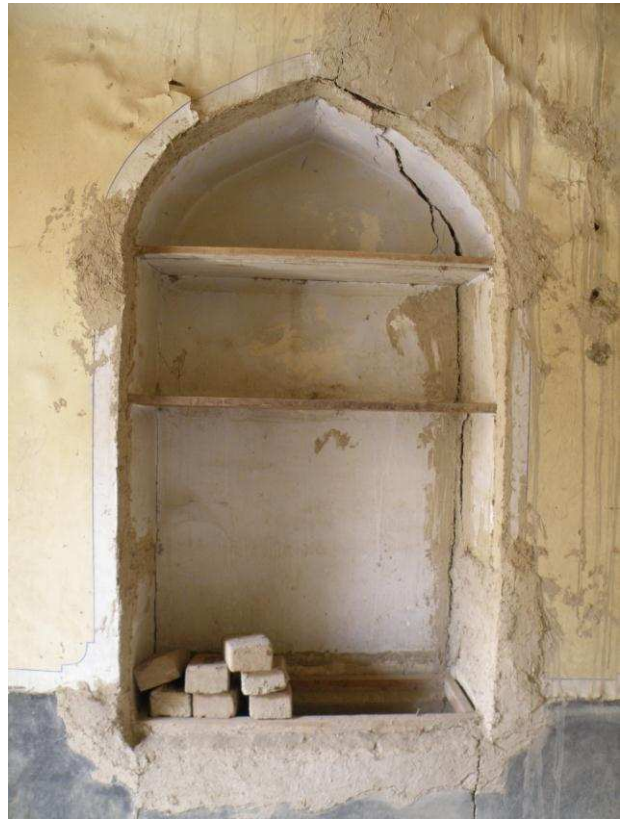
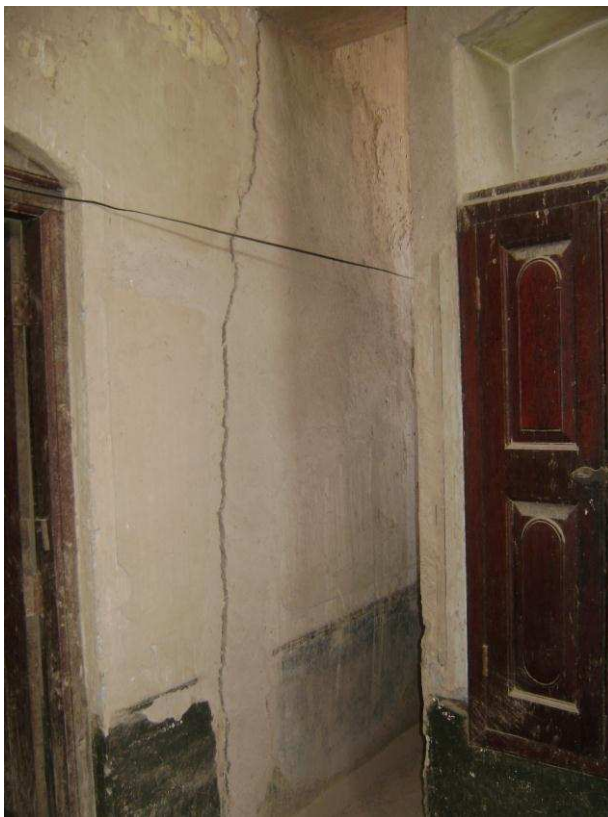
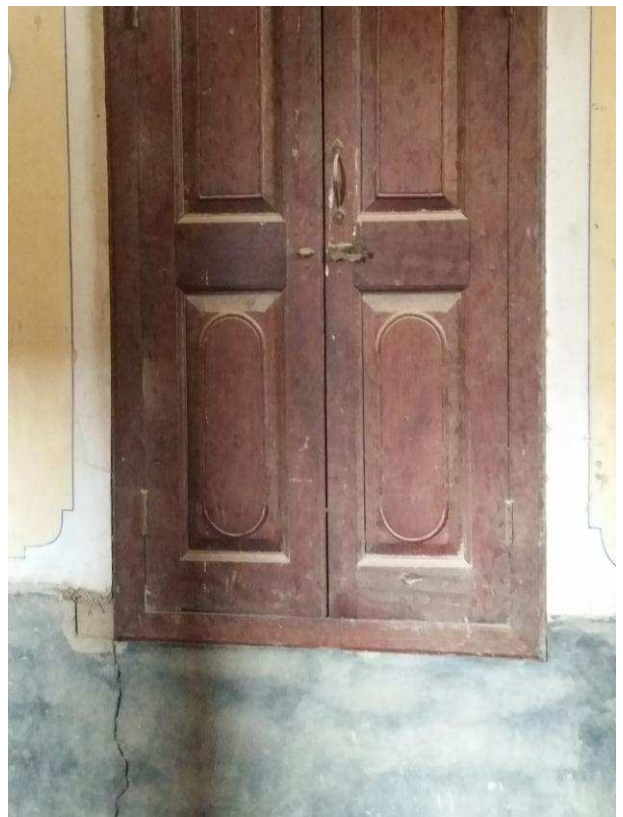
Various images showing cracks in walls and plaster.

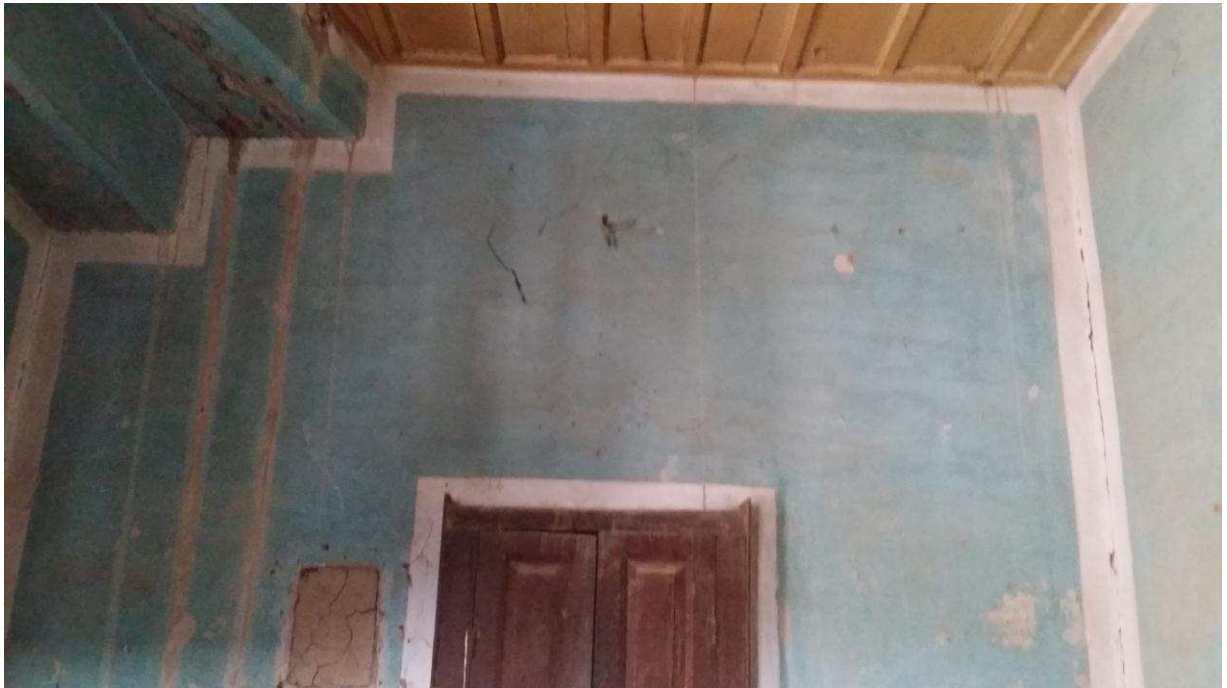
Rain water penetration from roof is evident from dripping water stains on the walls

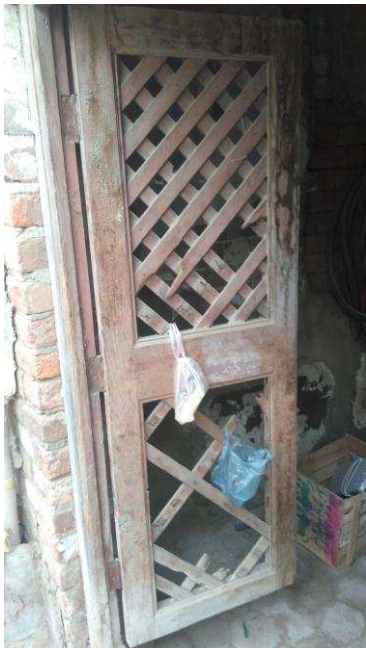
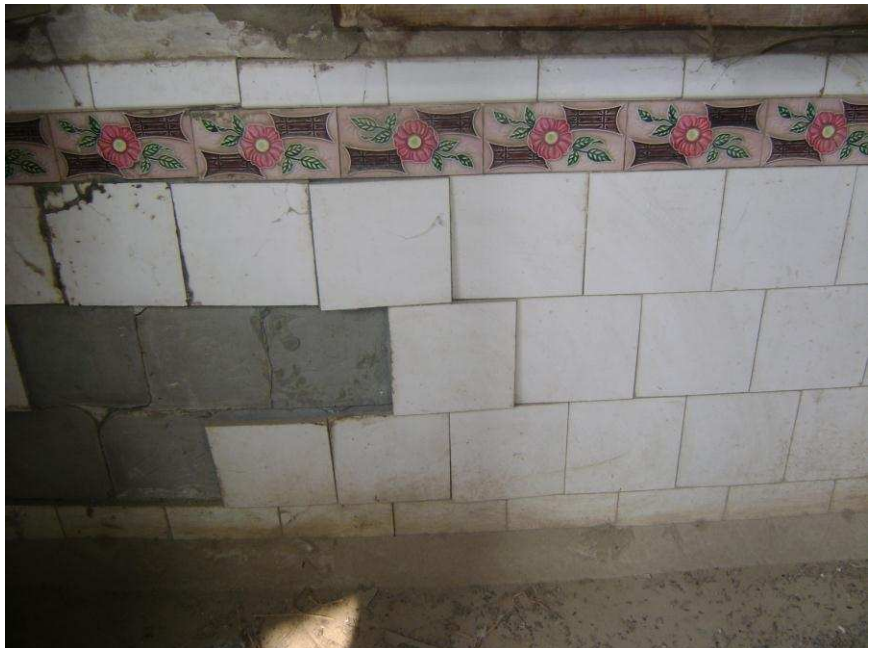
Disintegrating and broken architectural elements.
