Residence No. **4**

**Ahmed Ali Mangi House**

**SHK-UC2-0526 (Enlistment No. 2012-UC2/529)**

*20/ 117 Acharji Street/ Sui Gar Lane off Hathi Gate Lane  
UC2, Shikarpoor, Sindh.*

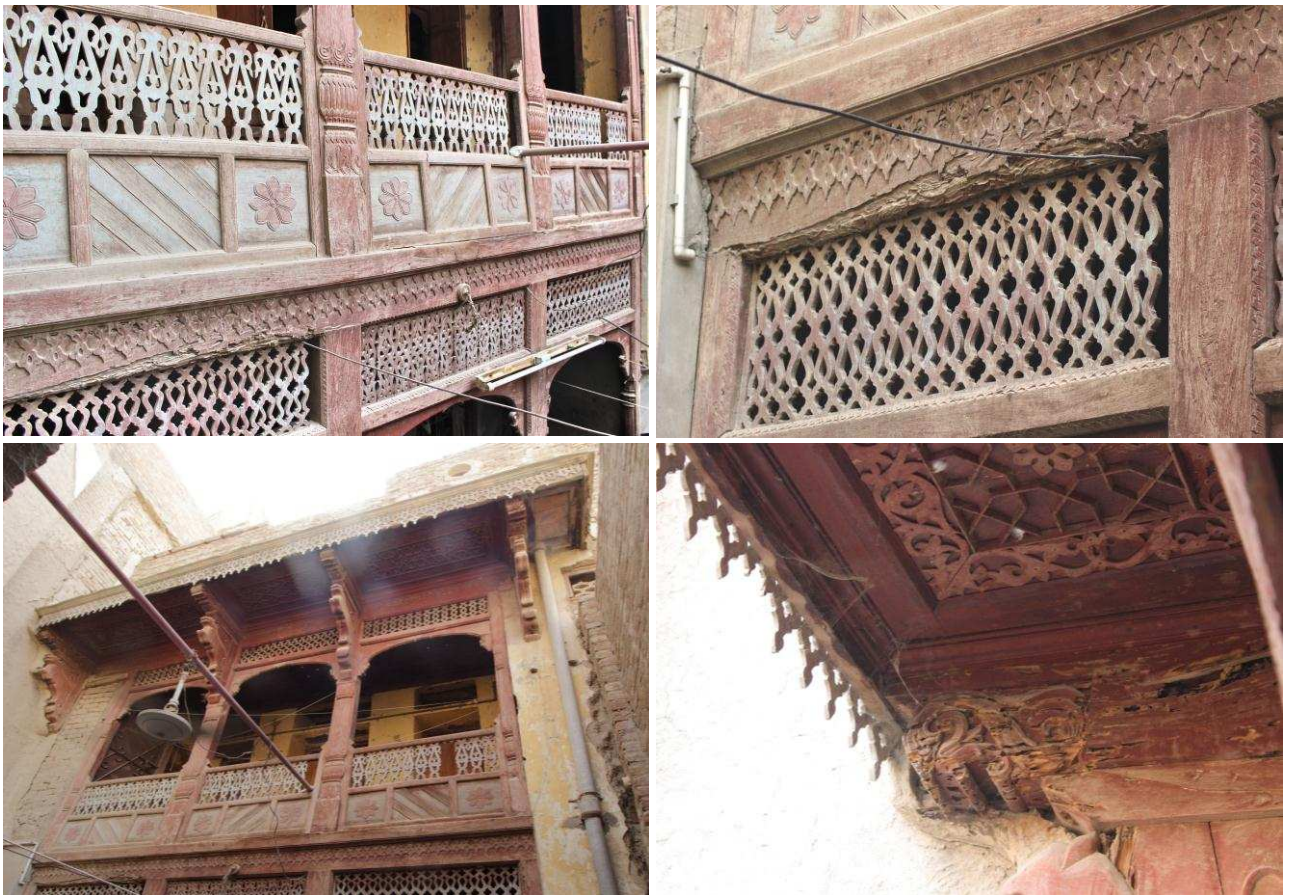
At a quick first glance the property gives an impression of being in good state of maintenance and repair, however, on closer observation it becomes apparent that deterioration of materials and structure is slowly setting in. The most evident forms of deterioration observed in this building include rising damp in ground floor walls and its resulting discoloration and disintegration of plaster along with salt efflorescence, minor cracks in walls, disintegrating mortar joints in masonry, damaged wall plasters in the interiors as well as exterior walls at roof level, and above all the signs of decay in timber façade elements - which could either be termite attack or more likely wet rot due to rain water penetration. The timber trellis work and pelmet bands also have disintegrating and displaced elements. In addition the owners also inform of rain water penetration inside the building through roof.

Various areas showing signs of decaying woodwork.

The identified problems are presently at an early stage thus immediate action for preventive conservation measures would certainly help curtail the deterioration process. If left unattended these factors may lead to a rapid and advanced level of deterioration. The family also desires further changes to incorporate their growing needs, hence timely guidance may lead to better and more sensitive interventions than those already done earlier on this property.

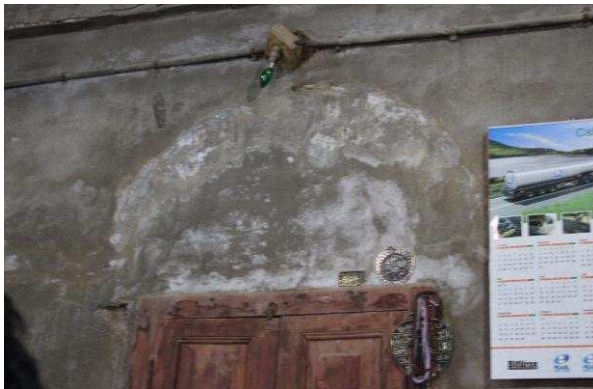
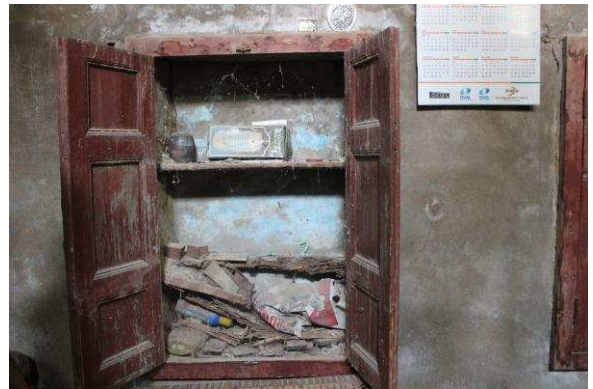
Water stains due to rising damp

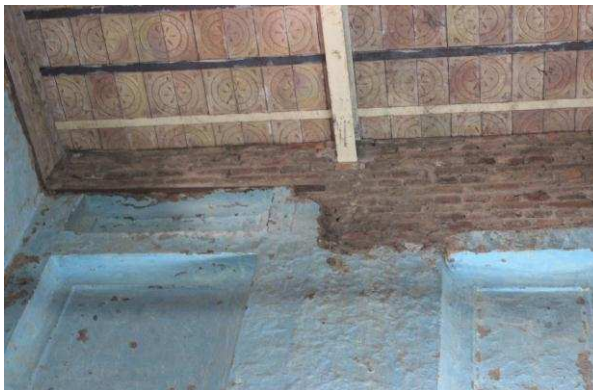
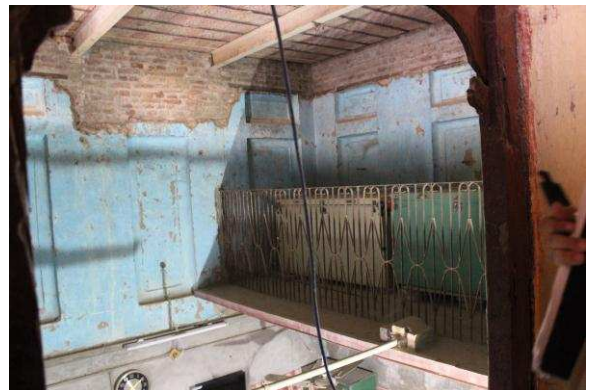
Damaged wall plasters
