Final Report

1st Phase (March - June 2012)

ACHR Community Based Heritage Research Project:
Karachi Historic Areas

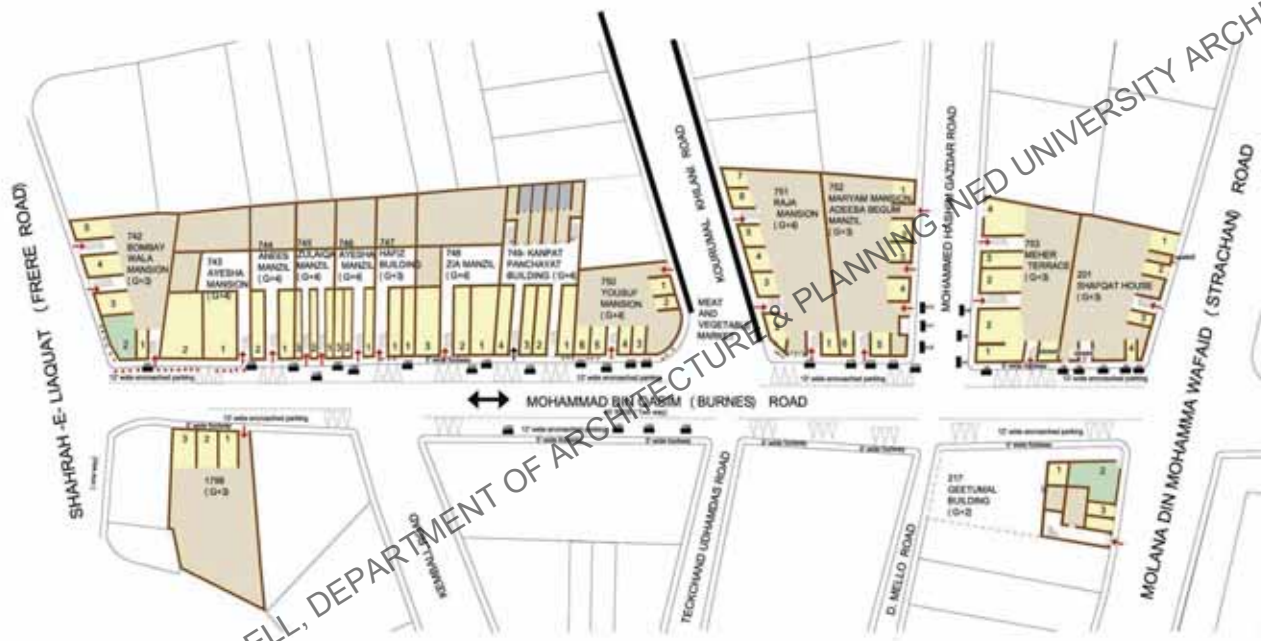
BURNES ROAD

- Enlisted building 1995-1997
- Enlisted building 2011
- Hawker
- Entrance
- Parking
- Informal sitting
- Labourers

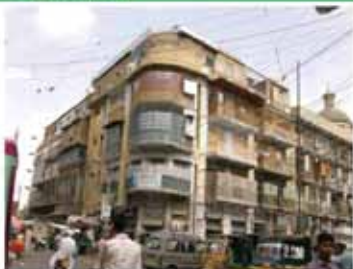
Meher Terrace
AM-1/11, Mohammad Bin Qasim
(Burnes) Road, Mohammad Hashim
Gazdar Road

The profile of façade between second and third entrance has been totally changed since past 15years. Some 30 years back the additional floor built in RCC was also added to the building. Exposed girders on roof of added floor can be observed. The building had a courtyard which is now encroached completely with a residential unit of G+1, built of block masonry. The RCC slabs of the building at places indicate severe deterioration, exposing the reinforcement bars.

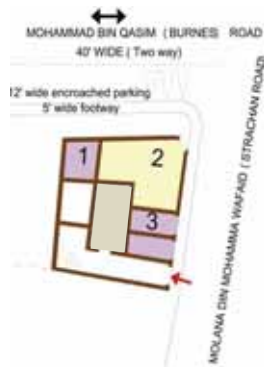
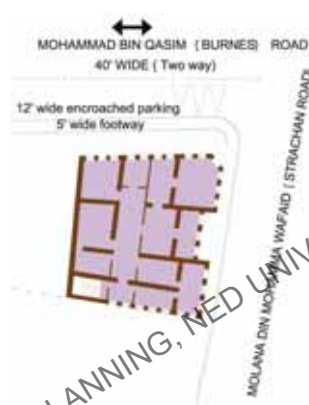
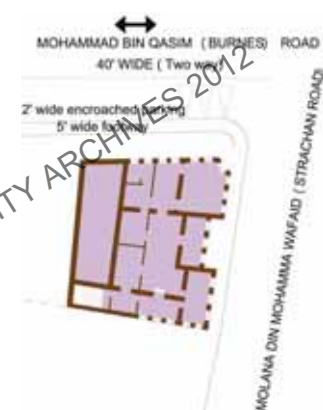
USAGE PLAN

GROUND FLOOR PLAN

FIRST FLOOR PLAN

SECOND FLOOR PLAN

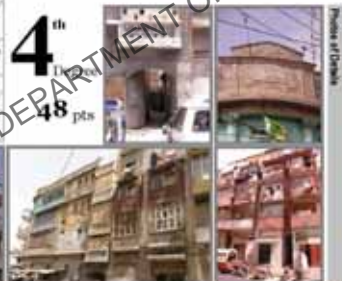
Front elevation

MARYAM MANSION, ADEEBA BEGUM MANZIL

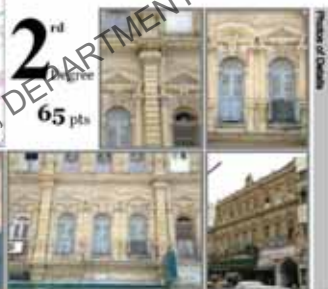
YOUSAFI MANZIL, FAIZ-E-HUSAYNI MAHAL

Damages and Alterations:

On upper floor some of the interior walls have been removed, converting the space into large areas for storage purposes. The users of offices at upper floor have also altered the original timber roof (which apparently was damaged due to termite attack) replacing it with steel girders painted in black. The first floor verandah/ terrace are also enclosed by masonry walls converting the space for storage purpose.

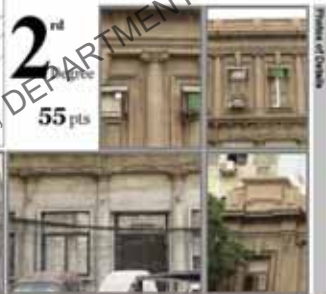
Details of the front facade

CAPTAIN & CO.
BUILDING

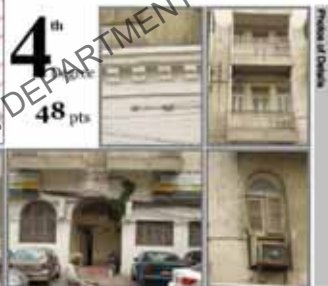
Fayz-e-Hussaini Mahal is a G+2 structure, under the ownership of Faiz-i-Hussaini Trust. It is presently in use for religious activities as well as a *serai khana* (motel) for the Bohra community. At ground floor the building has as a prayer area and the office of the trust which also offers Hajj and Umrah packages. The upper floors are entirely dedicated for providing accommodation to clients and community members visiting from other cities, but this activity is recently being withdrawn from the premises, and all upper floors are being vacated. The central courtyard space of building is very airy and well maintained. Staircases are of timber and in a good condition.

Damages and Alterations:

The building is in a well-maintained condition. The main gate has been replaced with a new iron gate. Marble flooring is added on ground floor. The building is re-painted every year. All required repair and renovation works necessary for the regular upkeep of the building are undertaken periodically.

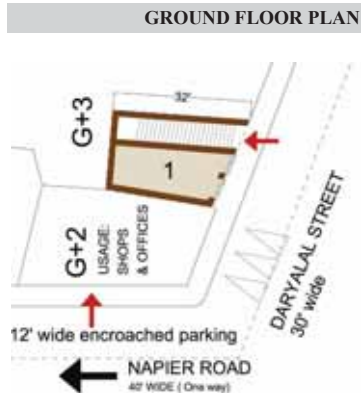
OCCUPANCY PLAN

A single shop exists at the ground floor of the building and is occupied pugree system.

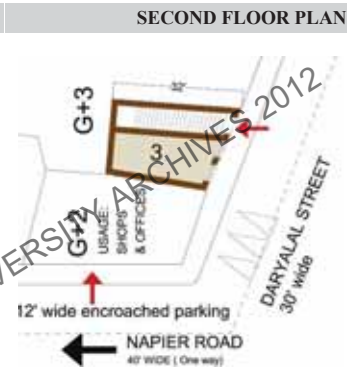
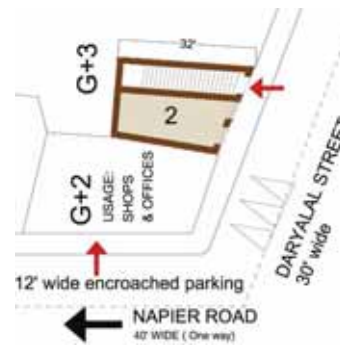
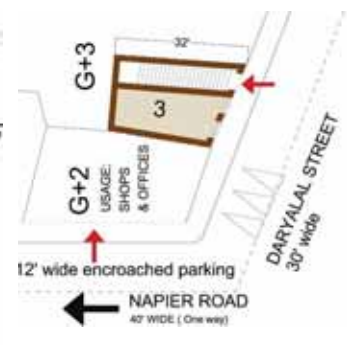
The ground floor has one shop in use by a chemicals dealer. Upper floors apparently have warehouses but these were not accessible.

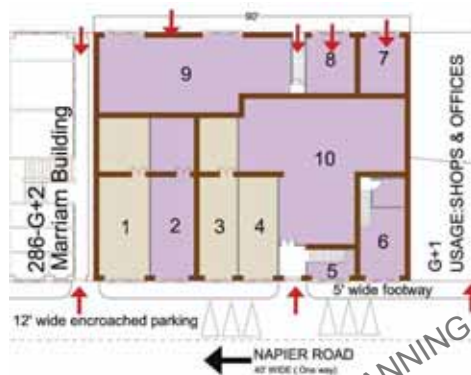
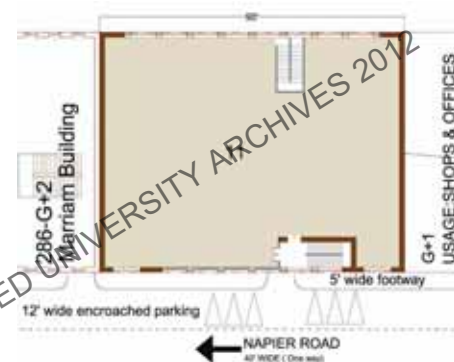
FIRST FLOOR PLAN

The ground floor has two shops having access from the front and two from the back street. Previously, shop (285-2) was the entrance of the building but now it has been converted into shop. Besides shops two large spaces are in use as warehouses. Information on remaining spaces could not be obtained.

Access to first floor was not allowed, but information was given that there are two offices on that floor.

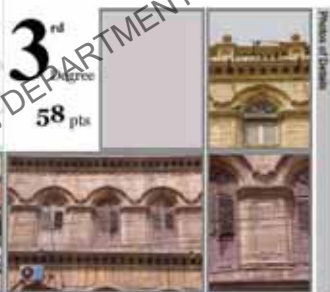
MARRIAM BUILDING

Damages and Alterations:

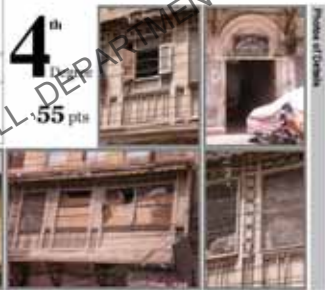
RAZAQUE CHAMBER

Damages and Alterations:

The major alteration observed is that roof renovation, which has been cemented.

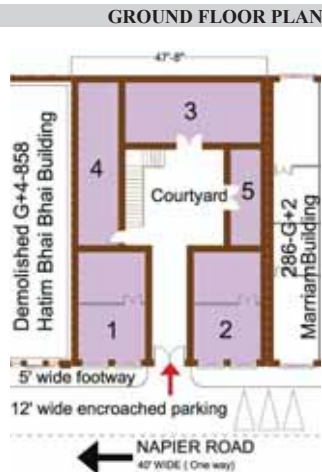
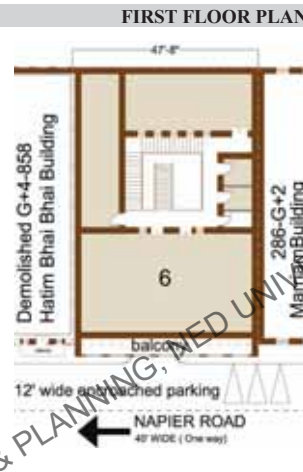
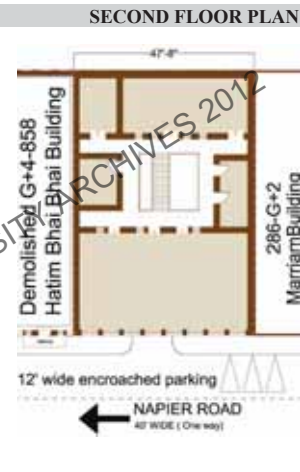
OCCUPANCY PLAN

The building has a central courtyard which is surrounded by warehousing spaces of chemicals. The shops in the front also deal with chemicals and partially in use for chemical storage. The courtyard is also used for storage and loading / unloading of goods.

The entire building is dedicated to chemical shops, warehouses and offices. The first and second floors have a centralized staircase - open to sky. Washroom is also located on first floor.

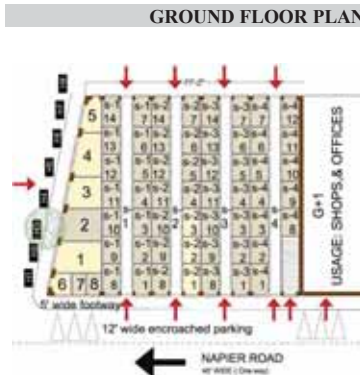
OCCUPANCY PLAN

The front of building has six large shops, all others at the back are of very small size having access through internal corridors. Most of the shops deal with wholesale supply of diapers.

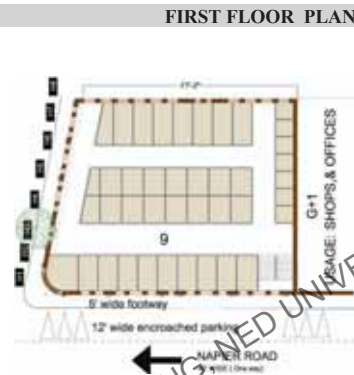
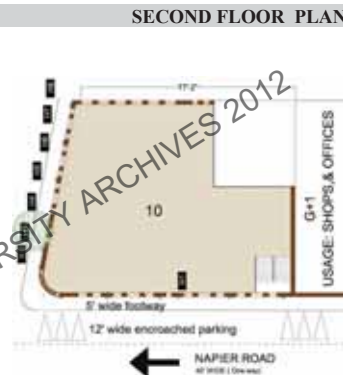
At present the ground floor has shops having their ownership transferred to individuals. Some are occupied on rental basis.

At ground floor building is divided by three internal corridors of five feet wide, each having eight shops on both sides.

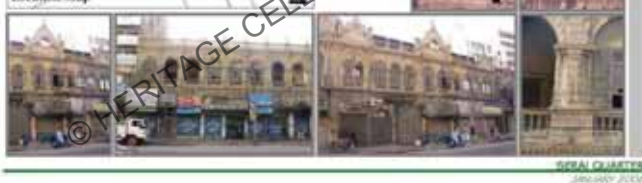
MANDVIWALA BUILDING

The exterior facade is largely intact in its original form, but the interiors of the building have been extensively altered in according to the requirements of occupants over the passage of time. Additional foundations and basement have been added. The original shops have been subdivided into several smaller shops.

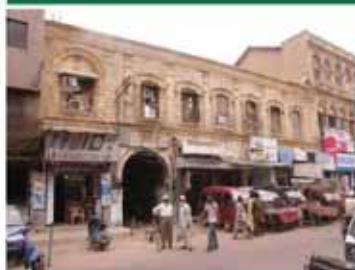
Chain Plaza(Hussaini Arcade)

The upper floor of the building has been damaged to the extent that presently only its façade remains. Only the front portion of the original building has been retained occupying approximately only ¼ of the plot. The rest of the plot has been subdivided and new multi-storeyed constructions are done on it; comprising of three entirely different buildings, i.e. the seven floors high Marvi Traders, five floors high Salam Center and another five floors high building. All of these trade towers are connected with wholesale markets in adjoining Mandviwala building through narrow passageways. The legal status of this plot sub-division and new constructions is not clear.

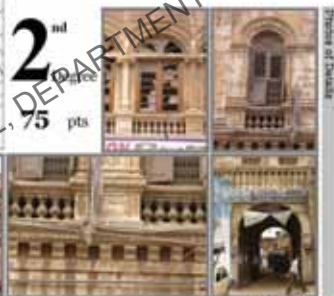
Kulsum Bai building is a G+2 storey building; originally having commercial and residential usage. Built in 1918, the property was claimed by its present owner at the time of partition, and since then owned by the same family. The entire ground floor is devoted to commercial usage having 4 shops, all of which are in use by the owner himself. Access to upper floors was denied but according to the owner, the first floor is divided into different spaces and one of these units is rented out to a family that is living here since partition. Rest of the spaces on first floor are vacant. Tenants use a later added staircase for their access. The building has a central courtyard; all shops have an internal access to the courtyard. There are no toilets on ground floor. A timber staircase (original) right behind shop number 95-01 leads up to the first floor. A door at first floor separates it from ground floor.

A second staircase is a later addition which provides access to residence on the first floor at the back side of the building. Timber roof of the entire building is replaced with tier and girders. Reason given by owner for this replacement was that the original roof had undergone extreme damage caused by heavy rains; the huge holes and cracks caused rain water penetration inside the building and was damaging its other portions as well. According to him, he would have retained the original roof, if it were not damaged so much. The original floor finish has also been changed to cement floor.

General perception of owner regarding historic building is very negative. From his point of view the building does not possess any importance and is in very bad condition, off and on different parts of roof and ceiling fall down, which is very dangerous. There is a huge problem of water in this area. Usually a tanker is used for filling up the storage tanks. The owner had submitted an appeal for de-listing the building against its heritage notification. The committee reviewed the case and decided to allow reconstruction at the back, maintaining the façade.

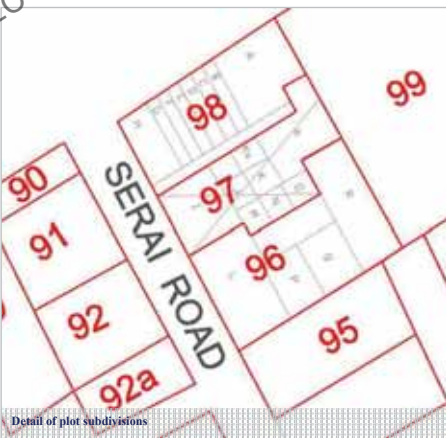
Detail of plot subdivisions

Information on plots M, N and O was not available.

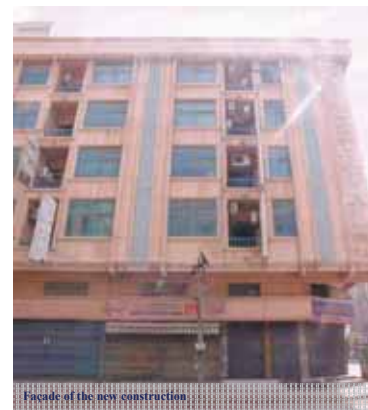
Facade of the new construction

The property owner submitted a de-listing appeal against the heritage notification, in response to which the building control authority officers surveyed the property and recommended that the property being in a dilapidated condition is dangerous, thus reconstruction should be allowed at the façade should be maintained. However, against this recommendation the review committee that met on 20.5.1998 decided that the property should stay as protected heritage and maintained accordingly.

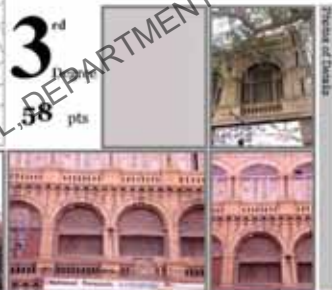
Feroze House is a G+2 storey structure, entirely in use as a commercial building. It is located on a corner plot at the junction of M.A Jinnah Road and Serai Road. From inside this building is linked with the adjoining structure i.e. Rubab Chambers by demolishing the separating wall in the courtyards of the two buildings and converting them into one single courtyard. On site no one recognizes the building as Feroze House but the entire complex is known as Rubab Chambers since 1960. Both the properties are also owned by a single owner, who also denies the fact that these two are separate buildings. Furthermore, it is not clear whether the buildings are connected at all levels as the access to the upper floors and inside the courtyard was not granted. Both properties however have different features on their façades.

From outside the building seems to be in sound structural condition, however access to the upper floors was not granted by the owner in the premise that both first and second floors are in severely damaged condition and lying vacant since past 20 years.

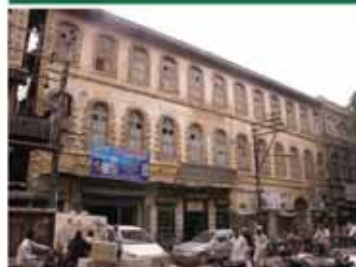
Rubab Chambers

The building from its exterior look seems to be in a fairly good state of preservation. The upper floors according to the owner, have not been in use since past 20 years. Their interiors are in a bad state of repair due to continued disuse.

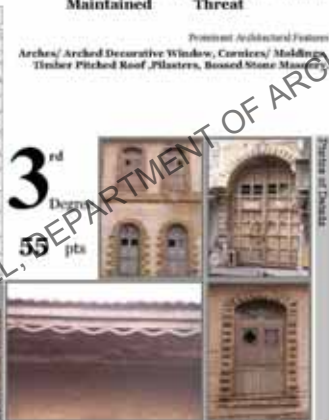
Arch details

Present Status: Partially Maintained
Threat Level: High Degree Threat
Alterations: Minor

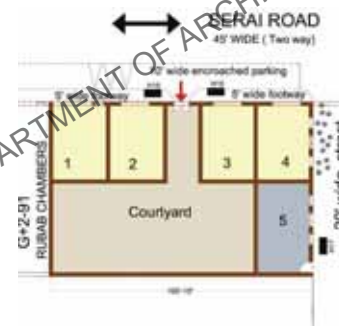
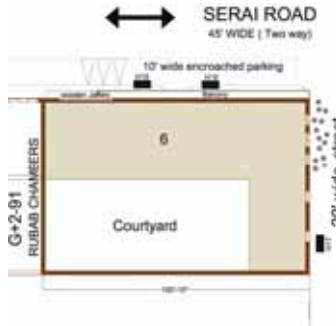
OCCUPANCY PLAN

The four shops facing Serai Road deal in hardware. The fifth space (no. 92-5) has its entrance from the side street, and can also be accessed from inside through the courtyard. This is currently in use as a warehouse.

Access to first and second floors was denied but according to site observations the physical condition and present status suggests that these upper floors are in use as warehouses, because all windows and even balconies are closed.

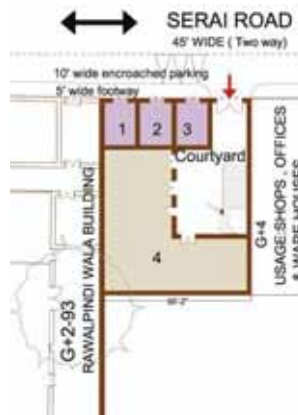
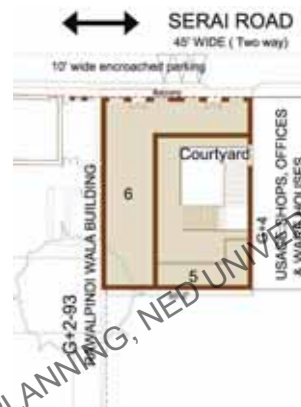
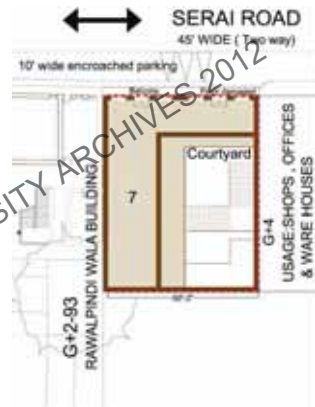
OCCUPANCY PLAN

The three shops on ground floor facing Serai Road deal with hardware.

On one side is the entrance to the courtyard, which has a wooden open to sky staircase leading to the upper floors. Besides the shops all other spaces are now vacant but previously were in use as the school.
