HIGH COURT OF SINDH

RECOMMENDATIONS FOR CONSERVATION PROCEDURES (Final Report)

Anila Naeem,

September 2003

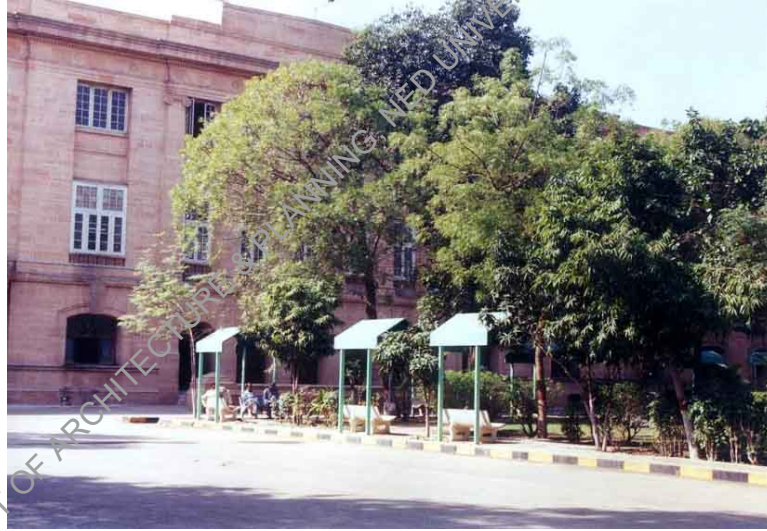
At present the open spaces between buildings in no way contribute towards enhancing the outdoor environment of the complex. Open spaces between buildings that have close inter linking functions play a vital role in giving an integrated feeling to any complex. Specially, in cases where the complex holds a public function, with hundreds of visitors everyday. High Court grounds do not have any shortage of space. They are huge and could absorb the large number of people with ease and comfort. All that needs to be done is to redesign and landscape the open spaces for the comfort of its users and under proper urban design principles. A combination of soft and hard

landscaping elements, with appropriately designed benches, waste paper bins, telephone booths, drinking water spouts, etc. could completely transform the presently harsh and un-welcoming environment into a relaxing and comfortable outdoor space.

Landscaping around the building should be done with carefully selected species of plants and trees that help in creating vistas to the monument rather than hiding it with their voluminous growth. More voluminous and shady trees should only be planned on the outer periphery and parking lot areas.

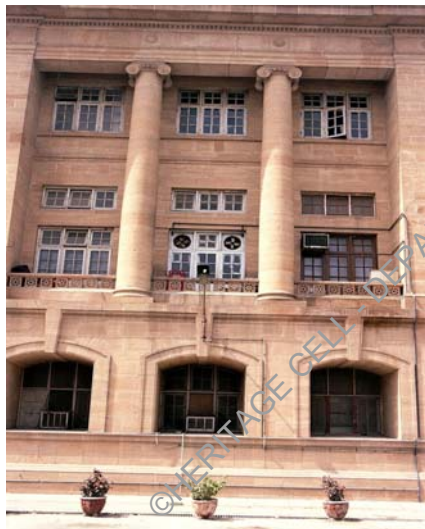
Unightly and unplanned light lamps have also been installed on various locations, mostly near entrances.

All these defacing interventions should be reverted in order to give back the building its aesthetic and visual appeal. The necessary requirements such as electric fixtures, wiring, etc. should be done with proper planning and detailing through concealing ducts and channels.

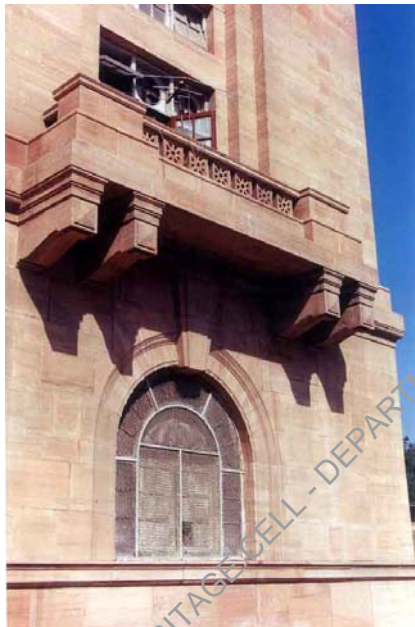
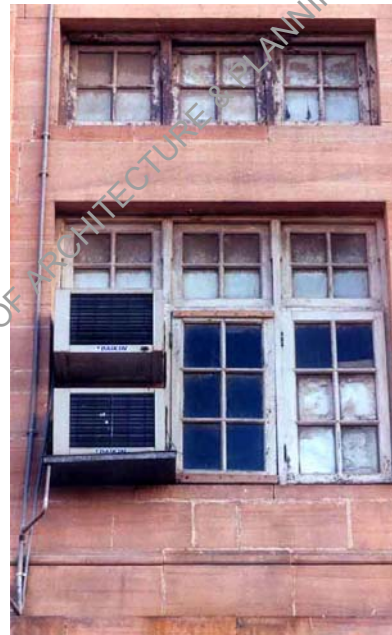
In addition to this, only a few doors and windows have their original polished finish still maintained, rest of them have been painted with several layers of white oil based paint. This accumulated layer of paint should be scraped completely, to the extent that the original color and texture of wood is exposed. This cleaned wood should then be polished with clear lacquer polish, which is then maintained through regular upkeep measures.

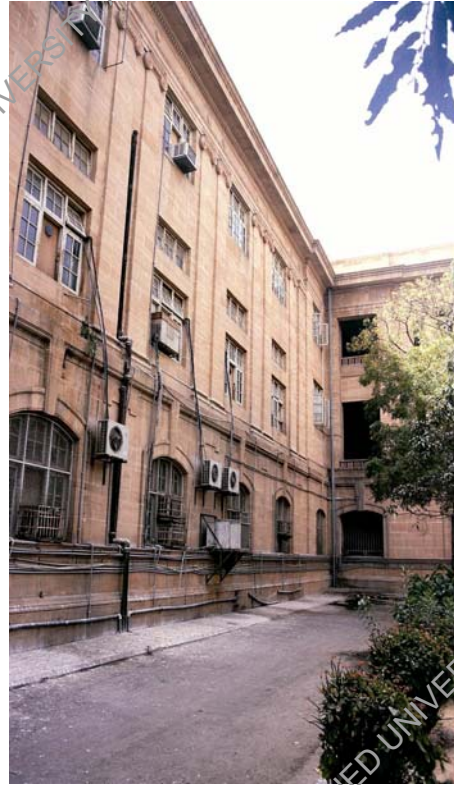
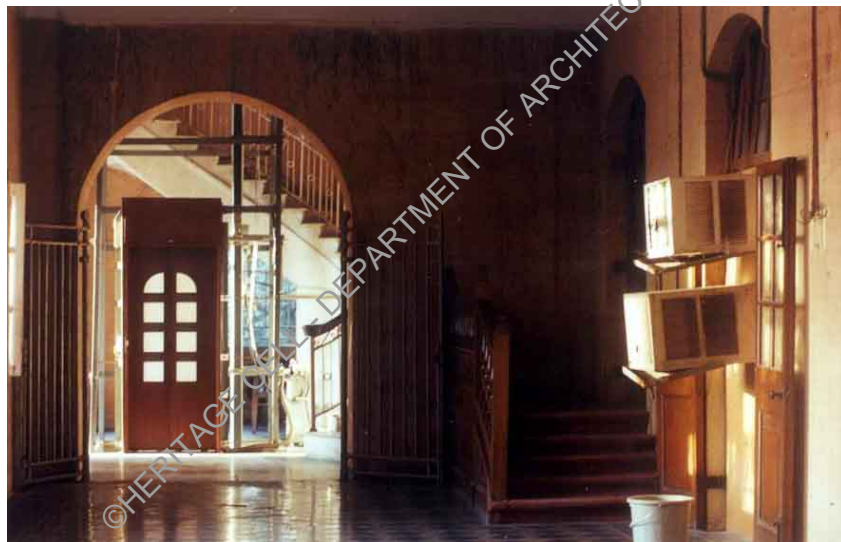
Air-conditioning units all over the building are a major reason for the defacement of the building and the serious cause of deterioration in the building. These units are placed everywhere without any concern to the impact they are having on the exterior as well as the interior of the building. Most of these units arbitrarily jut out from window openings, or are hung on the buildings' face on iron angles. Even to the extent that the corridors of the building, specially the ones used by the judges and VIPs, have AC units placed along them. These not only exhaust the hot air into the corridors but also cause water puddles due to improper drainage. Even the units placed along the external façade do not have properly installed drainage pipes in them, with the result that water washes over the building surfaces causing micro and macro biological growth. The standing water on all horizontal surface causes seepage and damage to stone masonry as well as structural members.

The inappropriate approach towards installing air-conditioning system into the building has caused major damages to the building, and these are still at work. It is very important that a proper long-term plan for air conditioning is planned that aims either for central air-conditioning through ducting or a cleverly worked out placement of outdoor units at the roof tops. This would eradicate the root cause of most of the problems identified on the buildings' interior as well as exterior.

- The most important and destructive implementation that the building has undergone in the past years is the installation of the A/C system. Since this is done in a piecemeal fashion, proper ducting for drainage as well as wiring has not been planned. As a result the entire building is being damaged severely. What needs to be done at this stage is to first identify all the spaces that are air conditioned at present or would be air conditioned in the future, and work out a complete master plan for the whole system. This should include proper locations for the A/C units, their drainage ducts, and wiring conduits. Preferably the system should be worked out either on a central A/C program or using split units. Window type units should be avoided, as they are the major cause for the defacing of the building facades.

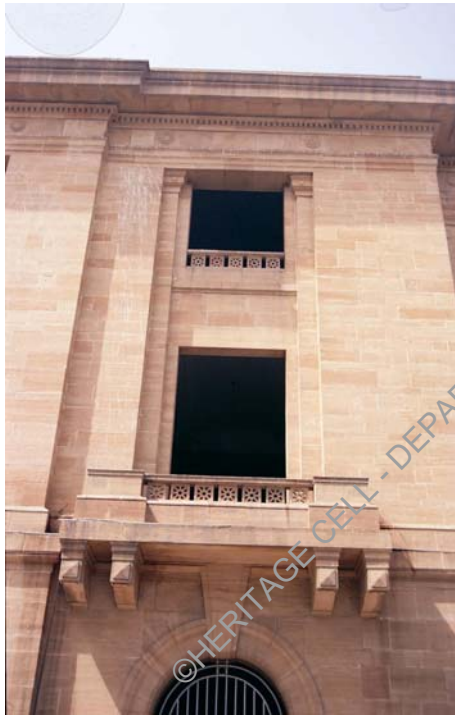
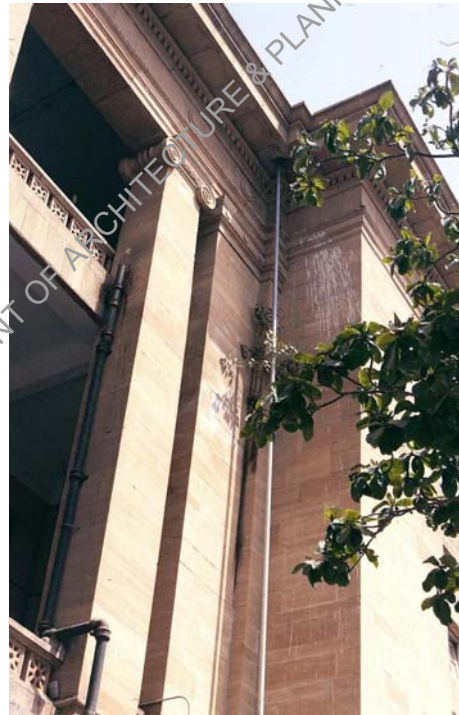
seriously effected façades are the ones around the courtyard, the reason being the close proximity of trees to it. In some locations this problem is so high that the entire façade is completely covered with white stains.

- Strips of gel applied on ledges where birds may roost. This provides an insecure footing, discouraging the birds from settling down. But once the gel dries off it can become a nuisance in itself, because it adhere to the surfaces rigidly and could not be easily taken off.

- Low voltage wires, with small electric charge, can be stretches between insulators along the ledges.
- Other known methods are trapping birds and removing them from site, shooting or scaring them away by producing noise. But these methods seem cruel and could be criticize by the bird lovers.

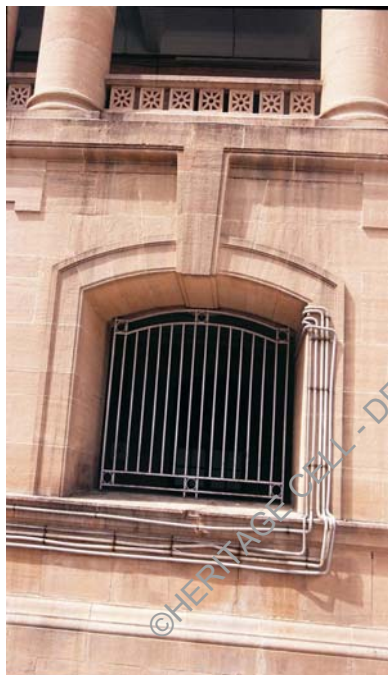
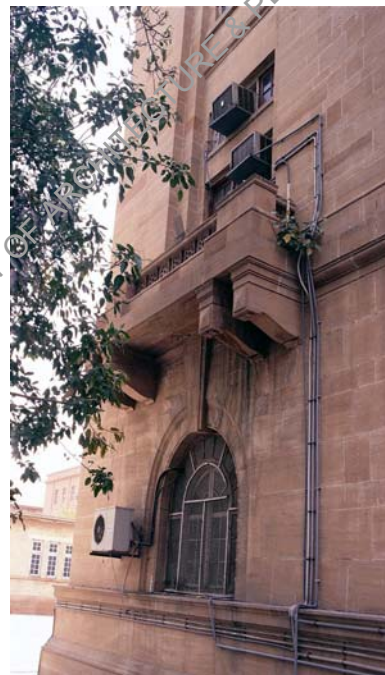
Dirt and other atmospheric pollutants suspended in air deposit more on the horizontal surfaces of the buildings, such as the window sills, cornice bands, etc. These surfaces get soiled more than the vertical surfaces of the buildings, which is apparent by a change in coloring of stone along these horizontal ledges.

After normal homogenous washing of the entire facade with suggested mild treatments, these more soiled areas can be dealt with in more detail by use of chemicals etc.

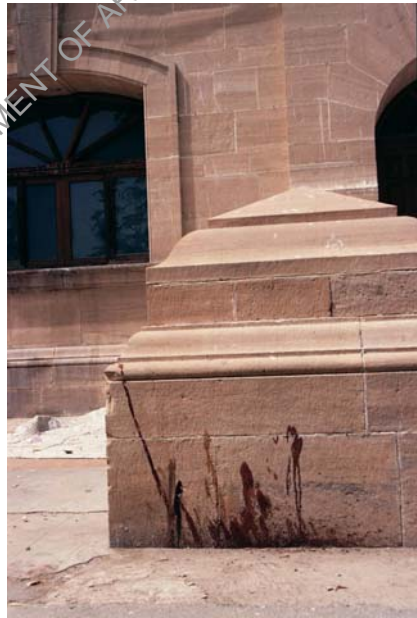
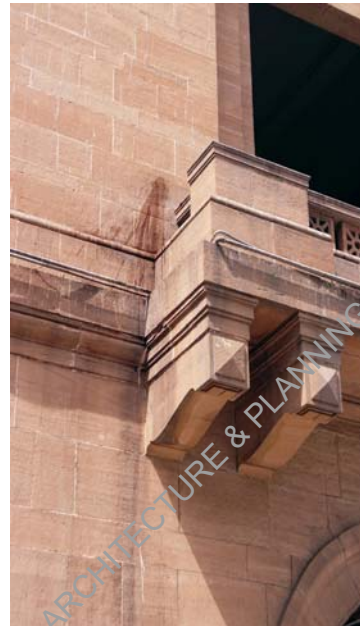
Beetle nut spit stains are a common problem and a major nuisance in most of the public buildings in Pakistan. These stains adhere to the buildings surfaces and are very difficult to clean. The main cause for this problem in buildings is the lack of awareness and realization for the importance of historic and cultural property. People in our society lack a sense of ownership towards public buildings, which is basically due to a lack of civic sense in our society. A careless gesture of spitting causes an unsightly appearance of the building. In order to control this problem strict measures should be taken by the administration, by instructing the staff to keep a close vigilance on the users of the building. Any person spotted spitting on the premises should be fined heavily or given equivalent penalty. Most of the culprits might even be within the administrative staff of the building. Strict action should be taken against such staff members.

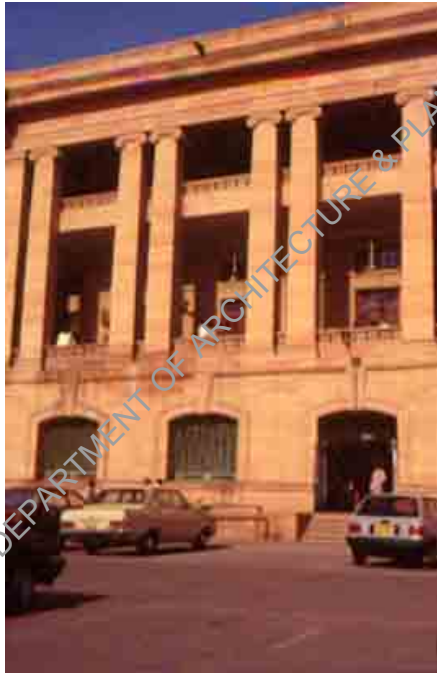
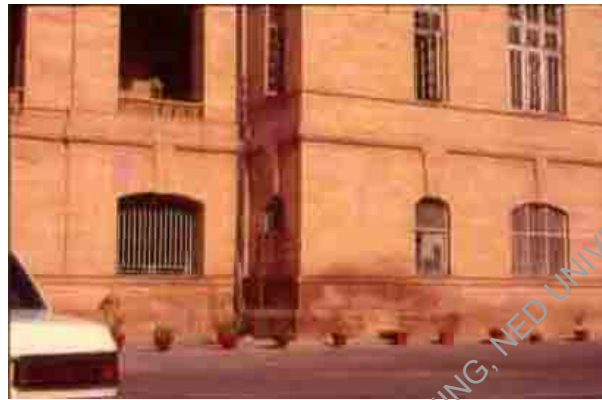
Moisture inside buildings penetrates either from the subsoil or from any other localized source inside the building. The High Court building does not show any signs of rising damp from the ground, but at certain locations moisture stains have been observed on the external masonry surfaces. These are mostly due to localized sources such as around toilets, or in areas where water coolers are placed. In case of toilets the leakage in plumbing is causing the water penetration. Whereas in case of water coolers the casual spilling of left over water in the glass over the balcony or

onto the floor is causing this problem. Both these sources of water can easily be controlled through proper detailing.

The third cause for such water stains inside or on external surfaces is the water draining from the air conditioning units. This problem and its remedies have already been discussed in earlier sections of this report.

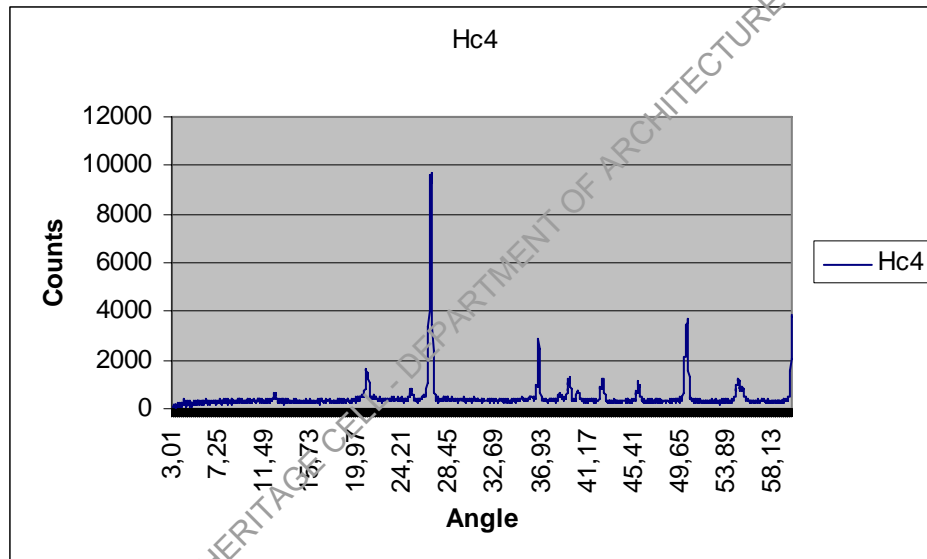
The mineral composition of the stone was further verified by “X – Ray Diffraction” test carried out on a sample of fine powder prepared from a piece of the stone sample. This further confirmed the high percentages of Silica and Silicatic compounds (minerals) present in stone.
