BUILDING OWNER: HASAN ALI SOOMRO
617 OFF WAGNO GATE LANE
ENLISTMENT NUMBER: 2012-UC1/37

SAFDAR AHMED RESIDENCE

TIBATI HAVELI

BUILDING OWNER: Ahmed Ali Mangi
117 Suigar Lane/off
Hathi Gate Lane
Enlistment number:
2012-UC2/529

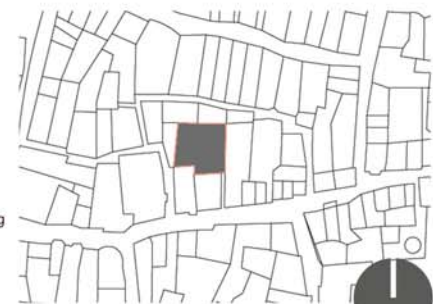
SUGGESTIONS:
Lack of maintenance due to several reasons such as termite infestation which in turn has caused structural issues in various parts of the house.
Cleanliness to better the environment and decluttering is suggested.

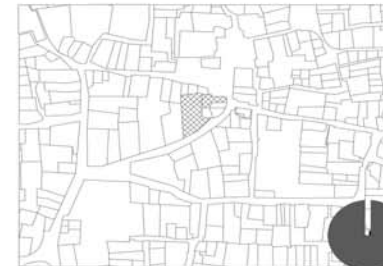
- 1.The lack of maintenance of the property.
 - 2.The current condition reflects the partial collapse of different spaces is facing threats of complete collapse of the structure.
- Just be owned as the representative of the remains of history unlike the many historic buildings because negligible consideration, it should be taken care of.
- is not possible to preserve the complete property, its elements can be used through the process of partition.
