## **HAMDARD MATAB BUILDING**

### **Renovation, Restoration and Repair Work**

*Heritage Cell - Department of Architecture and Planning,  
N.E.D. University of Engineering and Technology, Karachi*

**November 2011**

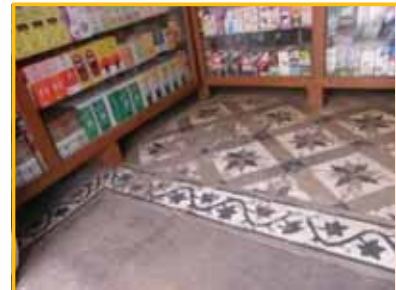
**Original flooring at shop**

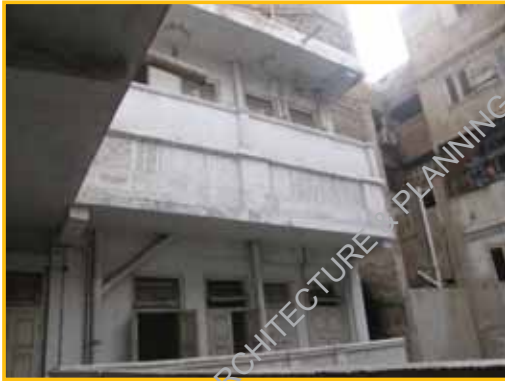
**Toilet blocks of first floor**

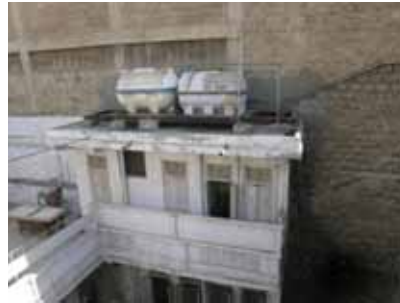
The roof is accessible through a wooden staircase. The roof has exposed plumbing lines running all over its floor and also has piles of debris at different locations which need to be removed. There is no water tank at this floor. The water is supplied, to the building, by fibre glass water tanks which are placed over the roof top of second floor toilet block. On roof, water seepage stains are also observed, indicating the fact of improper surface water drainage and poor condition of screeding at different locations. Parallel to this it is also found that there are seepage stains at the side boundary wall which is due to the overflowing problem of adjacent building's tank. For drainage purposes pipelines are used instead of water spouts, in fact all of water spouts are choked. (Refer drawing: iv)

**Fibre glass water tanks placed on the roof top of second floor**

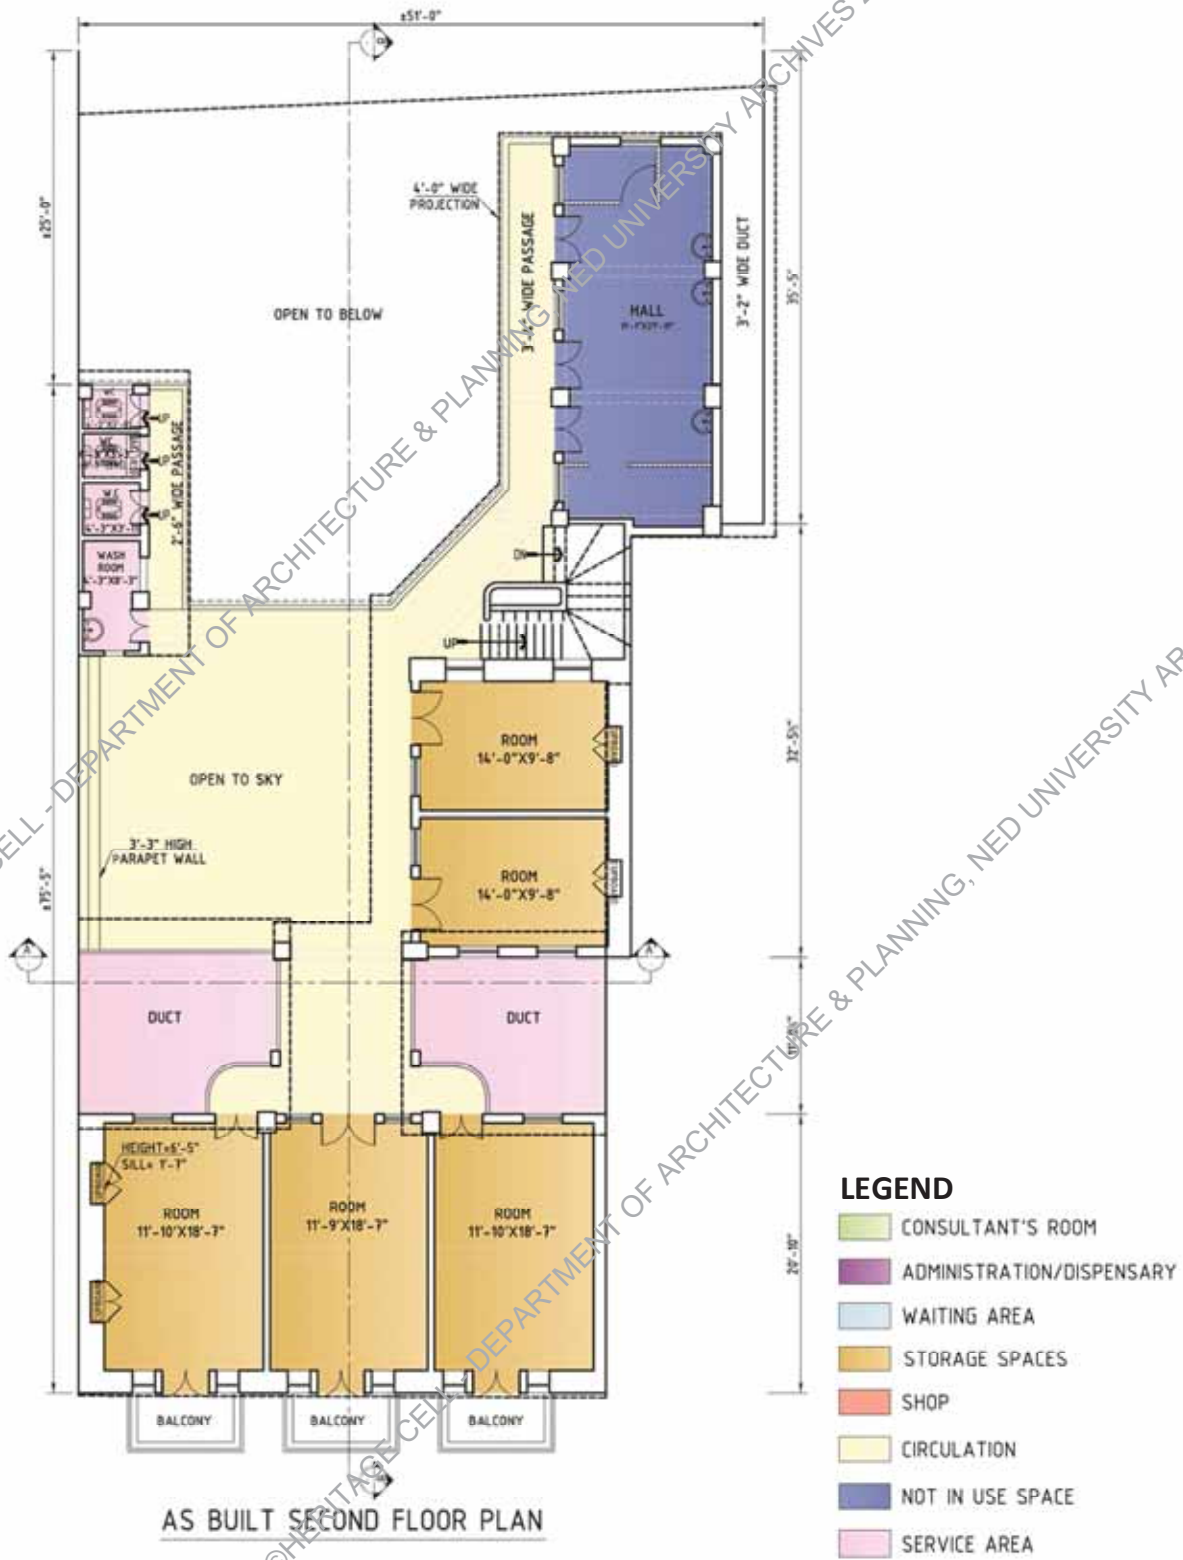
Drawing iii

Most of the spaces on second floor are being used as storage areas. The three rooms facing courtyard use to have a pathology lab which was closed in 2004. These rooms used as servant quarters for some time but now are not used. It is observed that this floor has been under utilized state. Some areas on the floor have accumulated debris, which need to be removed. The cemented area, which is open to sky, indicated seepage stains at different locations. This pointed towards the fact that flat roof of the area has improper surface water drainage. (Refer drawing: iii)

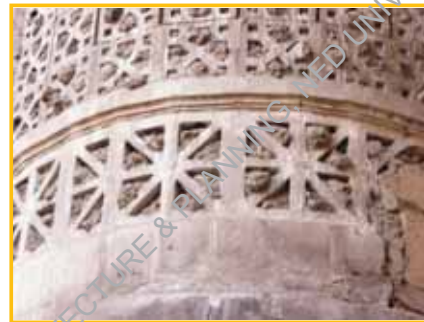
**Parapet wall on roof:** The original parapet wall at the roof level has been completely replaced by masonry parapet wall finished with plaster. Although traces of original parapet wall still exists at the interior of the building. (Refer drawing: xi)

Original parapet detail

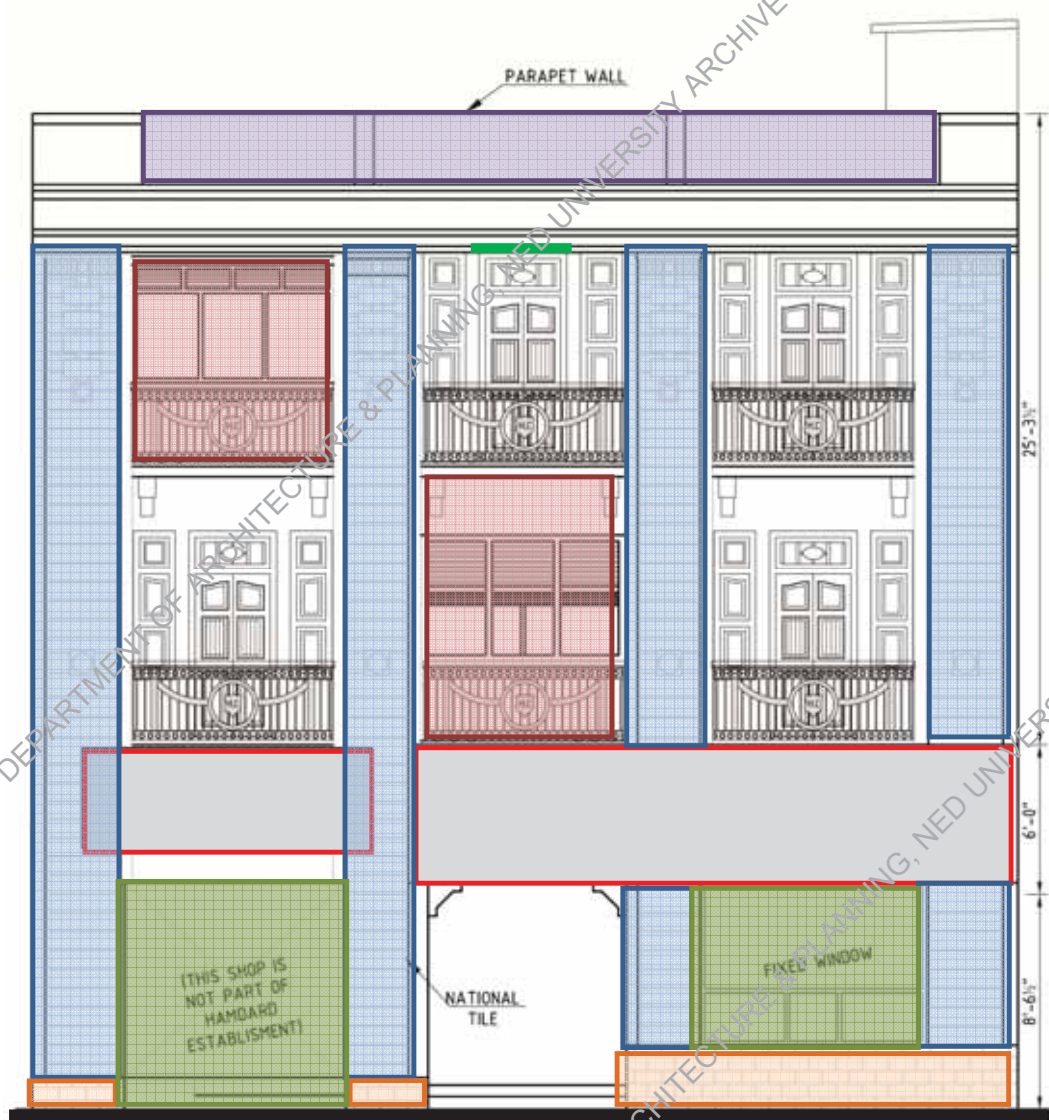
**Paint on Stone Surface:** The original material of the exterior façade is stone. However, the stone surface has been painted over with grey colour paint. (Refer drawing: xi)

**Hoardings and Signages:** The existing façade has huge sign board bearing the name of “Hamdard Matab”, along with it there exists other smaller horizontal and vertical sign boards as well. These boards all together give an unpleasant impact to the building; covering almost half of the ground floor frontage. In addition to that, the shop shutters and tile cladding also completely covers the ground floor. Thus additions have completely obscured the original ground floor frontage. (Refer drawing: xi)

**Alterations in Balconies:** As mentioned earlier that there exist three cantilevered balconies on each of the first and second floors, making the total of six balconies altogether. Out of the three cantilevered balconies of first floor, central balcony has been completely closed by using asbestos sheets and wooden louvers. This balcony is accessible from inside room; which once was the room of Hakim Said and now is in use of the senior consultant. This balcony also served as the washroom for some time after the death of Hakim Said, but now it has been in no use. From interior it is still in very dilapidated state. (Refer drawing: xi)

Similarly out of the three cantilevered balconies of second floor, left corner balcony has been closed by using asbestos sheet and is been used as storage room. Also addition of asbestos sheet is observed on the centre balcony on second floor as temporary covering. (Refer drawing: xi)

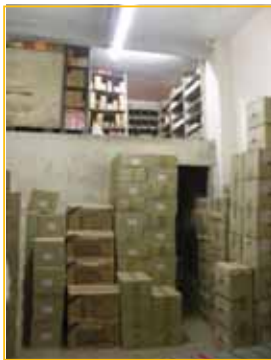
Addition of partition wall inside hall area

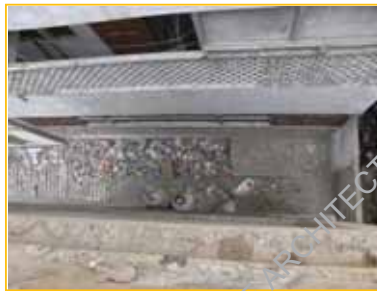
View of Ground level storage from top, which was once back lane within the same plot

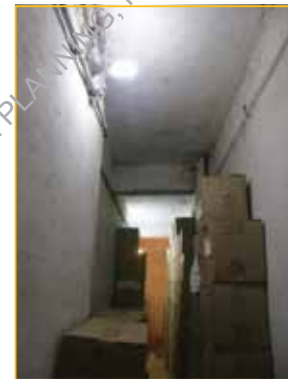
Back lane conversion into additional storage

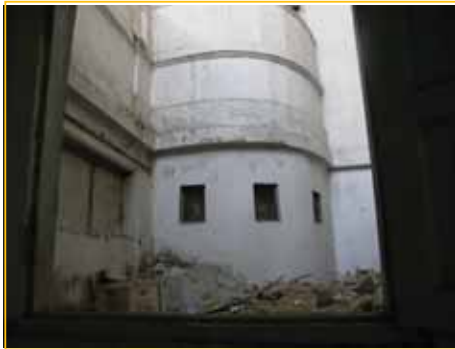
View of the duct area from first floor

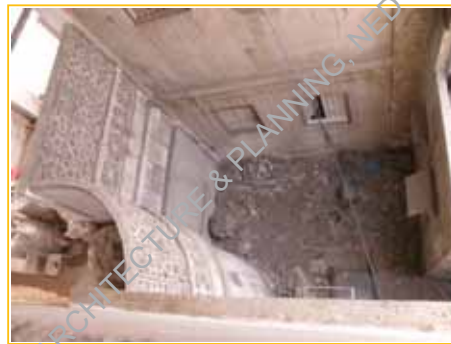
View of the duct area from second floor

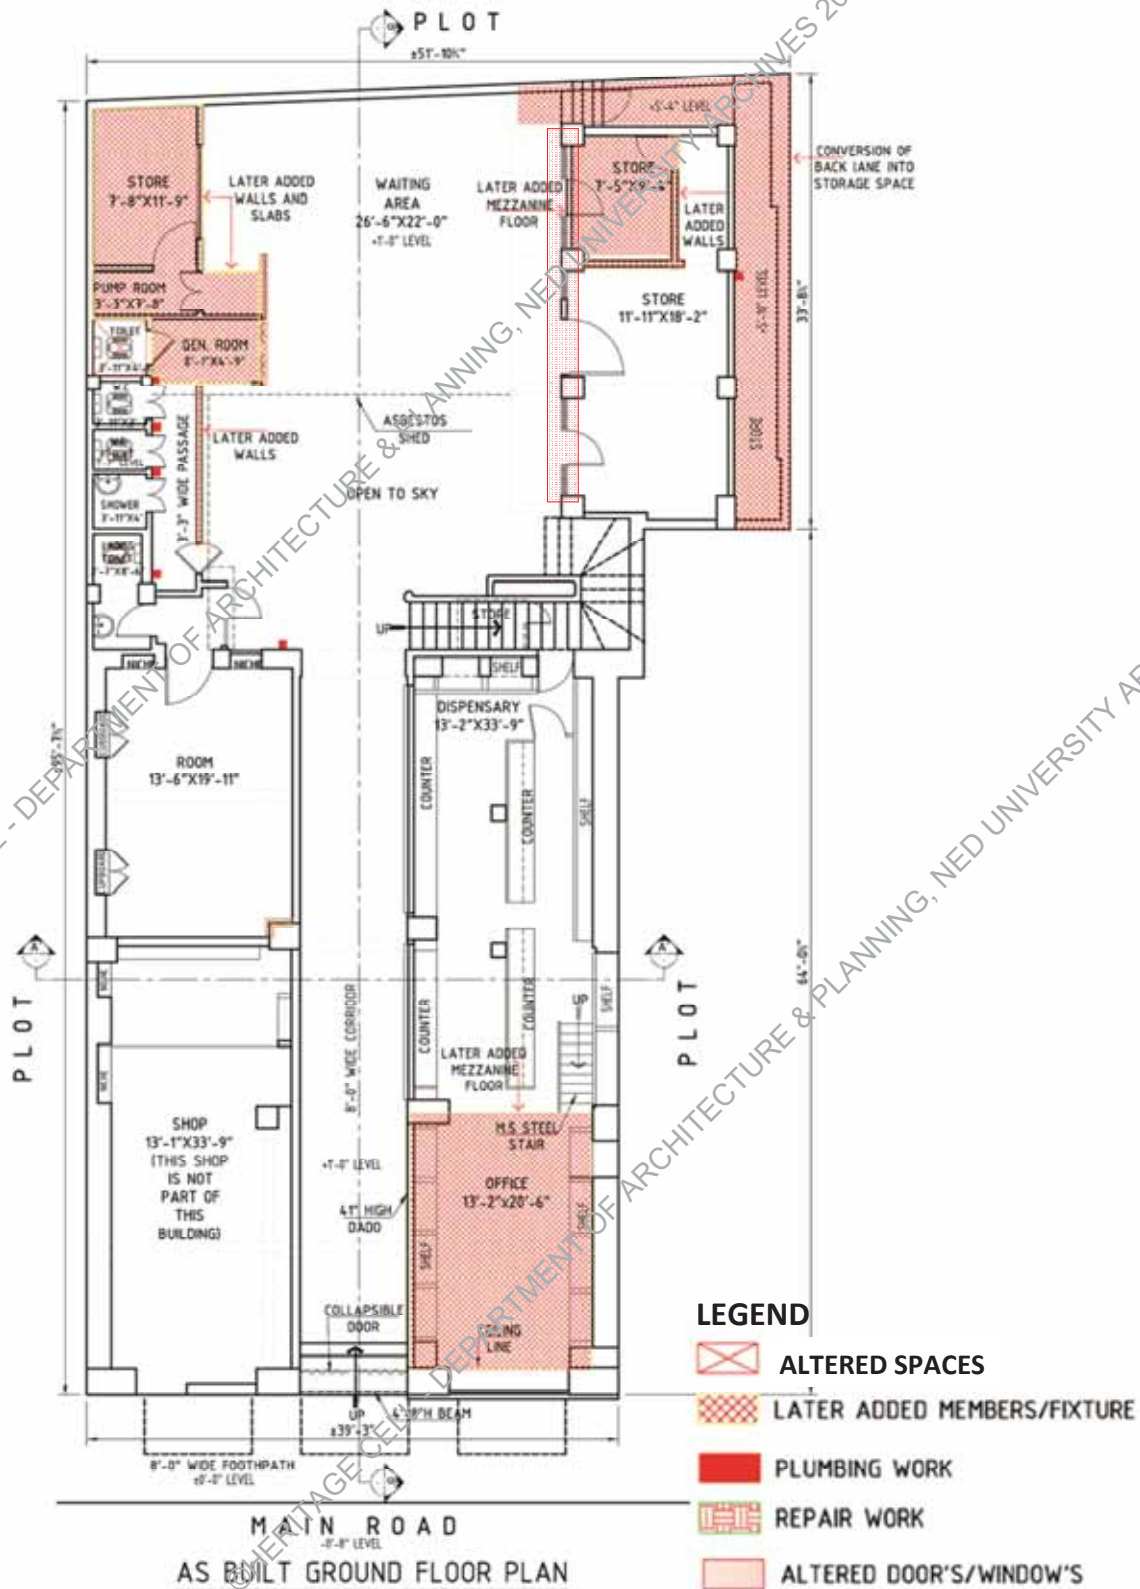
Drawing xii

Observation during survey indicate that problem of garbage dumping from neighbouring plots is of serious nature as the situation worsens in rainy season, when the garbage gets dampened and smelly. In addition asbestos roofing also starts leaking at certain locations. Apart from that, later installed plumbing pipes at different locations throughout the building also create a visually disturbing impact on the façades. Besides these certain other structures presently existing on the plot are later additions. These include the rooms built adjoining the toilet block, as machine area generator room and storage area. The storage area served both as storage and servant room, at present. (Refer drawing: xii)

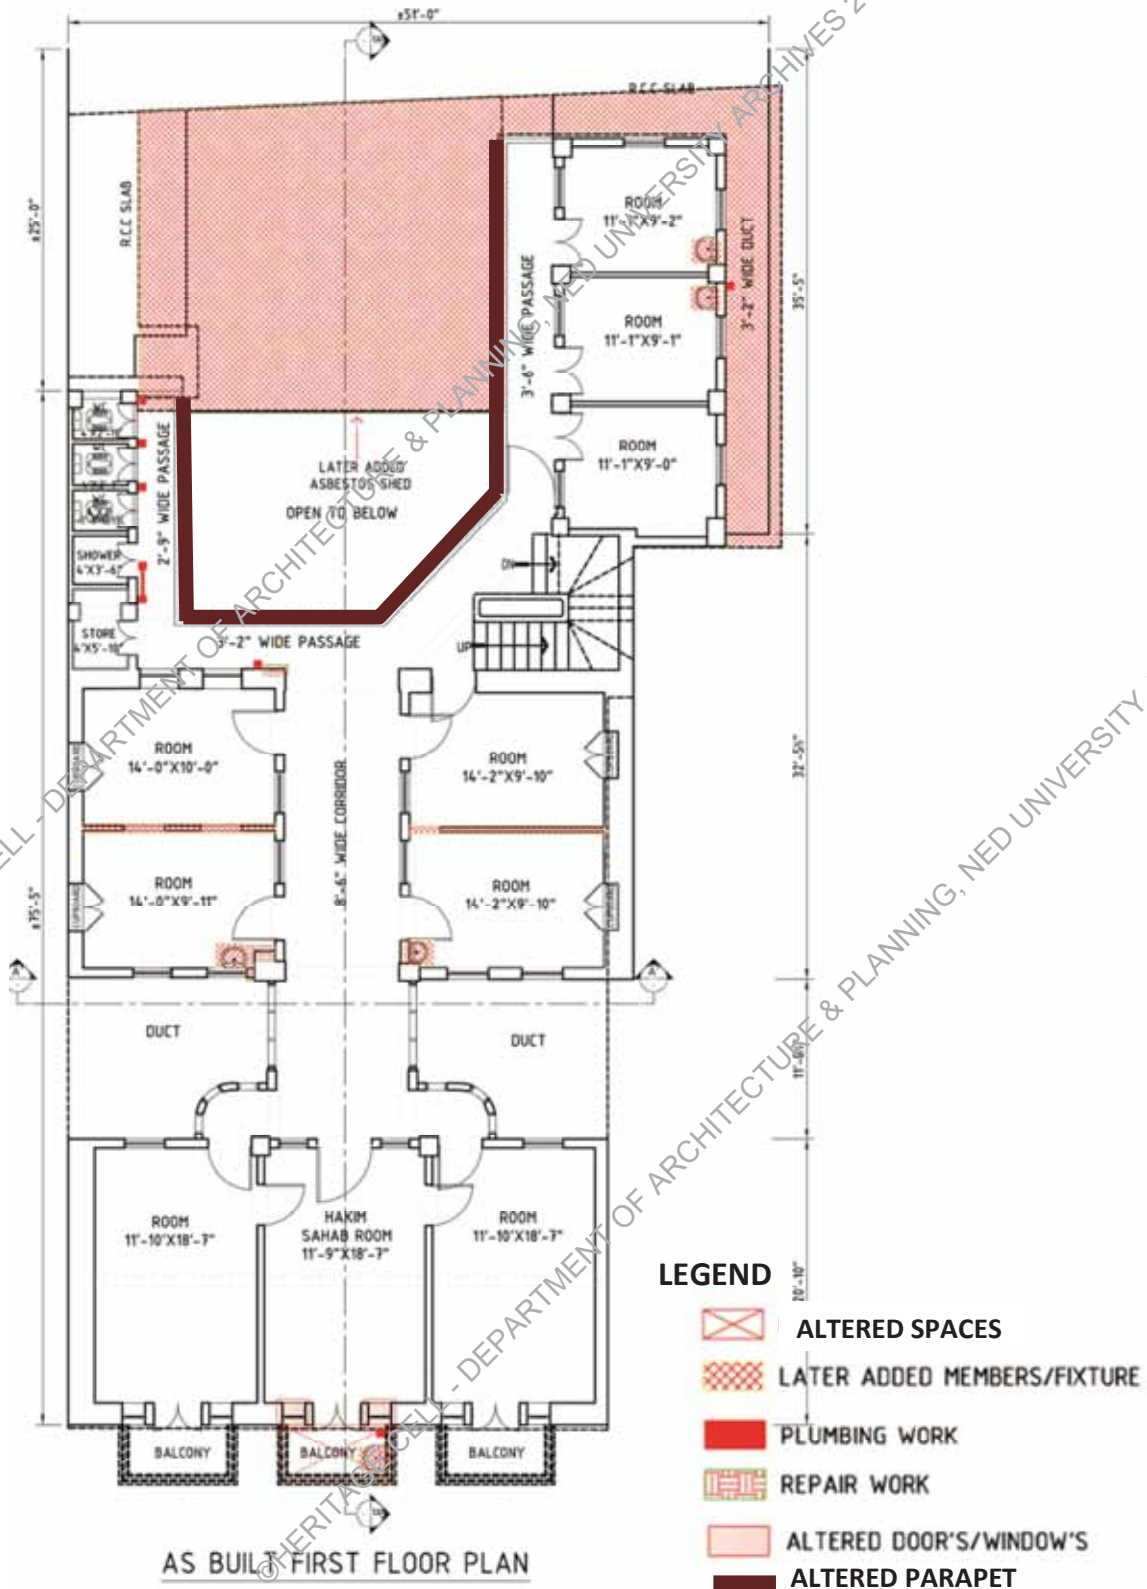
Drawing xiii

On first floor, partition walls have added for dividing single rooms into two, for incorporating additional consultants within the building. The balcony of Hakim said's room has been altered into different functions from time to time and is now in dilapidated state. It was initially altered to serve the function of toilet which was later changed into AC unit's duct. The unplanned alterations along with their improperly fixed drain-pipes causing problem of water penetration,

as water washes over surfaces and now creates puddles over cantilevered balcony's floor. Due to the absence of proper drainage of standing water from the floor, seepage occurs through the slab, damaging the construction materials. Later added washbasins along with their exposed drainage lines have also observed, giving unpleasant visual of building's interior facades. The proper duct spaces are not in use also. The original flooring has been replaced or covered, using red acrylic tiles and ceramic tiles. Finishes seems to be in very dilapidated state. (Refer drawing: xiii)

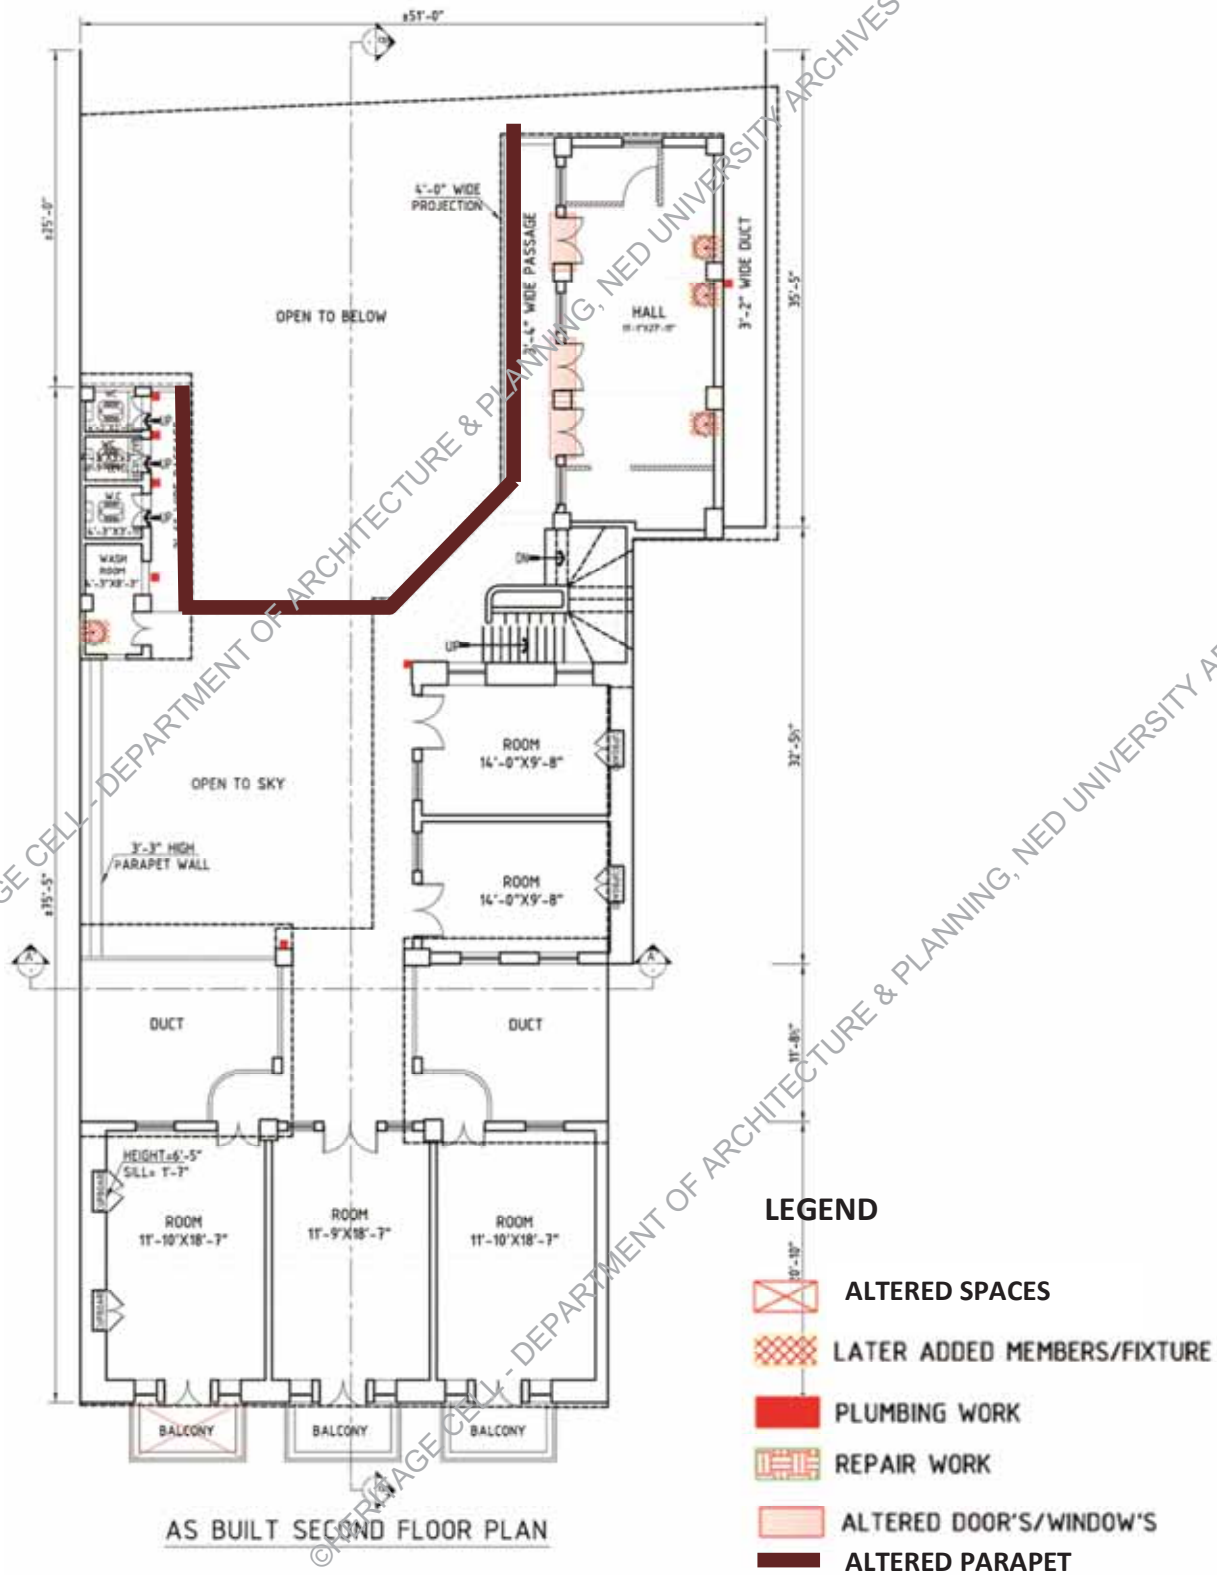
Drawing xiv

On second floor, a cantilevered balcony, at the corner, has been altered into additional storage area. This balcony has visually closed from outside but accessible from inside of the building. The hall at the back, facing towards the courtyard, was once used as pathology lab. Partition walls have added inside the hall for utilizing the space accordingly. The addition of washbasins along with their drainage pipes have observed at this floor also. The original pattern flooring has been replaced by applying cement pilaster on the floor, although the traces of the original pattern flooring have also observed. The cemented floor has water seepage stains at various locations,

indicating the problem of poor screeding and improper surface water drainage. This standing water seeps through the slab, causing damage to the structural members. (Refer drawing: xiv)

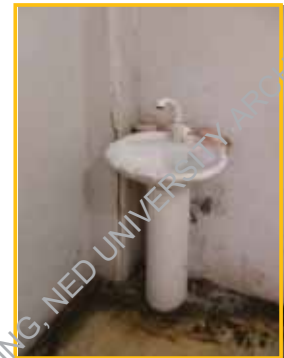
At the Ground Floor, the seepage observed in some storage areas and on the roof of one consultants room. While on the First Floor, the seepage ratio is quite high on the beam and ceiling. Mostly it has been detected in the corridor or adjoining areas of corridor. The Second Floor's toilet blocks and circulation space are affected by seepage.

- ❖ Installation of wash basin The major problem identified in Hamdard Matab building is the seepage. The Hamdard Matab building does not show any signs of rising damp from the ground, but at certain locations seepage stains have been observed on the external surfaces. These are mostly due to localized sources such as in areas where wash basin's drain lines have been installed. In case of areas where wash basins have been installed; added as need occurred, are a major source of water penetration into the building. As these facilities are scattered in small pockets they have not been provided with a service shaft or duct through which their water supply and drainage pipes could pass through. Thus at some places these pipes run along the outer wall, whereas at other places they are embedded inside the floor or are concealed with an exposed duct.

- ❖ Installation of fiber water tank Another cause of seepage is the leakage of water from fiber water tanks. The plumbing, in most of the cases, is faulty and leaking pipes have become a source of water penetration inside the building.

- ❖ The installation of urinal caused added plumbing pipes in Hakim Said's room balcony, although it's not in use but currently existing AC ducts has increased seepage on the floor.

- ❖ Plumbing Issues The plumbing, in most of the cases, is faulty and leaking pipes have become a major source of water penetration inside the building.
- ❖ Water Drainage There are some temporary asbestos shed over the duct area which caused water stain inside or on external surfaces due to water draining. In rainy season the water stands over the asbestos shed and ultimately on the roof of the duct, which would not drain out properly. The standing water on all horizontal surfaces causes seepage and hence damages the structural members.
