# DOCUMENTATION AND CONSERVATION REPORT

## Karachi Port Trust (KPT) Head Office Building

### STATE OF CONSERVATION REPORT

Prepared by: Heritage Cell, Department of Architecture & Planning  
NED University of Engineering & Technology, Karachi

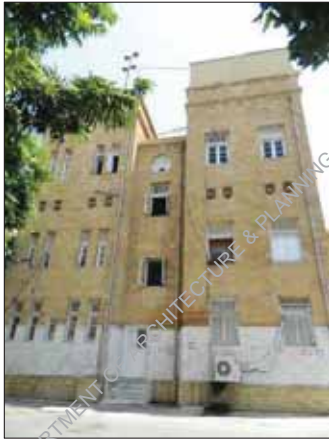
With the passage of time, exposed service ducts like rain pipes, plumbing pipes, electricity wires and AC units have also been installed on the building façade. Overhead water tank was also placed over the building rare side elevation.

Figure 41. Exposed Plumbing Services on Building's rare side

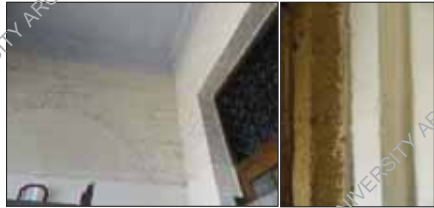
The internal walls are coated with an off white paint. There are some stone masonry walls inside the building which have also been coated with the same color of paint. Since the ceiling level is high enough (about 16 ft.), therefore, lofts (slabs resting on metal girders) have been added in several areas. Some rooms have false ceilings which were added later for better lighting and aesthetics.

Figure 48 (a, b). Paint Coat on Stone Walls
