**KILLARNEY HOTEL :  
A PROPOSAL FOR RESTORATION**

**Anila Naeem,**  
*Associate Professor, Department of Architecture and Planning,  
NED University of Engineering and Technology, Karachi.*

**June 2004**

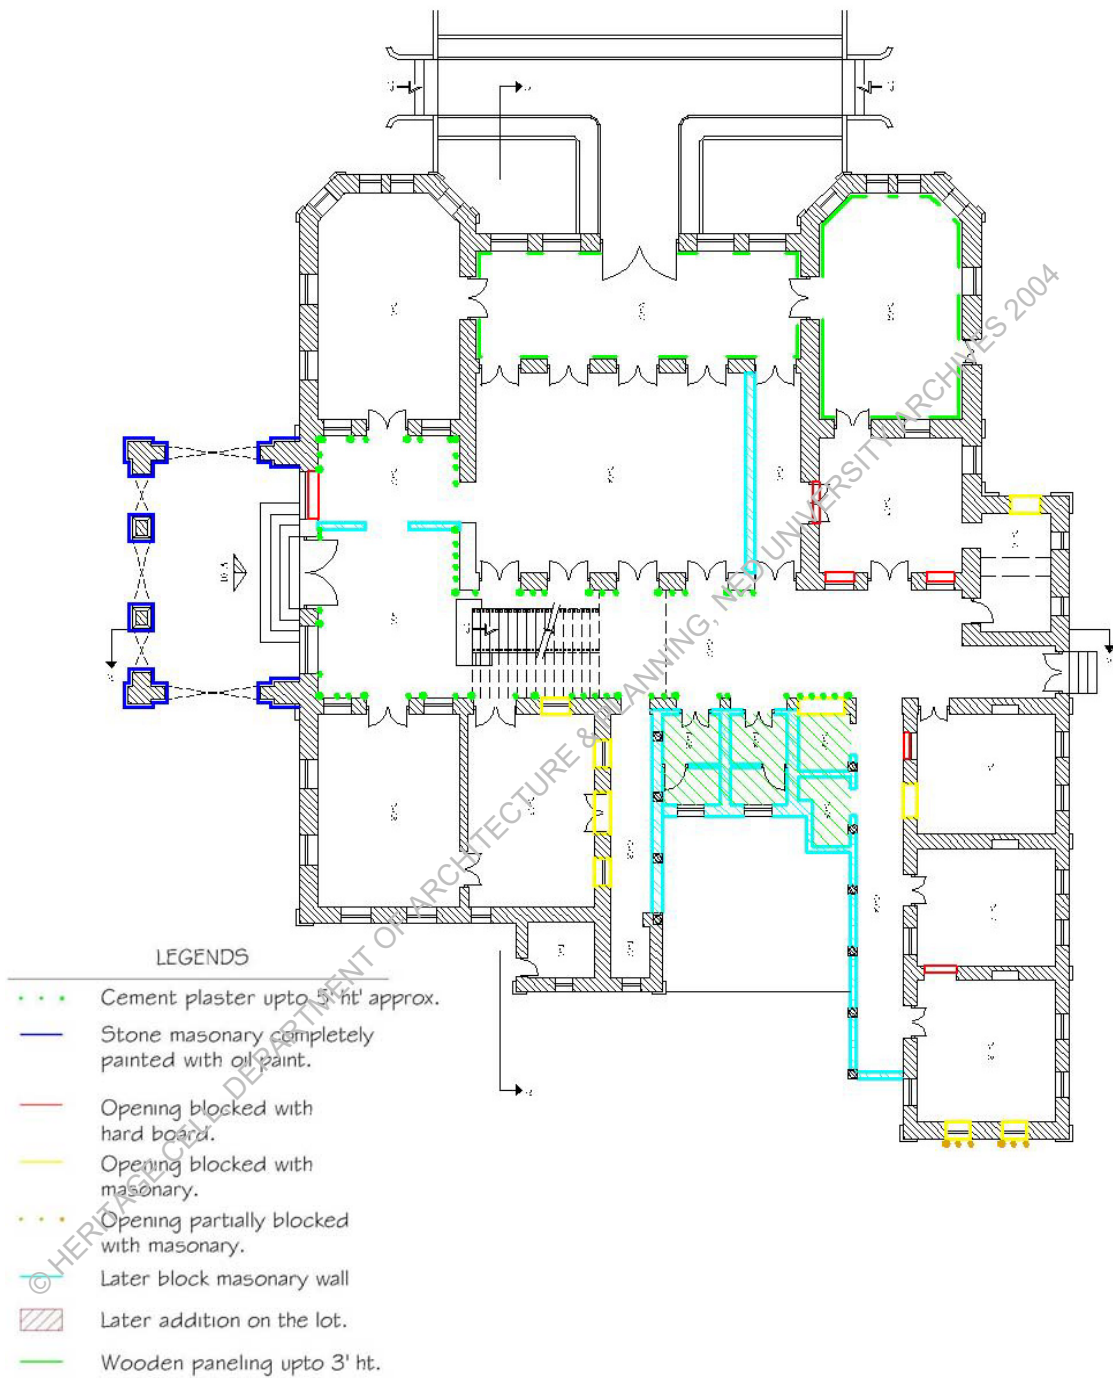
**Plan Show on Alteration Ground Floor**

A detailed survey of the building reveals that it has undergone several alterations during its life span. One very clear phase seems to be undertaken during its use as the Russian Consulate as this phase shows alterations done intentionally to create an air of grandiose in the structure. Thus many details in cement concrete are observed that (supposedly) added to the architectural enhancement of its features.

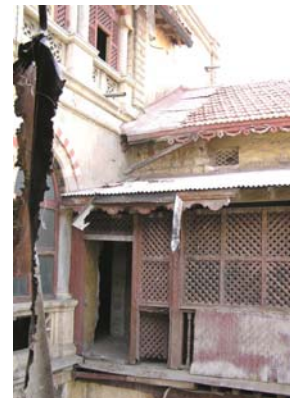
The building of Killarney Hotel has very fine decorative details that enhance the architectural quality of the structure. Luckily these details have survived till date and are present on the building without much damage. These include the carved timber pelvets running along all the edges of the pitched roofs. Close observation shows that these have a different design at different locations. There are some missing parts which have fallen off and are misplaced, due to lack of maintenance. Such missing details need to be reintegrated in the restoration. Since first hand authentic information is available on the building, thus

Similarly a few acroterions along the first and second floor parapets have also fallen off. But their exact design and detail is available from the surviving ones thus these can also be reintegrated in the building.

replicating these missing parts to their exact detail and design will not be a difficult task.
