DOCUMENTATION & CONSERVATION REPORT

Edulji Dinshaw Building - Lady Dufferin Hospital

STATE OF CONSERVATION REPORT

Prepared by: Heritage Cell, Department of Architecture & Planning
NED University of Engineering & Technology, Karachi

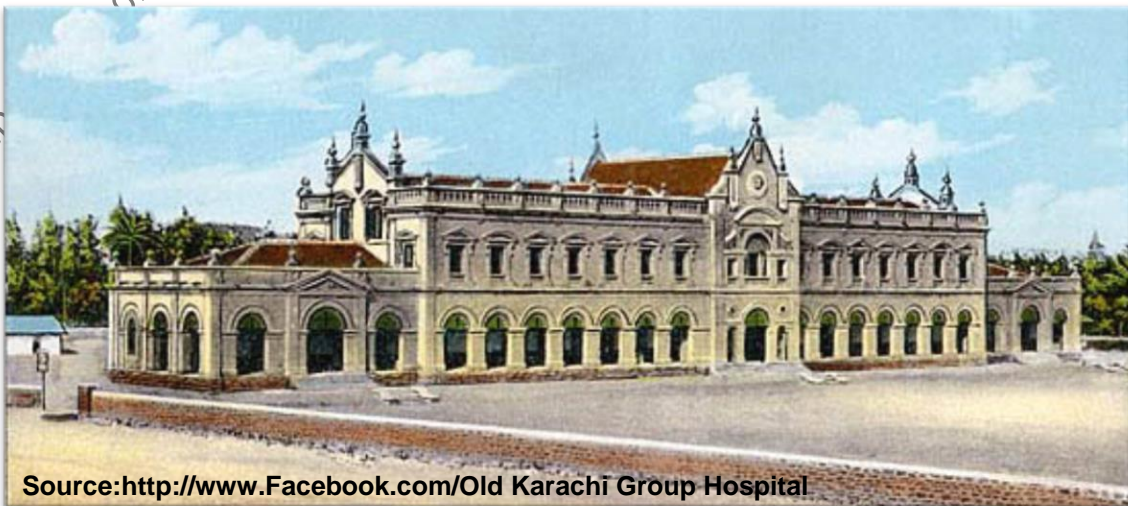
Figure-25 Undated Historic Image of Lady Dufferin

The entire roof profile has been completely altered as evident from the undated historic image indicating a timber pitched roof profile, finished with terracotta (*khaprail*) tiles. The original roofing is now completely replaced with RCC slabs, punched with ten protruding skylights that provide natural light to first floor spaces. The extensions at two ends of the building have also resulted in the loss of ornate gable detail at the two side façades of central two storey high portion of EDB (**Figure 26**). The pitched roof over the central gable is also replaced with a flat roof and an additional RCC water tank (**Figure 27**).
