NATIONAL FOODS LADIES CLUB: GUIDELINES FOR RESTORATION AND NEW EXTENSIONS

*Heritage Cell - Department of Architecture and Planning,
N.E.D. University of Engineering and Technology, Karachi.*

December 2010

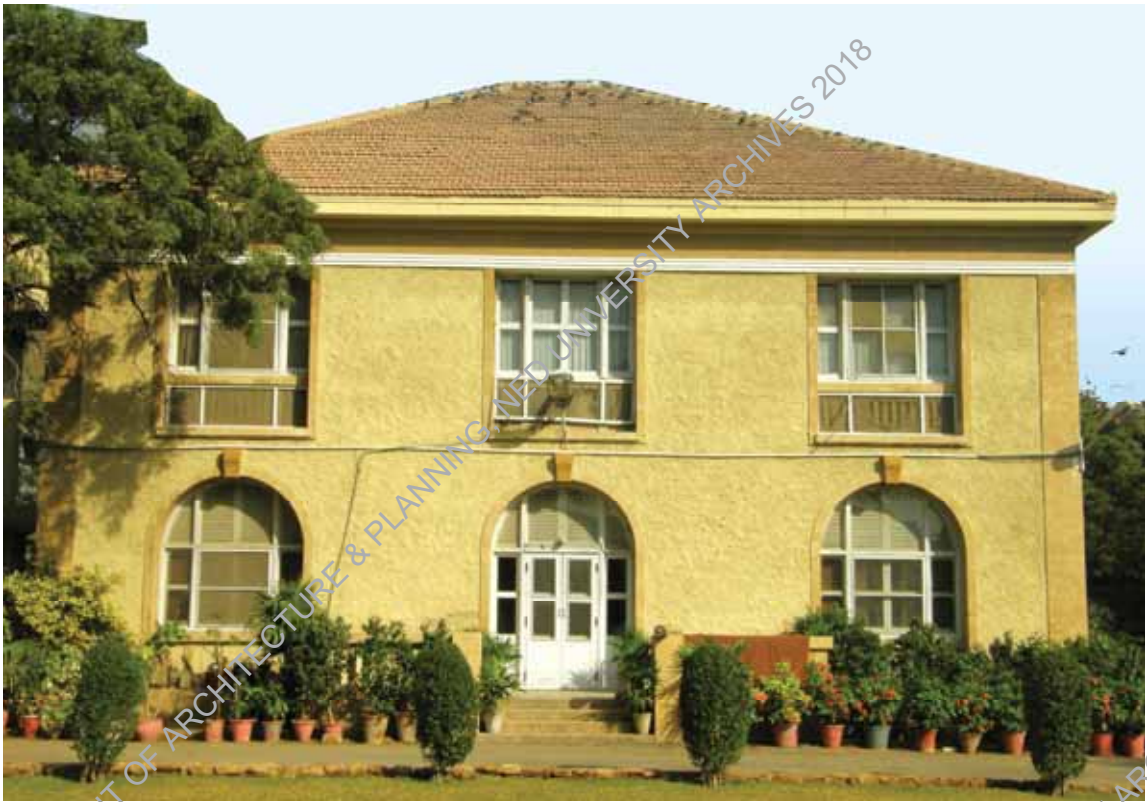
Western façade having the main entrance to the building.

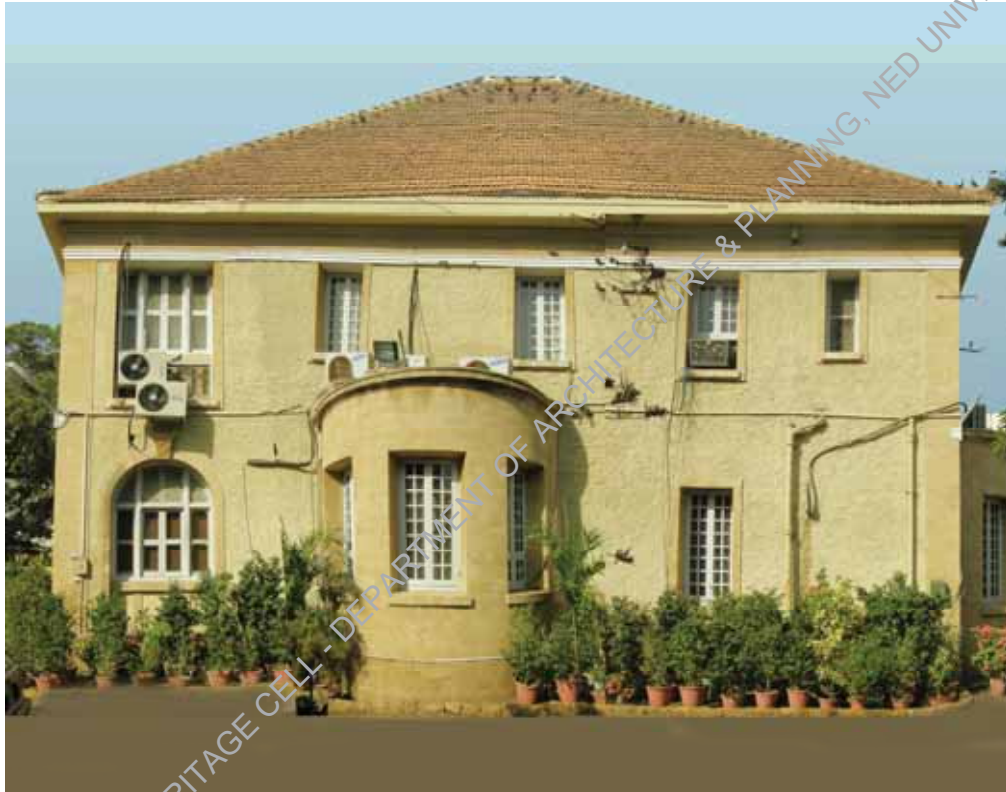
Southern façade having the semicircular niche in a ground floor room.

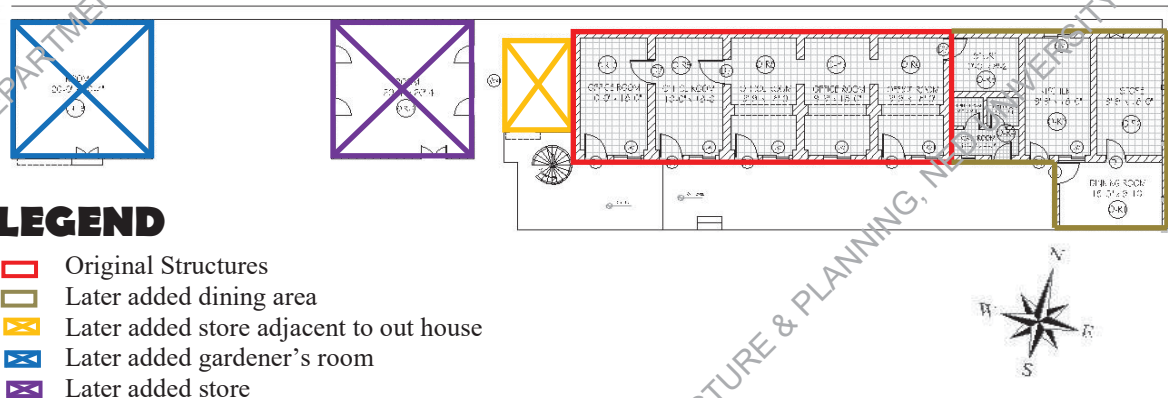
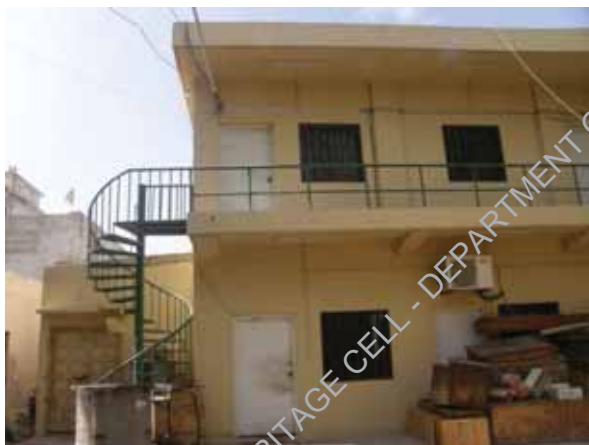
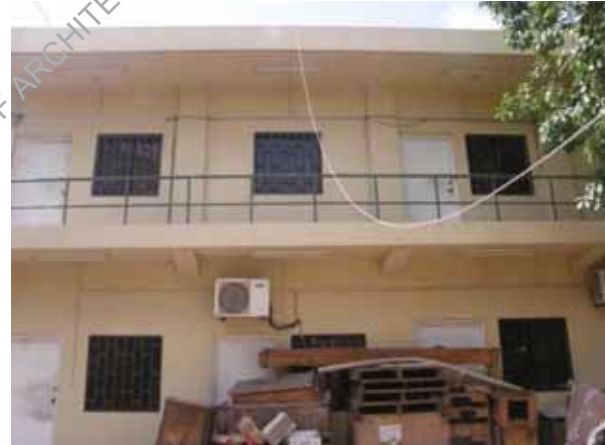
The original part of the out-houses structure comprises of the five rooms, which have the upper storey as well. An external spiral stairway built in metal, provides access to the upper floor, through an open veranda/ balcony on which all the rooms open. The wall thicknesses of the original structure indicate that it is a stone masonry structure, but in its present state no exposed stone masonry is visible. The structure has been heavily plastered with cement plaster and also extended with later extensions on the ground level. Although the out-houses no longer possess any important architectural features reflective of its original character but the footprint of the building being part of the original layout scheme holds significance.

View of spiral staircase and front elevation of the out-houses.

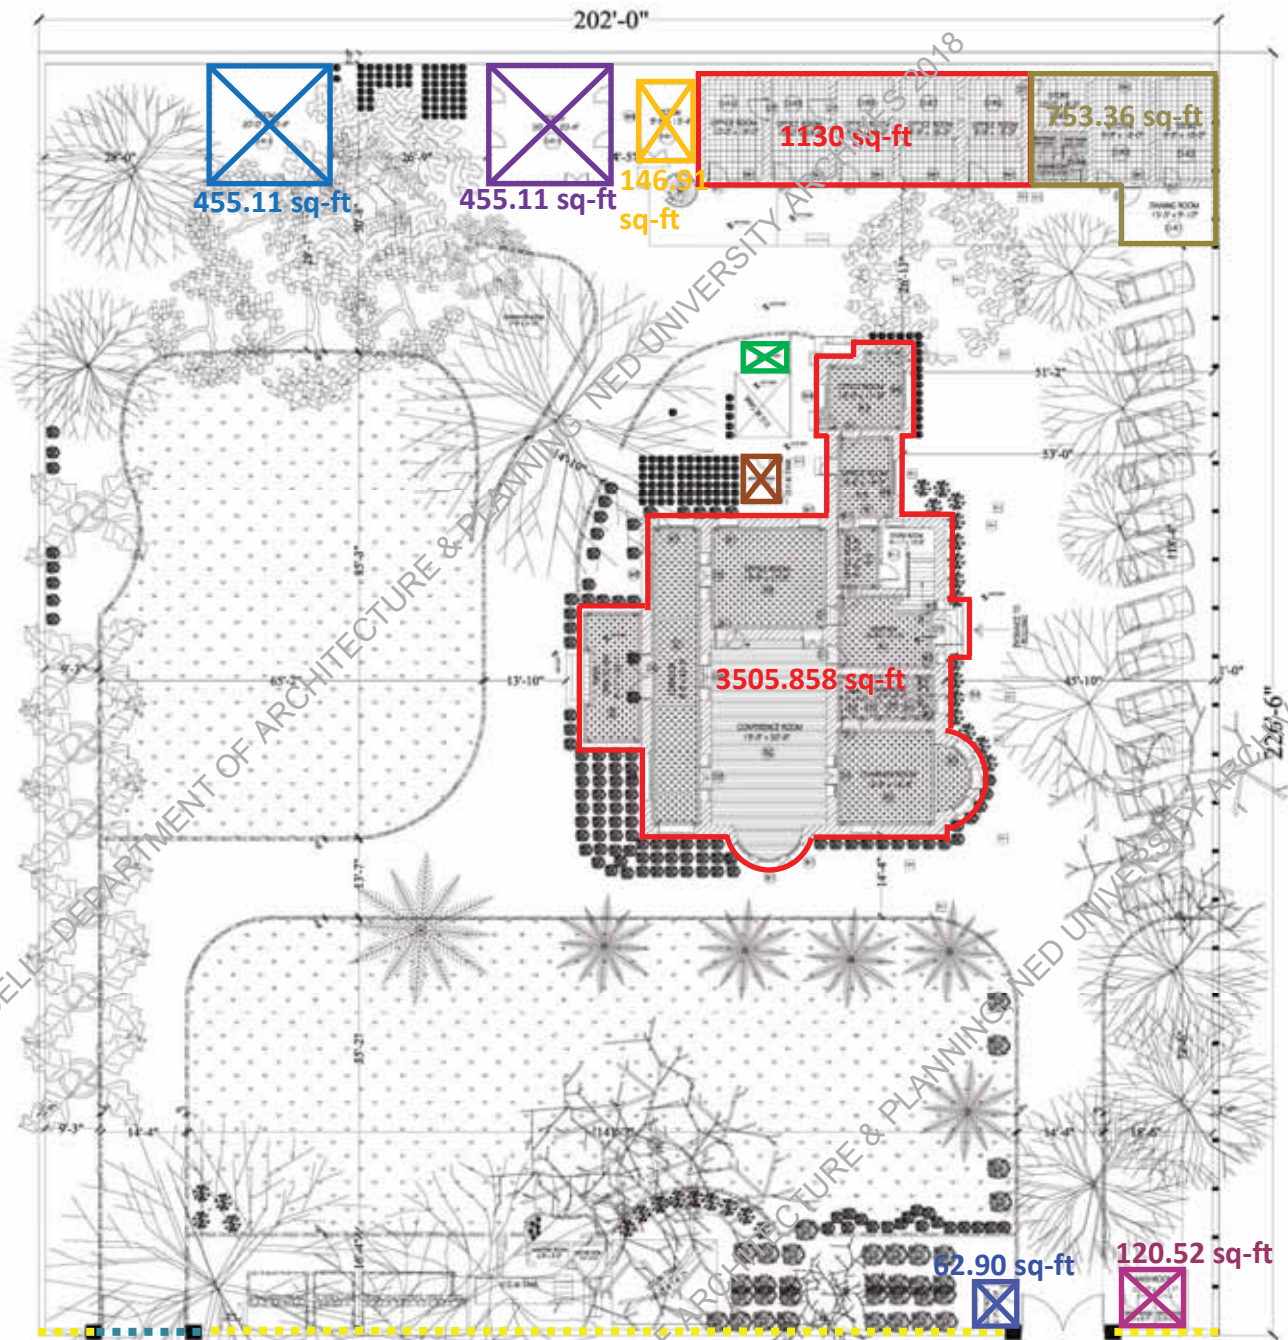
The site of National Foods Ladies Club is in a well preserved condition; to a great extent retaining its original character and proportion of built and open spaces. Only a few alterations on the site have been observed. These are being considered as of having a minor impact on the overall ambiance of the site.

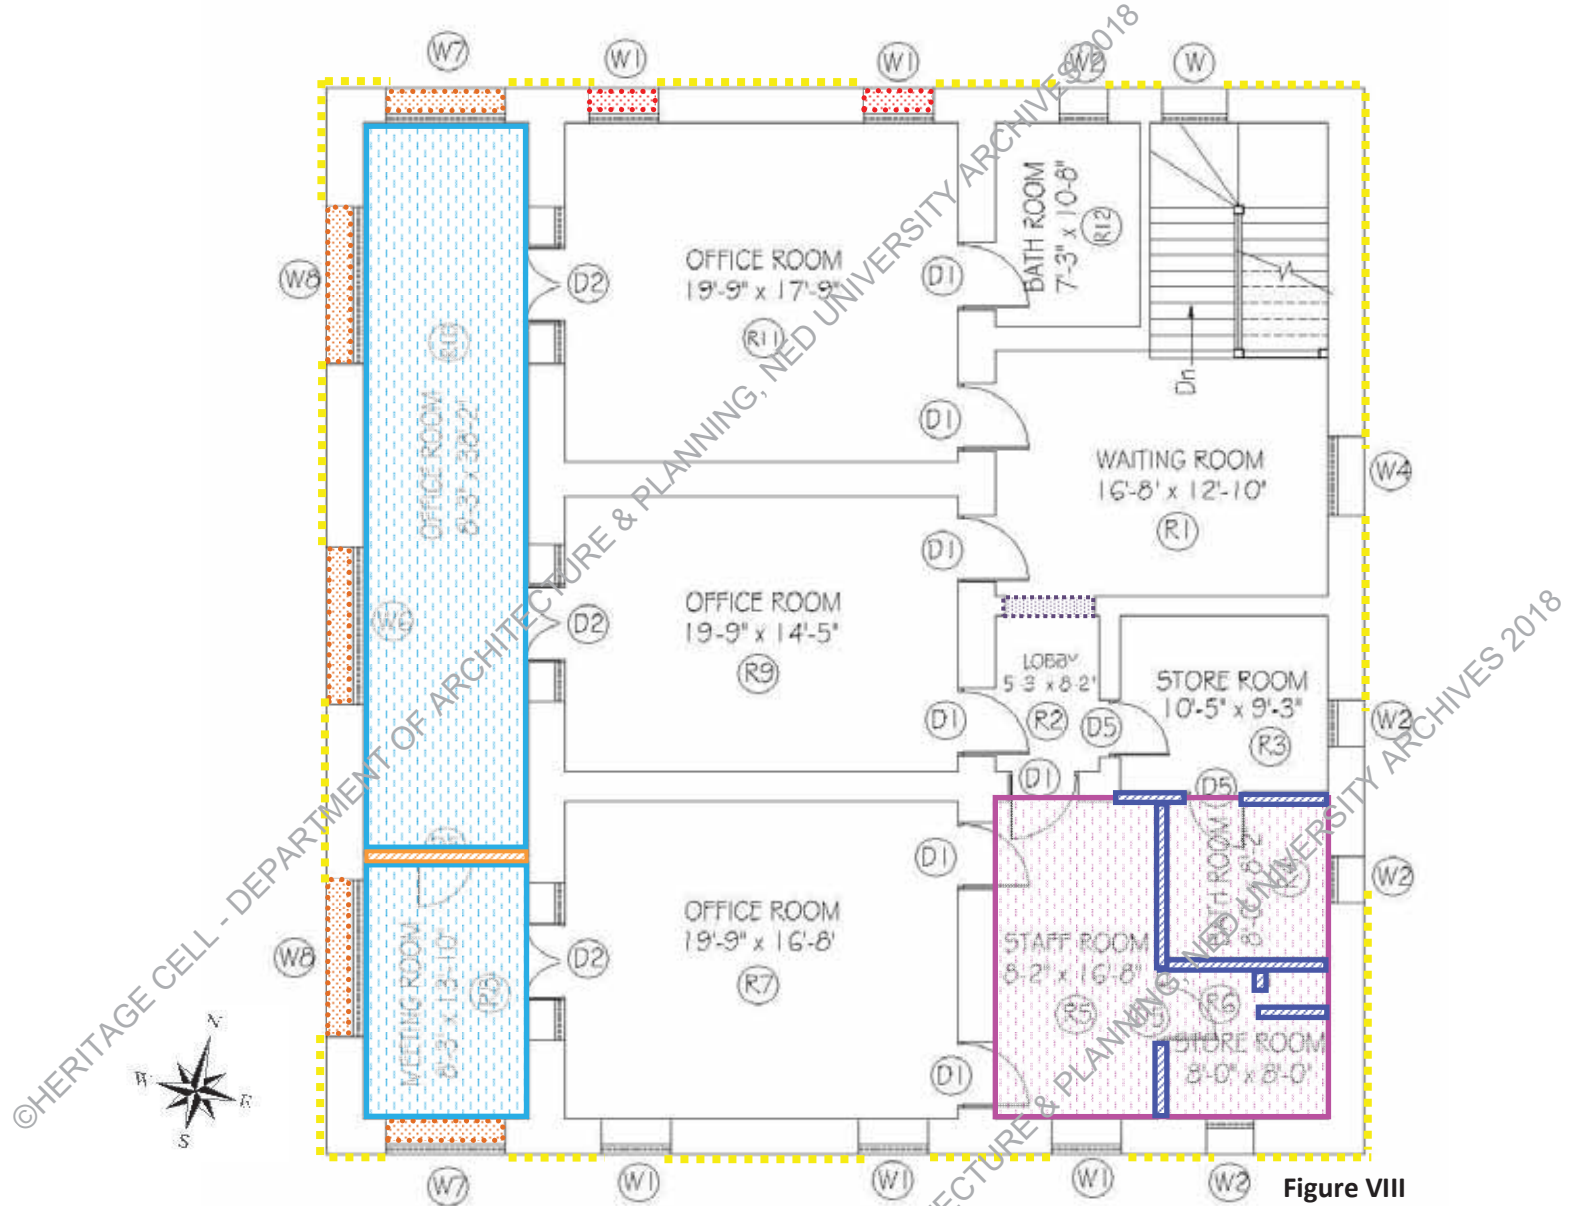
Both the verandahs have been converted into closed spaces probably to create an air conditioned environment. The stone parapets on both the floors have been filled in with cement mortar. On the external face of the first floor stone parapets netting is also fixed which creates an unsightly look on the exterior.

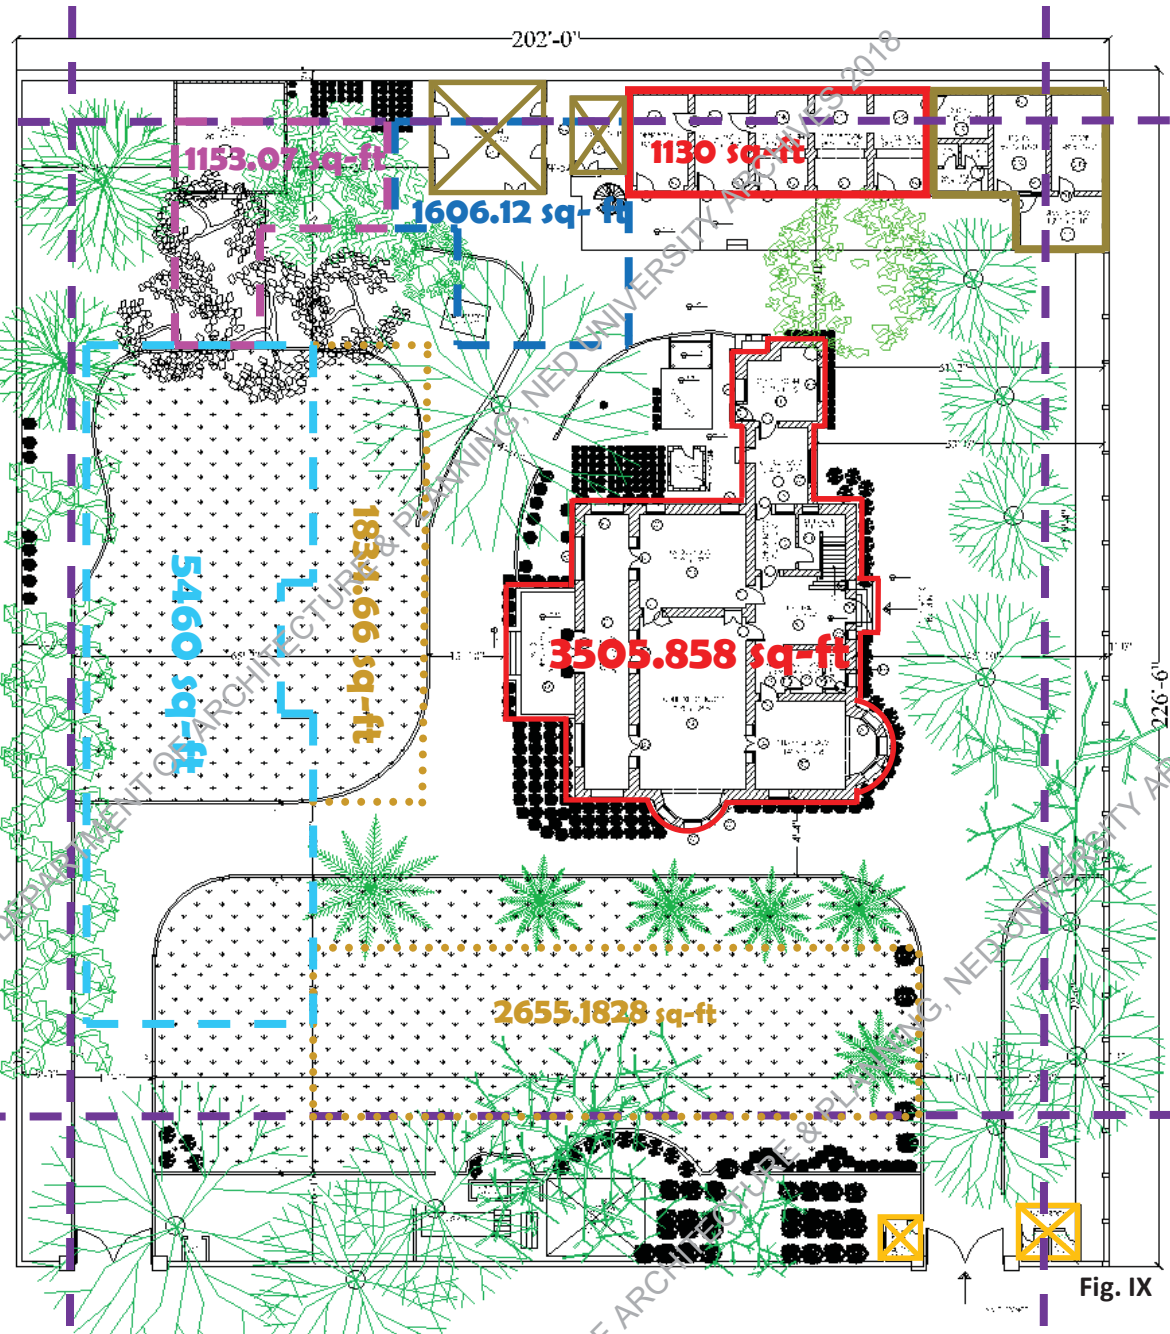
Fig. IX

- 7757.163 sq-ft opposite to the western elevation of the main building (marked with light blue color in fig. IX). The structure can go up to level of 3 floors; giving a total FAR of 23271.489 sq-ft. If required its basement area can be extended (as marked in ochre dotted lines) to add another 4489.1828 sq-ft area at the basement level.
- 1153.07 sq-ft in northern side (marked with pink color in fig. IX). FAR would be 3459.21 sq-ft, if the structure goes up to 3 floors.
- 1606.12 sq-ft in northern side adjacent to the out-house (marked with dark blue color in fig. IX). FAR would be 4818 sq-ft for 3 floors.

By adding the proposed new blocks the foot print of the built-up area (at ground level) will increase to 12855.048 ft², which makes 43.2% of the total area. The total FAR acquired would increase to a total of 36385.128 ft² which is 40.87% of total allowable FAR. The additional blocks proposed to be built on site cover a total area of 8219.2 sq-ft at ground level.
