Residence No. **3**

Haji Sher Mohammad Tibati Haveli
SHK-UC2-0461 (Enlistment No. 2012-UC2/465)

20/ 189, 190 Off Daiki Lane No. 2
UC2, Shikarpoor, Sindh.

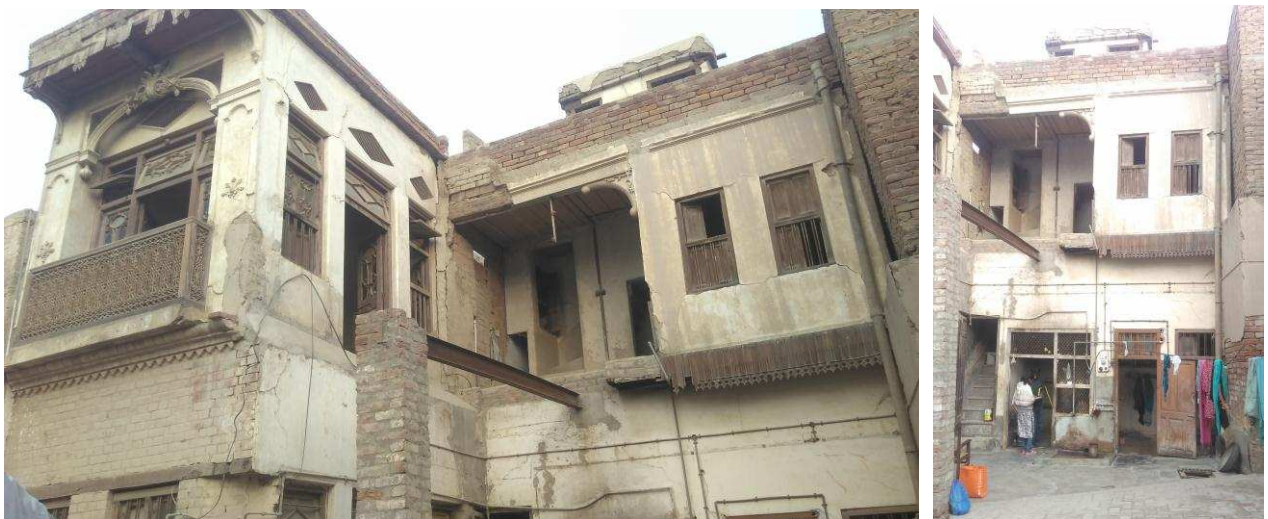
Fig: 17 – Images showing the courtyard on west side of the building, facing front façade of the building

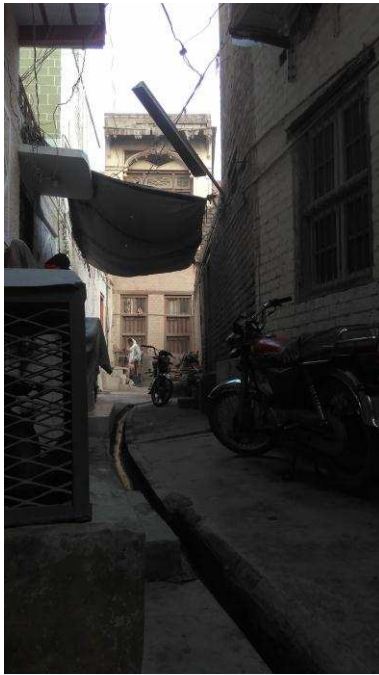
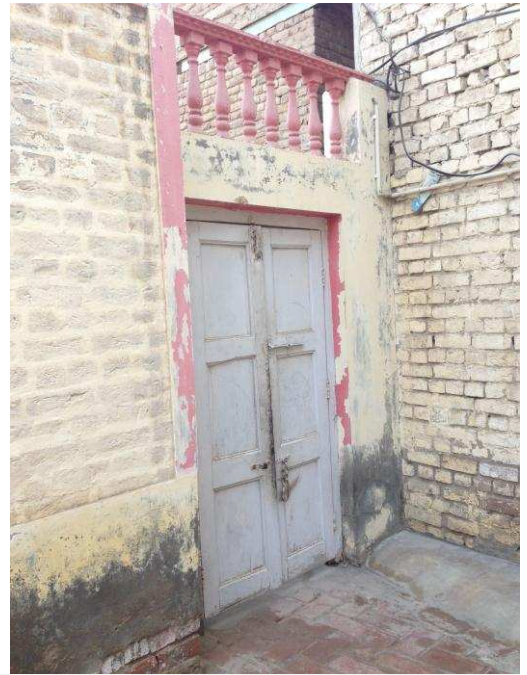
View of property from western side (left). Back side entrance from east side courtyard (right).

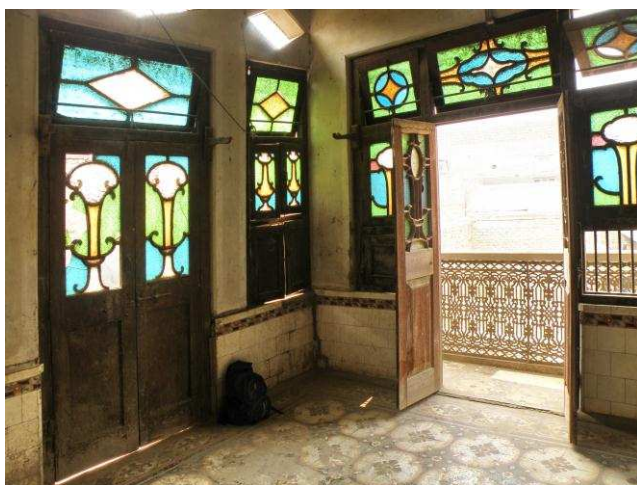
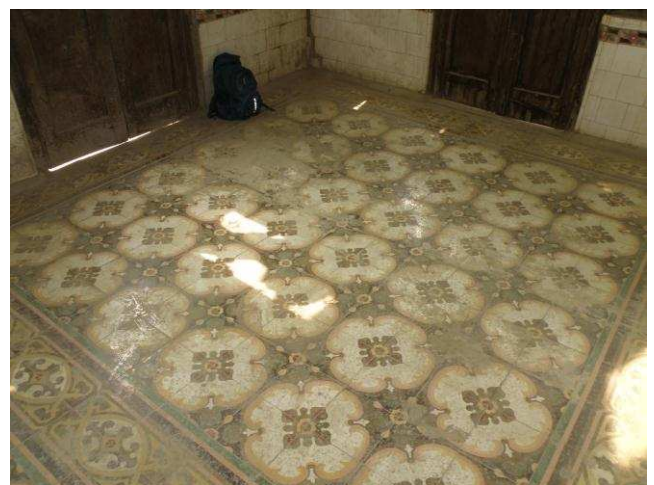
A wooden staircase with timber nosing of 1"x1" leads to first floor. The staircase opens at a mid level mezzanine supported by brackets. The wrought iron grill parapet has a design of floral patterns. This mid level is not in a stable state and needs urgent repairs. The first floor room is simple in design but has rich in surface decorations. The main hall that connects the rooms has a distinct form of flooring with borders and a big oval shaped motif in the center. The same hall has an open drainage gutter line running close to the edges of the walls. The walls of rooms on first floor are embellished with painted borders done in multi colored floral patterns. Each of the room has a different flooring pattern mainly done in pigmented cc tiles. Due to the small size of household and presently instable structural condition of first floor it is not much used by the inhabitants, evident from accumulated layers of dust depositions all over the walls and floors surfaces.

Interior views of the first floor room with a small balconnette
