Condition Assessment of Heritage Buildings - Karachi Declared as “Dangerous”

JUNE 2018

Structural Consultant

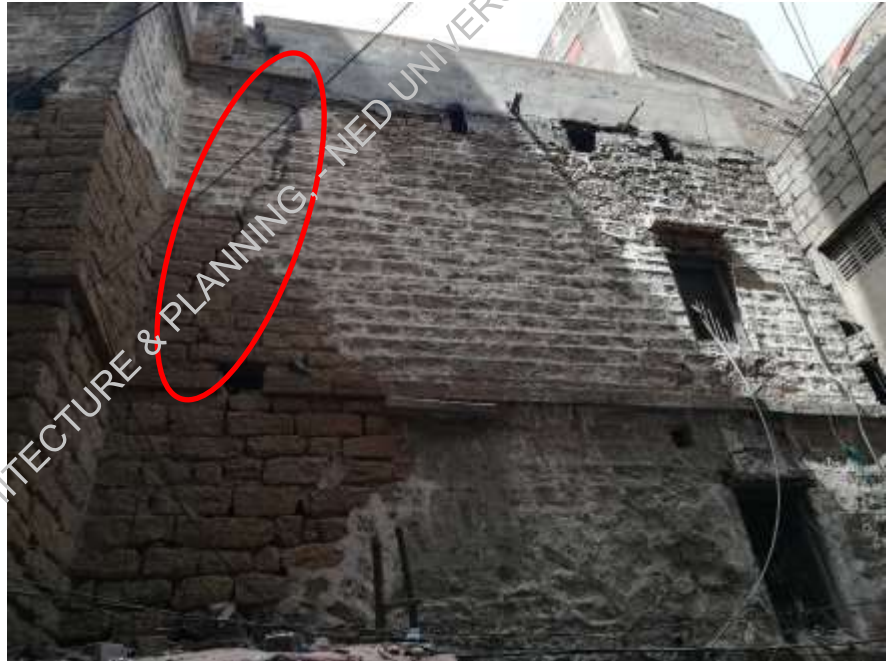
- On front façade, loose stone masonry can be noticed at a few locations and cracks were noticed on the first floor.
- Wide cracks were visible on front facade.

Plate-2: Wide cracks at the rear façade of building

- In existing condition, building structure is not stable and is susceptible to failure/collapse.
- Extensive strengthening is required to make the structure stable. Strengthening measures to be done with careful methodology which will include propping of existing walls/floors before proceeding with any strengthening technique.
- Interventions should be removed such as the additional floor on top and extra floor finishes where present, to decrease the dead load on existing walls,
- Strengthening techniques can be adopted, including but not limited to;
 - a. Pointing of mortar in existing stone masonry joints,
 - b. Application of mesh plaster
 - c. Introducing internal mild steel frame within the building to secure the occupants from fatal damages

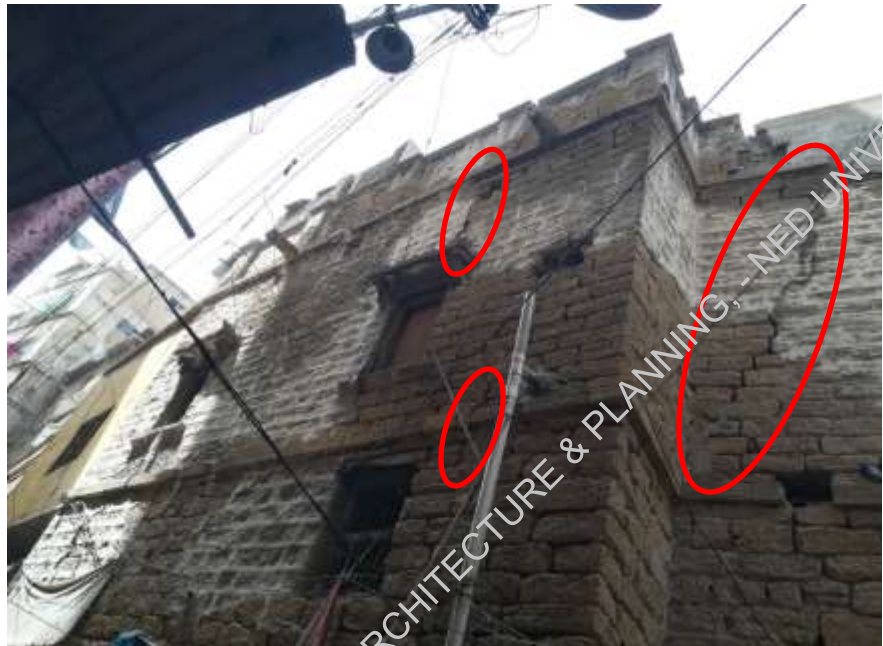
Plate-3 Right side

- The building is spread over wide area.
- Two floors had been added on top roof.
- It was observed that from entrance the left portion is tilted on left side and right side is tilted towards right side.

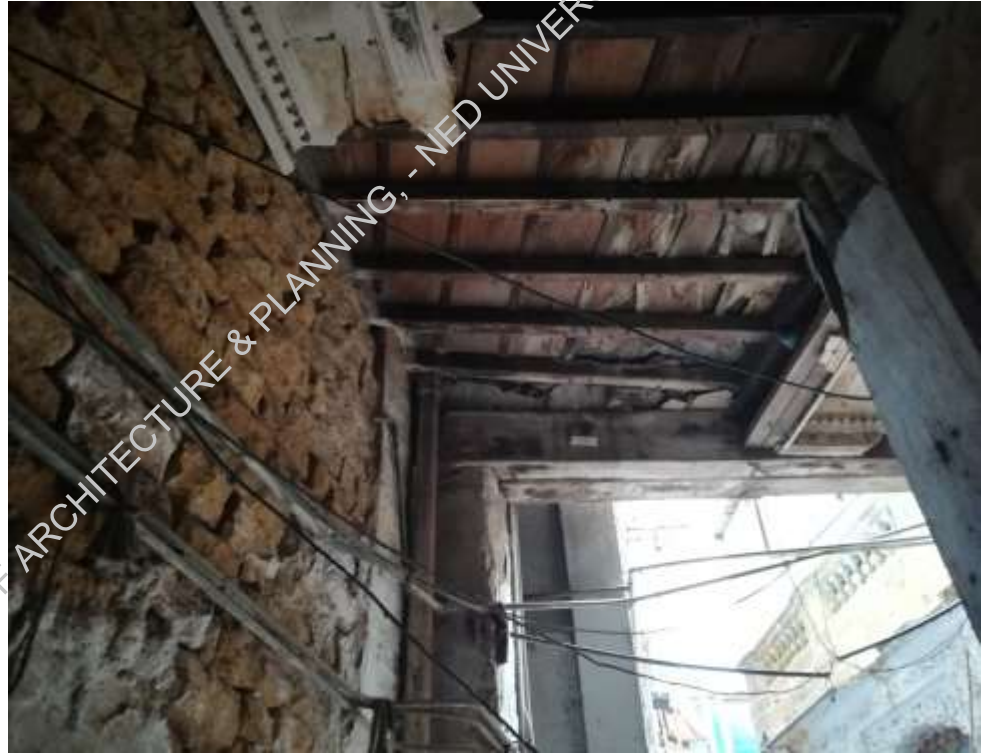
- Load Bearing Stone wall is a typical construction type followed.
- In most of areas, reinforced concrete floor laid later on, was found in bad condition with concrete cover fallen off. Refer Plate-4, 5, 6 & 7.

Plate-4: Timber slab in bad condition.

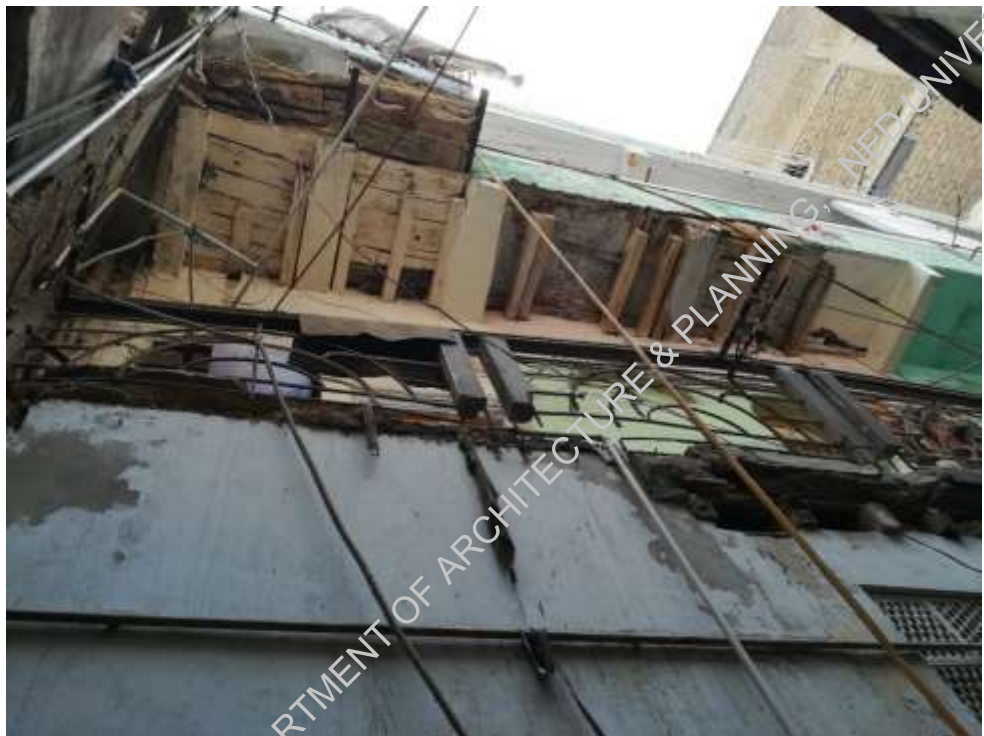
Plate-5: Concrete construction done later on, in bad condition

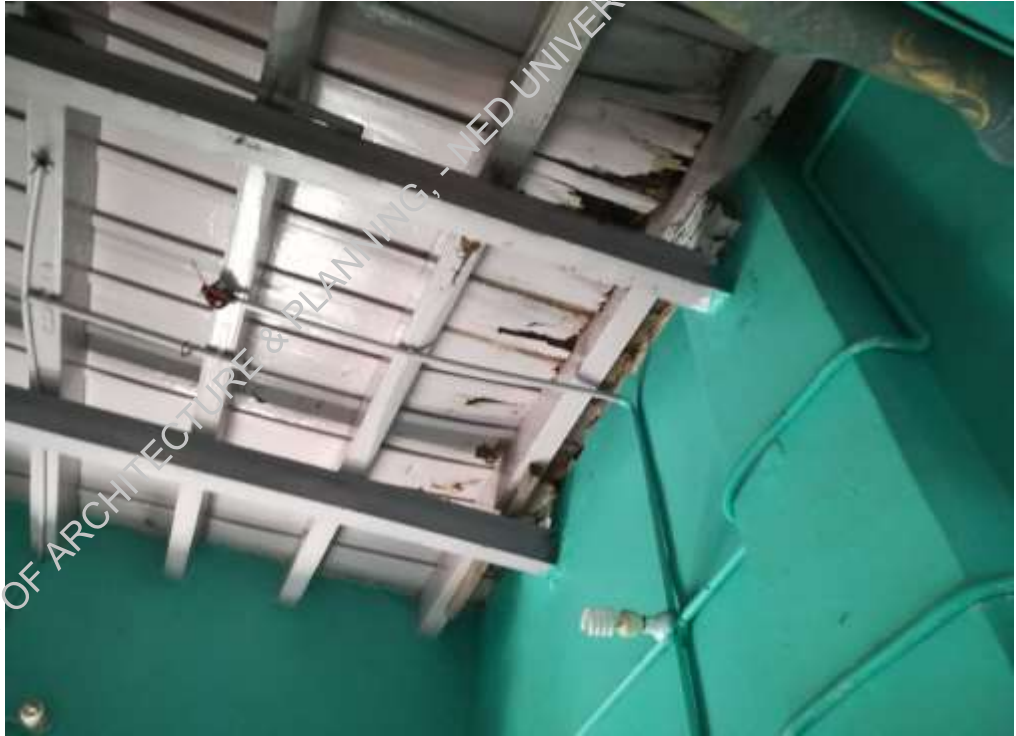
Plate-6: Deformed timber slab resting on MS beams installed at later stage.

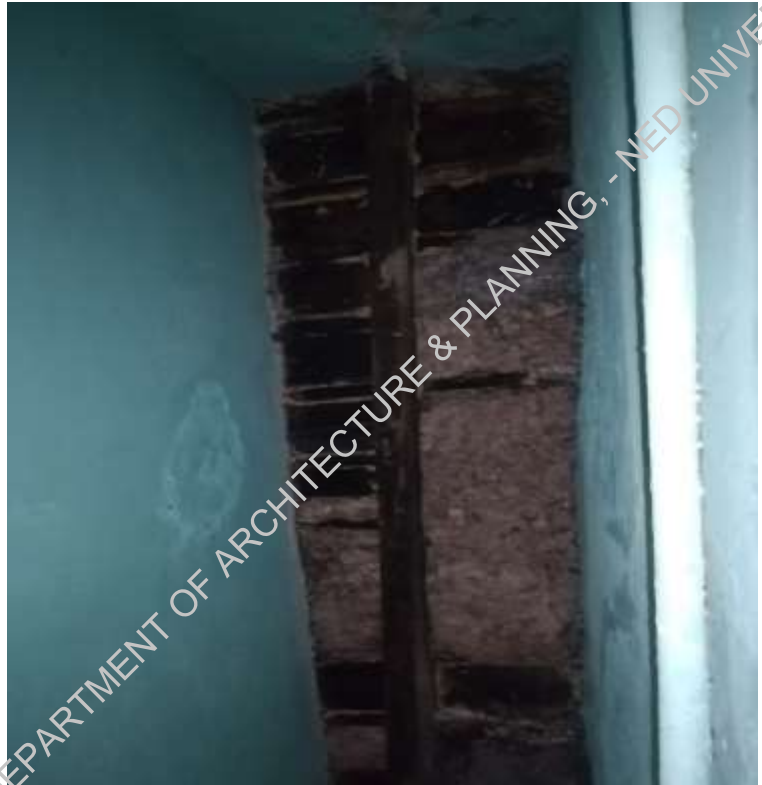
Plate-7: Bad condition of roof slab due to seepage.

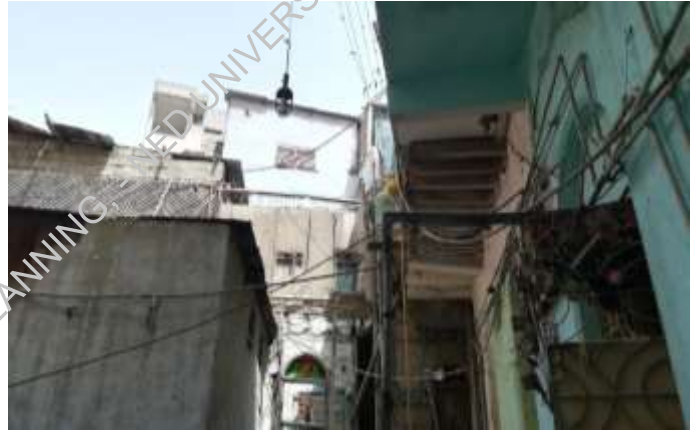
- In central courtyard, Reinforced concrete construction, which was done later-on, was found in bad shape. The rebar is exposed. (Refer Plate 8 and 9)
- The ground floor is partially occupied by shop keepers doing cloth dying works the effects of seepage and different colors and chemicals used were also evident.

Plate-8: Central court being turned into RCC construction

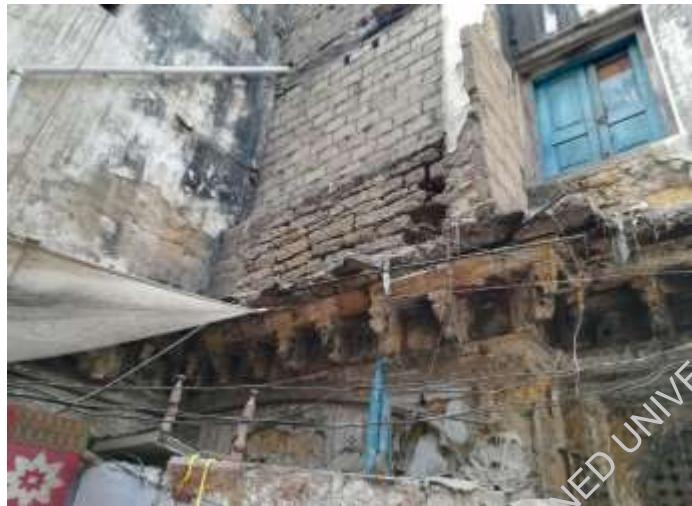
Plate-9: Bad condition of stone and RCC structure

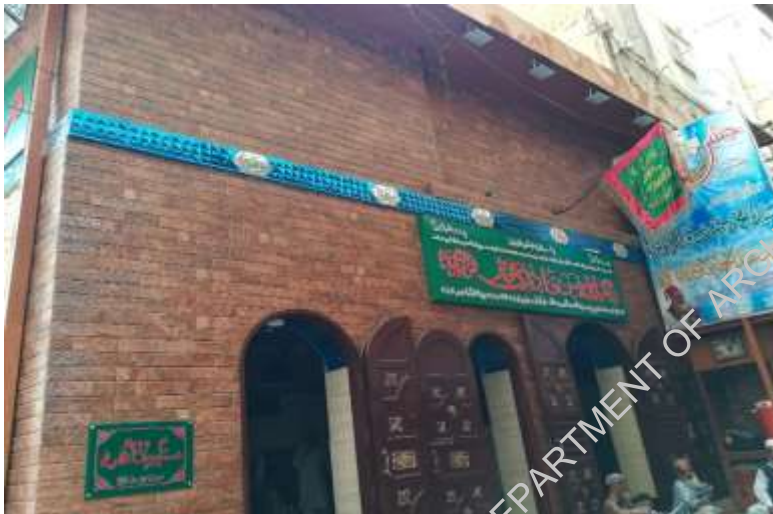
Plate-1: Front Façade- proper tiling works

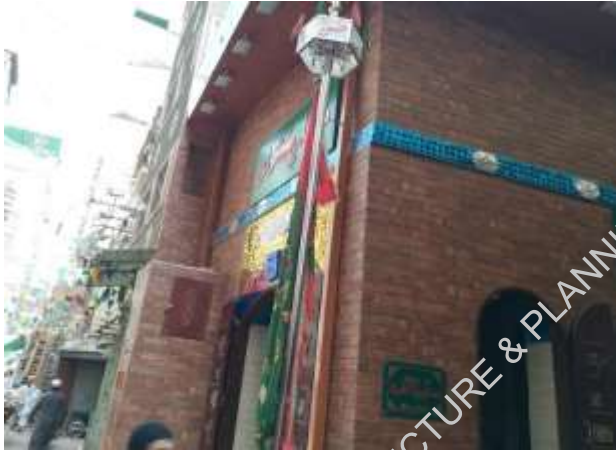
Plate-2: side view all stone is covered with tile works

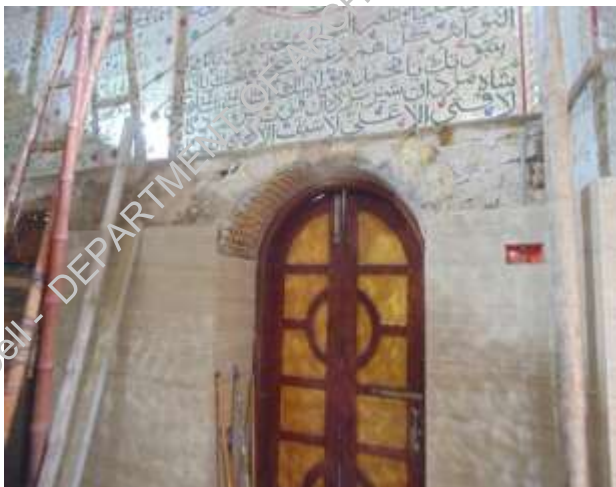
Plate-4: During-Construction view

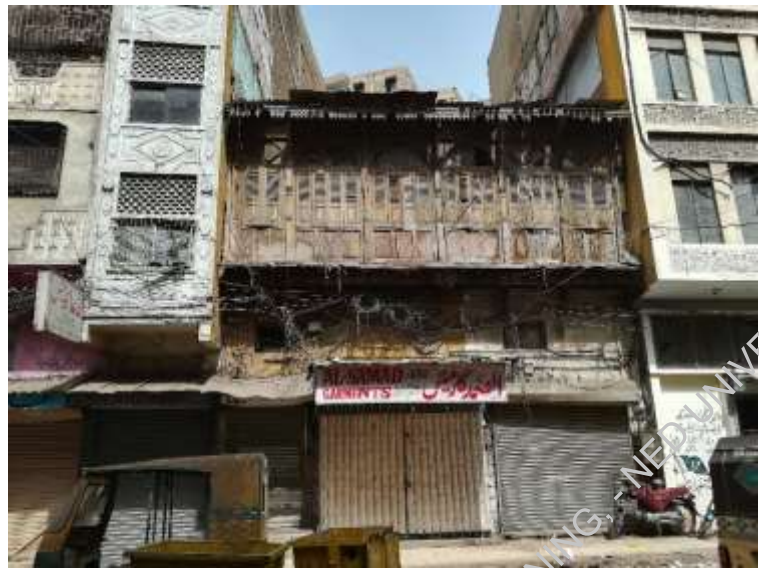
- The original building used to be ground plus 3 stories, whereas additional roof was also in partial use. Refer Plate-1 for picture taken in 2007.
- The top floors were demolished by the residents recently. it appears that first floor is vacant. Refer Plate-2
- Building could be observed only from outside as it was inaccessible.
- Rear part of building appeared collapsed Refer Plate-3.
- From the back side of the building the stone seems to be loose and material has been filled in places to keep it intact. Refer Plate- 4.
- On front façade, loose stone masonry can be noticed at locations.

Plate-2: Front Façade- after demolition

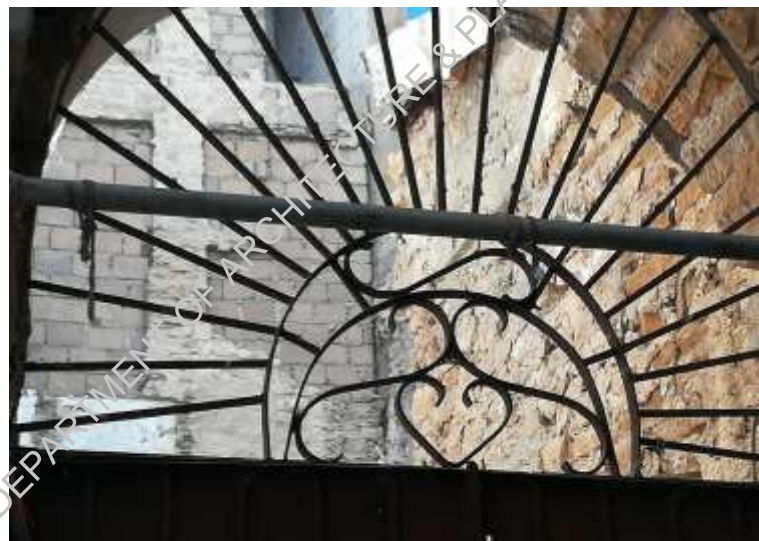
Plate-3: rare view shows apparent demolition

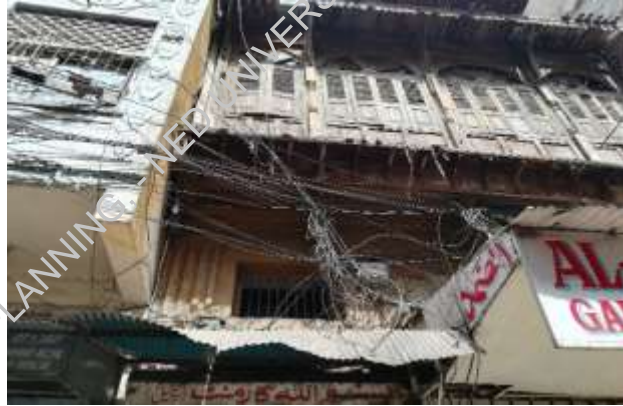
- First floor balcony is made of wood. The front projection seems to be deflected and the edges are broken. The brackets of projection are as per original construction but due to lack of maintenance they are in bad condition. Refer Plate-5 & 6
- Intervention appears to be limited to ground floor shops.

Plate-5: original wooden façade

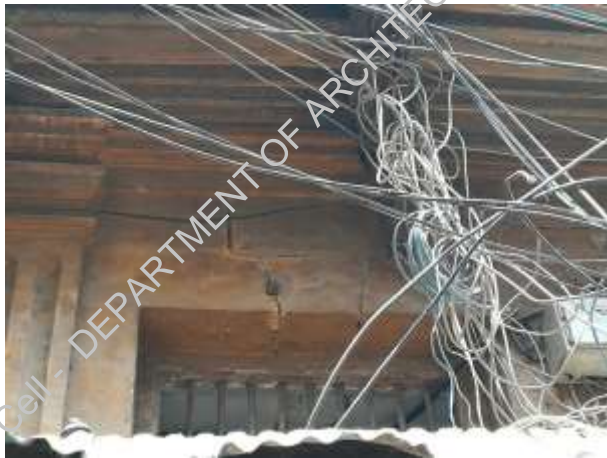
Plate-6: cracks observed

- In existing condition, partially collapsed building structure appears in non-workable condition.
- Moderate strengthening might be enough to make structure safe and workable for ground plus one story.
- Building could not be observed from inside, hence strengthening level suggested is based on visual inspection of façade only.
- Strengthening measures to be done with careful methodology which will include propping of existing walls/floors before proceeding with any strengthening technique.
- Interventions if present inside, should be removed
- Strengthening techniques can be adopted, including but not limited to;
 - a. Pointing of mortar in existing stone masonry joints,
 - b. Application of mesh plaster;
 - c. Introducing internal mild steel frame within the building to secure the occupants from fatal damages.

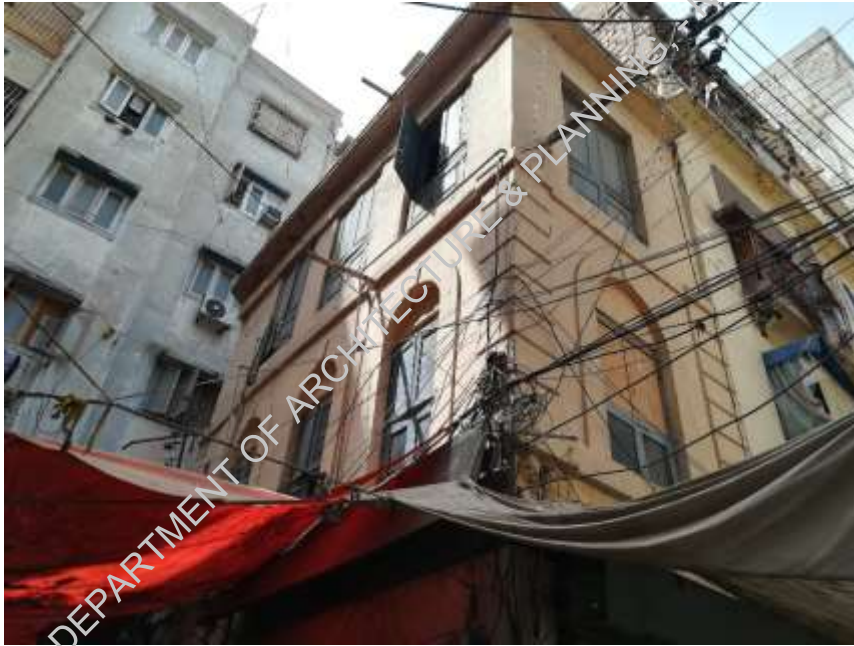
- The original building is ground plus two stories, no intervention at roof level was observed. Refer Plate-1.
- On front façade, horizontal cracks at top roof were observed in beam at lintel level and the slab projection. The stone wall seems to be intact. Refer Plate-1 & 4.
- Side elevation has a vertical crack generating from bottom and extending to the top story. Crack is at the joint of two adjacent buildings.
- The crack is almost 1” wide separating the building from its neighboring structure.

Plate-1: Front Façade- loose stone masonry can be noted at many places. Additional floor on top is also visible

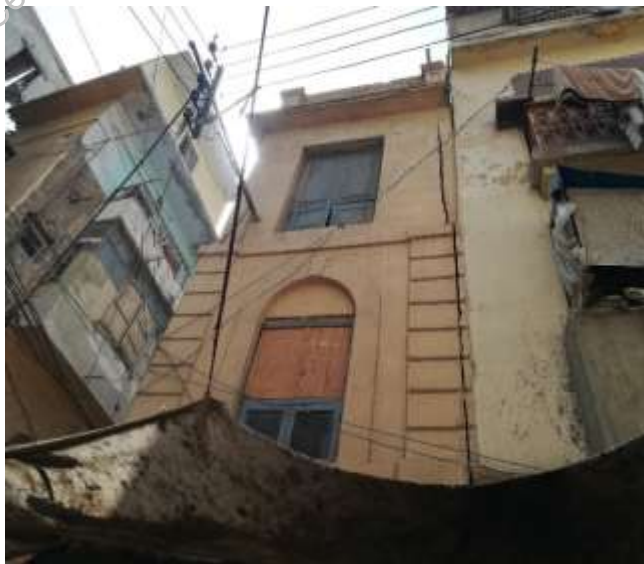
Plate-2: Vertical separation cracks at the right-side façade of building observed at rear side

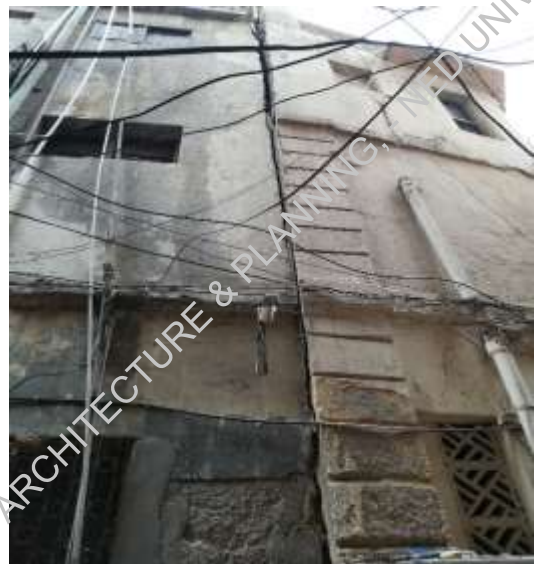
- Building is slender and appears to have tilted outwards creating gap with adjacent building.
- Shops are being made on ground.
- The building was inaccessible from inside and could be observed from outside only.

Plate-3: Separation of Building

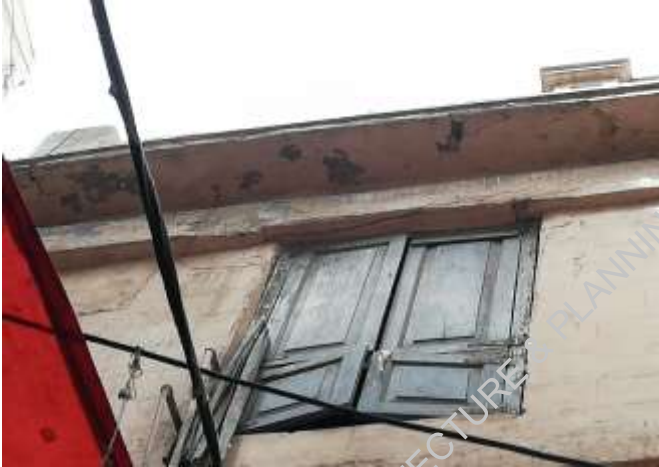
Plate-4: reinforced concrete slab in bad condition.

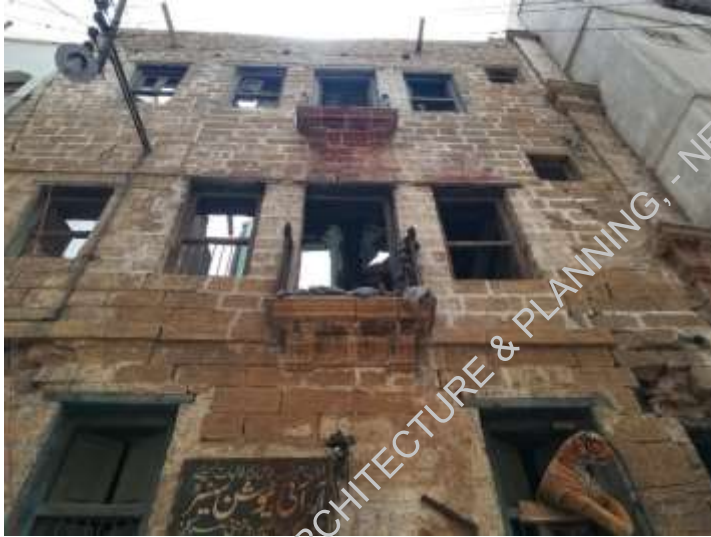
- The original building was ground + 3 stories. Refer Plate-1.
- On front façade, loose stone masonry can be noticed at many locations.
- Most floors have been collapsed leaving façade wall only.
- Few areas appeared to have been affected by fire.
- Termite infestation was also noticed a few places.
- In staircase area, which had collapsed, original timber construction for flooring was observed. Refer Plate-4.
- In central courtyard, Reinforced concrete construction could be noticed.

Plate-1: Front Façade- loose stone masonry can be noted at many places. Additional floor on top is also visible

- In existing condition, building facade is not stable and is susceptible to failure/collapse.
- Extensive strengthening is required to make the façade stable.
- New Building structure inside will have to be constructed to join façade and make it stable.

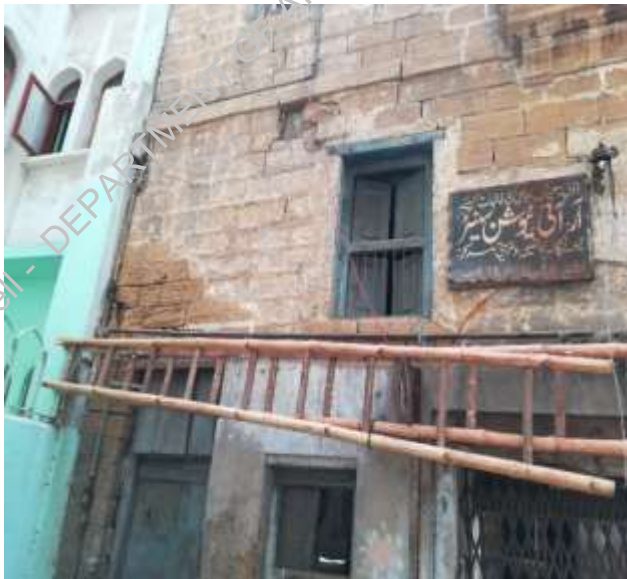
Plate-3: left side close up view of front façade

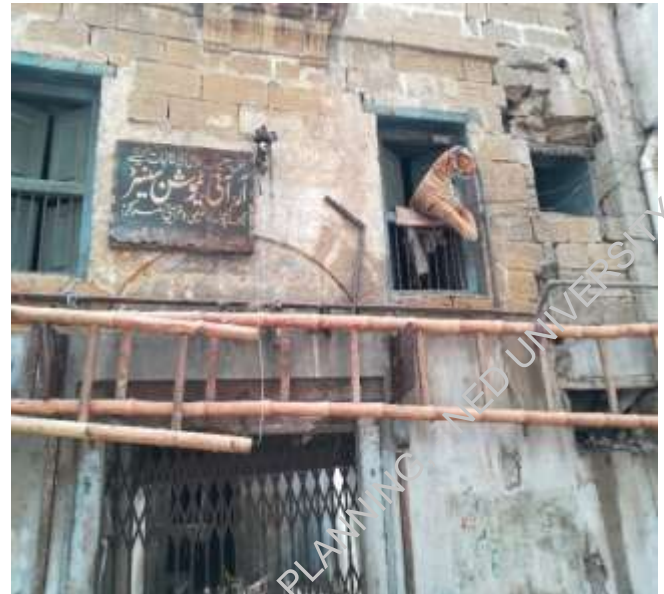
Plate-4: right side close up view of front

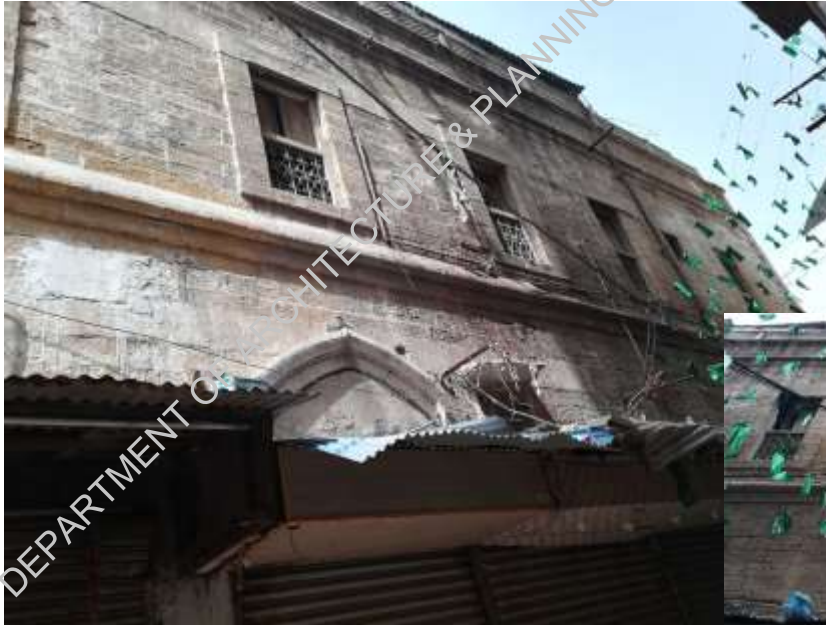
- The original building is ground + 1 story with partial intervention on roof. Refer Plate-1.
- The ground floor is of 16ft clear height.
- Remains of arches are present where now shop shutters are being made.
- On front façade, stone masonry seems intact. Localized lintel shows sign of distress.
- Mortar of stone is being repaired in few locations.

Plate-1: Front Façade- loose stone masonry can be noted at places. Additional floor on top is also visible

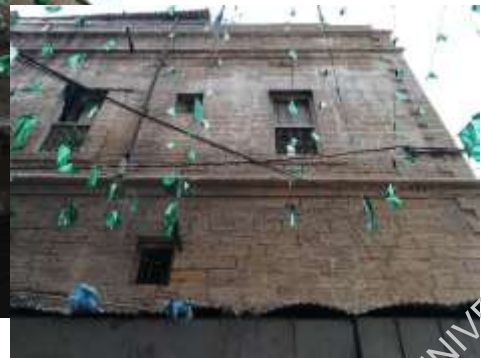
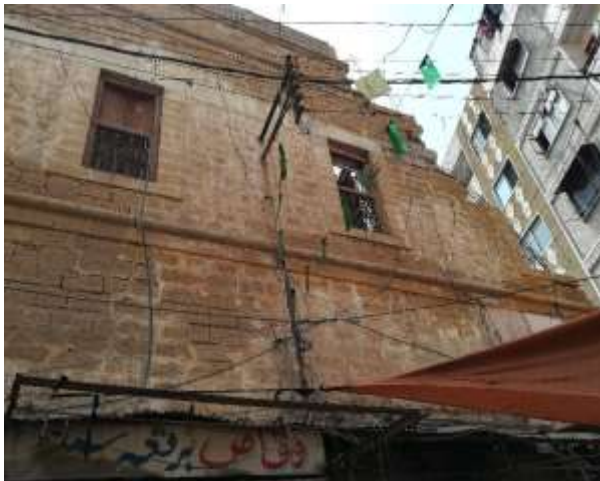
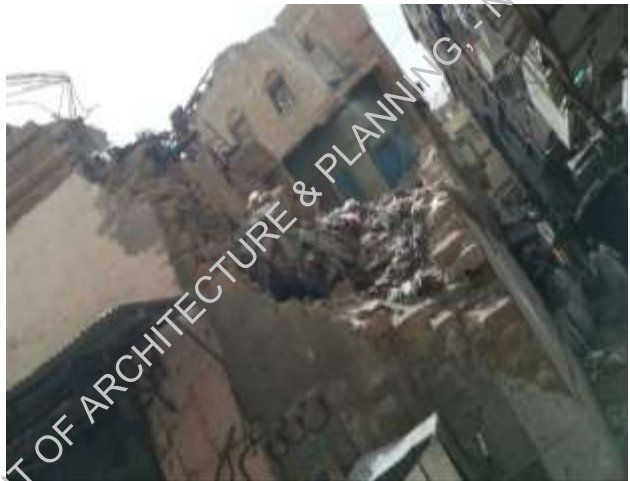
- Right side elevation has a long diagonal crack.
- Rear part of building is collapsed. Refer Plate-3.
- Vertical cracks from side can be seen. The resident from neighbor claim that the debris is still falling off.

Plate-2& 3: side façade of the building collapsed

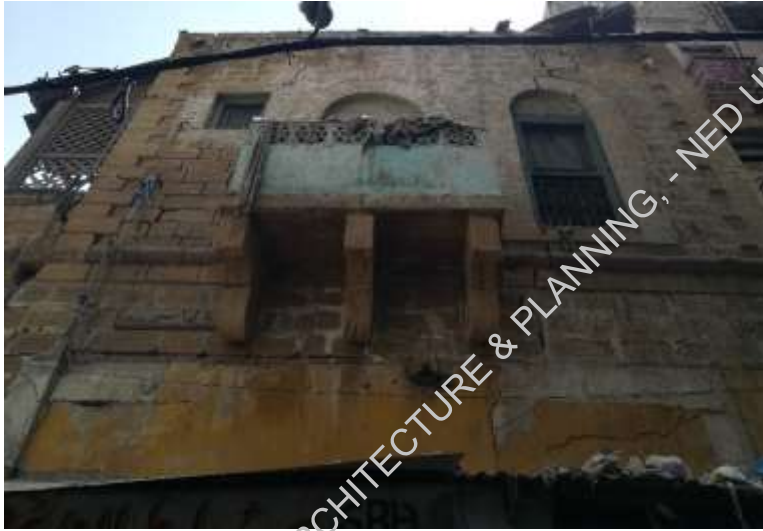
Plate-4: projection and bracket in original condition

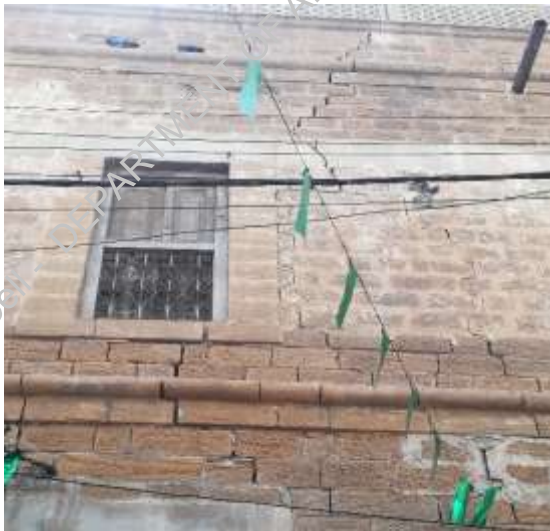
Plate-5: vertical cracks on both floors in façade

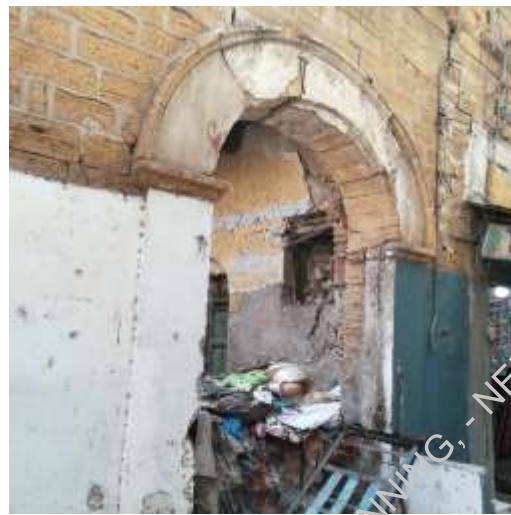
Plate-6: Cracks around the arch

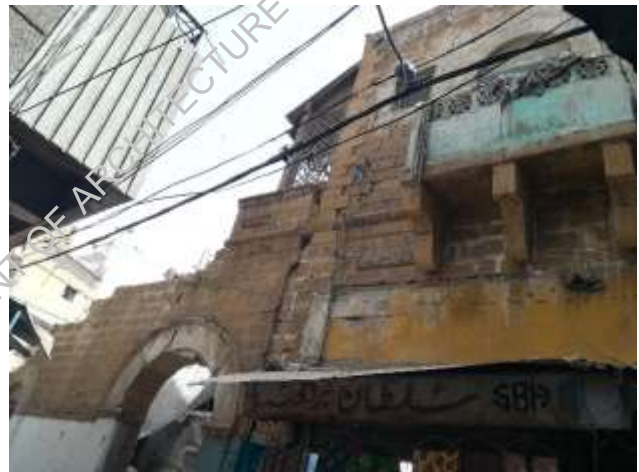
Plate-8: Cracks at location of collapse

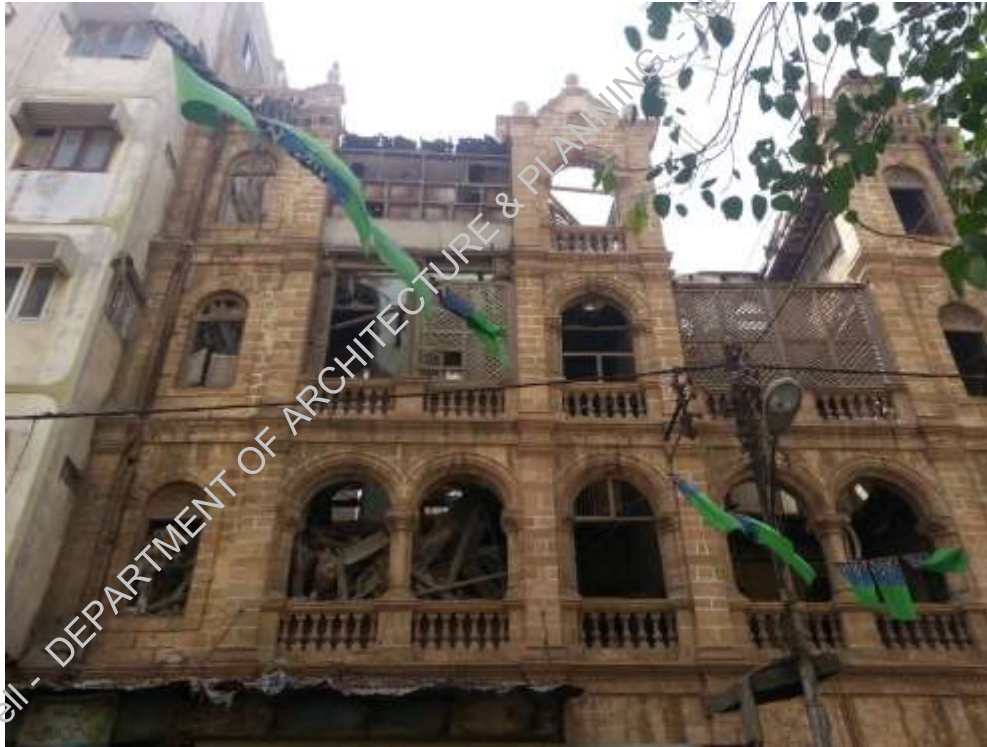
- The original building is ground plus two stories with partial third story intervention. Refer Plate-1.
- On front façade, stone masonry seems to be crumbling at places.
- Rear part of building has deteriorated extensively.

- Building could be observed from outside only.
- Internal floors have been collapsed. Refer Plate-3.
- Timber beam and wooden slab is in bad condition. Refer Plate-1 to 4.

Plate-1: Front Façade- loose stone masonry can be noted at many places. Additional floor on top is also visible

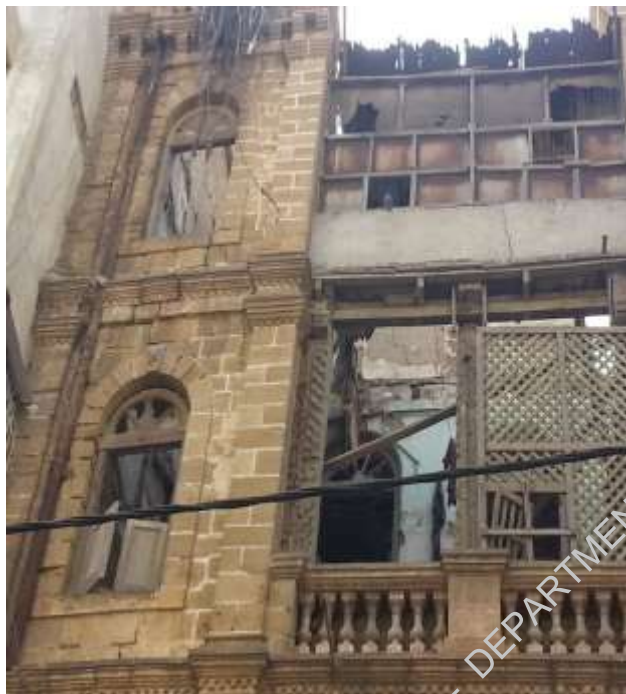
Plate-2: Wide cracks at the façade of building

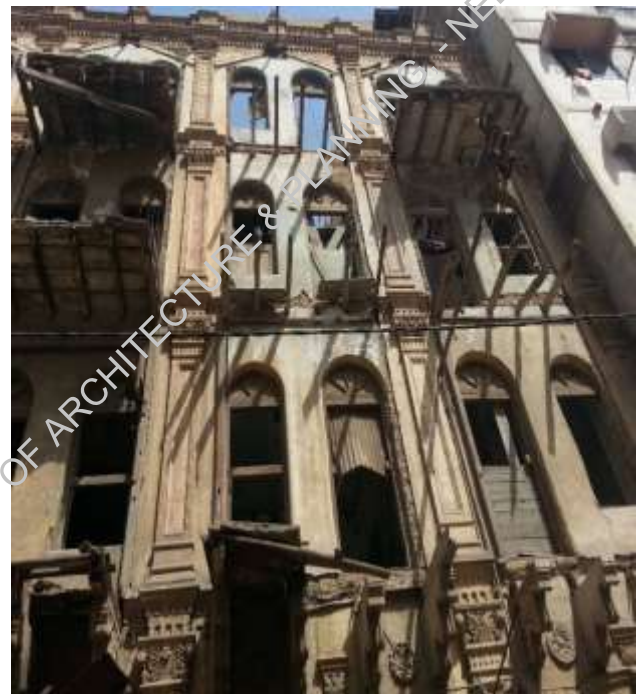
Plate-3: Rear side

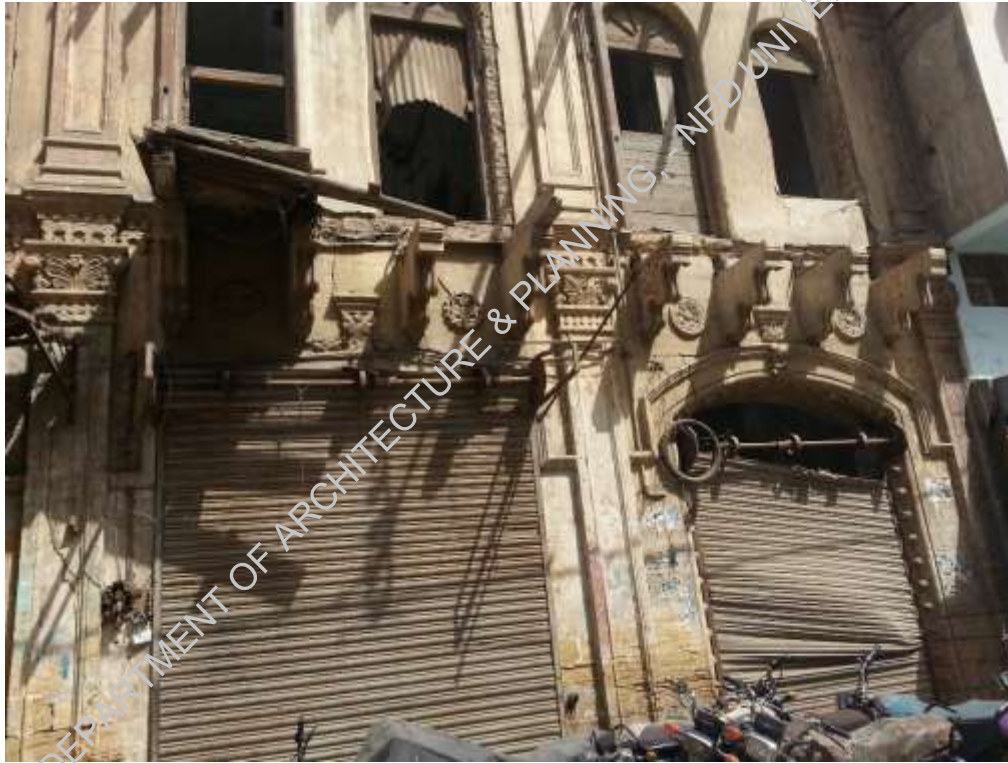
*Plate-6: broken
projections*

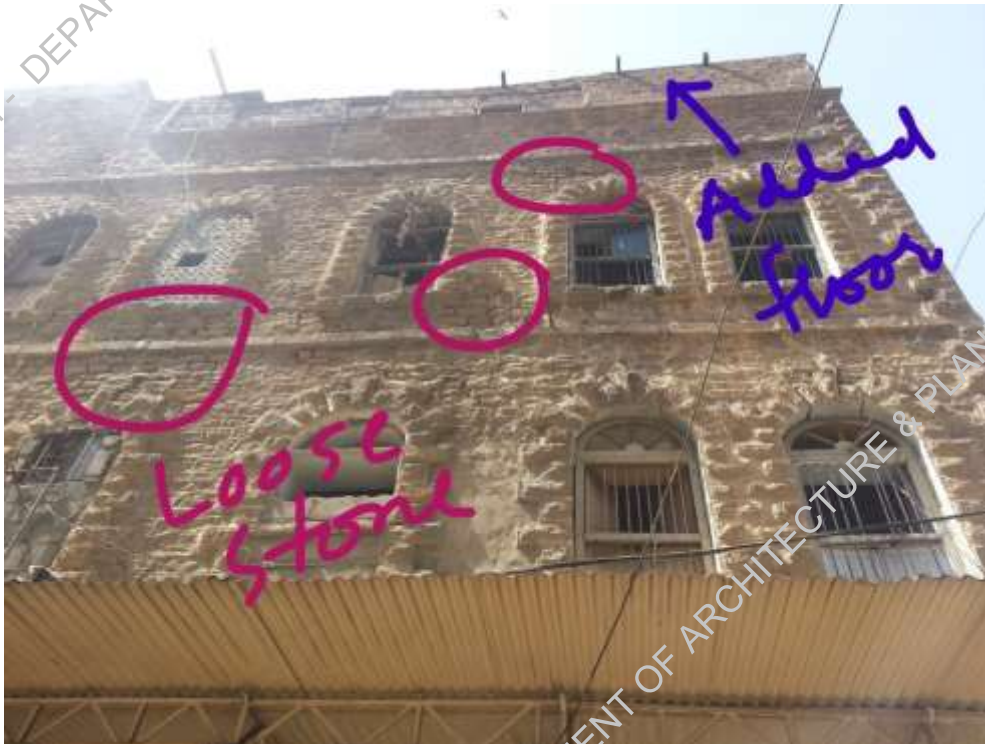
- On front façade, loose stone masonry can be noticed at many locations.
- Rear part of building was collapsed showing interventions at floor levels of building from first floor and onwards. Refer Plate-3.

Plate-1: Front Façade- loose stone masonry can be noted at many places. Additional floor on top is also visible

- In existing condition, building structure is not stable and is susceptible to failure/collapse.
- Extensive strengthening is required to make the structure stable. Strengthening measures to be done with careful methodology which will include propping of existing walls/floors before proceeding with any strengthening technique.
- Interventions should be removed such as the additional floor on top and extra floor finishes where present, to decrease the dead load on existing walls,
- Strengthening techniques can be adopted, including but not limited to;
 - a. Pointing of mortar in existing stone masonry joints,
 - b. Application of mesh plaster
 - c. Introducing internal mild steel frame within the building to secure the occupants from fatal damages.

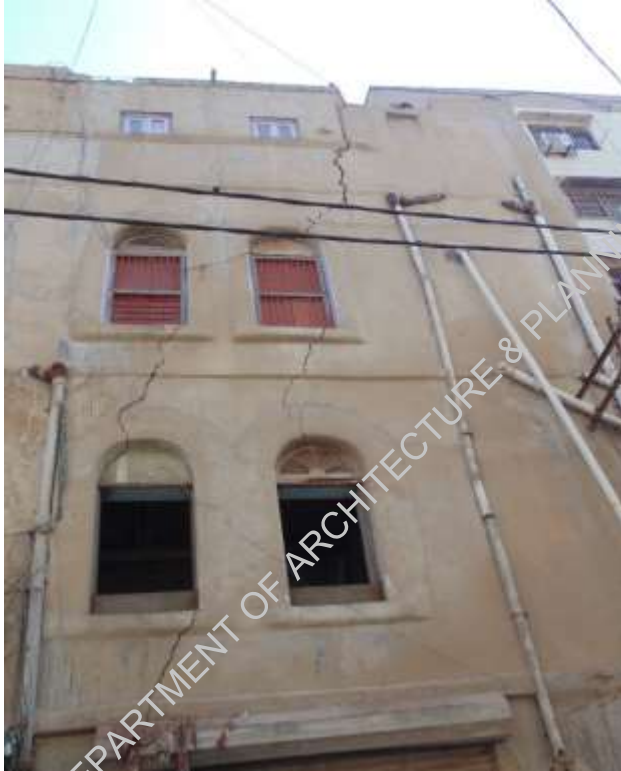
- Comparison of Plate-2 and 3 clearly demonstrates the failure pattern of rear side. Wide cracks were visible (Refer Plate-2) along which failure happened later on.

Plate-2: Wide cracks at the rear façade of building before collapse

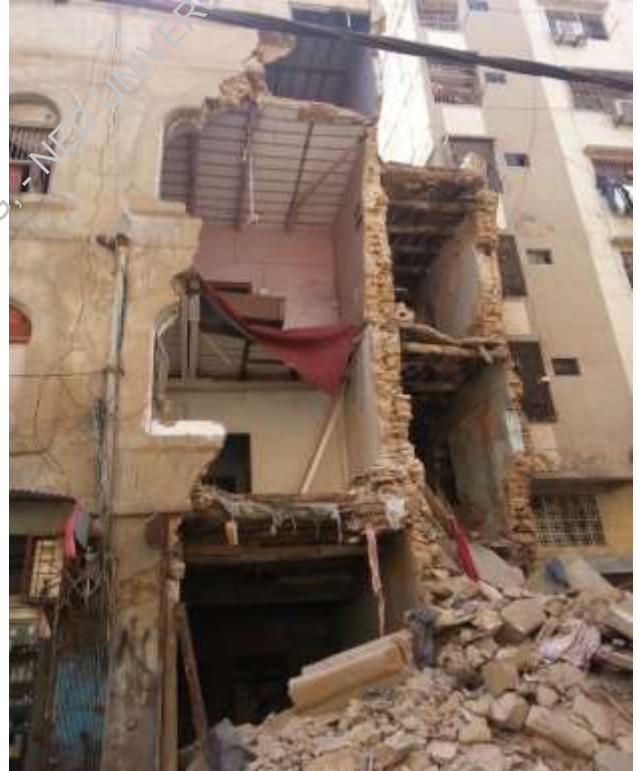
- Load Bearing Stone wall is a typical construction of double-Wythe stone wall with small rubble stone in middle.
- In staircase area, which had collapsed, original timber construction for flooring was found. Refer Plate-3.

Plate-3: After collapse of rear side

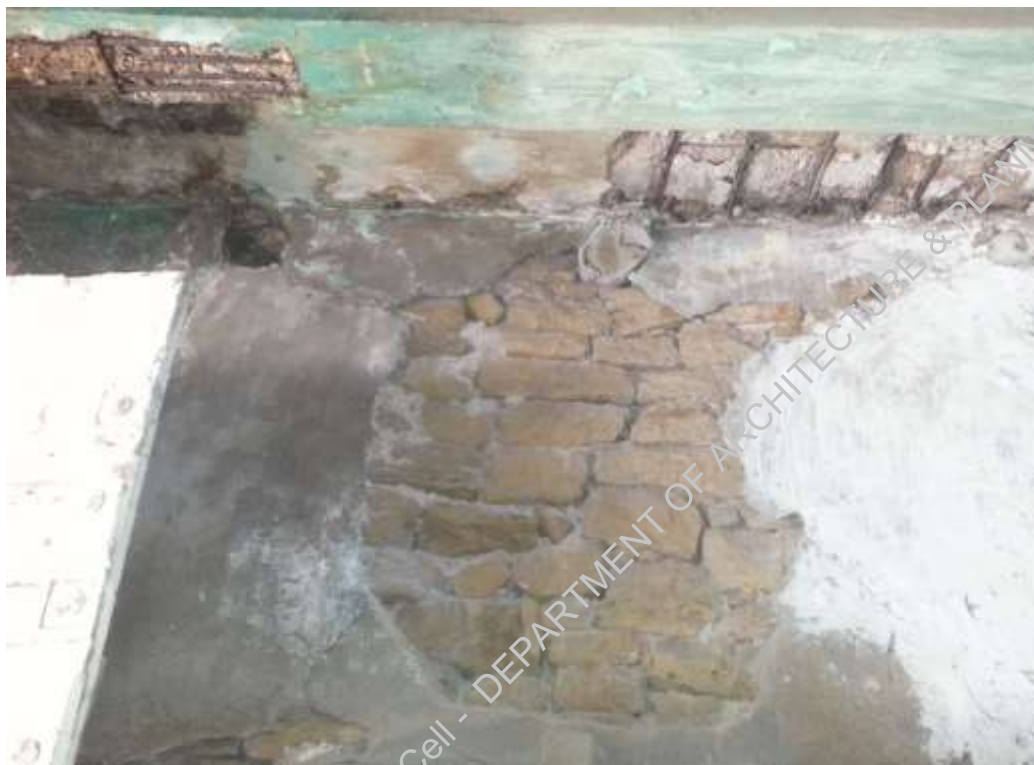
- In most of areas, reinforced concrete floor laid later on, was found in bad condition with concrete cover fallen off. Refer Plate-4, 5, 6 & 7.
- In central courtyard, Reinforced concrete construction, which was done later-on, was found in bad shape. (Refer Plate 8 and 9)

*Plate-6: Loose
stone masonry is
visible*

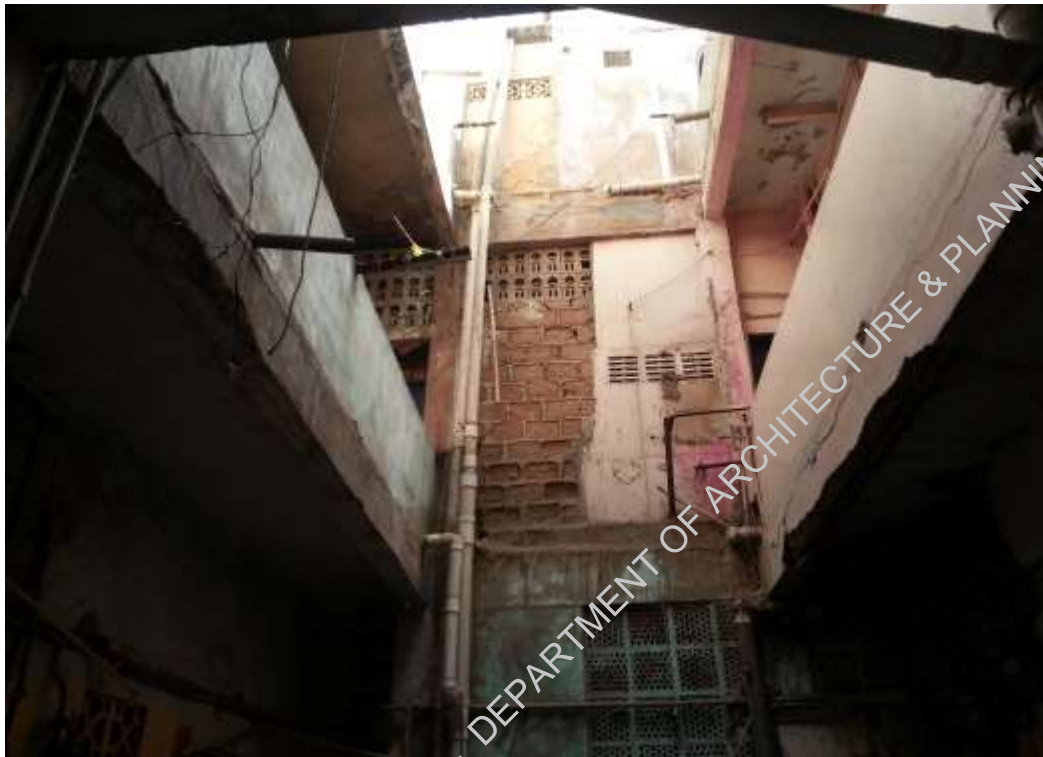
Plate-8: Central court being turned into RCC construction

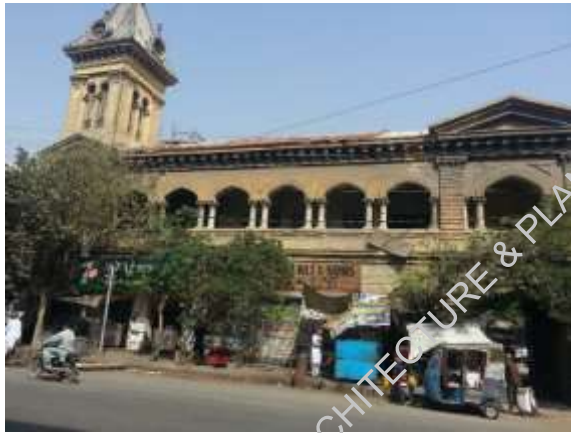
- Building appears to be in good condition. Refer Plate-1, 2
- Termite infestation was observed at a few locations. Refer Plate-6
- Floor decking is also in good condition.

Plate-1: Front Façade

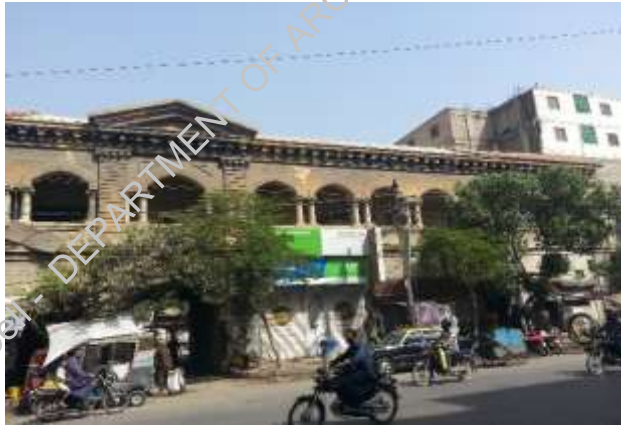
Plate-2: Other view of Front Façade

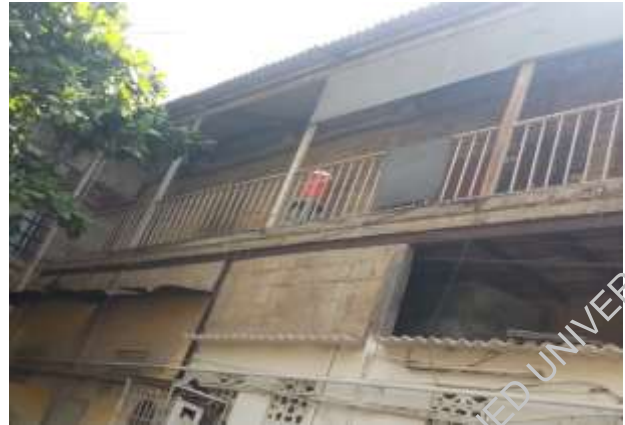
Plate-3: Left side façade

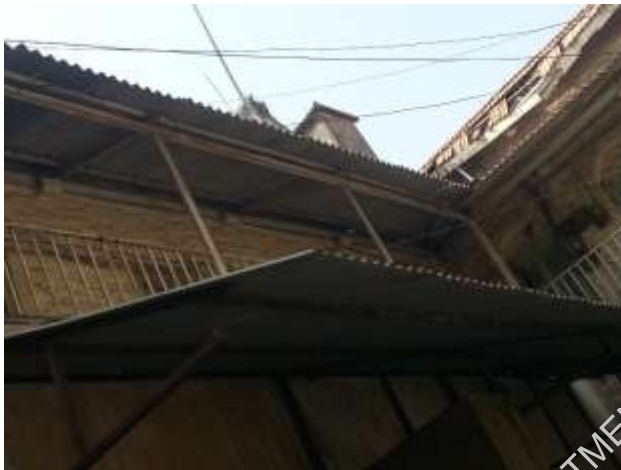
Plate-4: Projection inside the court yard

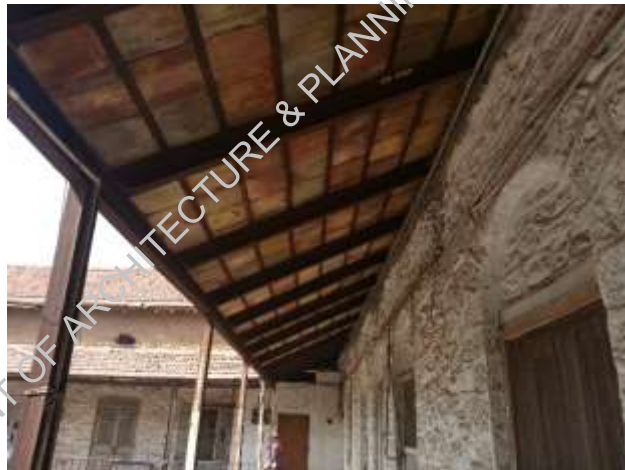
Plate-5: Original projection still intact in place

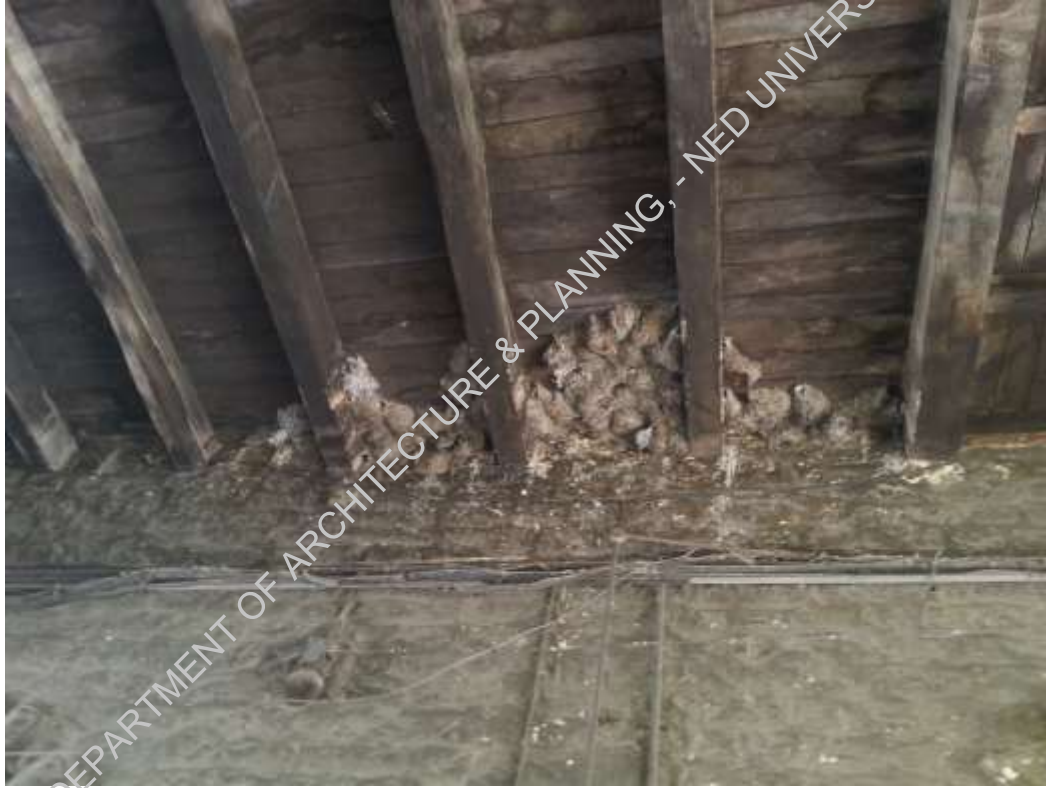
*Plate-6:
Termite
infestation near
main entrance.*
