Condition Assessment of Heritage Buildings - Karachi Declared as “Dangerous”

JUNE 2018

Structural Consultant

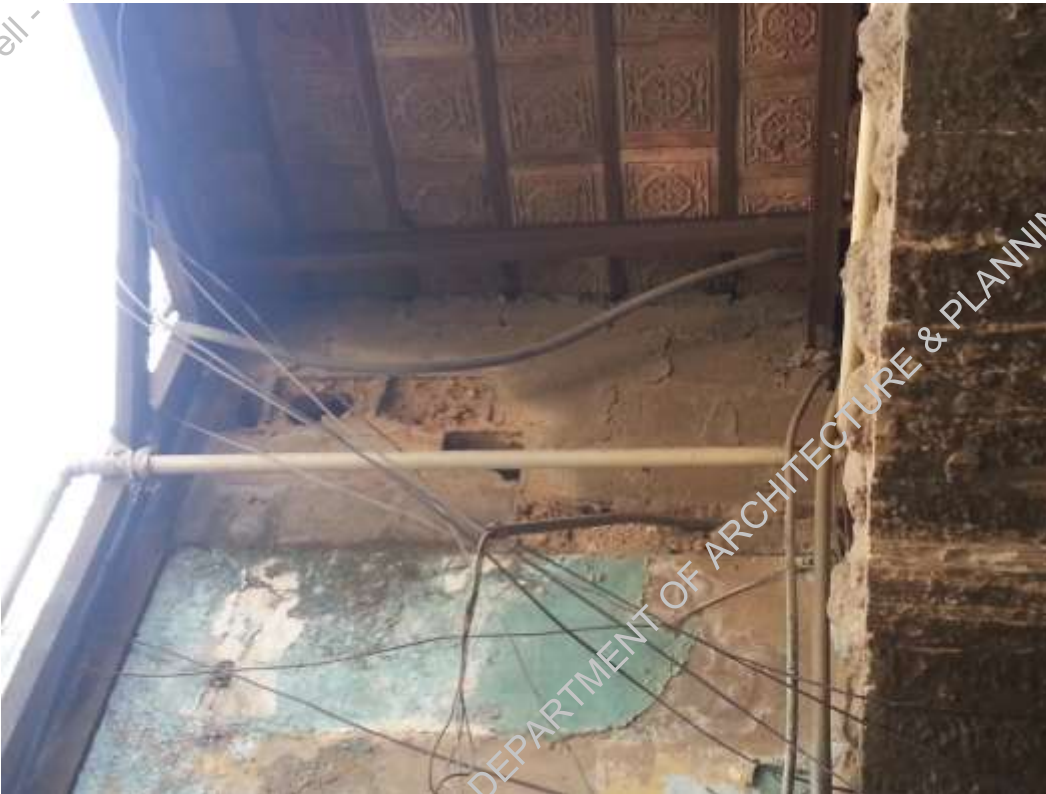
*Plate-7: Stone
masonry being
punctured for
various reasons*

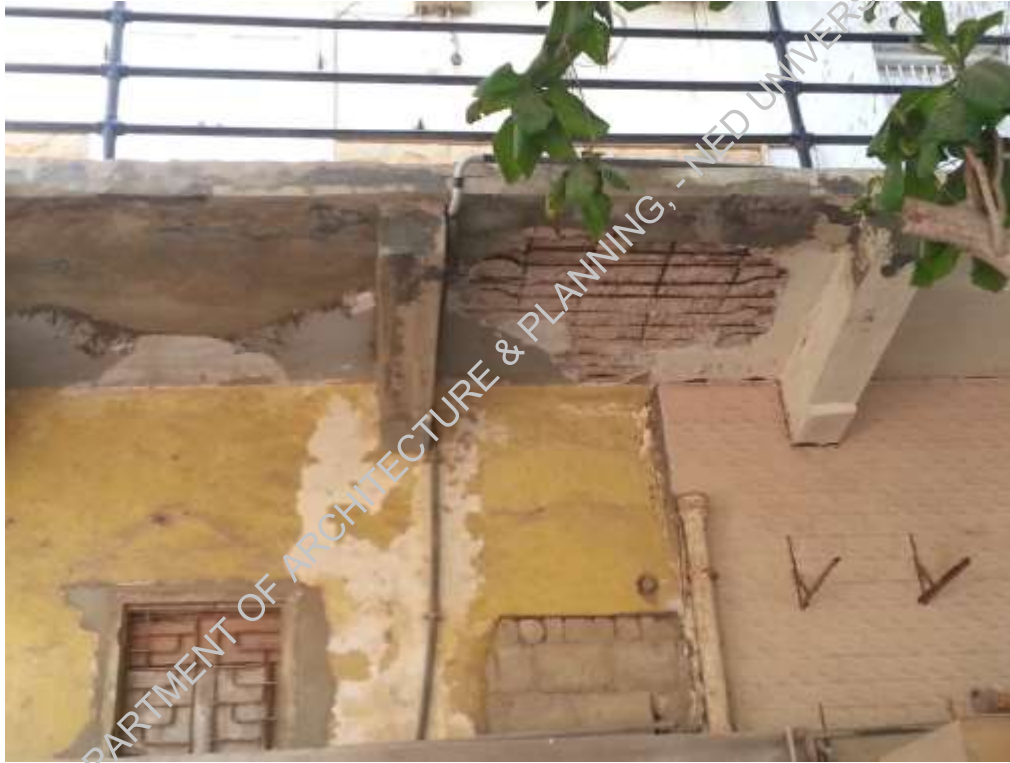
- At few places, concrete cover is fallen off from RC projections. Refer Plate-8
- Staircase RCC beam has cracks in soffit. Refer Plate-9

*Plate-8: Concrete
cover fallen off*

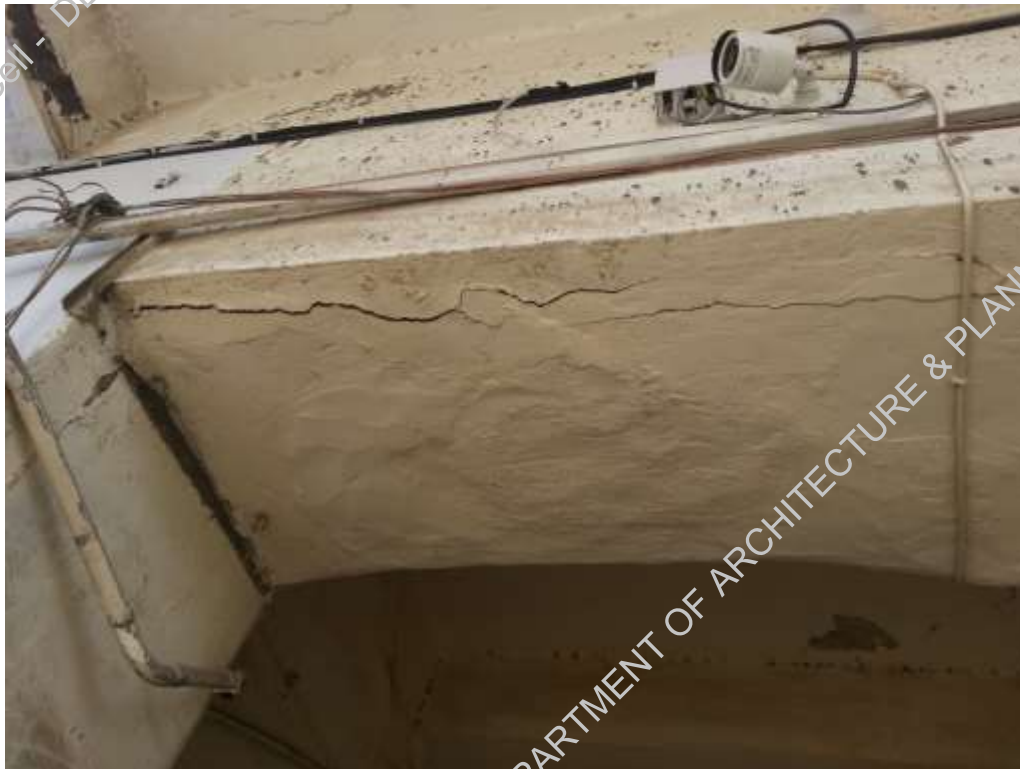
*Plate-9: Bad
condition of Beam
above stair*

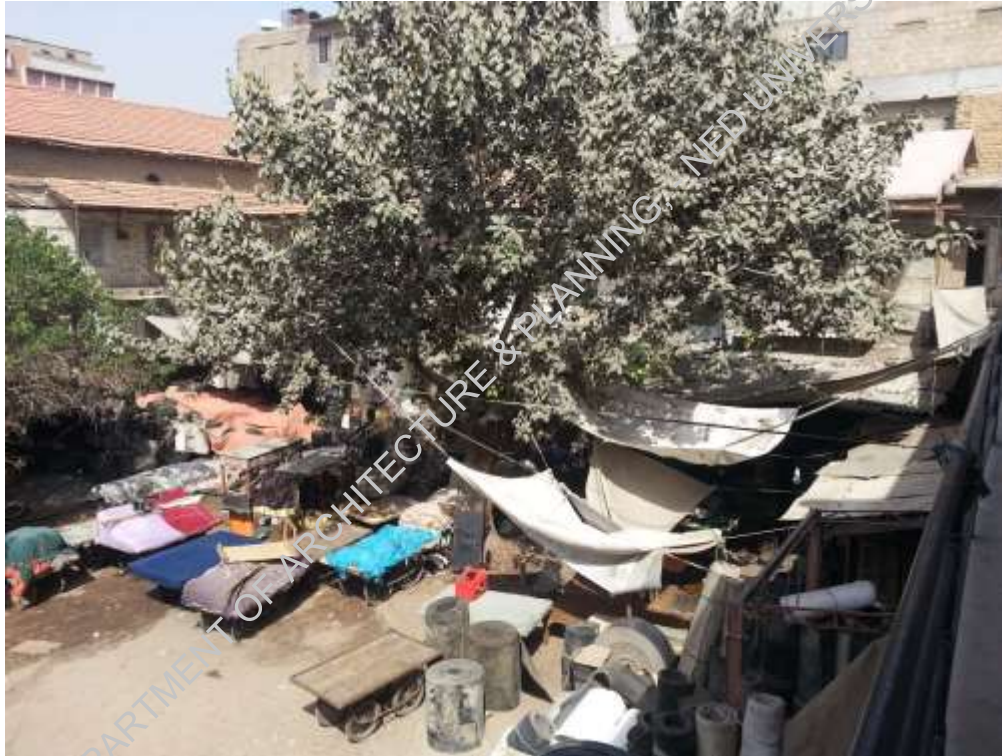
*Plate-10: Central
court*

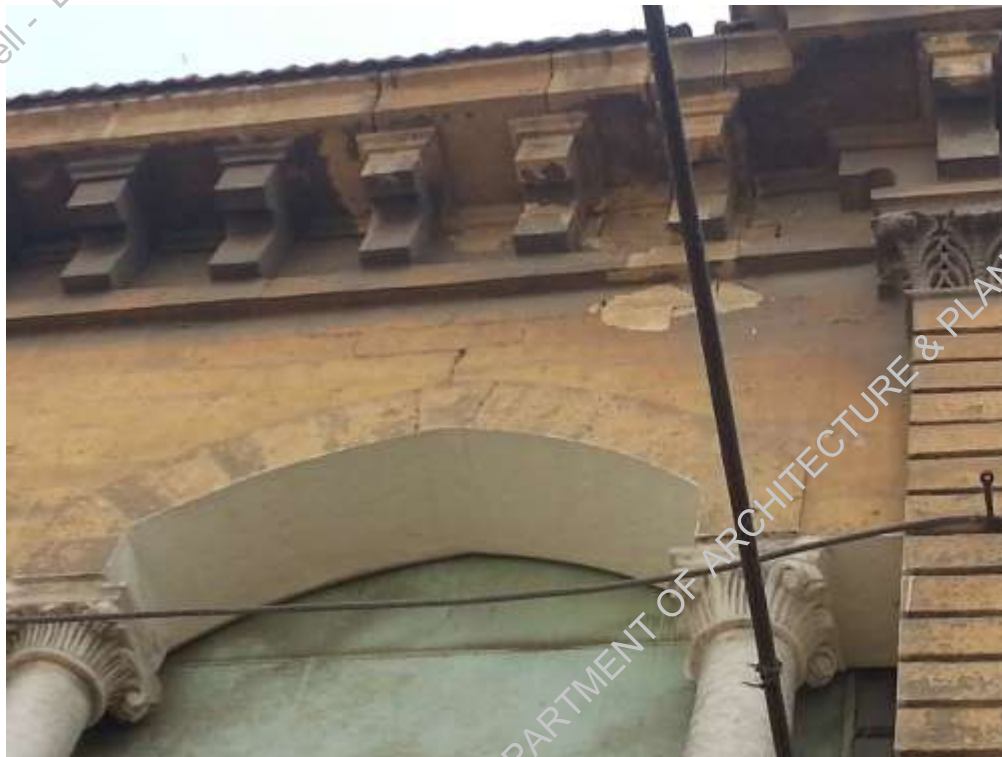
*Plate-11: Façade
Masonry*

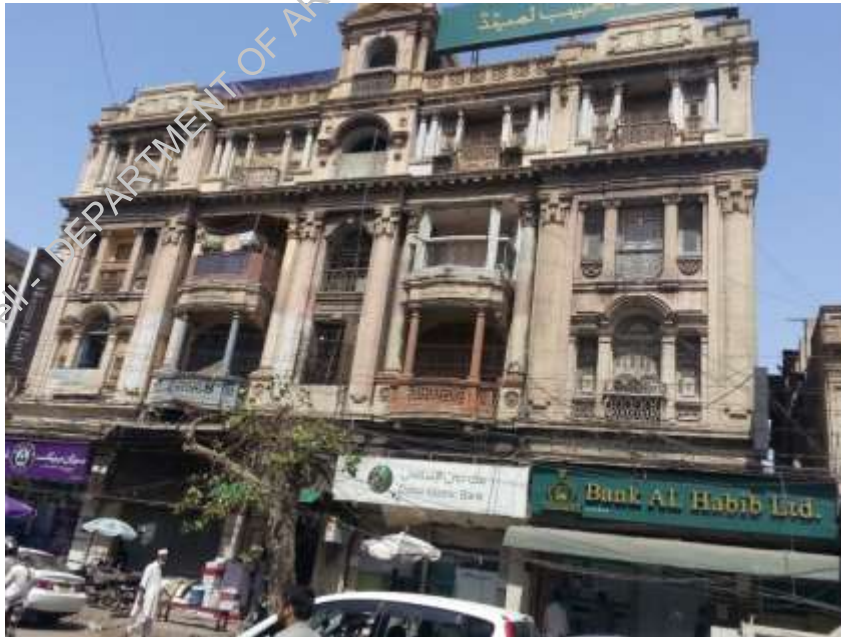
- The main building is in two blocks and is connected from side via Façade frame structure.
- Front Block is G+3 Story with partial 4th story, and is in good condition. Refer Plate-1 and 2.
- Rear Block 2 G+3 Story with full 4th story intervention and is partially collapsed Refer Plate-3
- Rear Block entrance shows sign of distress with broken stair case and other collapsed story structural elements. Refer Plate-4
- In most of areas, where original slab is been encountered, is in bad condition.
- In most places the reinforced concrete floor is being laid later on. Refer Plate-6 & 9

Plate-1: Front Façade- in good condition

- Front Block of Building structure appears in good condition and localized repairs might be required.
- Rear block building structure is partially collapsed, whereas, the rest of area require moderate level strengthening to make structure stable.
- Strengthening measures to be done with careful methodology which will include propping of existing walls/floors before proceeding with any strengthening technique.
- Interventions, if any, should be removed
- Strengthening techniques can be adopted, including but not limited to;
 - a. Pointing of mortar in existing stone masonry joints,
 - b. Application of mesh plaster
 - c. Localized internal MS Angle frame

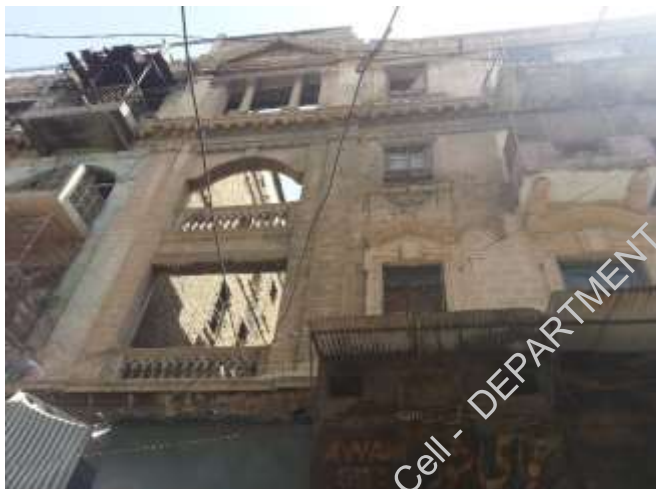
Plate-2: Wide cracks at the rear façade of building before collapse

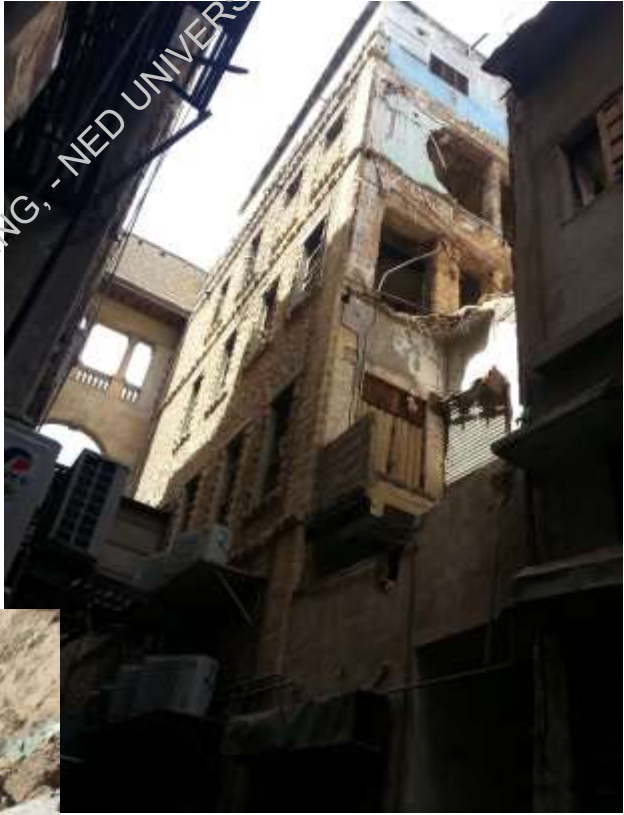
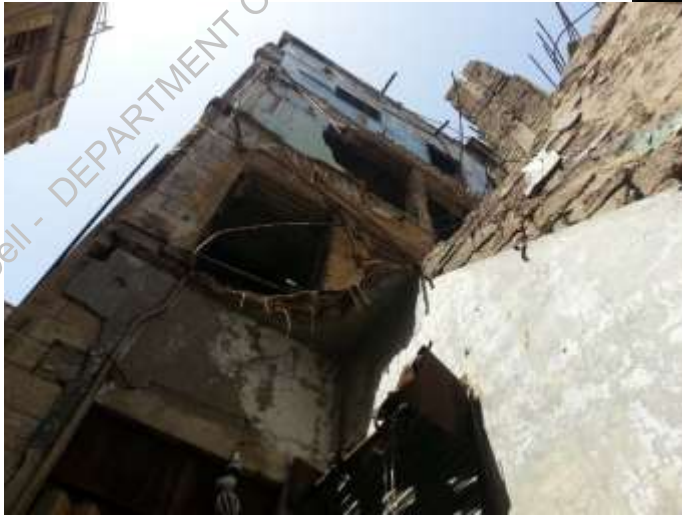
Plate-3: After collapse of rear side

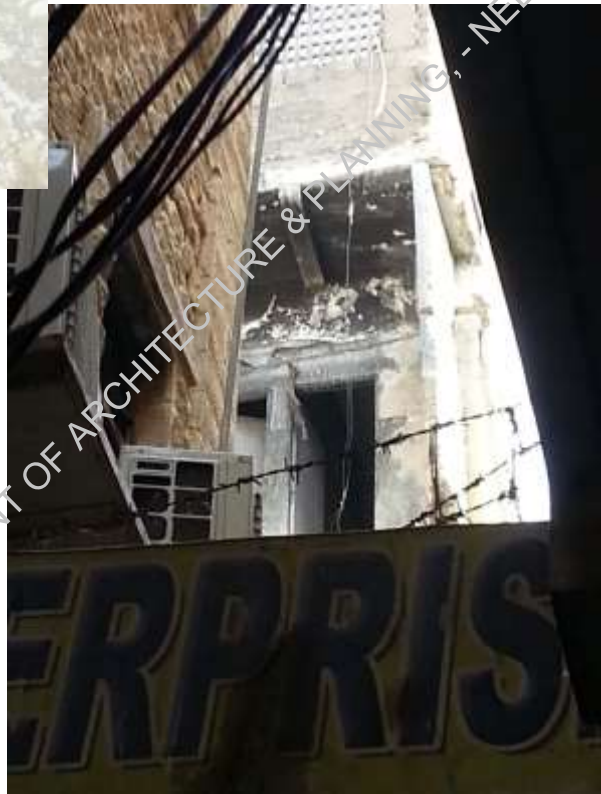
Plate-4: reinforced concrete slab in bad condition, concrete cover has fallen off.

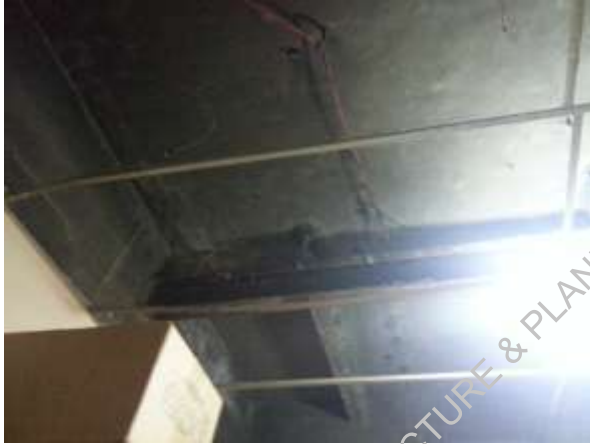
Plate-5: Concrete construction done later on, in bad condition

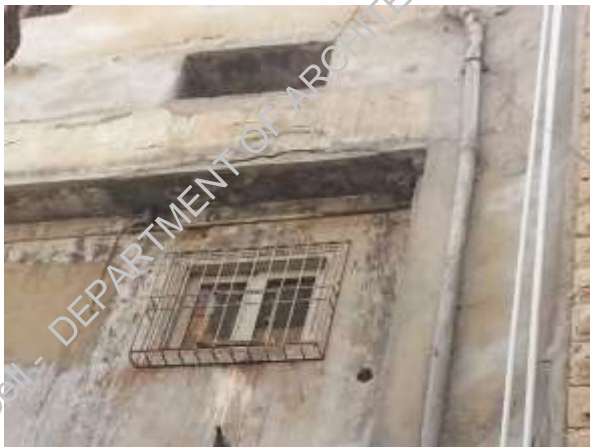
Plate-6: Loose stone masonry is visible

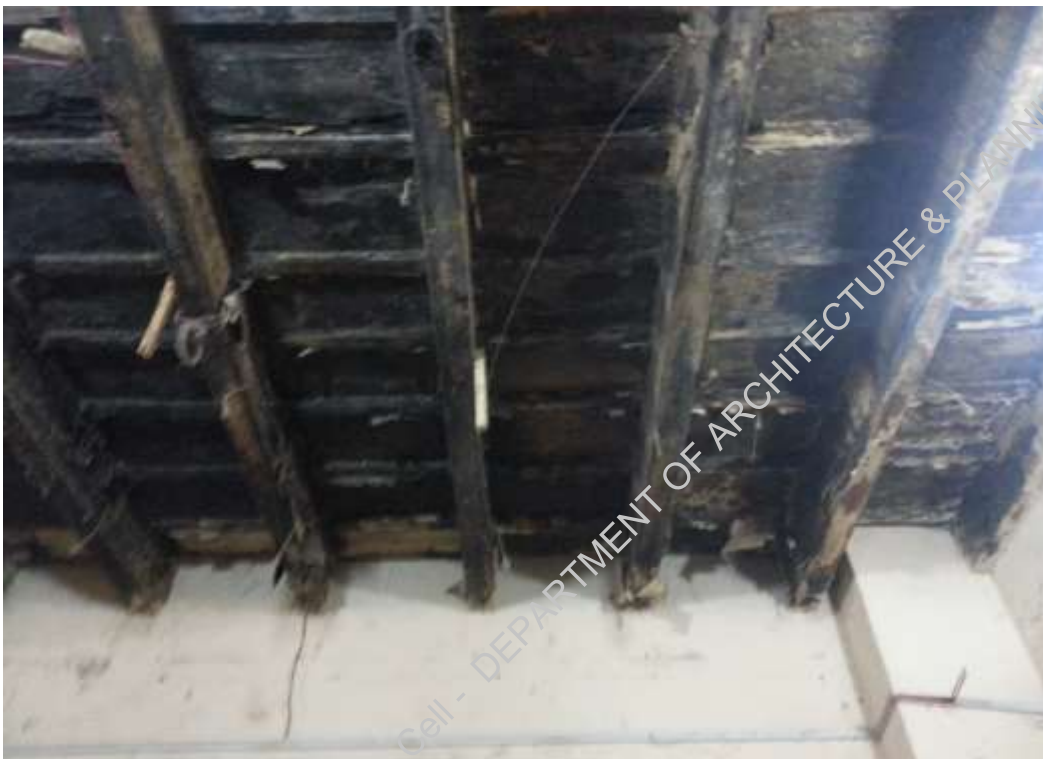
Plate-7: Bad condition of roof slab due to punctures and seepage from plumbing lines

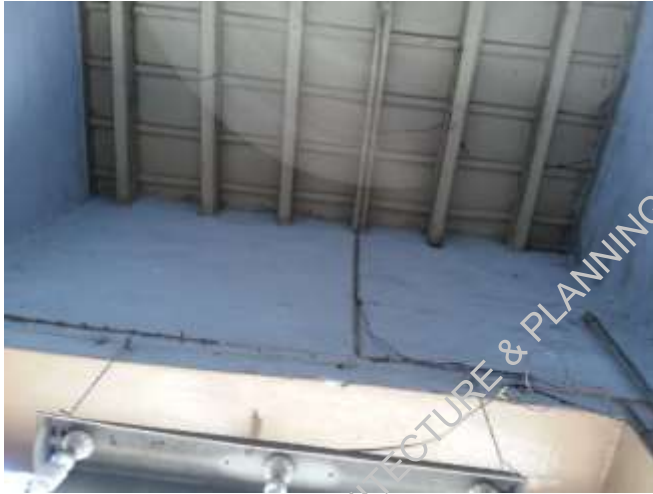
Plate-8: Central court being turned into RCC construction

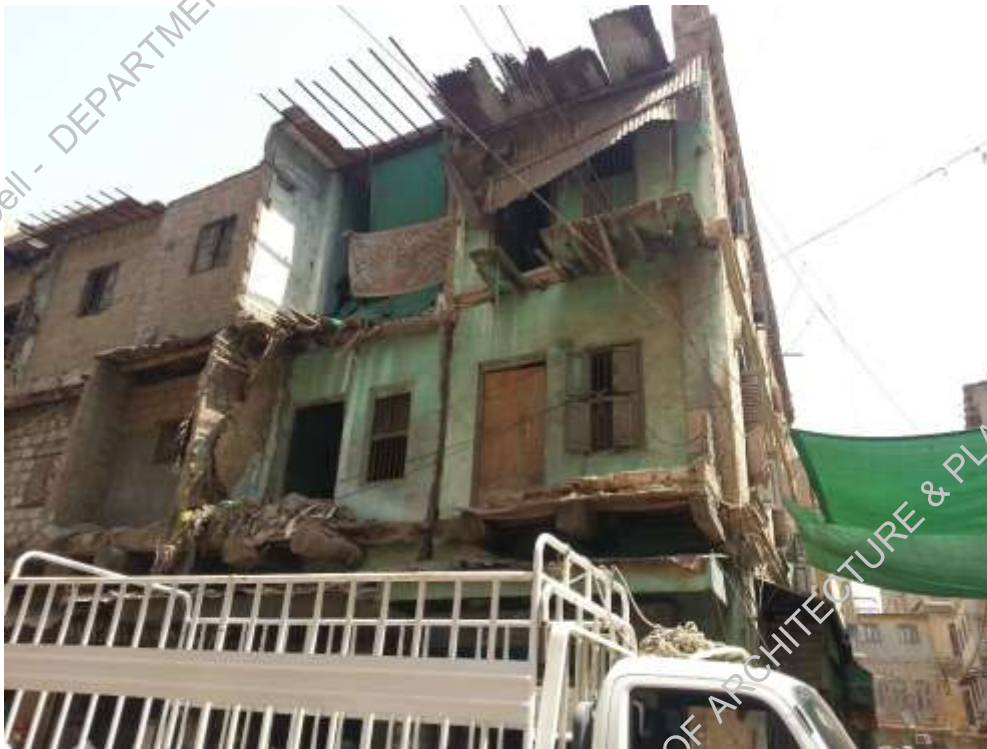
*Plate-1: side Façade-
Partially Collapsed*

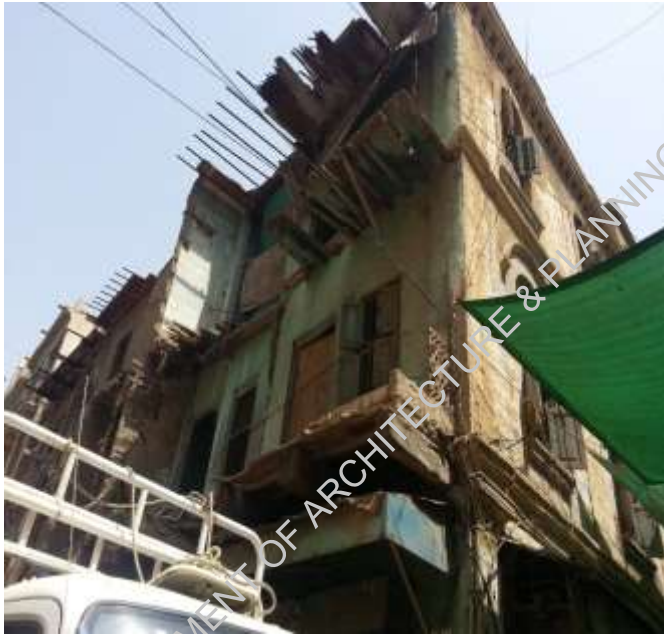
Plate-2: original wooden structural elements in deteriorated condition

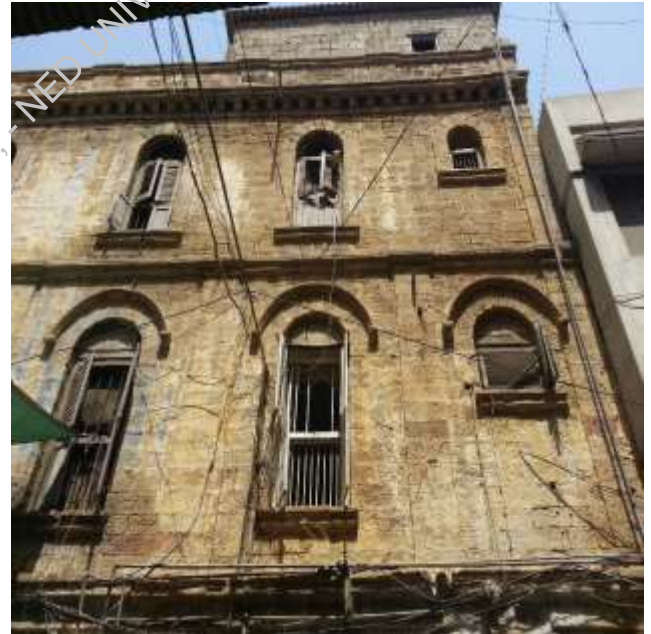
Plate-3: Front Façade

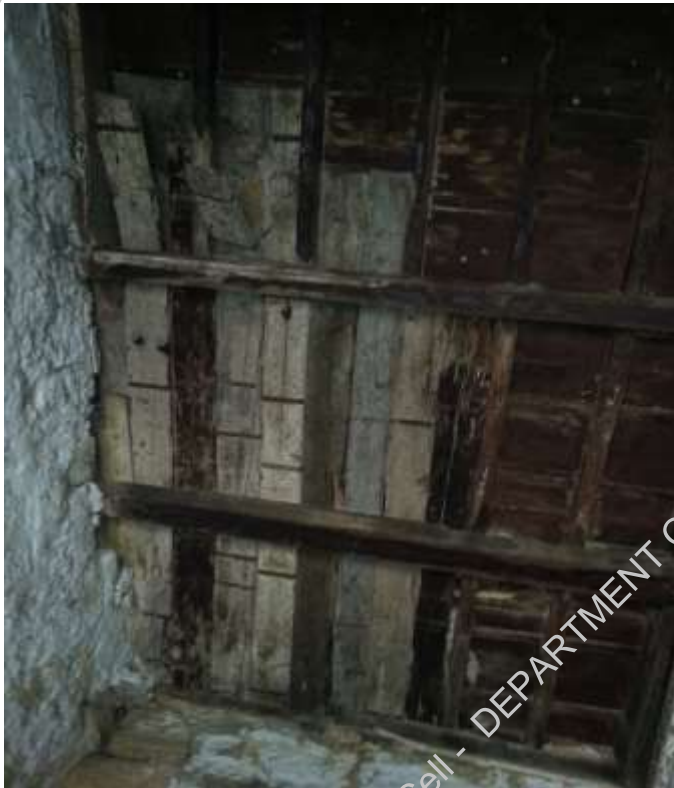
Plate-4: Timber slab in bad condition

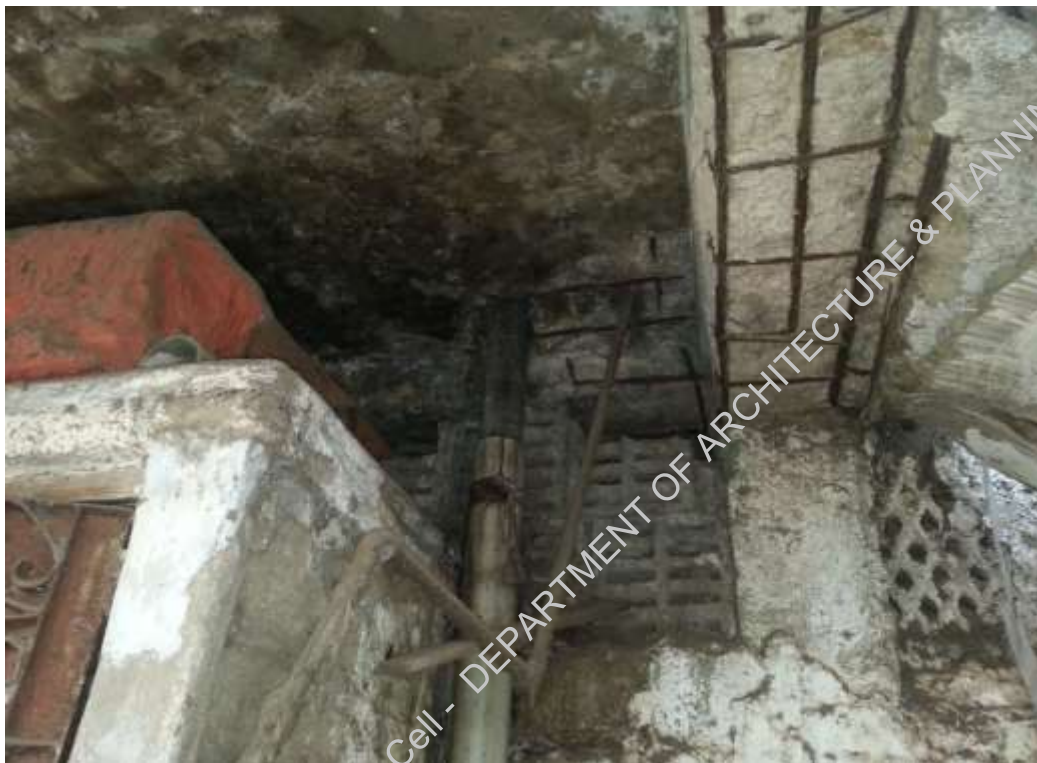
*Plate-6:
Exposed
rebar's subject
to rusting*

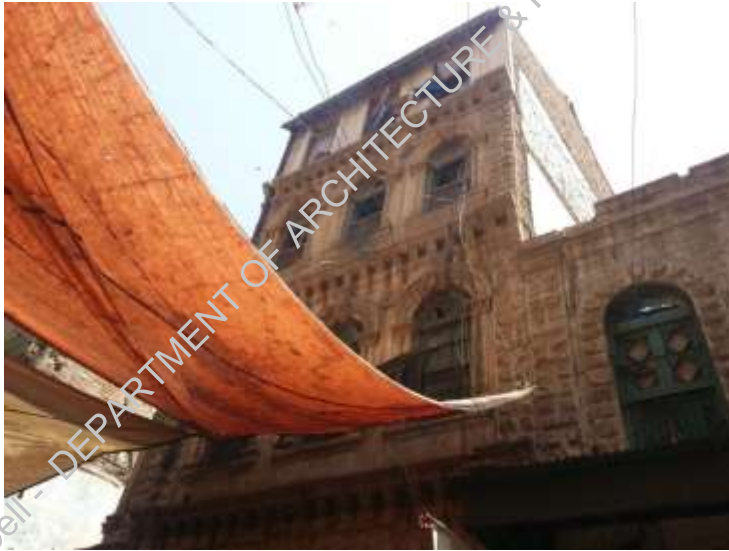
- The original building is ground plus two stories with third story addition sometime later. Refer Plate-1.
- On front façade, no loose stone masonry can be noticed at many locations.
- The over-all condition of the building is very good. Few locations need repair works.
- The stair case is of wood and need minor repair work.

Plate-1: Front Façade- loose stone masonry can be noted at many places. Additional floor on top is also visible

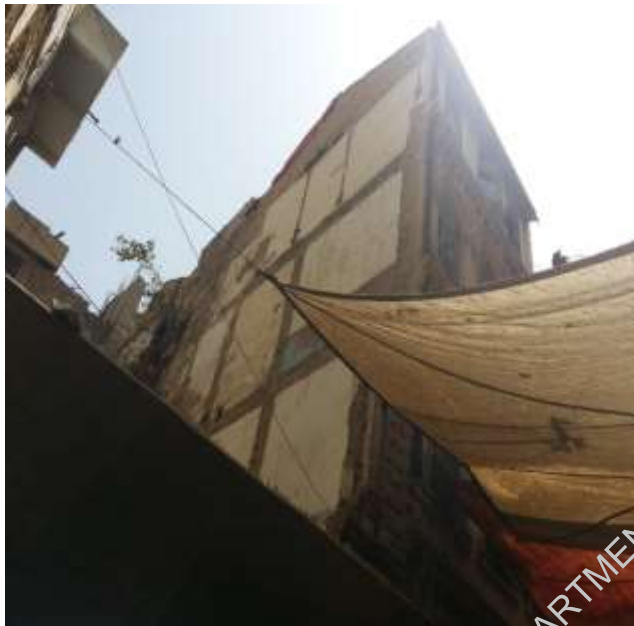
Plate-2: Side View

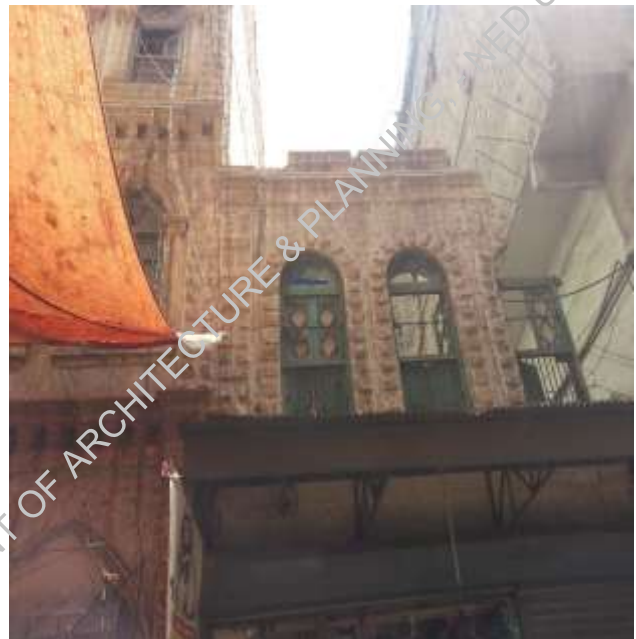
Plate-3: Front View

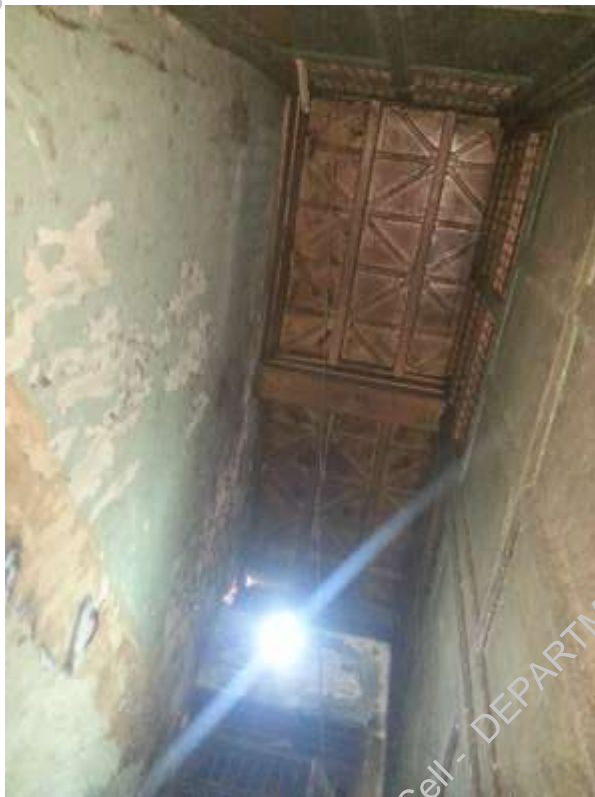
Plate-5: Original condition of wooden roof

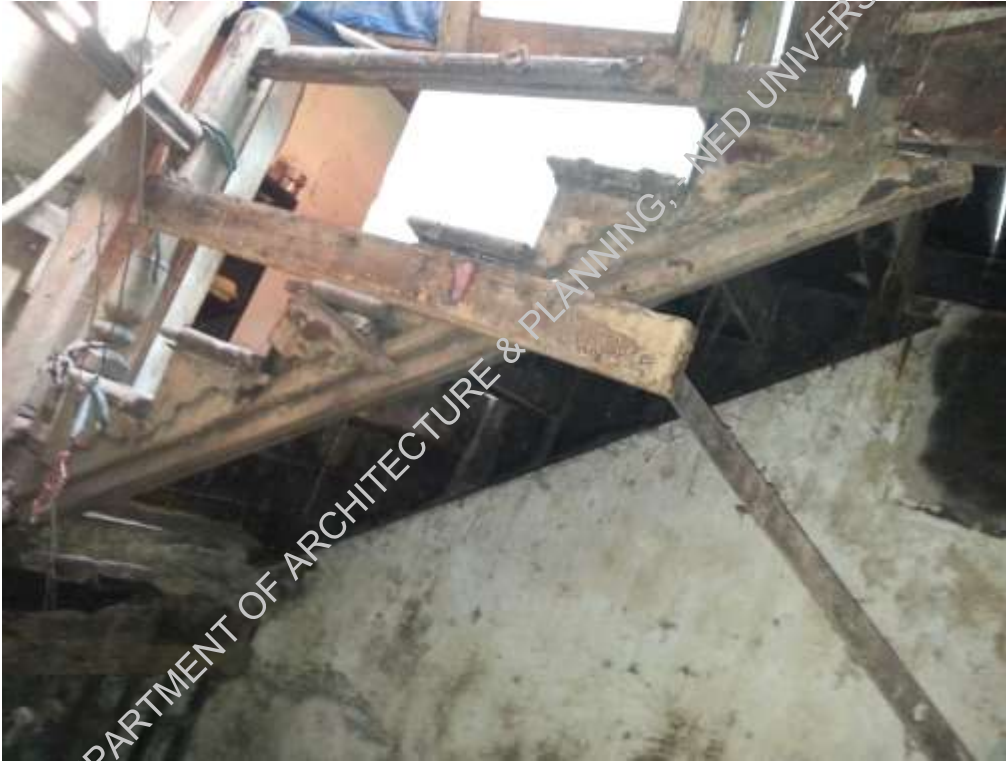
*Plate-6: Staircase
in bad condition*

- The over-all condition of the building appears stable as condition of stone masonry is ok. However, at few locations, such as staircase and wooden floor, repair works are needed.
- The stair case is of wood and need minor repair work.
- Top roof slab made in RCC need extensive repair.

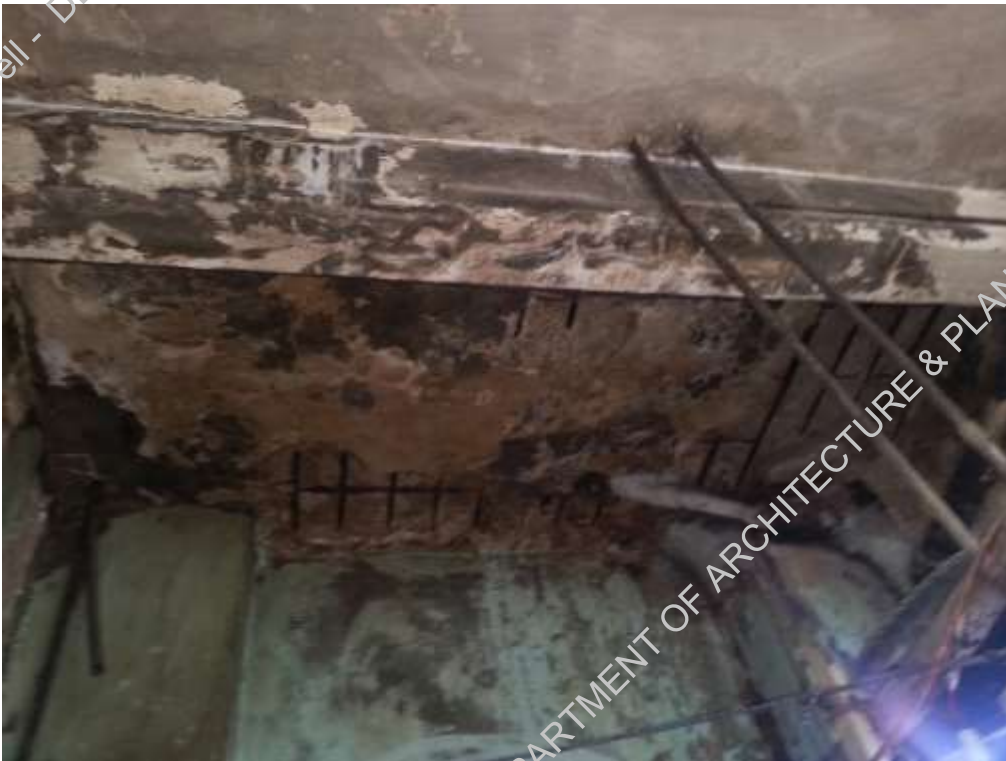
*Plate-7: Bad
condition of roof
slab due to
punctures and
seepage from
plumbing lines*

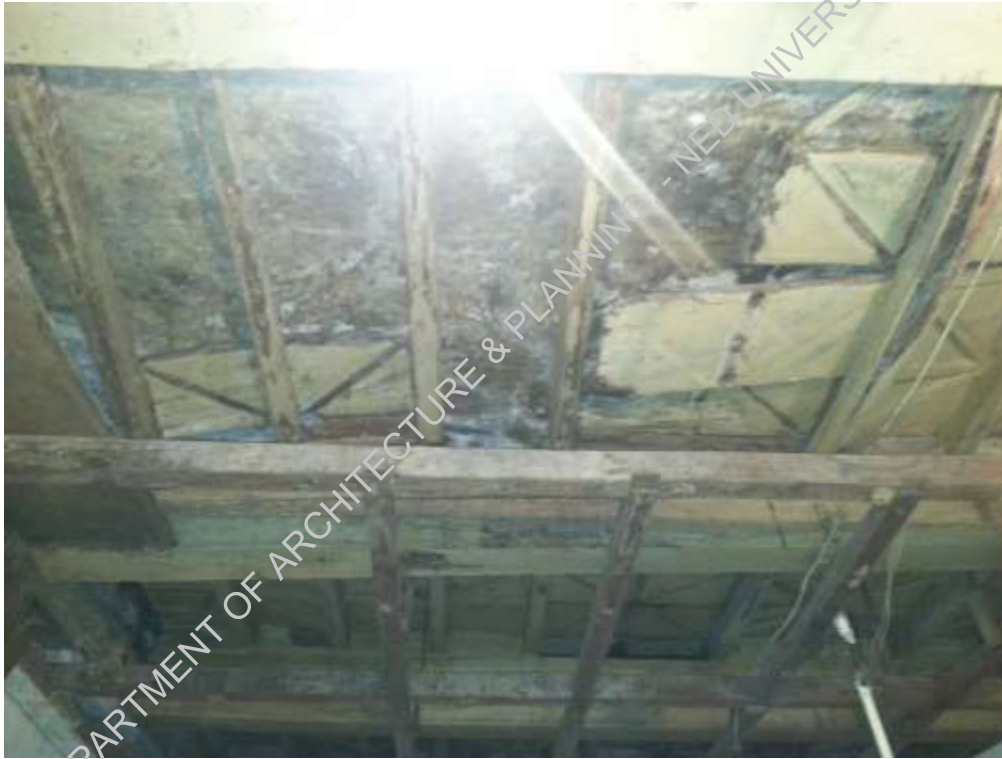
Plate-8: wooden deck condition inside

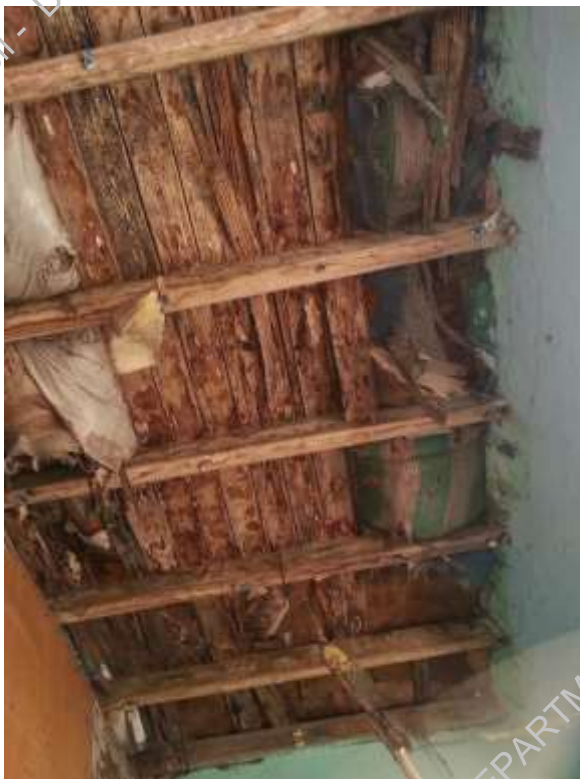
Plate-9: Bad condition wooden flooring

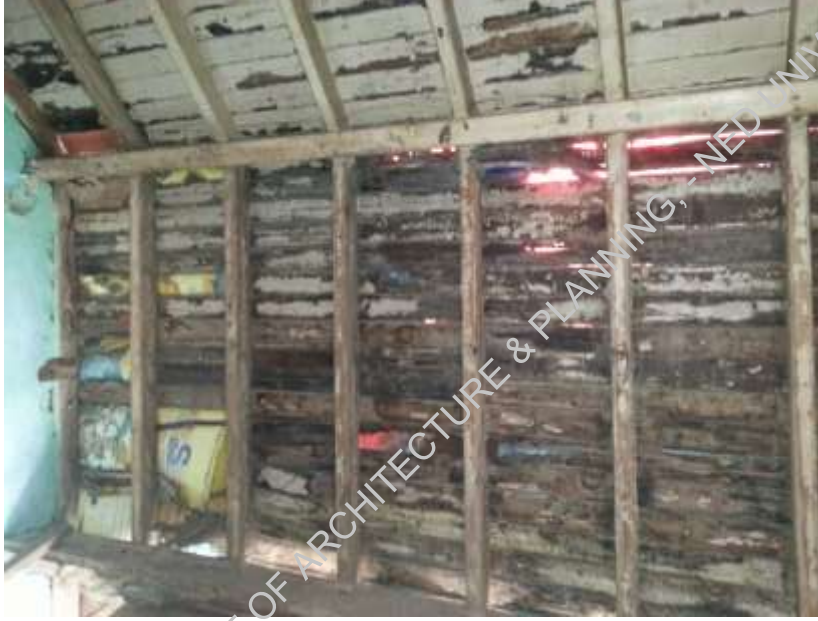
Plate-10: Bad condition of original timber flooring

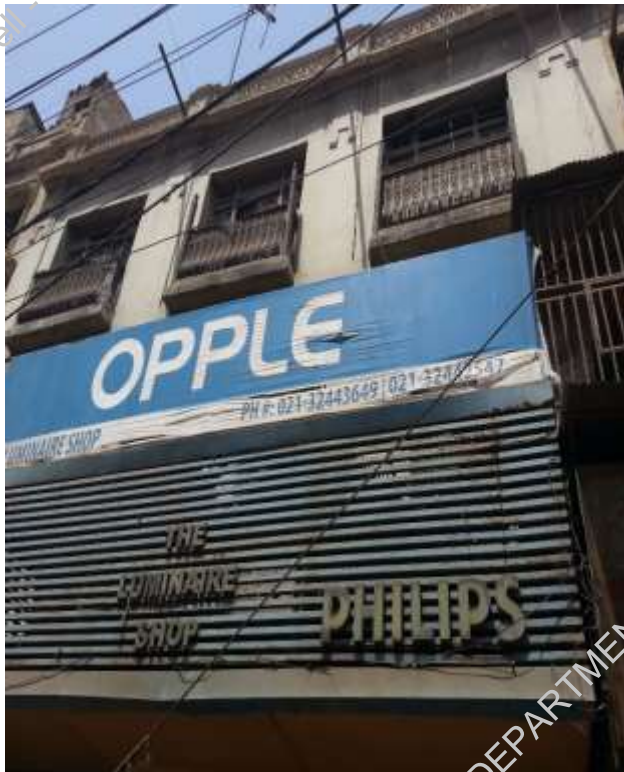
- The original building is ground plus two stories. Refer Plate-1.
- On front façade, no sign of distress was observed. However, a big advertisement board can be observed hanging from the façade. Refer Plate-2.
- Rear part of building also seems in better condition except from the parapet which is partly damaged. Refer Plate-3.
- The original wooden slab seems to be in good condition. Refer Plate-4
- The staircase is also sound. Refer Plate-5.
- In roof slab projection concrete cover is been fallen off from places. Refer Plate-6.
- Inside condition also look in quite good condition. Refer Plate 7

Plate-2: façade of building

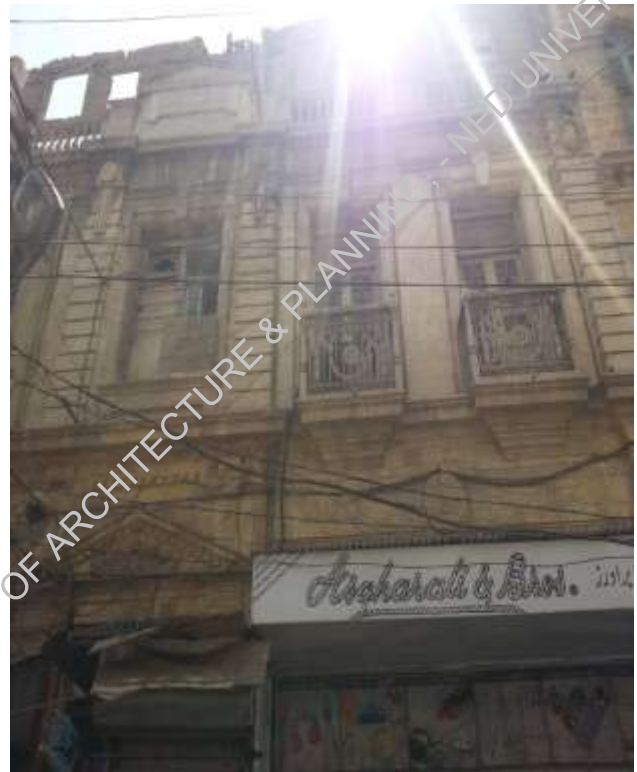
Plate-3: rear side

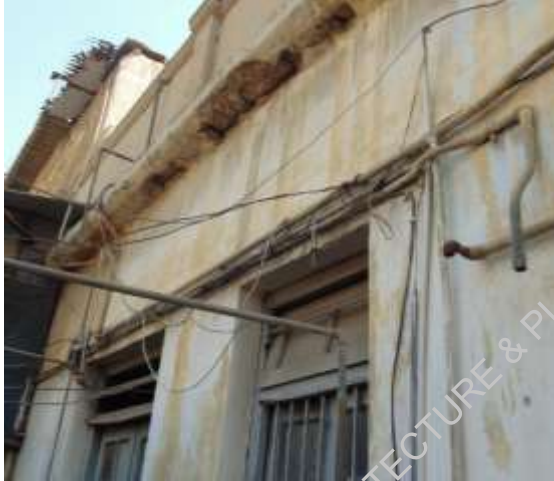
Plate-6: slab projection in bad condition

- Building appears to be in stable condition.
- Minor repair work is needed at few locations.

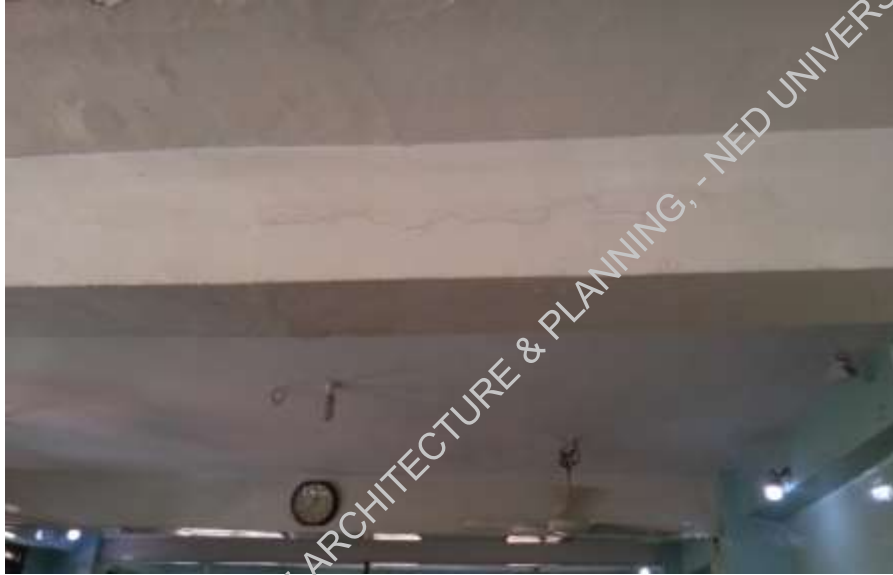
- The original building is ground plus 1 story with partial mezzanine and intervention at roof. Refer Plate-1.
- On front façade, no loose stone masonry can be noticed at any locations except for very minor cracks in the RCC projection. Refer Plate-2.
- Slab of first floor seems in good condition, proper repair works are evident. Refer Plate-3.
- Partial intervention at roof top was observed with temporary sheeting roof. Refer Plate-4.
- Horizontal cracks were observed a few places on roof RCC beams. Refer Plate-5 & 6.

Plate-5: horizontal cracks in roof beams

- Minor repair works are needed, especially in reinforced concrete projections and floor beams.

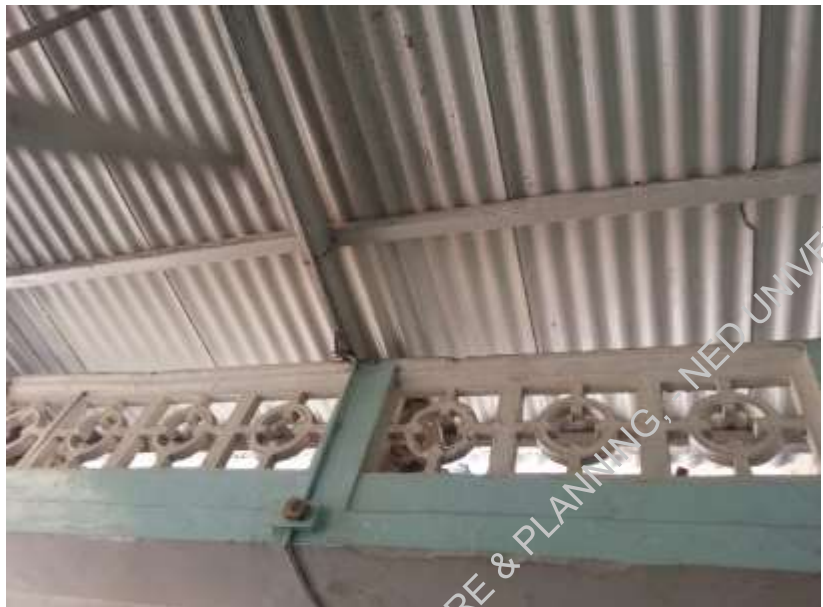
Plate-6: horizontal crack in the RCC element

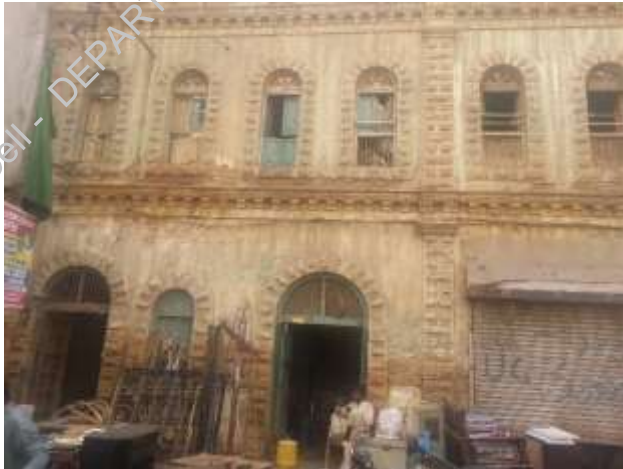
- The original building is ground plus 3 story with partial fourth story intervention. Refer Plate-1.
- On front façade, no loose stone masonry can be noticed however at few locations vertical cracks have been observed at 3 locations from lintel to sill. Refer Plate-2 and 3.
- The ground floor is in better condition.
- Part of Floor inside have been collapsed and traces of fire were also observed at one location.

Plate-2: Vertical Cracks at few location

- Overall condition of supporting system of building appears stable, however, reinforced concrete construction (slabs/beams) need repair.
- Interventions such as top most story added later should be removed.
- Façade has cracks at few locations but do not appear dangerous, should be repaired immediately however.

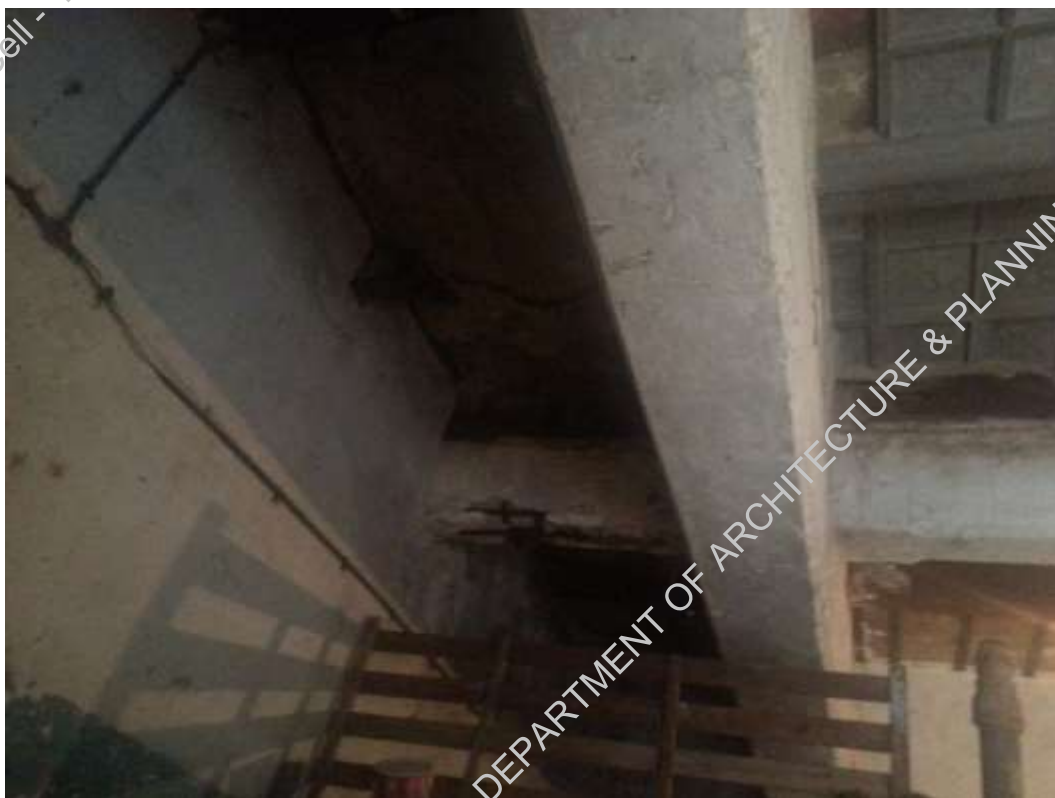
*Plate-6:
Concrete cover
fallen off at
places*

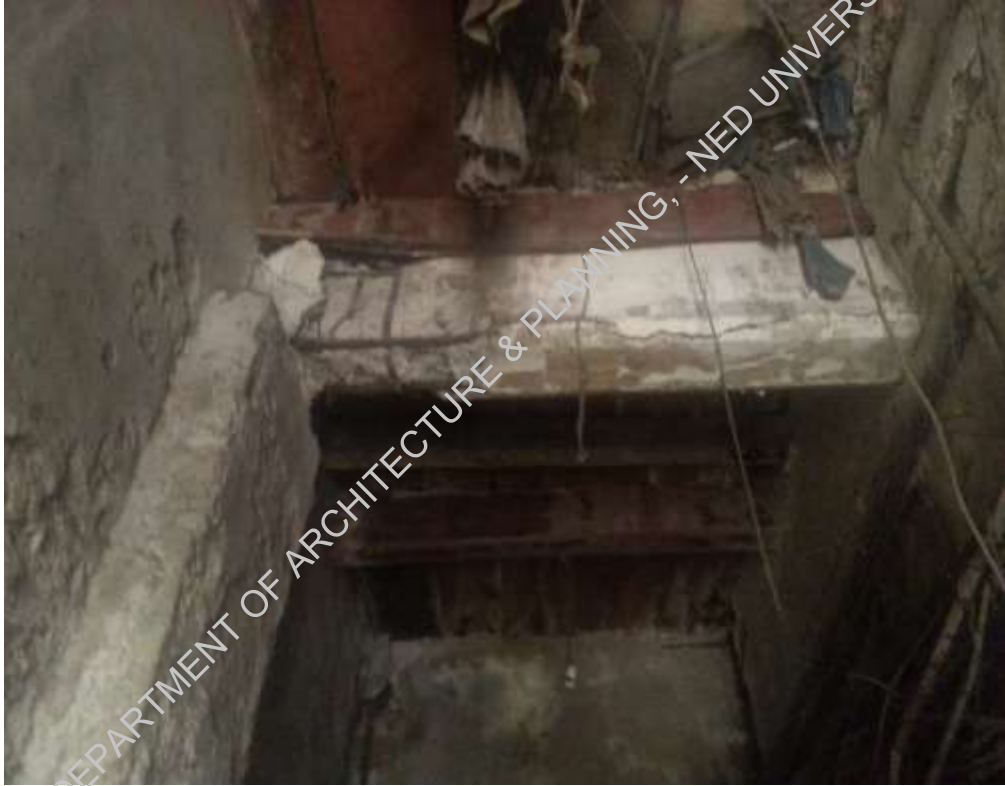
Plate-7: Bad condition of slab due to punctures and seepage from plumbing lines

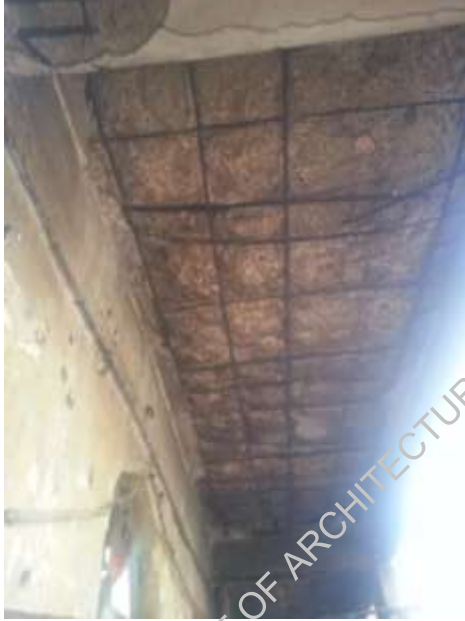
Plate-10: Bad condition of slab

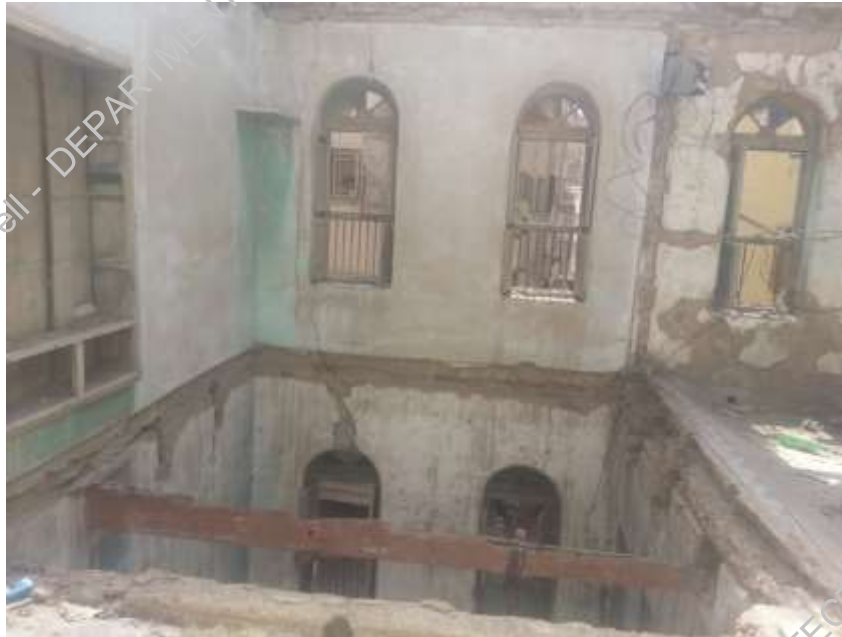
Plate-10: collapsed slab at 3rd floor

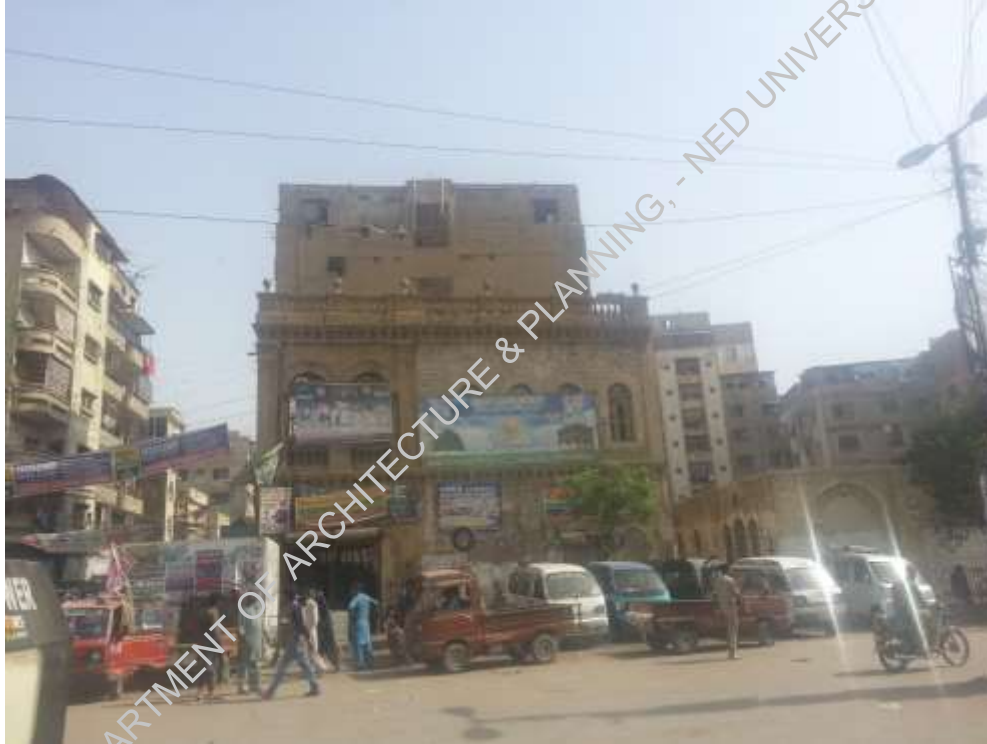
- The original building is ground plus 1 story. Refer Plate-1.
- On front façade, loose stone masonry can be noticed at many locations.
- At first floor, the building seems to be tilted at right.
- The framing elements slab and walls are being removed on first floor causing the façade to deteriorate.

Plate-1: Front Façade- loose stone masonry can be noted at many places.

- In existing condition, building structure seem unstable,
- Extensive strengthening is required
- Repair works are needed like pointing in joints, and repair of deck/floor works
- Masonry has eroded at few places and patch work is needed to strengthen the weak areas.
