Condition Assessment of Heritage Buildings - Karachi Declared as “Dangerous”

JUNE 2018

Structural Consultant

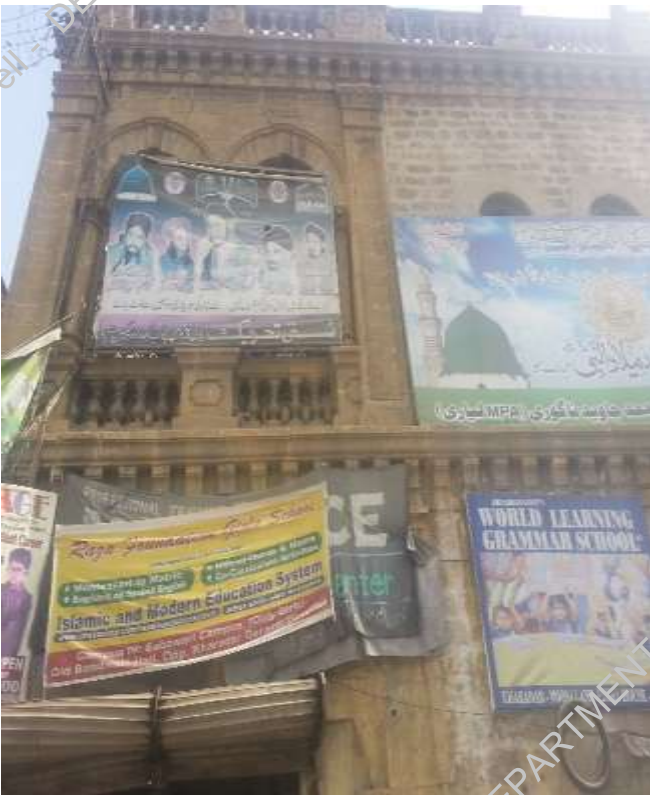
Plate-2: Wide cracks at first floor level

- In existing condition, building structure seem unstable,
- Extensive strengthening is required
- Repair works are needed like pointing in joints, and repair of deck/floor works
- Masonry has eroded at few places and patch work is needed to strengthen the weak areas.

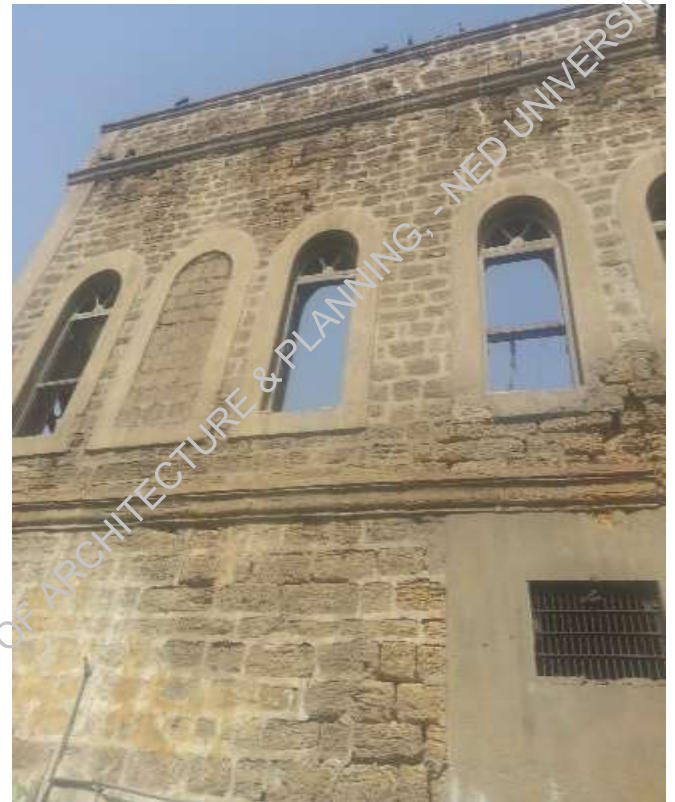
Plate-3: mortar has been eroded

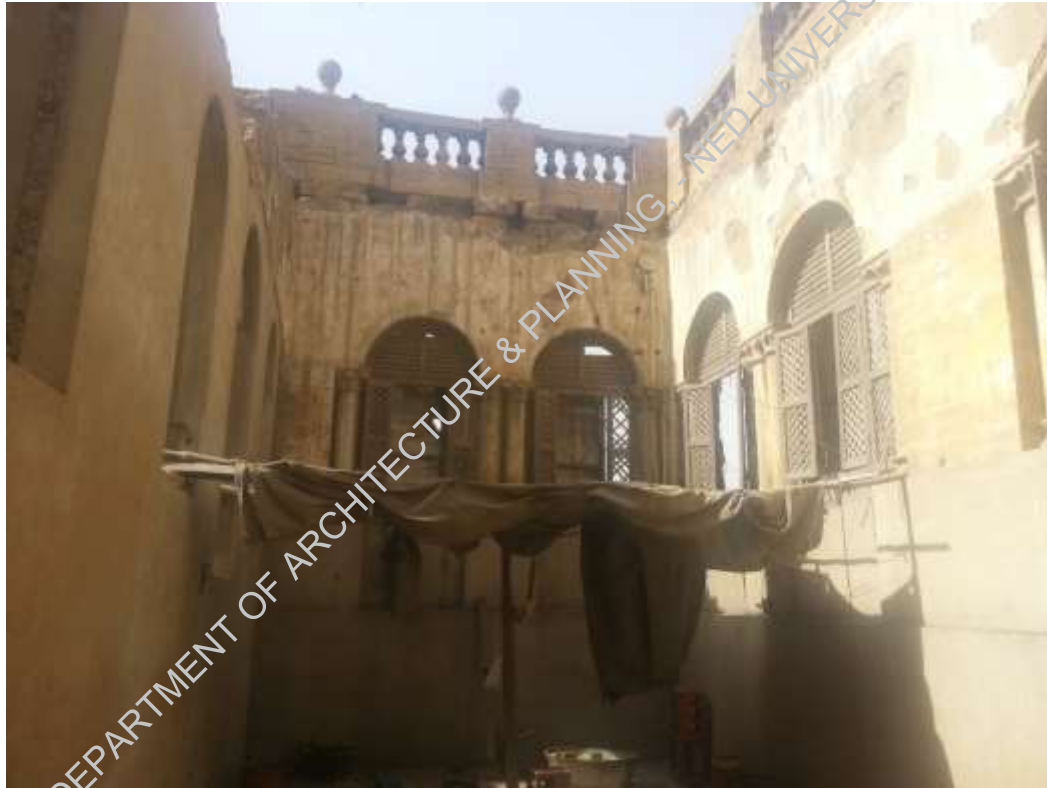
*Plate-4: slab
removed at roof*

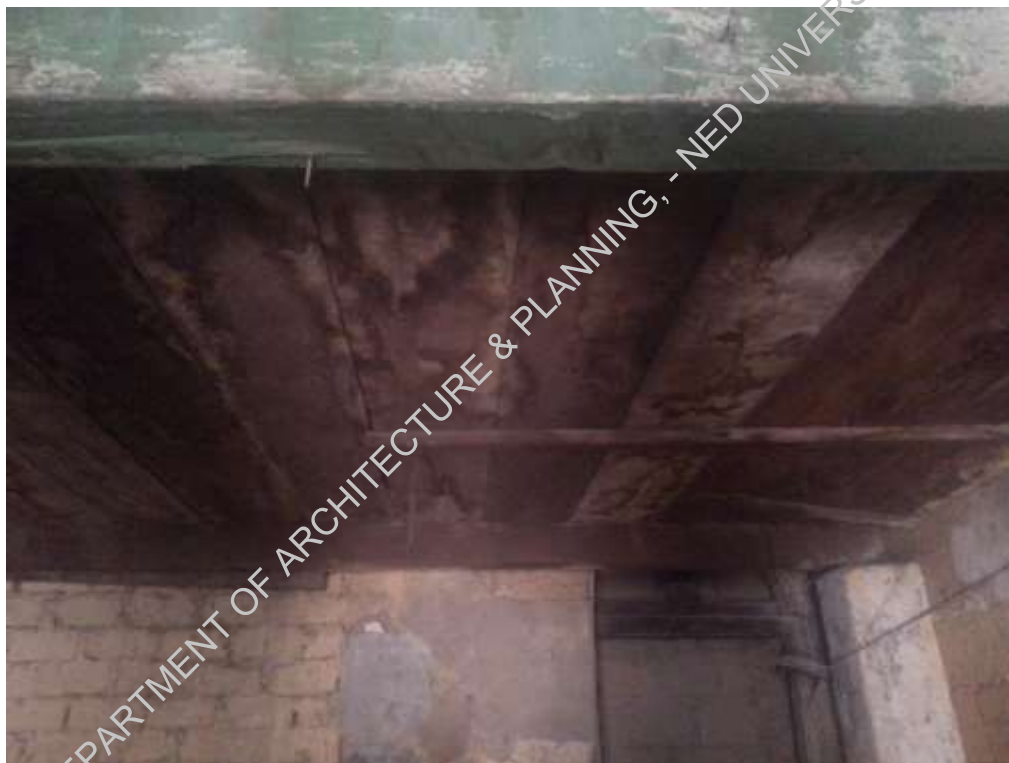
*Plate-6: traces of
seepage*

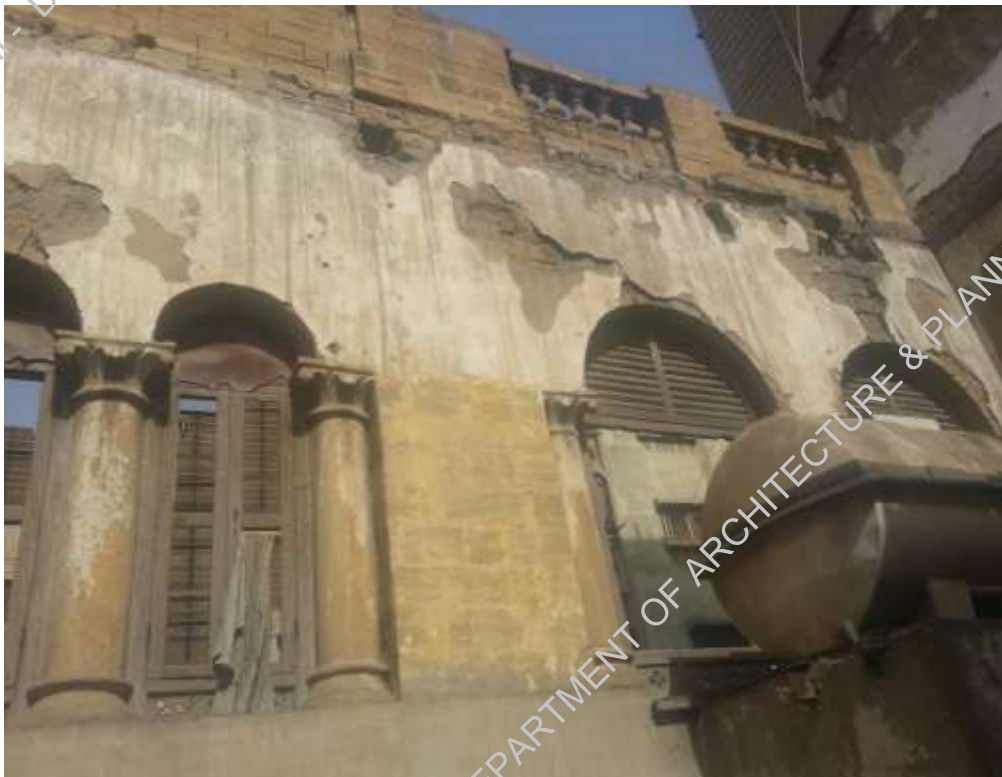
*Plate-9: Bad
condition of
plaster and
masonry at first
floor*

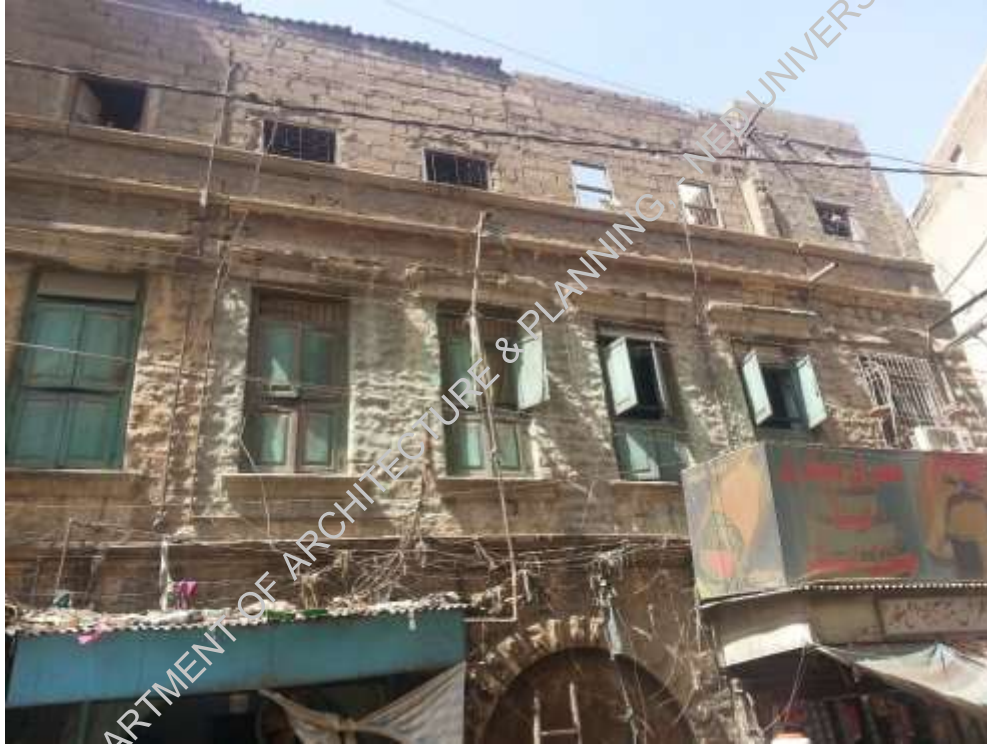
- The original building is ground plus 1 story with intervention at roof. Refer Plate-1.
- On front façade, loose stone masonry can be noticed at many locations.
- The concrete cover is crumbling in various locations. Budge in column is observed. Deflection in beams can also be observed.
- Traces shows that most damages is due to seepage and lack of maintenance.
- Stair Case condition is also bad

Plate-1: Front Façade- loose stone masonry can be noted at many places. Additional floor on top is also visible

- In existing condition, building structure is not stable and is susceptible to failure/collapse.
- Major strengthening is required to make the structure stable.
- Strengthening measures to be done with careful methodology which will include propping of existing walls/floors before proceeding with any strengthening technique.
- Interventions should be removed such as the additional floor on top and extra floor finishes where present, to decrease the dead load on existing walls,
- Strengthening techniques can be adopted, including but not limited to;
 - a. Pointing of mortar in existing stone masonry joints,
 - b. Application of mesh plaster
 - c. Introducing internal mild steel frame within the building to secure the occupants from fatal damages.

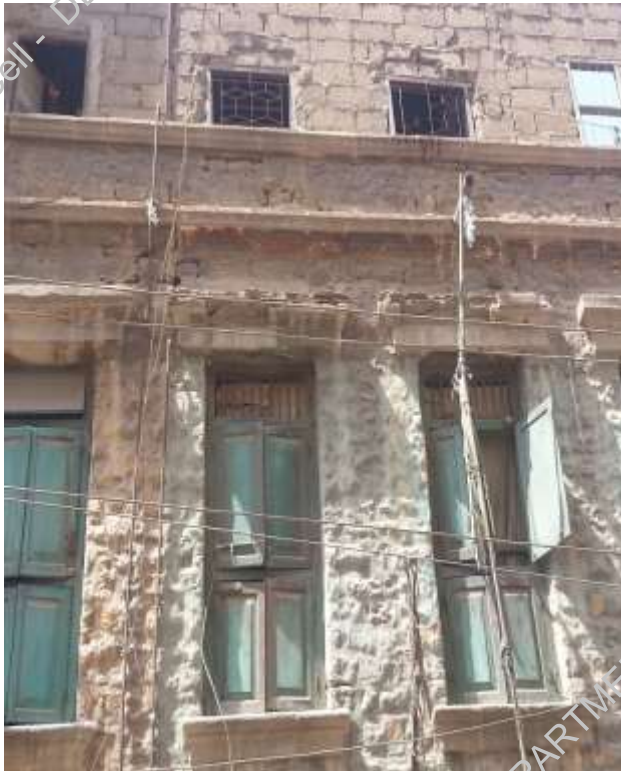
Plate-2: bad condition of masonry in façade

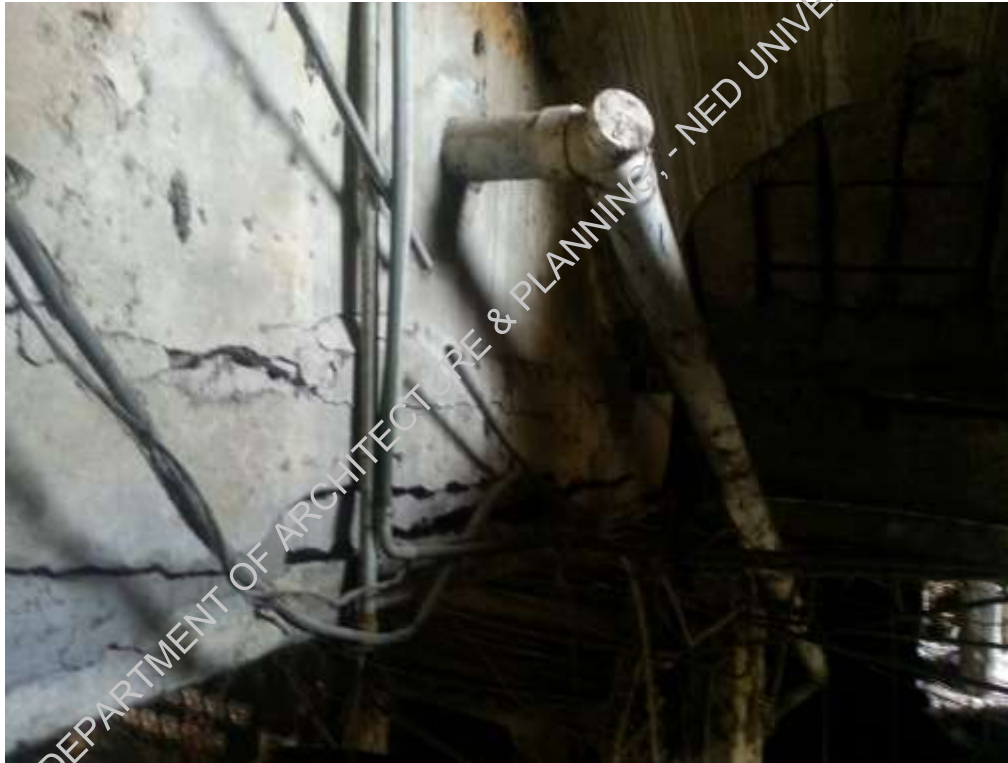
*Plate-6: concrete
in bad condition*

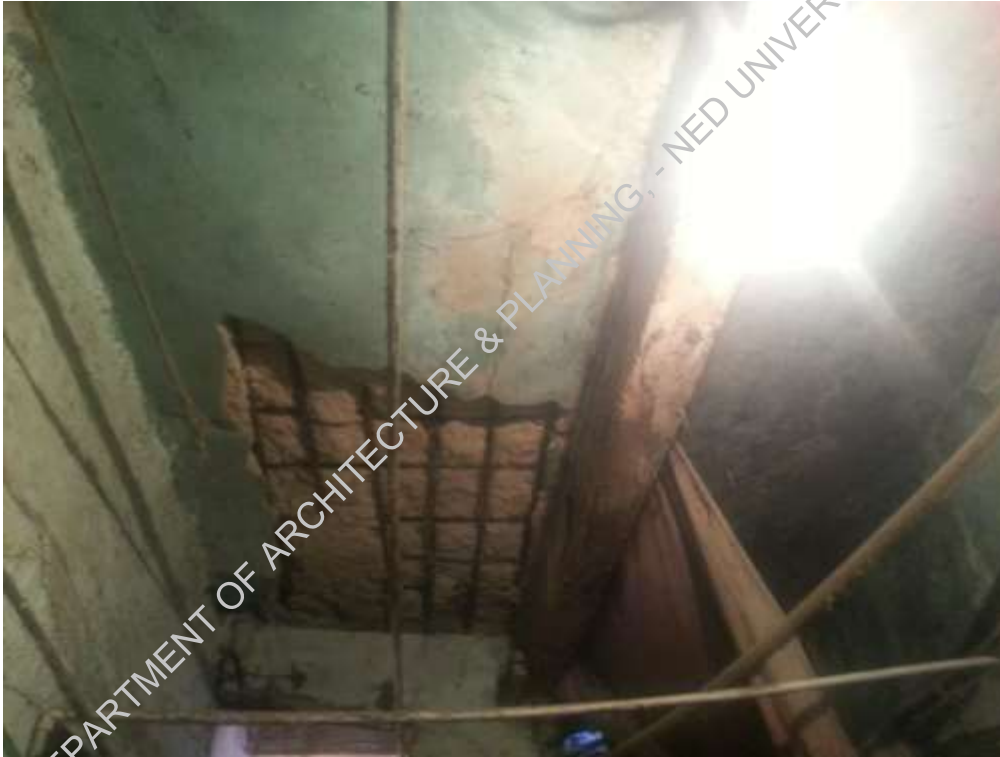
*Plate-8: RCC
construction
deteriorating*

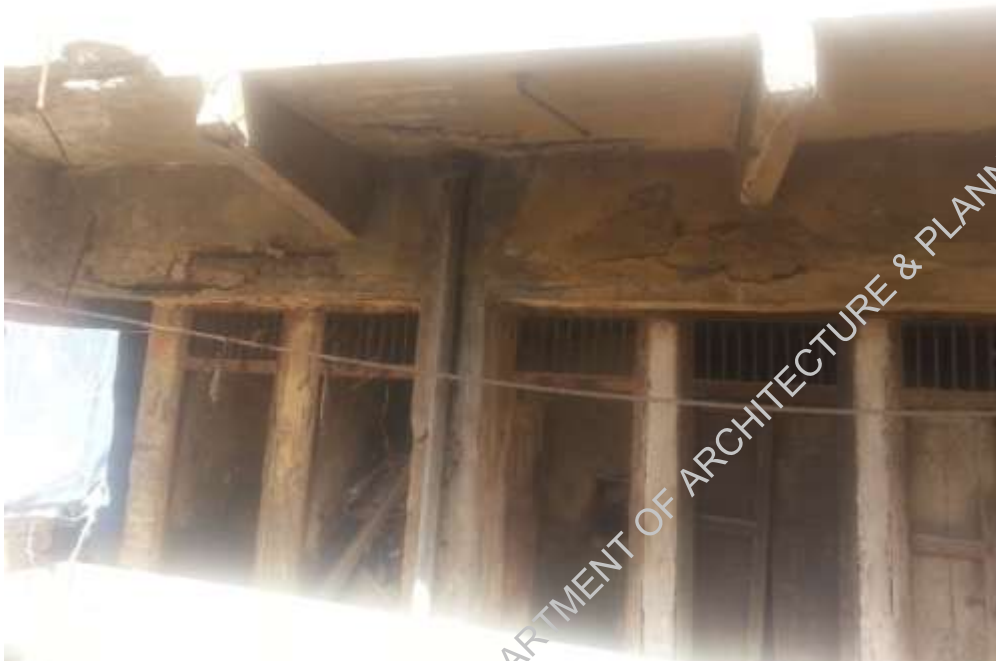
*Plate-9: cracks
observed above
lintel*

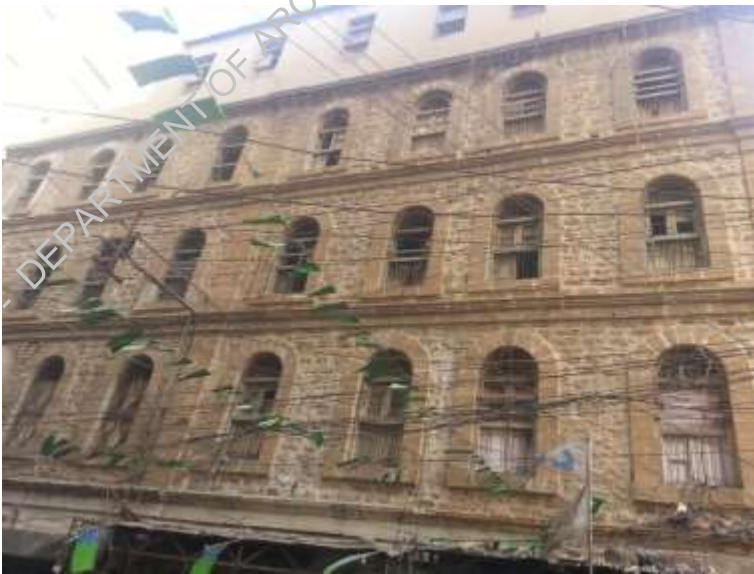
Plate-1: Front Façade- top story added later on can be seen

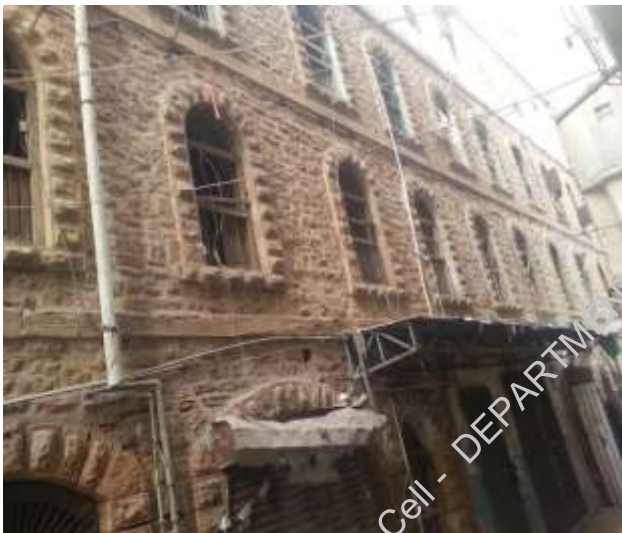
Plate-2: right side façade

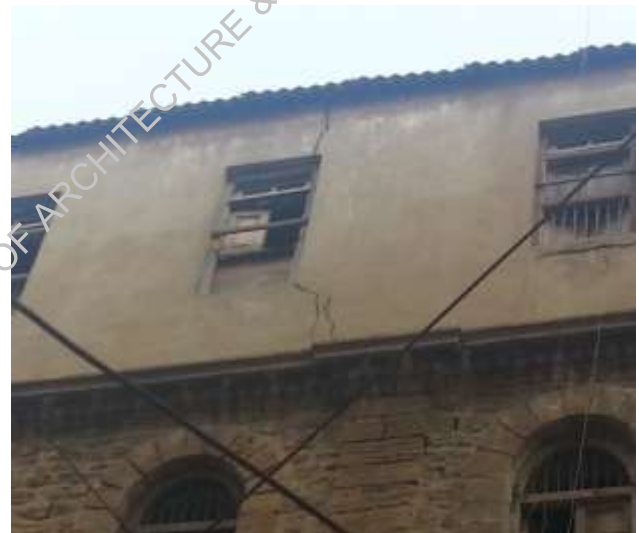
Plate-3: crack in wall of intervention at roof

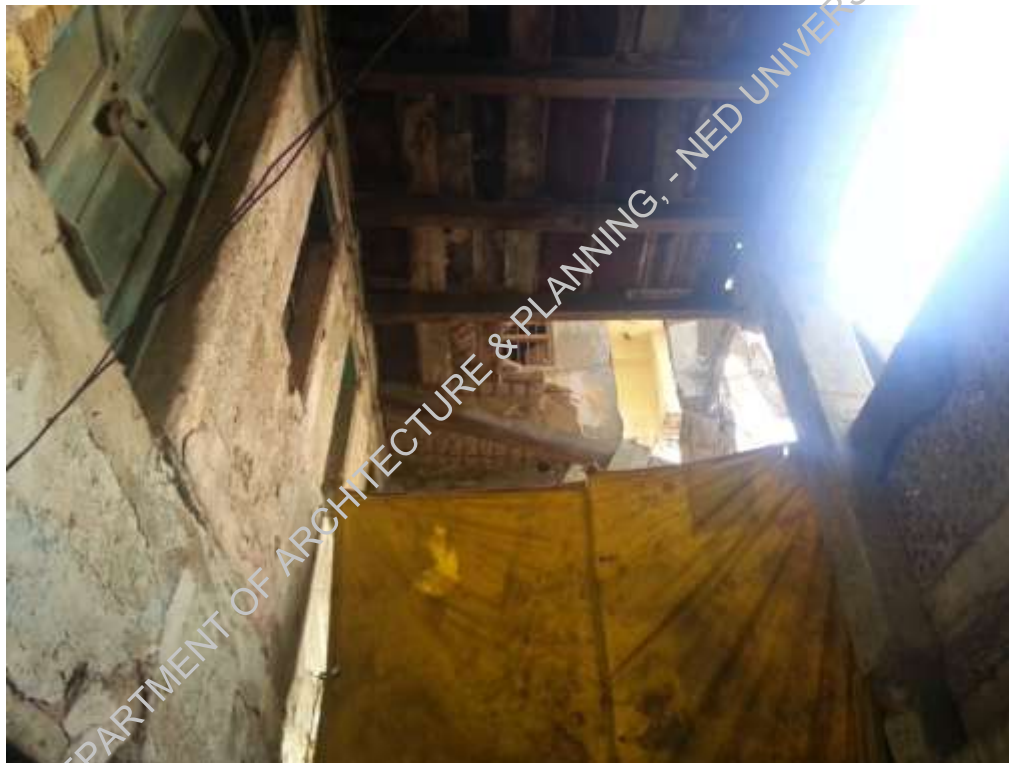
*Plate-6: bad
condition of
timber slab*

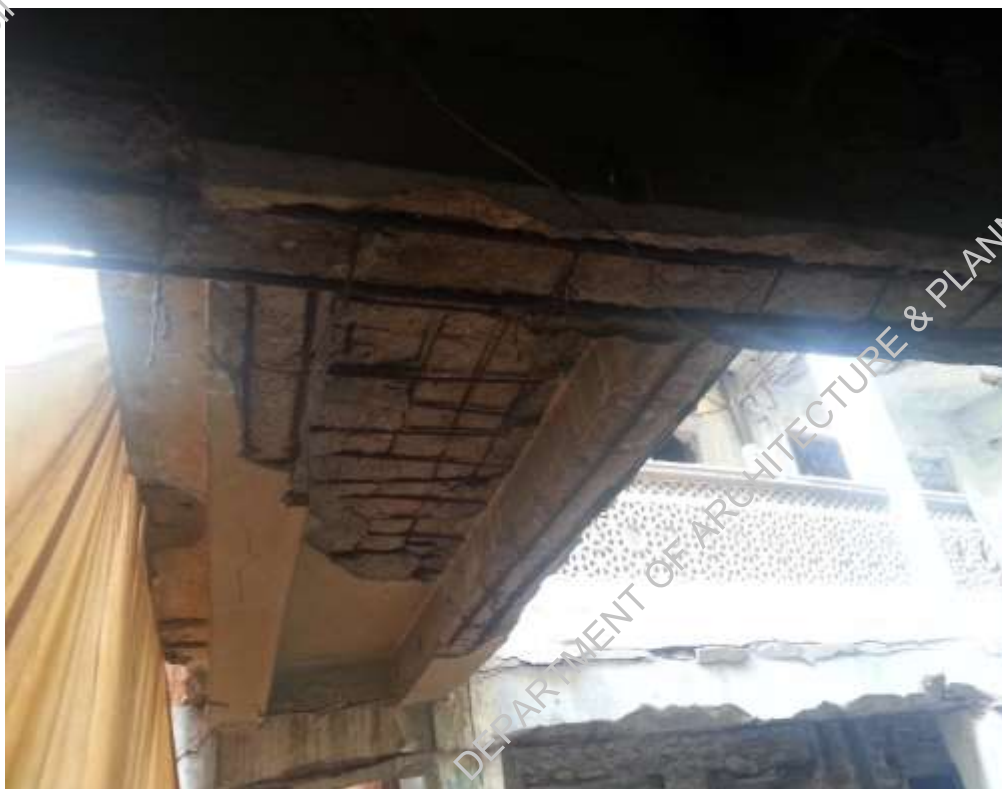
*Plate-7: concrete
cover fallen off*

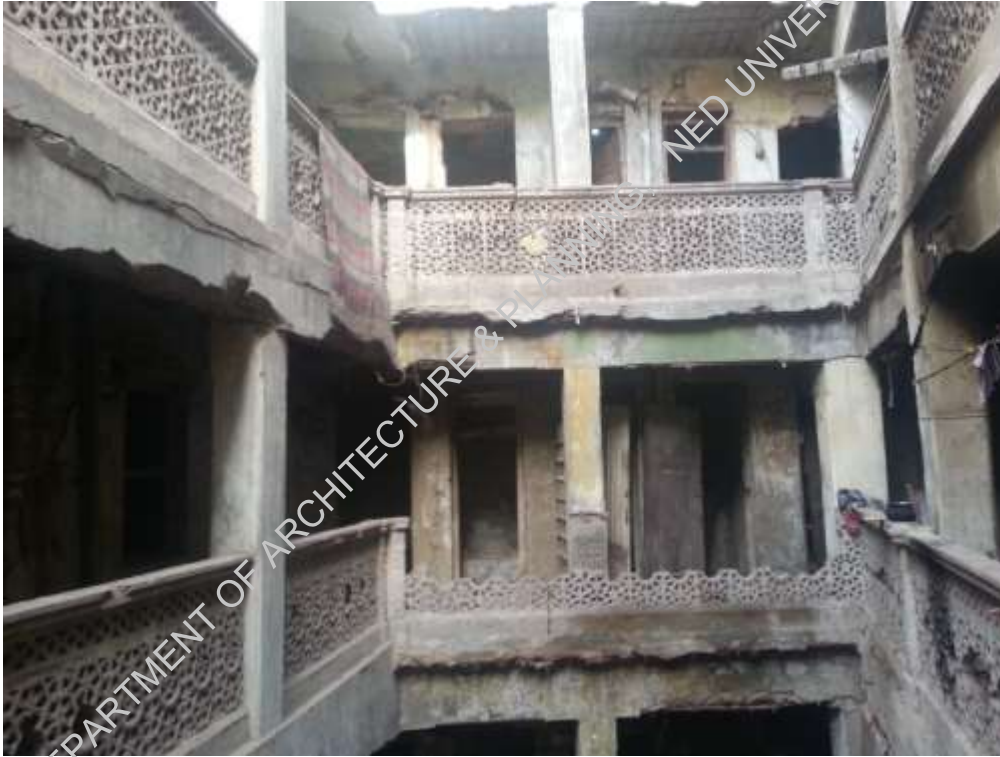
Plate-8: Central court being repaired and turned into RCC construction

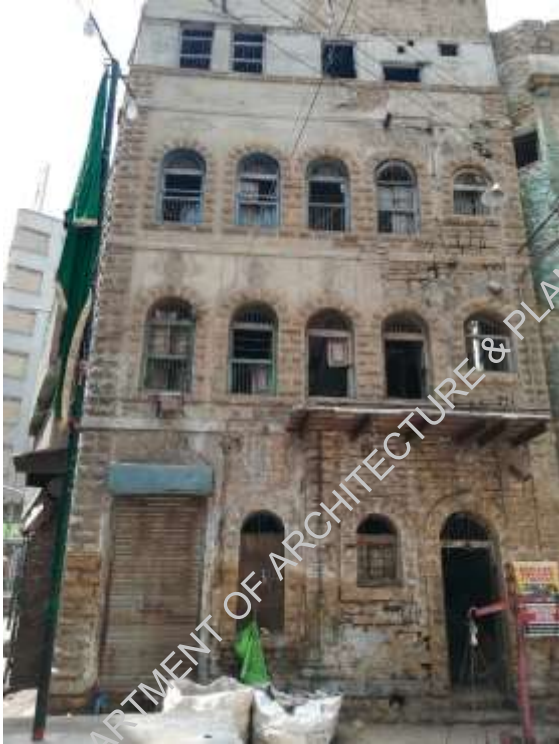
Plate-1: Front Façade- loose stone masonry can be noted at many places. Additional floor on top is also visible

- In existing condition, original building structure appears to be in need of moderate level of strengthening. However, additional floor on top should be removed to avoid any risk to existing structure due to additional stresses by its load.
- No major cracks in stone walls were noticed, hence it is anticipated that pointing work/joint repairs will strengthen the masonry walls.
- Interventions from roof top should be removed.
- Internal staircase and wooden decks need to be repaired as they are in very bad condition.

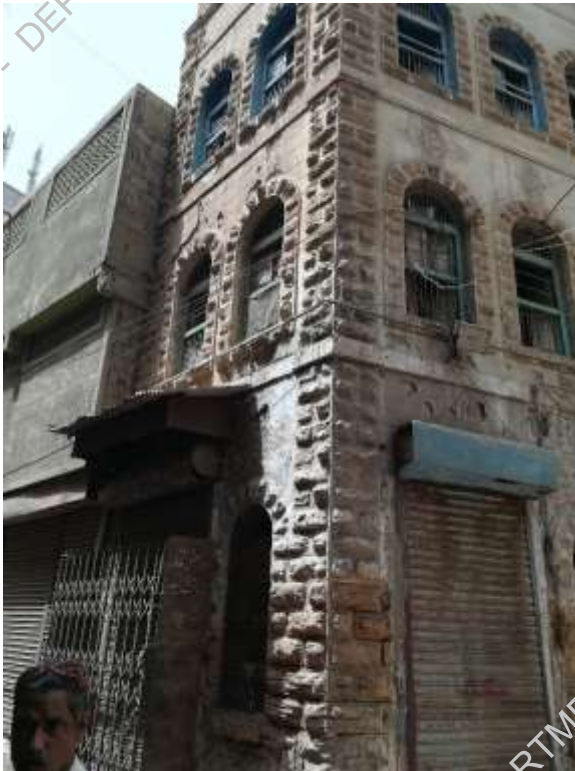
Plate-2: Side façade of building

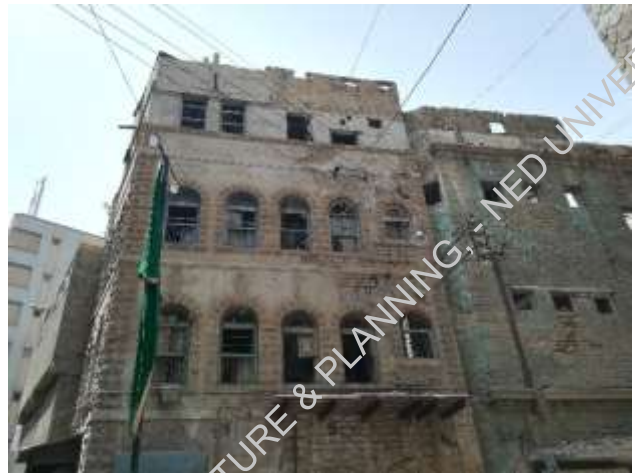
Plate-3: Front façade

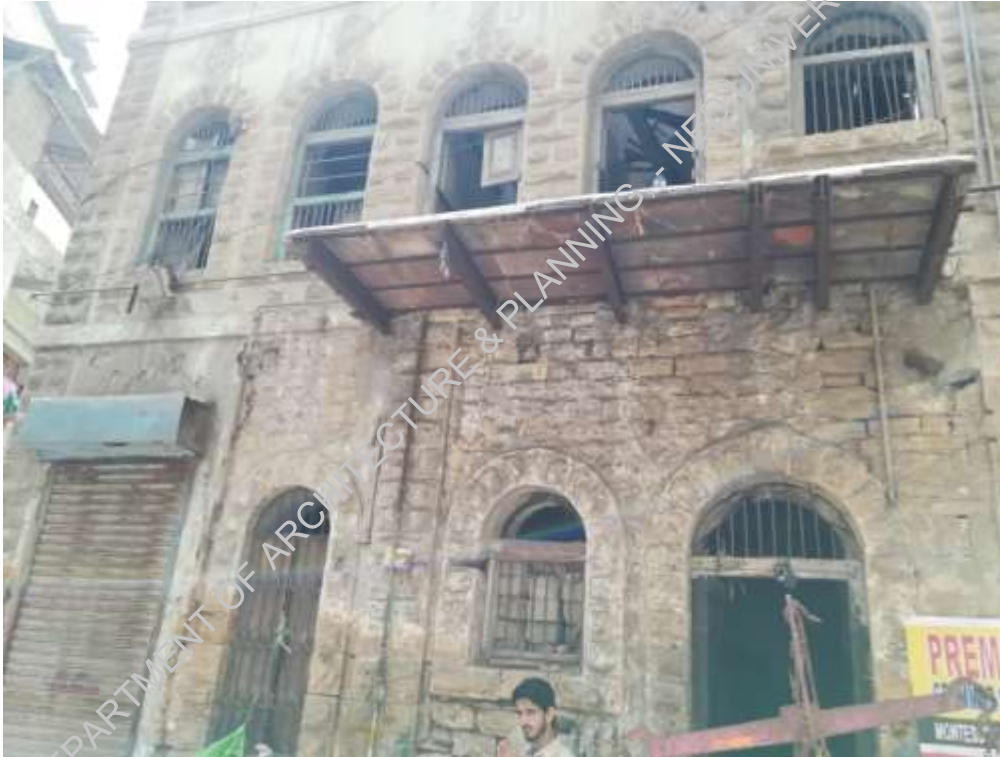
Plate-8: Bad condition of facade in front

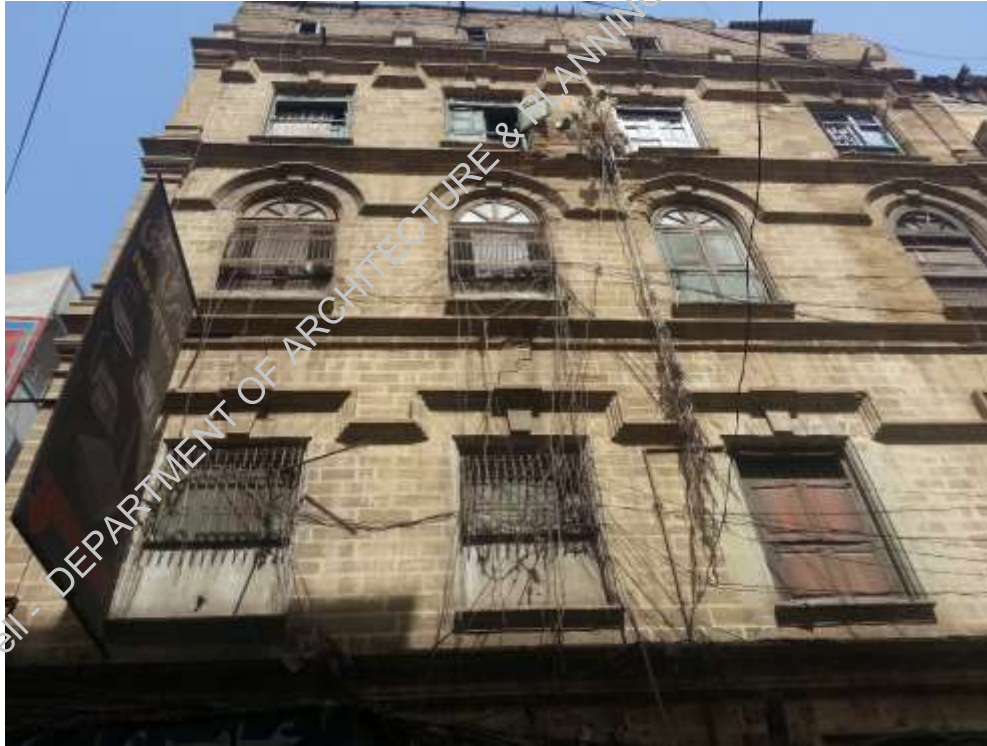
Plate-1: Front Façade- loose stone masonry can be noted at many places. Additional floor on top is also visible

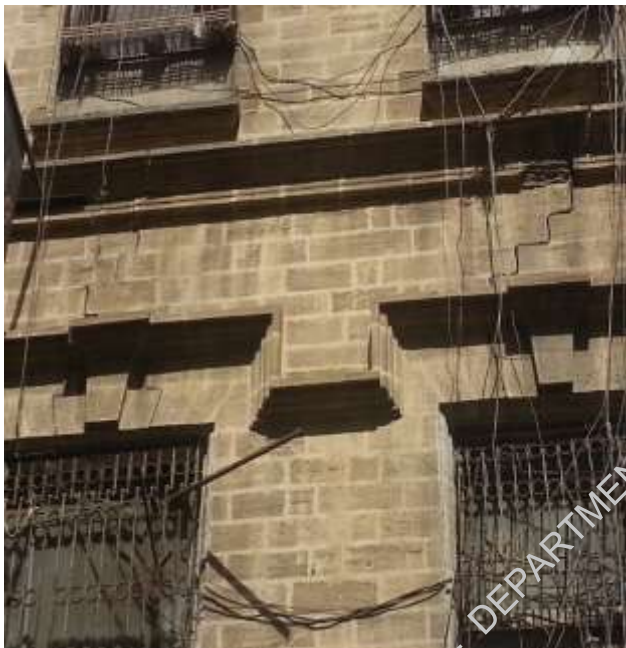
Plate-2: Wide cracks at façade

- In existing condition, building structure appears to be stable.
- Cracks are noticed in façade, which should be repaired.
- Concrete construction done later on is in bad condition and needs major repair.

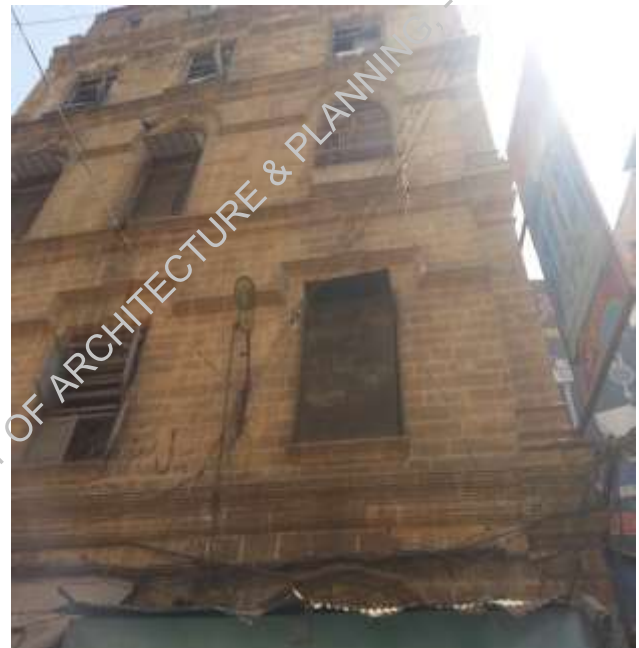
Plate-3: side façade

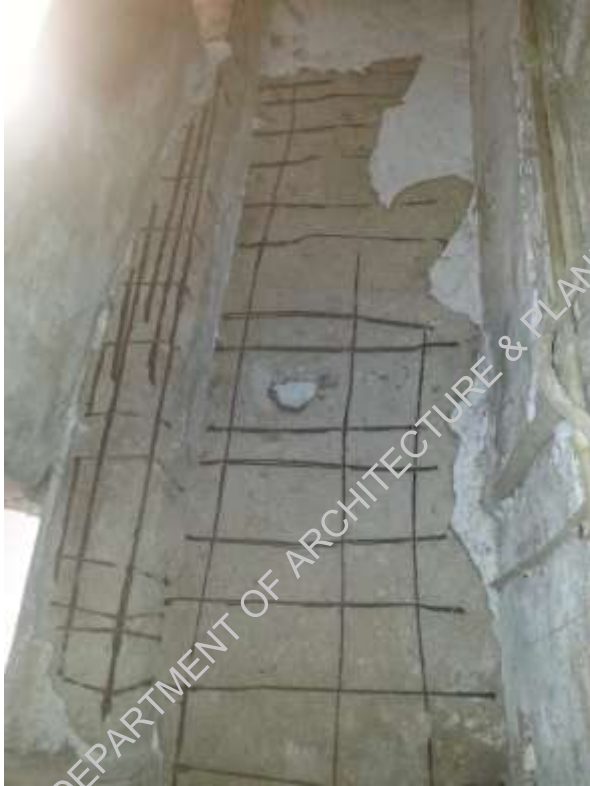
Plate-4: reinforced concrete slab in bad condition, concrete cover has fallen off.

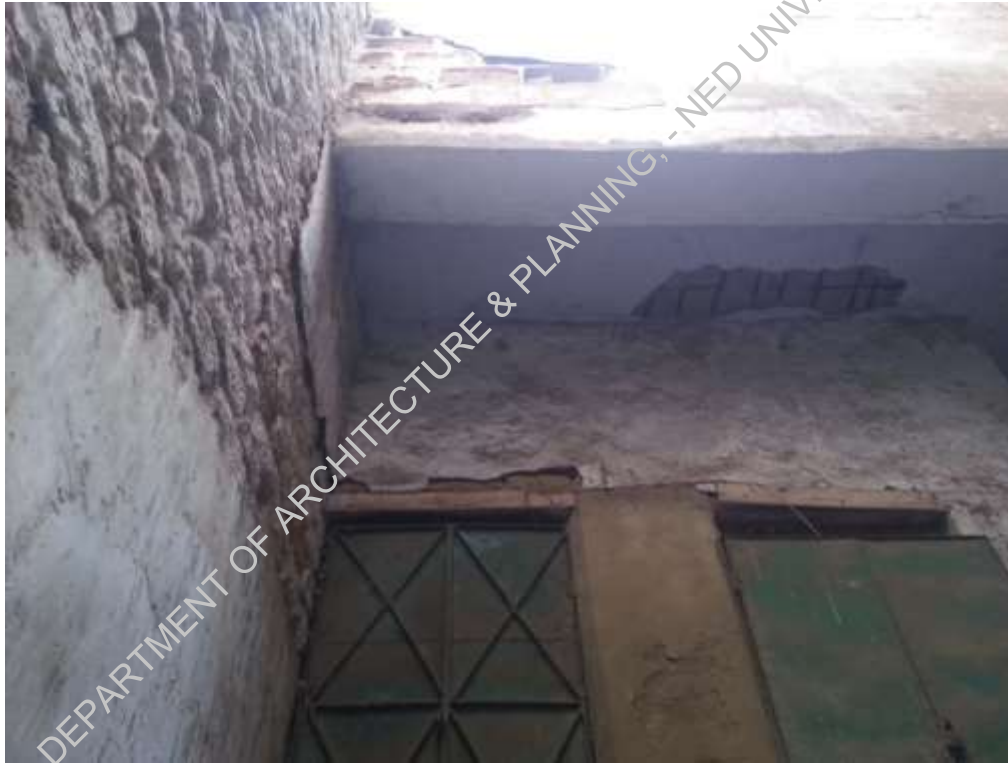
Plate-6: Loose stone masonry is visible

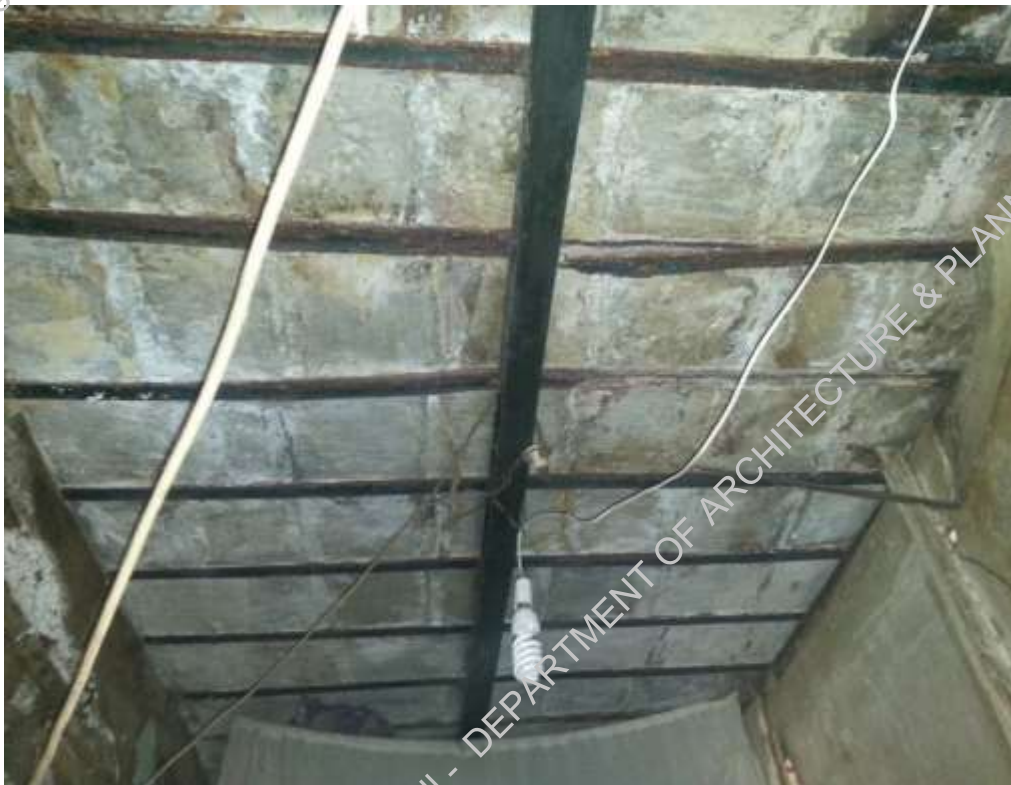
Plate-7: Bad condition of roof slab due to punctures and seepage from plumbing lines

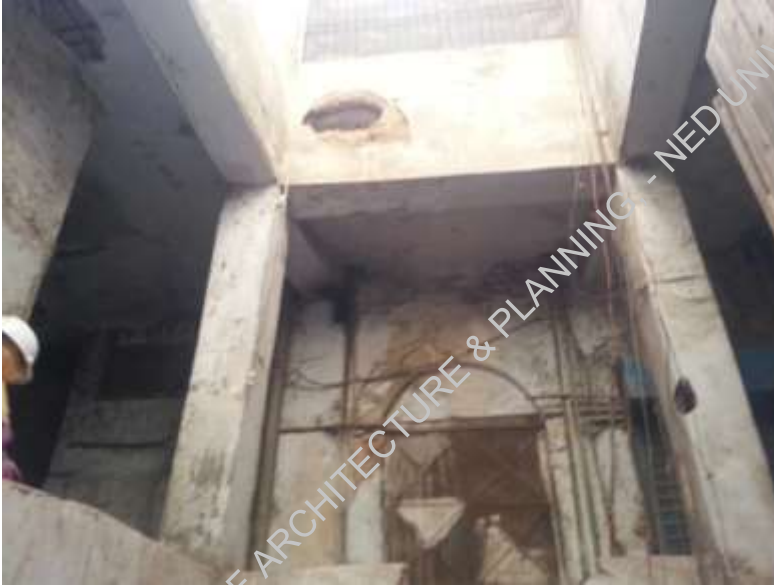
Plate-8: Central court being turned into RCC construction

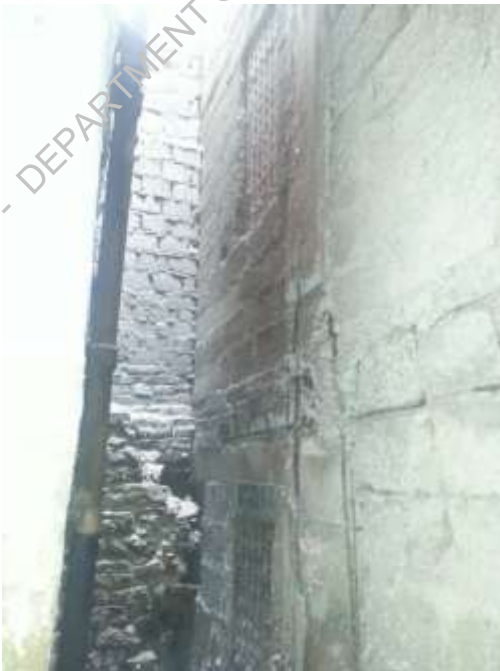
Plate-9: condition of reinforced concrete construction of central court

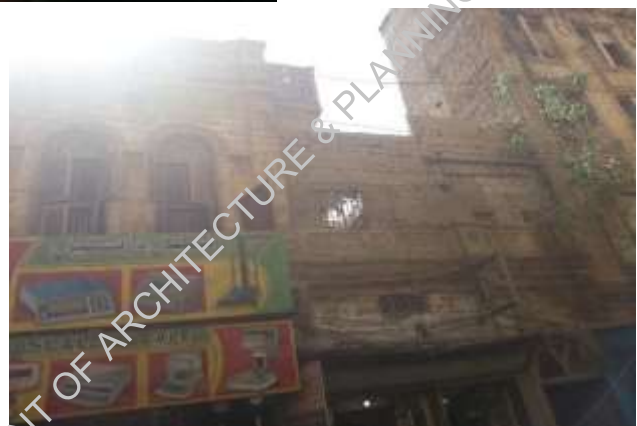
Plate-3: Wide cracks at the side façade of building

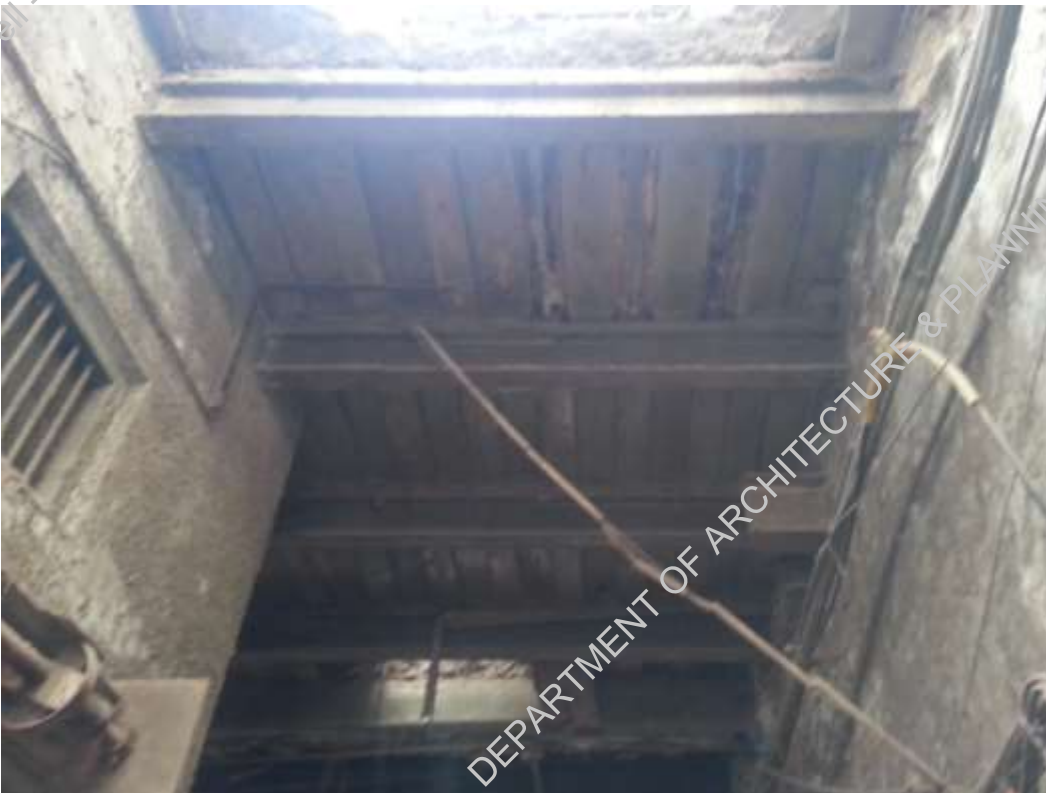
Plate-5: slab crumbling

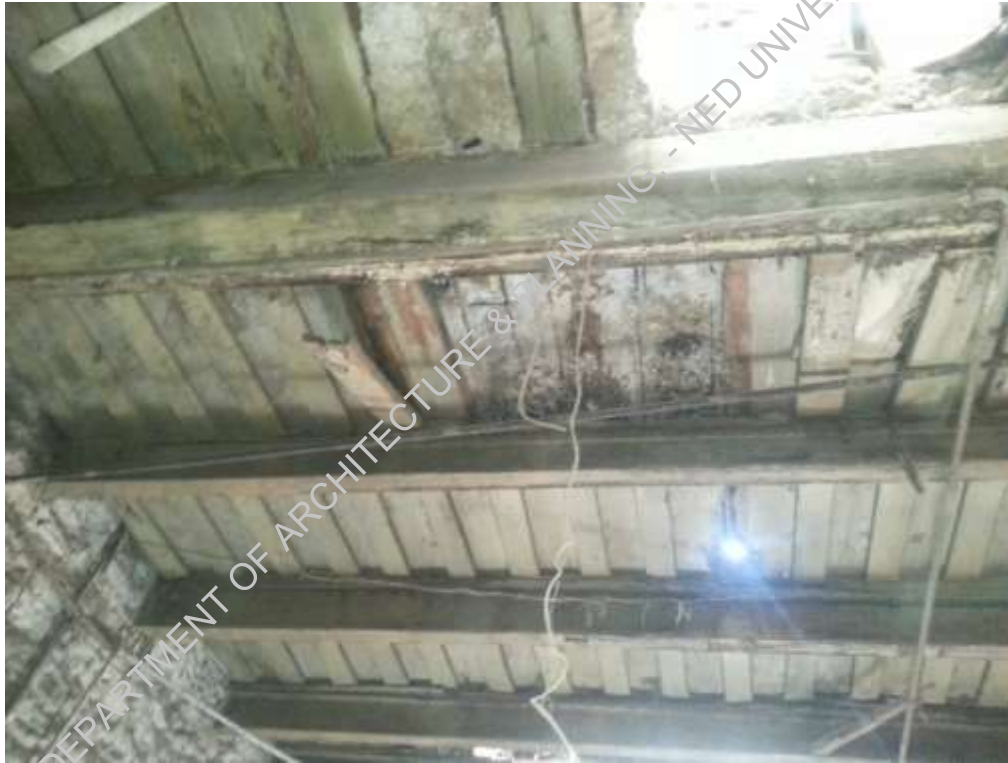
Plate-6: Bad condition of original timber flooring and walls at ground floor

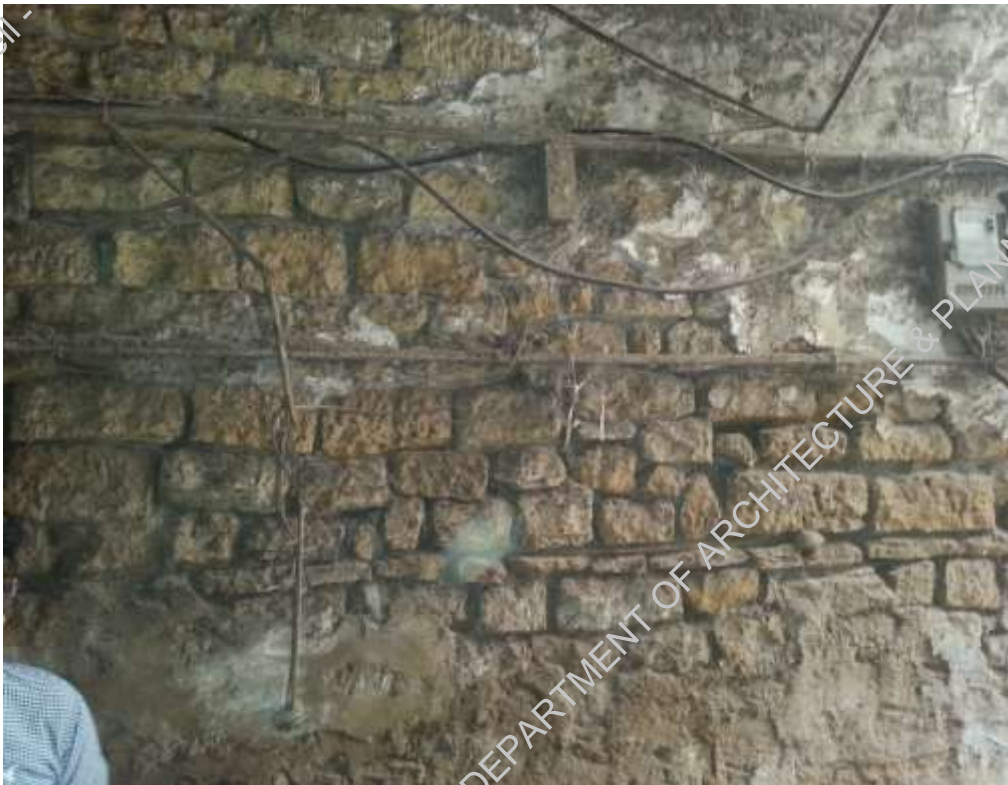
Plate-7: Bad condition of masonry

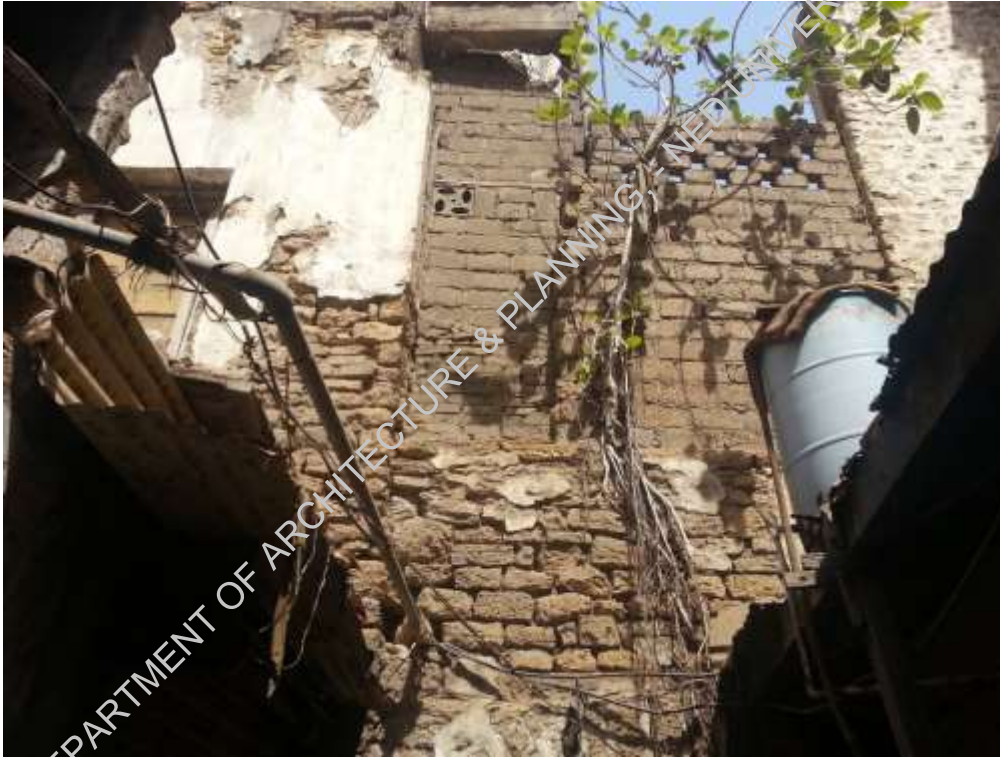
*Plate-8: Central
court plantation
with in the wall*

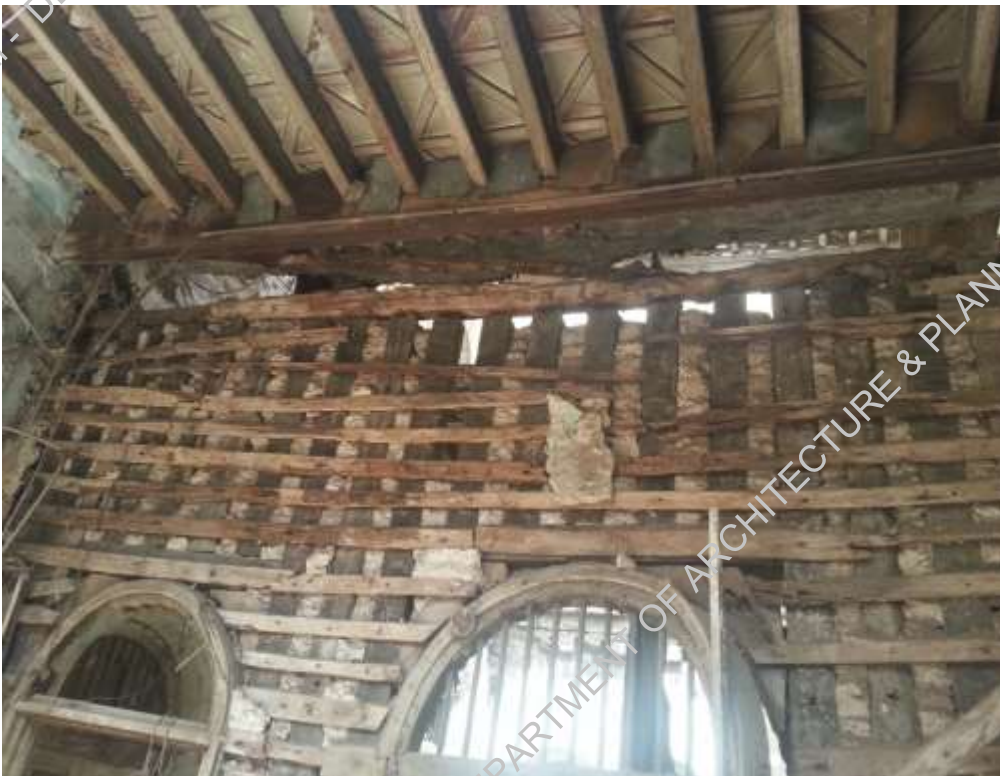
*Plate-9:
strengthening
done at any later
stage*

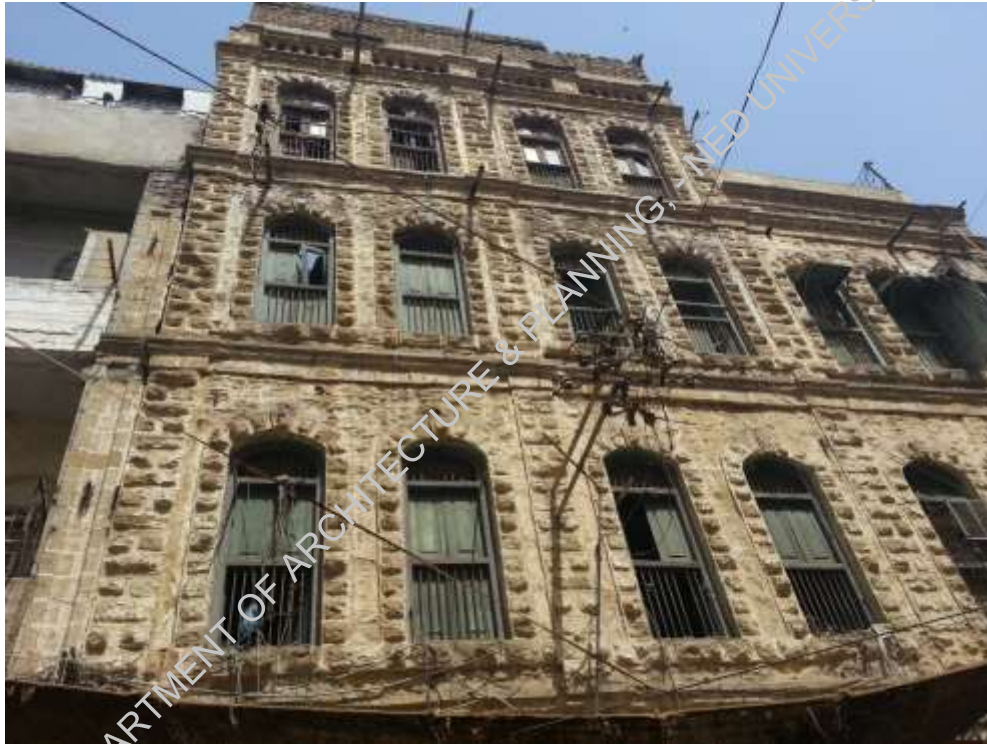
Plate-1: Front Façade- loose stone masonry can be noted at many places. Additional floor on top is also visible

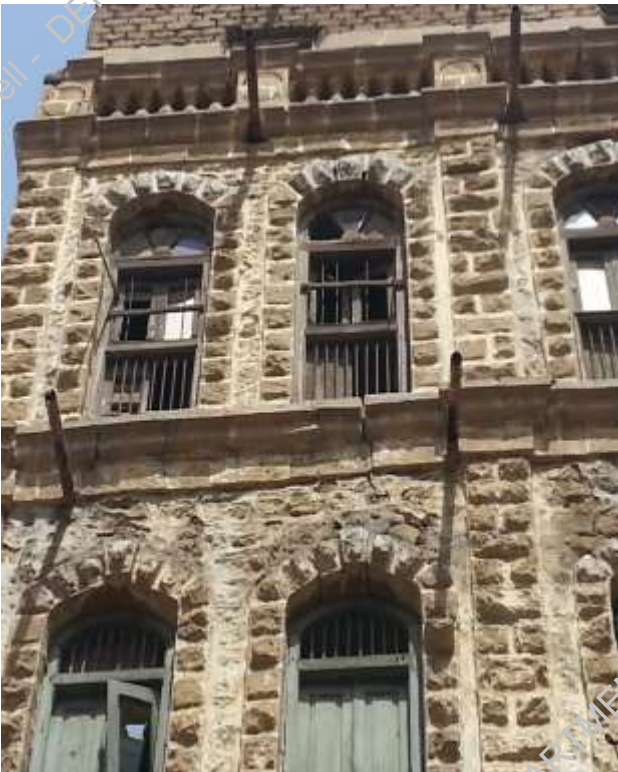
Plate-2: Wide cracks at the façade of building
