Condition Assessment of Heritage Buildings - Karachi Declared as “Dangerous”

JUNE 2018

Structural Consultant

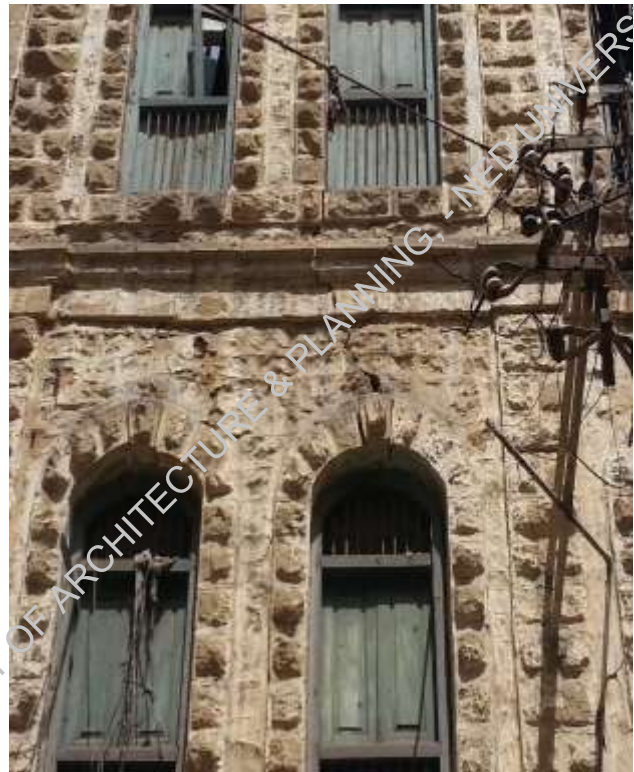
Plate-3: Wide cracks

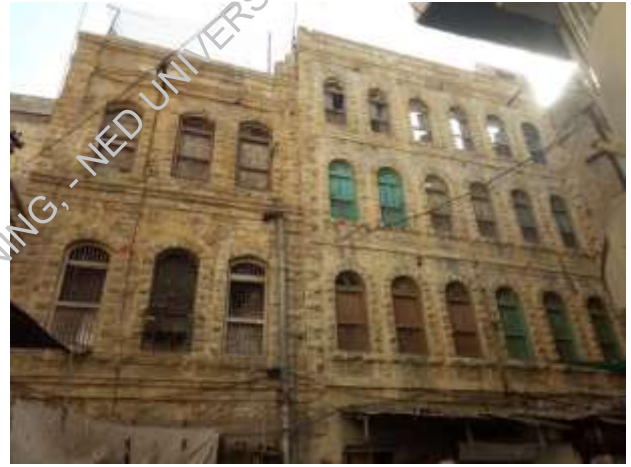
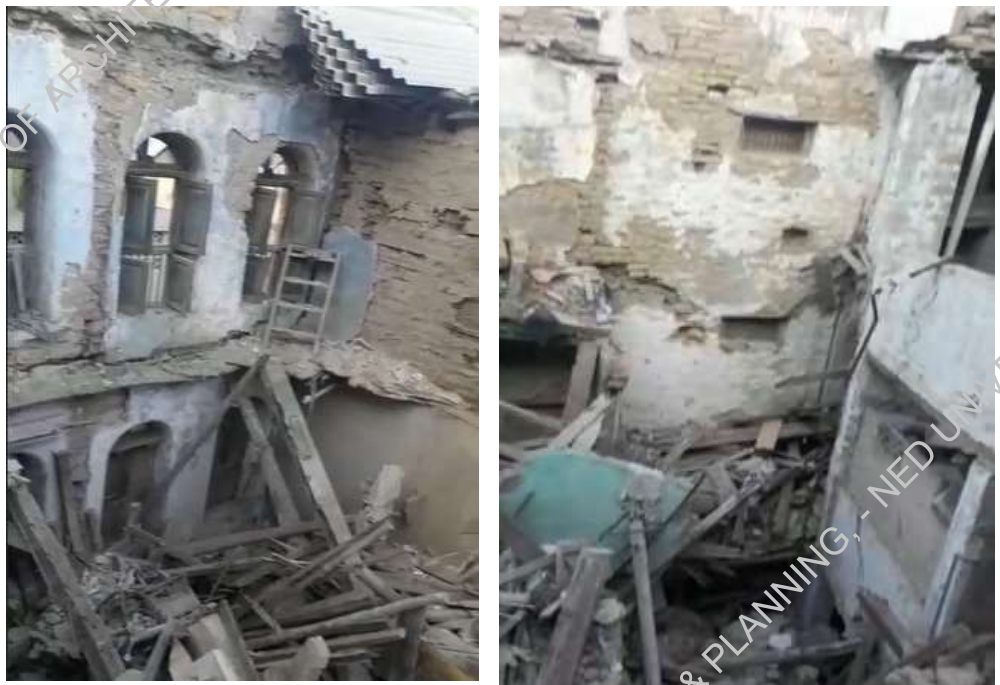
*Plate-5 & 6:
collapsed*

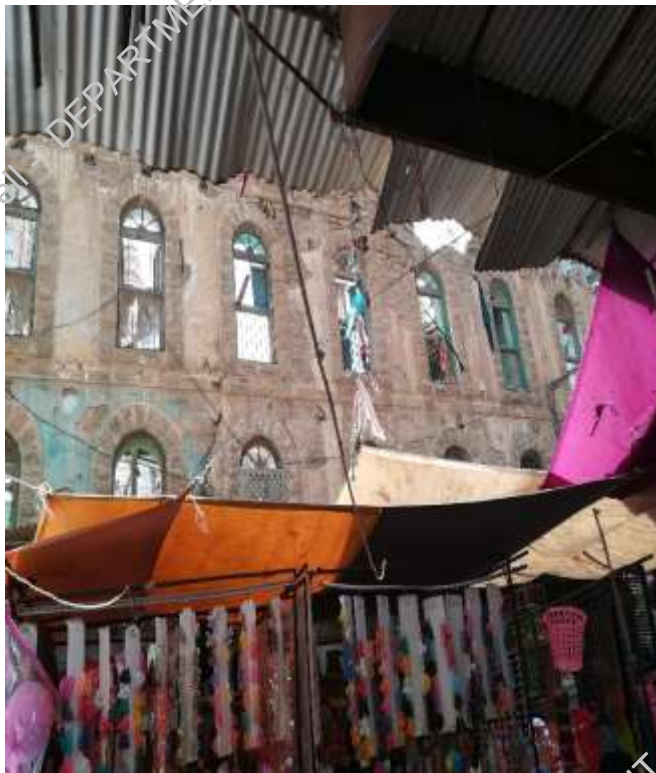
Plate-2: Wide cracks at the façade of

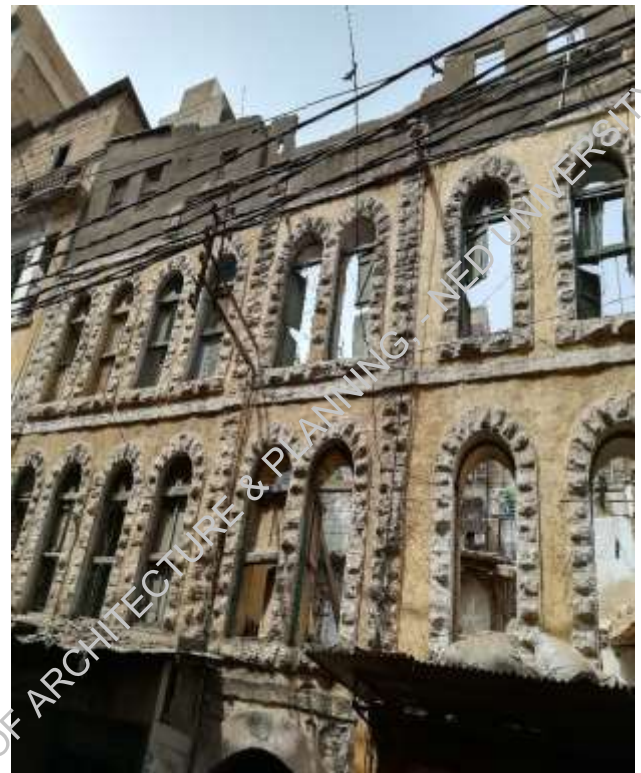
Plate-3: façade rear side

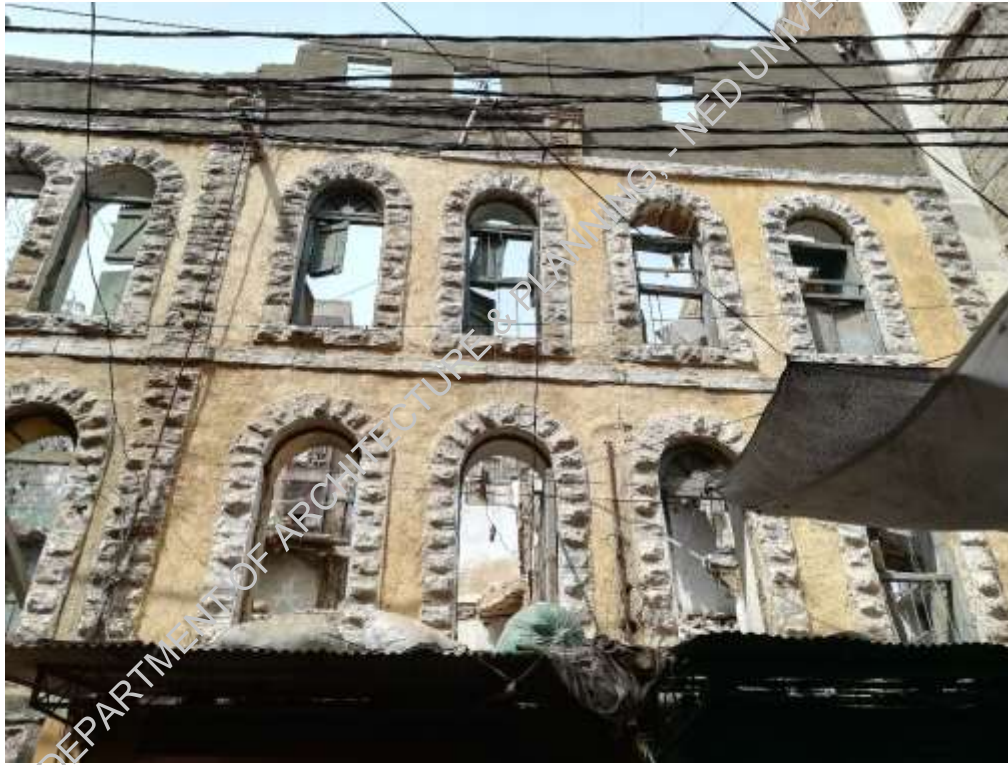
*Plate-6: Loose
stone masonry is
visible*

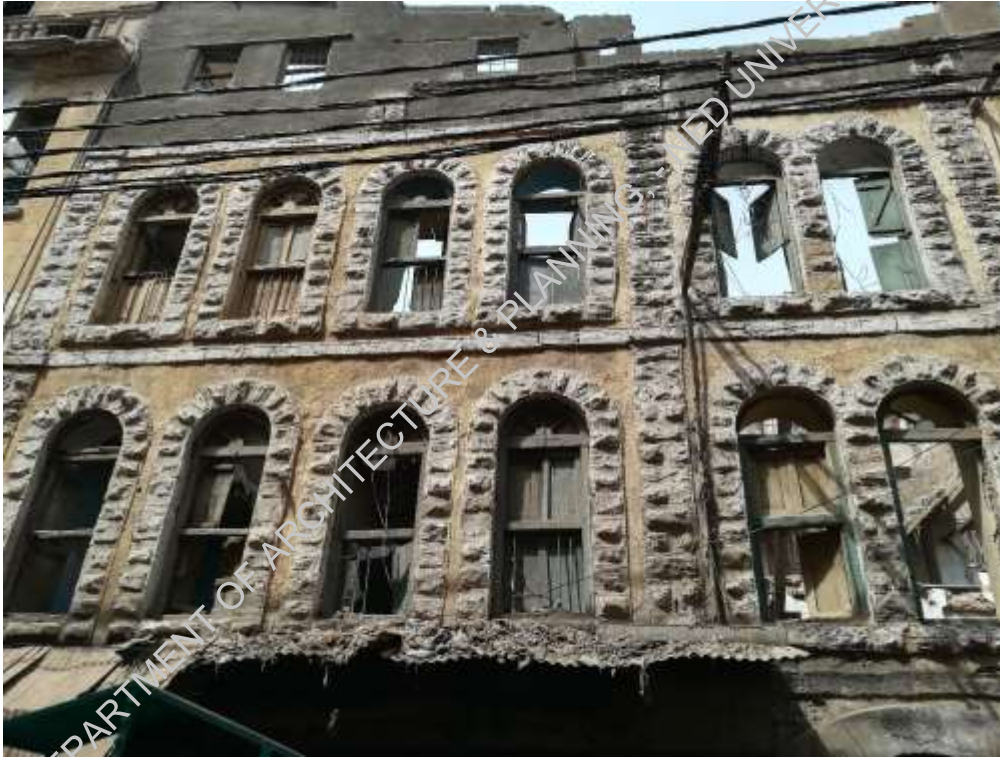
*Plate-8: masonry
at rare façade in
bad condition*

- Only façade wall is intact with masonry intervention on top, whereas internal structure has collapsed. Hence the façade is also unstable in current condition and needs major repairs to hold it.

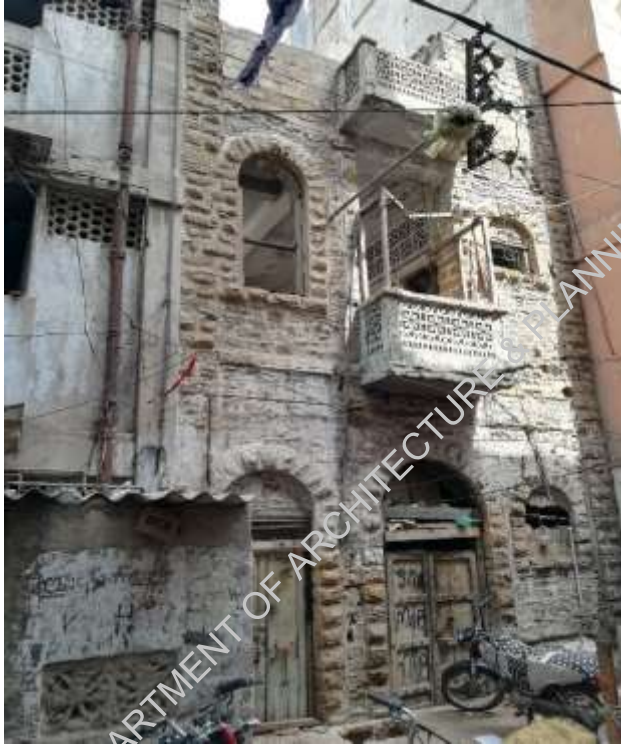
Plate-1: Front Façade- loose stone masonry can be noted at many places. Additional floor on top is also visible

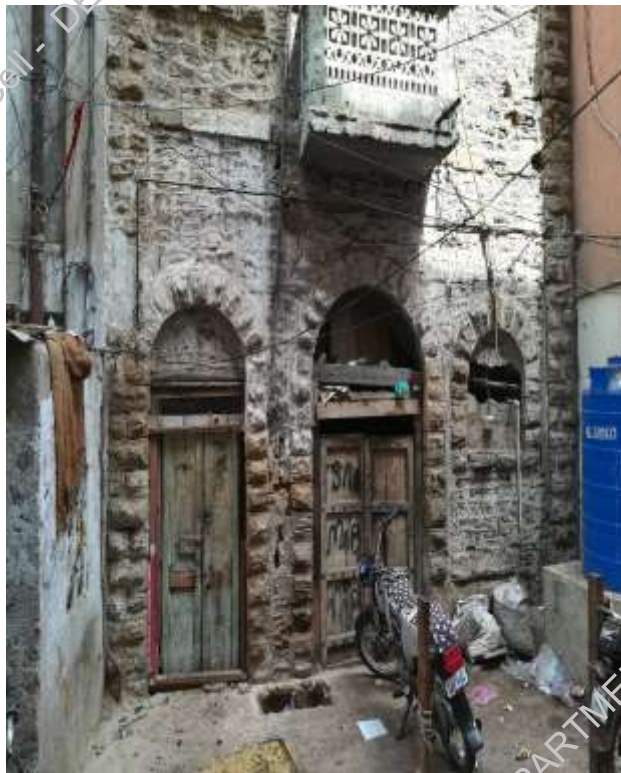
Plate-2: Wide cracks at the rear façade of building before collapse

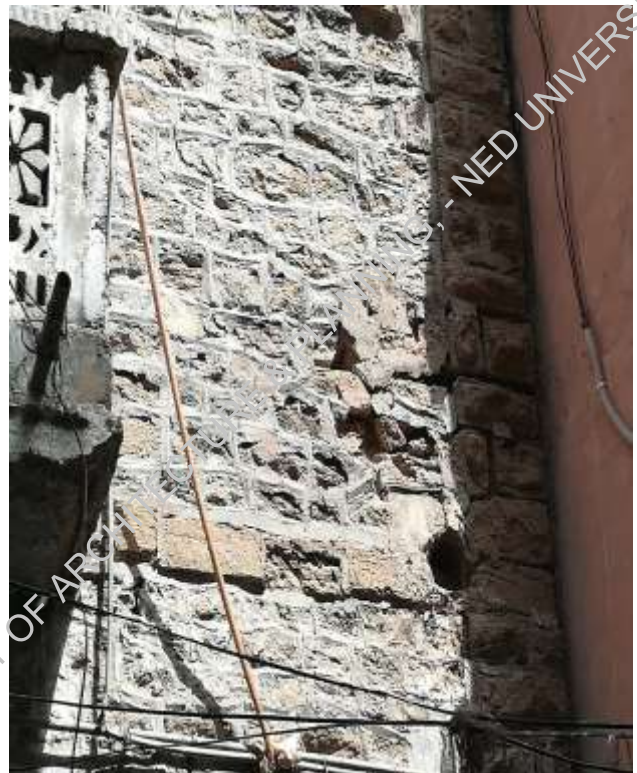
Plate-3: After collapse of rear side

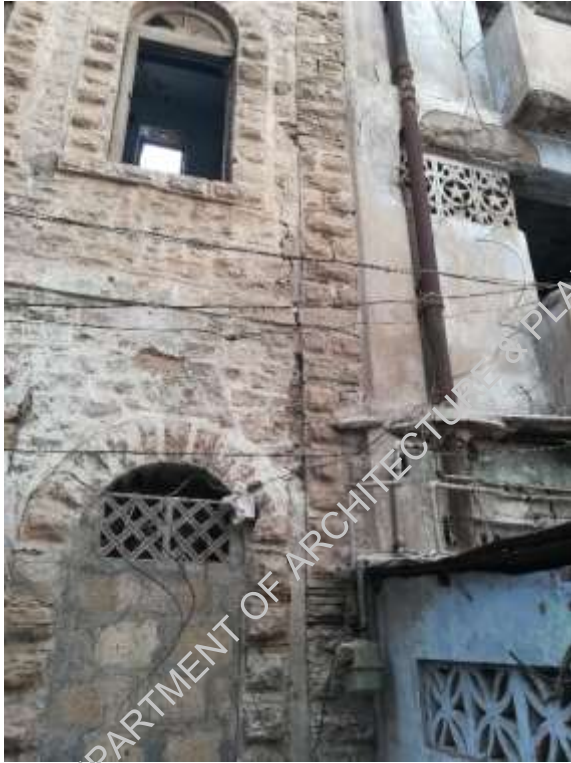
Plate-6: Loose stone masonry is visible

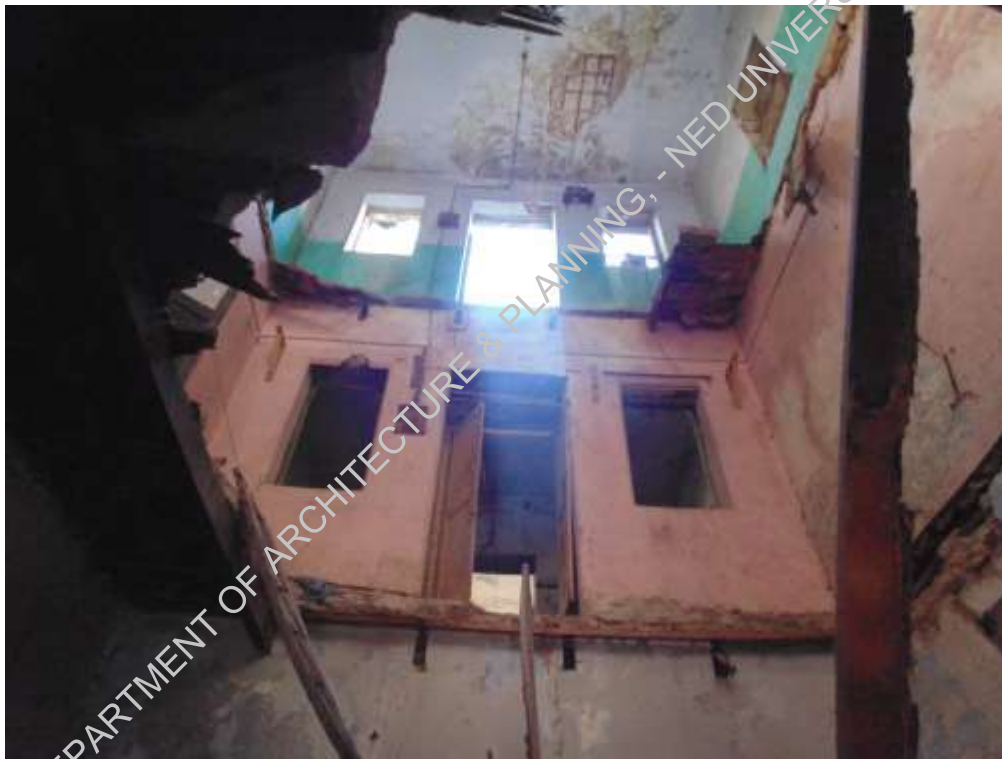
Plate-8: Central court being turned into RCC construction

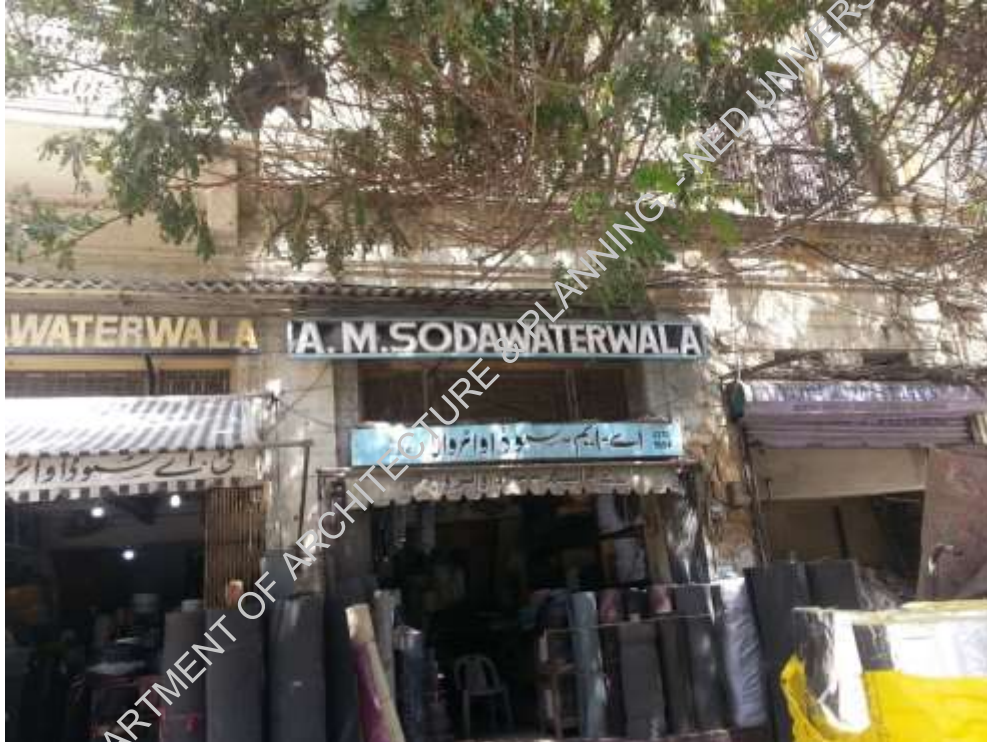
Plate-1: Front
Façade-

- The original building is ground plus two stories Refer Plate-1.
- On front façade, no signs of distress were observed.
- The ground floor slab and beams were also intact.
- Building appears to be in good condition.

- Building appears to be in good condition
- Minor repair works are needed to restore the building to its original glory.

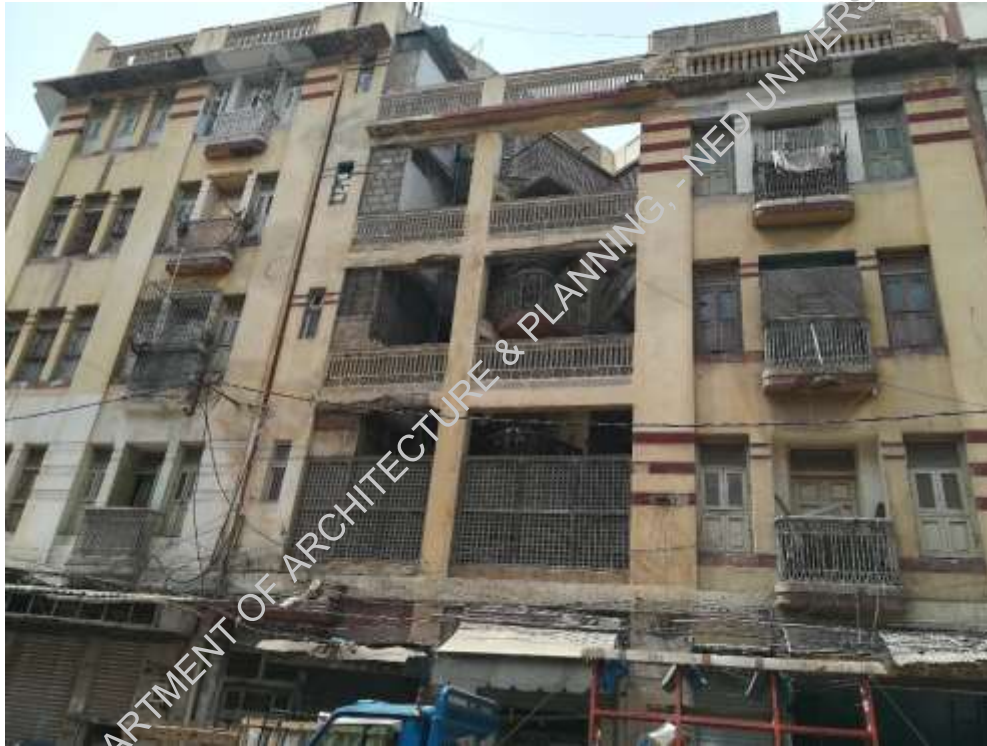
*Plate-1: Front
Façade-*

- Building appears to be in good condition. Refer Plate-1, 2, 3.
- Floor decking is also in good condition.
- At few places, concrete cover is fallen off from RC projections due to poor maintenance.
- Staircase was replaced with RCC and is in good condition.

- In existing condition, building appears to be stable.
- Minor repair work in reinforced concrete construction can restore the structure.

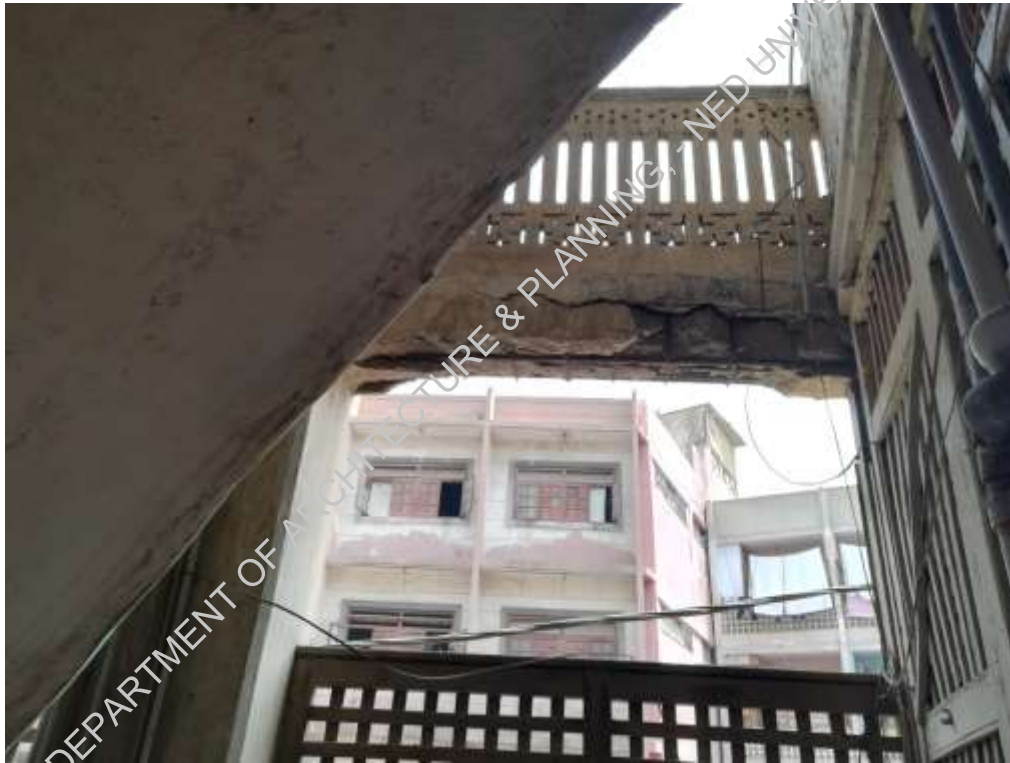
Plate-6: poor maintenance

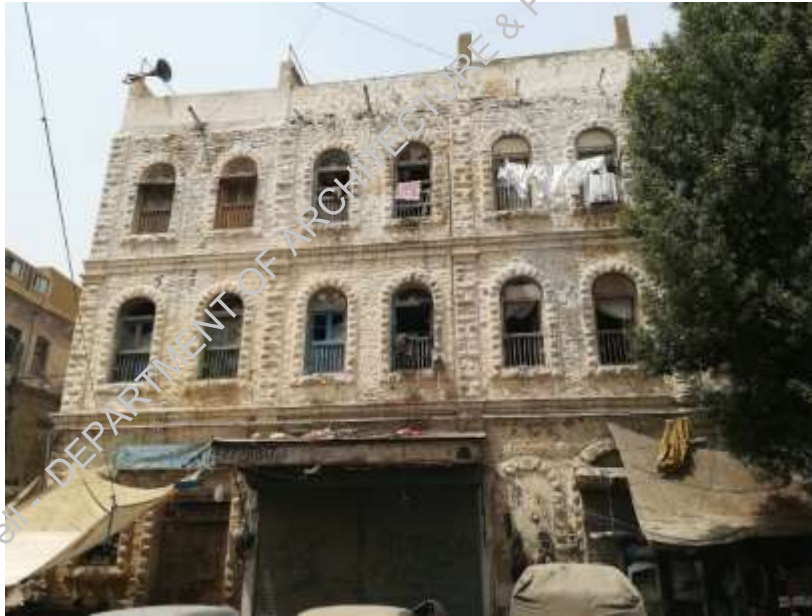
- The original building is ground plus two stories. Refer Plate-1.
- On front façade, loose stone masonry can be noticed at a few locations and cracks were noticed on the first floor.

Plate-1: Front Façade- loose stone masonry can be noted at many places.

- In existing condition, building structure is not dangerous but needs major repairs.
- Extensive strengthening of internal reinforced concrete structure is required to make the structure stable. Strengthening measures to be done with careful methodology which will include propping of existing walls/floors before proceeding with any strengthening technique.
- Interventions should be removed such as the additional floor on top and extra floor finishes where present, to decrease the dead load on existing walls,
- Strengthening techniques can be adopted, including but not limited to;
 - a. Pointing of mortar in existing stone masonry joints,
 - b. Application of mesh plaster
 - c. Introducing internal mild steel frame within the building to secure the occupants from fatal damages.

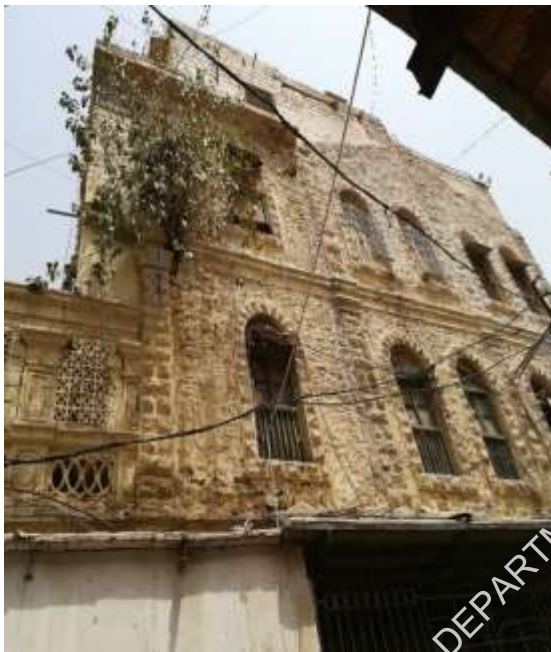
- Vegetation was visible on front façade widening the crack from its origin.
- In most of areas, reinforced concrete floor laid later on, was found in bad condition with concrete cover fallen off.
- In central courtyard, Reinforced concrete construction, which was done later-on, was found in bad shape. The rebar is exposed.
- The ground floor is partially occupied by shop keepers
- The building is spread over wide area.

Plate-2: Wide cracks at the façade of building

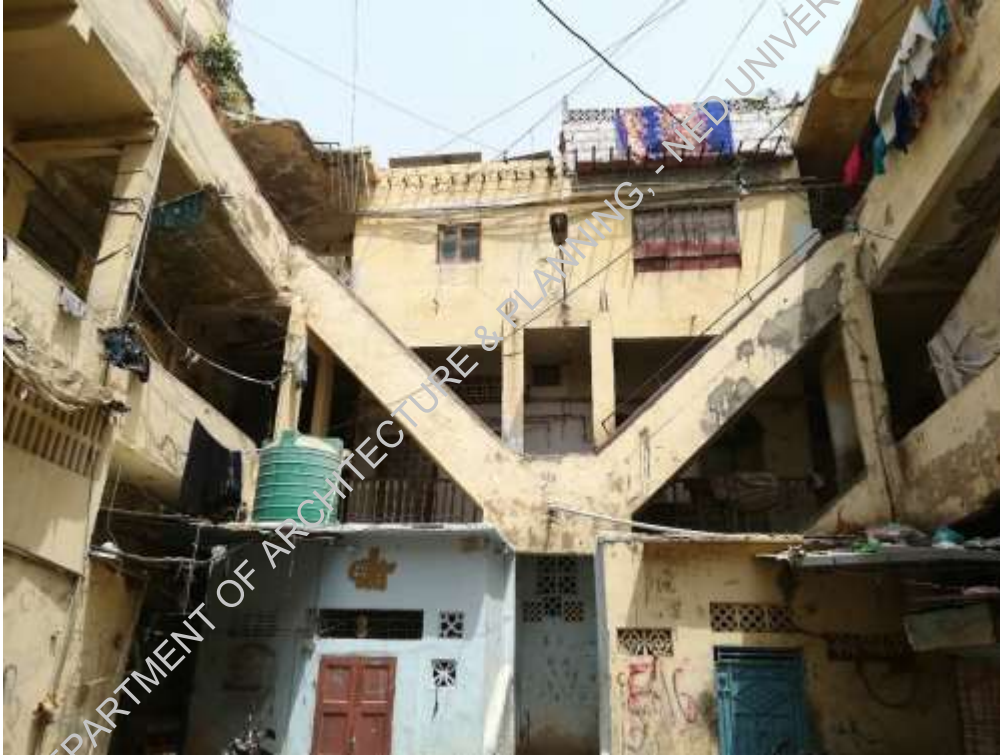
Plate-6: Central court being turned into RCC construction

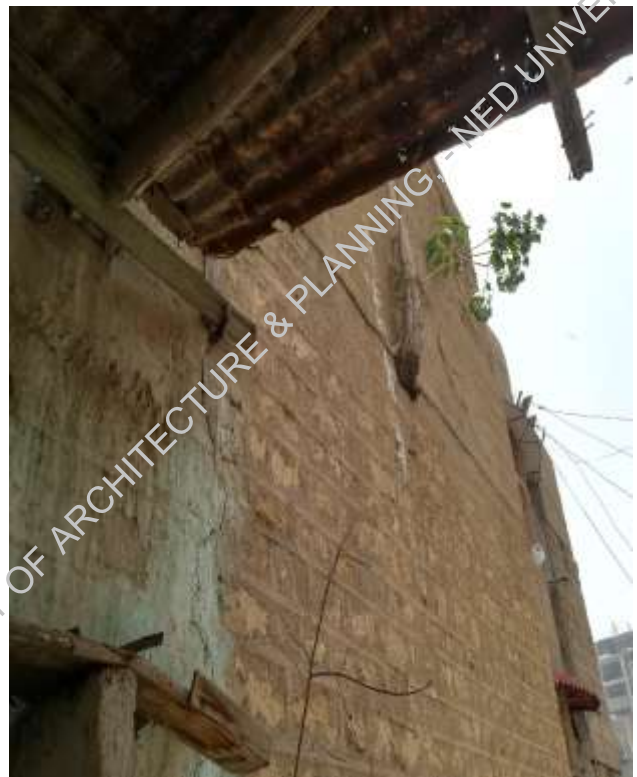
- The original building is ground plus 1 story with partial intervention of the roof story, added sometime later. Refer Plate-1.
- Façade appears to be ok but wooden projections/balconies were in bad shape.
- On Rear façade from inside plantation can be observed growing from the wall causing cracks to form Refer Plate-3.
- The vertical crack is observed inside and the timber slab is deflecting in various places.

Plate-3: After collapse of rear side

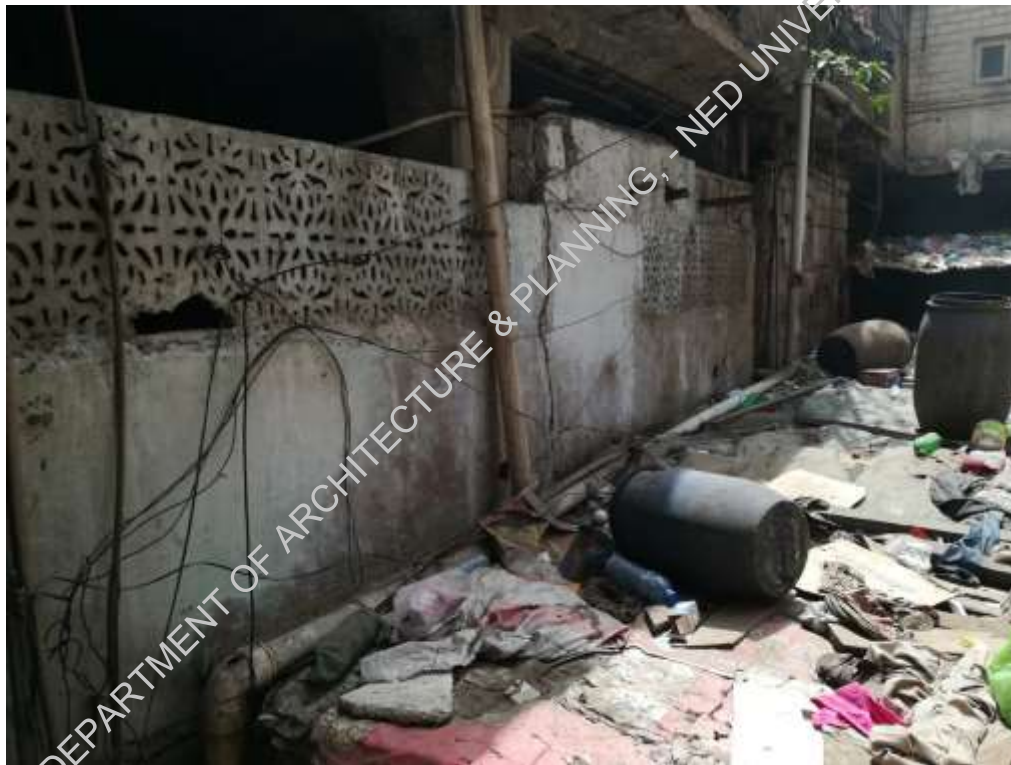
Plate-6: Loose stone masonry is visible

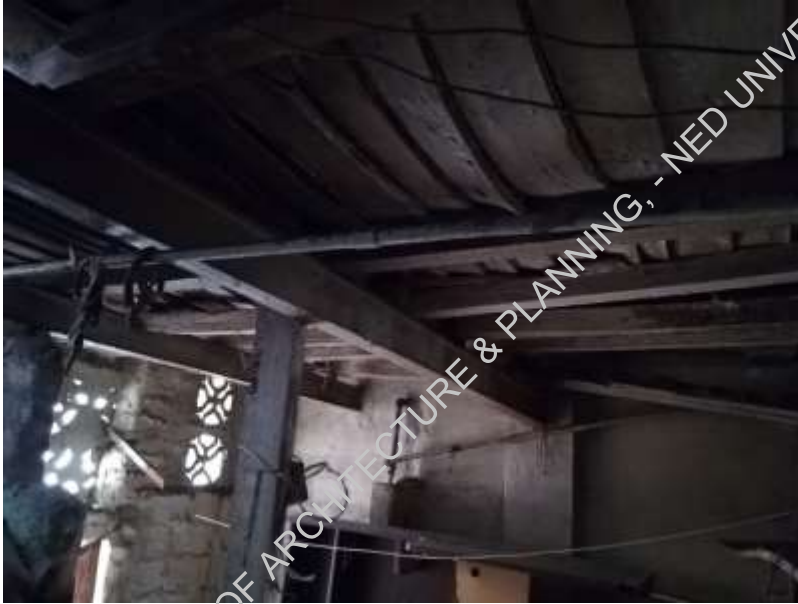
Plate-8: Central court being turned into RCC construction

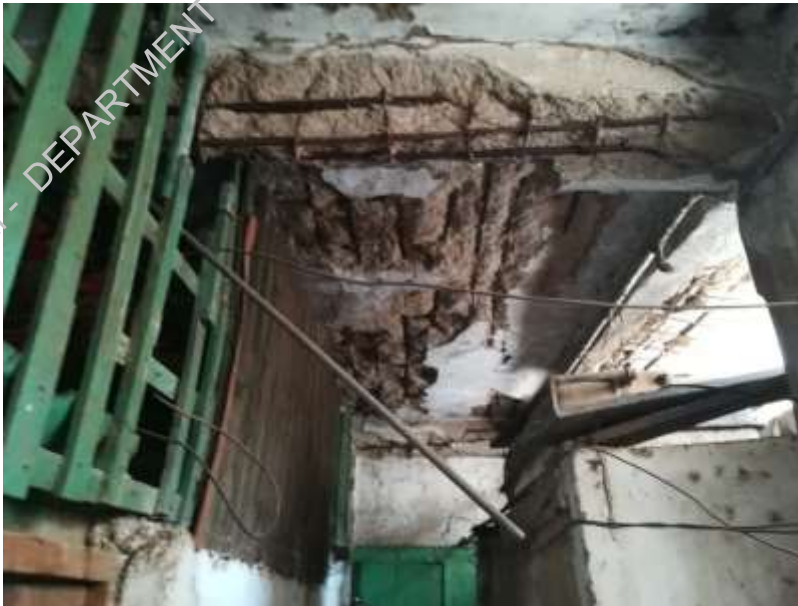
Plate-9: Bad condition of reinforced concrete construction of central court

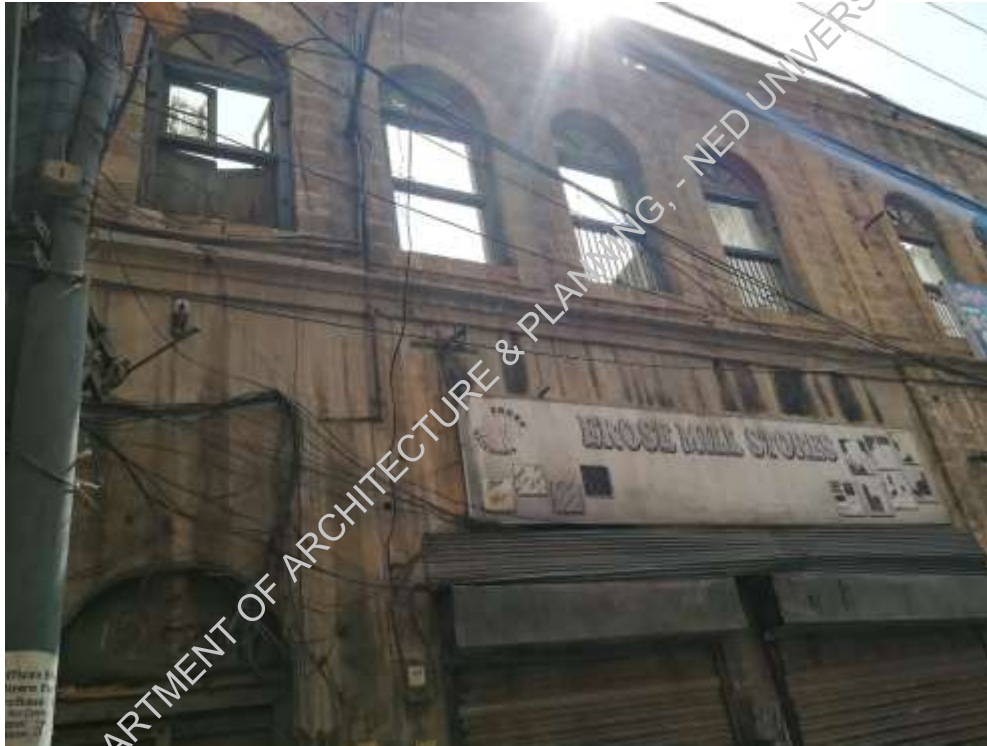
- The original building is ground plus 1 story. Refer Plate-1.
- On front façade, loose stone masonry can be noticed at a various locations and cracks were also noticed.
- In most of areas, reinforced concrete floor laid later on, was found in bad condition with concrete cover fallen off.
- In major part of building, roof structure inside has been removed making façade wall unsupported.
- The building is spread over wide area.

Plate-1: Front Façade- loose stone masonry can be noted at many places.

- In existing condition, building structure is not stable and is susceptible to failure/collapse.
- Extensive strengthening is required to make the structure stable. Strengthening measures to be done with careful methodology which will include propping of existing walls/floors before proceeding with any strengthening technique.
- Interventions should be removed such as extra floor finishes where present, masonry walls or additional built-ups, to decrease the dead load on existing walls,
- Strengthening techniques can be adopted, including but not limited to;
 - a. Pointing of mortar in existing stone masonry joints,
 - b. Application of mesh plaster
 - c. Introducing internal mild steel frame within the building to secure the occupants from fatal damages.

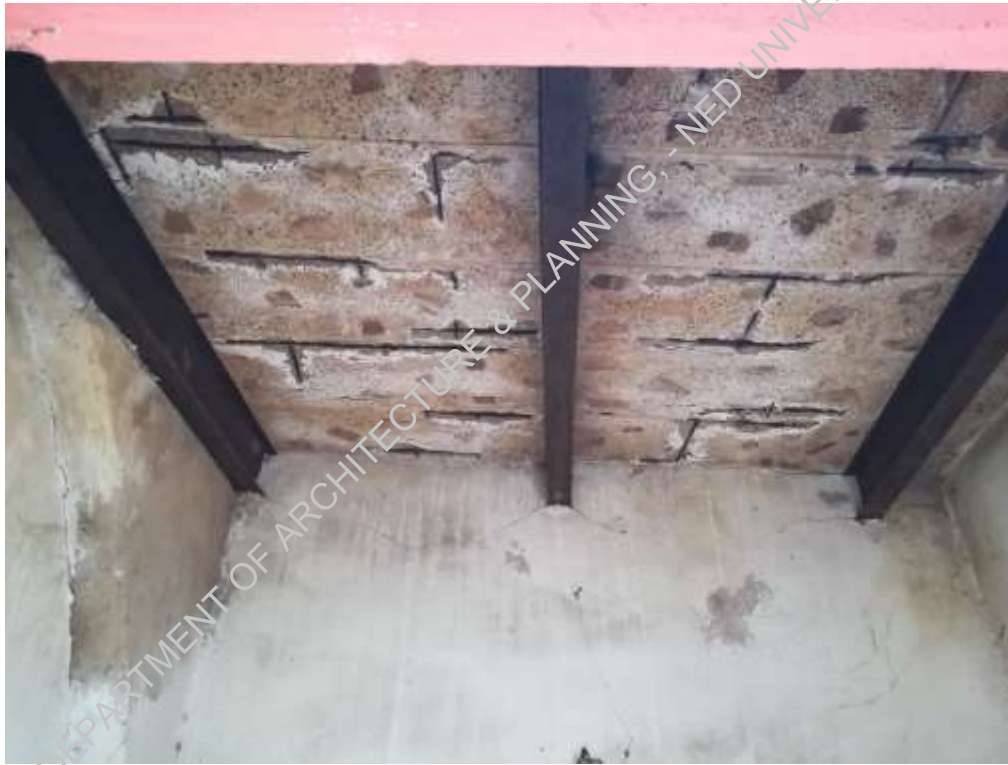
Plate-6: Concrete construction done later on, in bad condition

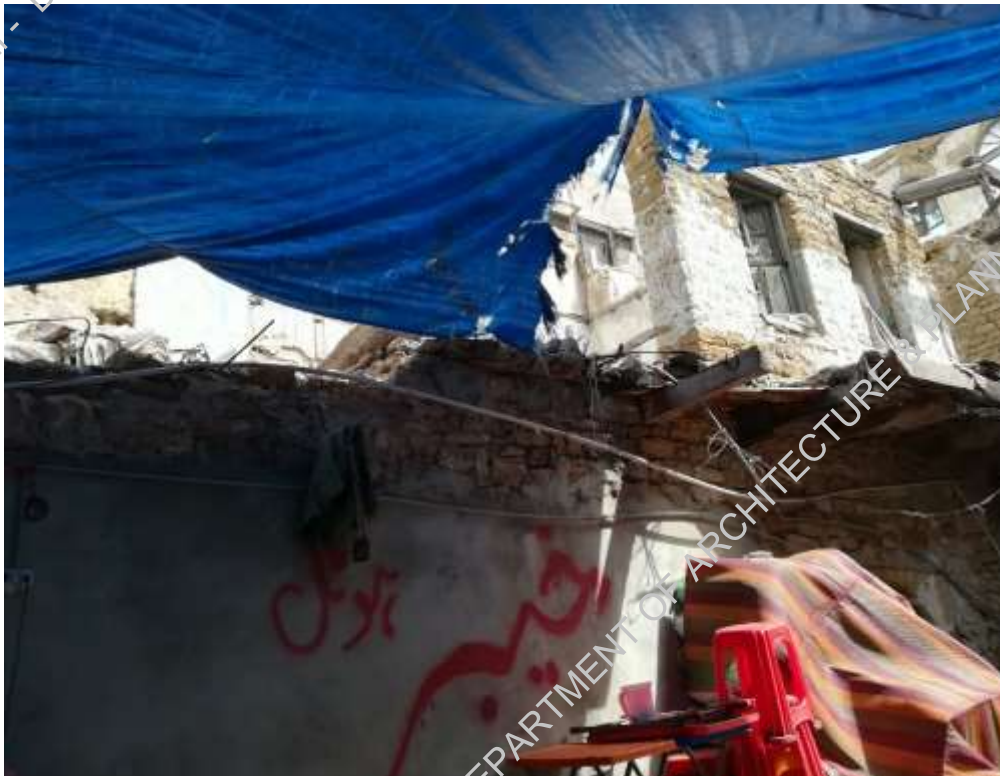
*Plate-9: slab
broken*

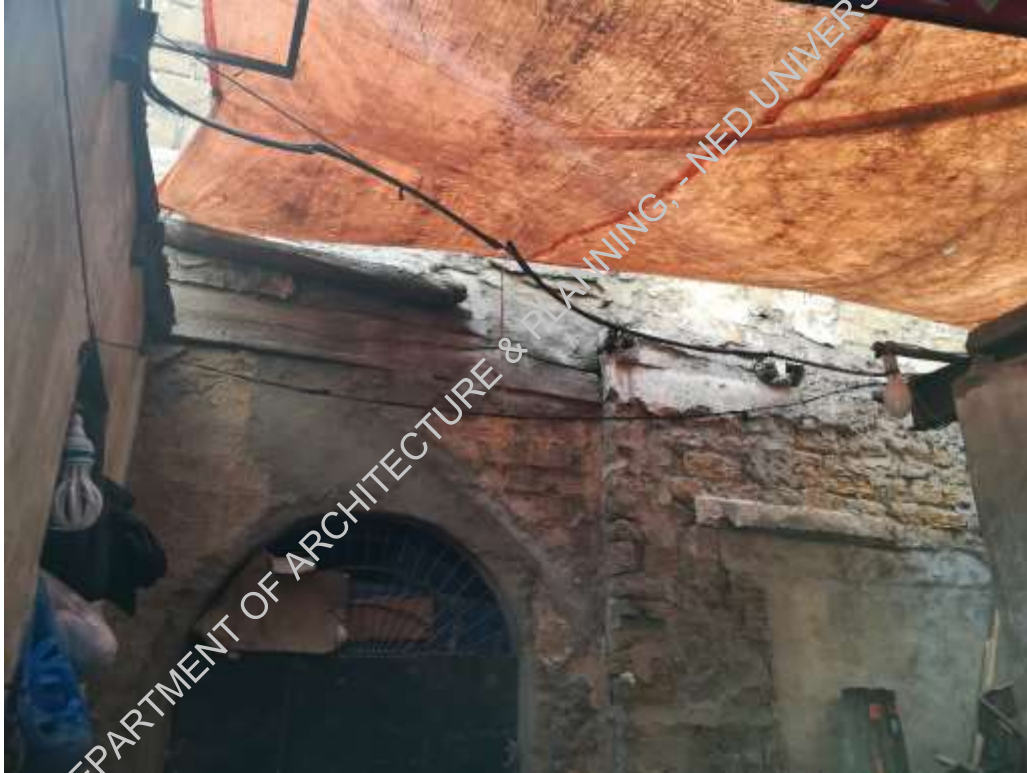
Plate-10: Loose masonry visible

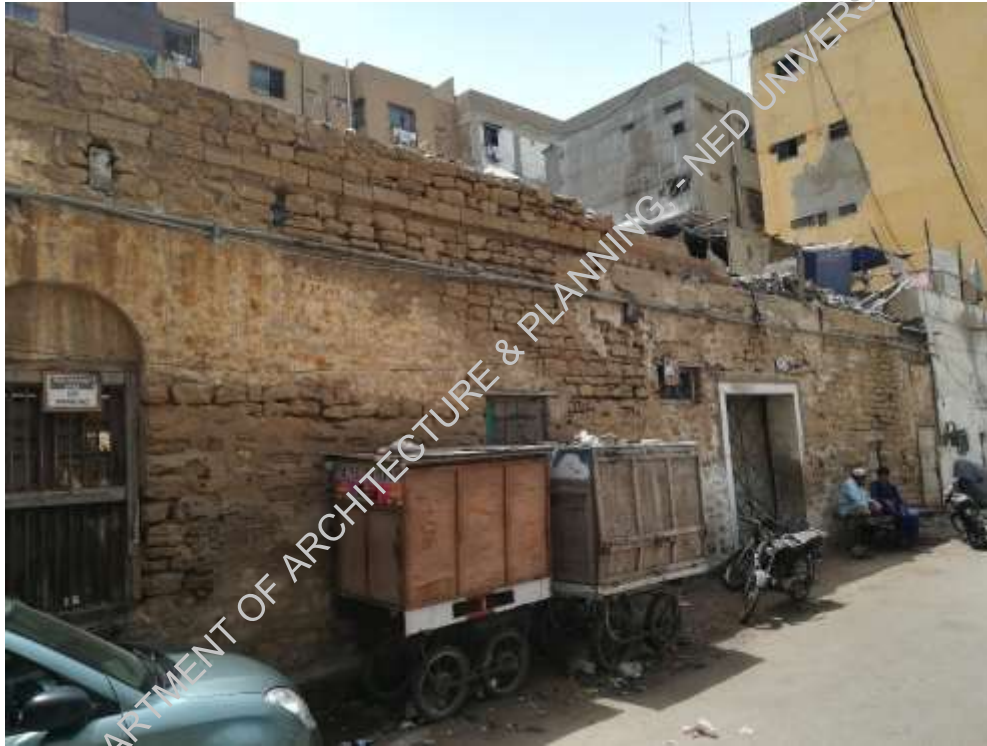
- The original building is ground floor only. Refer Plate-1
- Stone seems to be loose and mortar in joints have been eroded.

Plate-1: Front Façade- loose stone masonry can be noted at many places.

- Being only ground floor, the structure can be made stable by pointing of mortar in joints and/or stone repair works.
- Roof can also be replaced with new framing/sheets to restore the building.

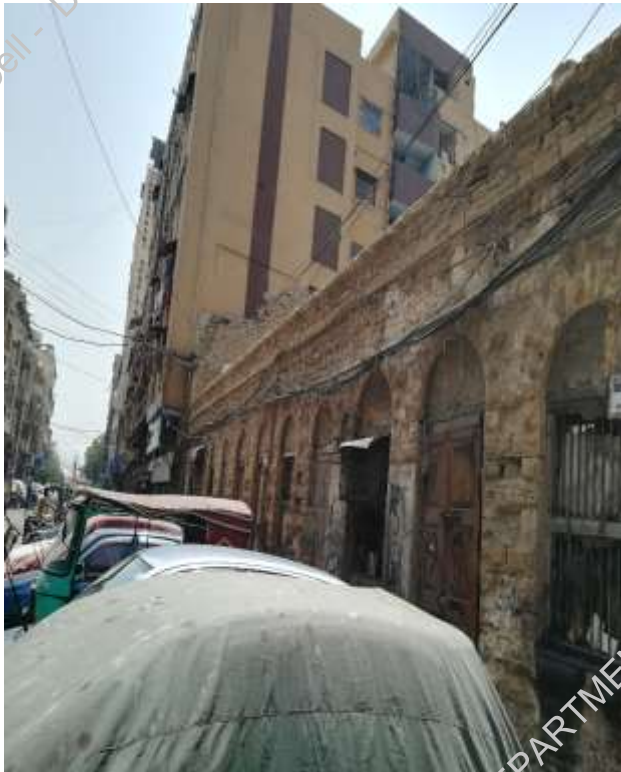
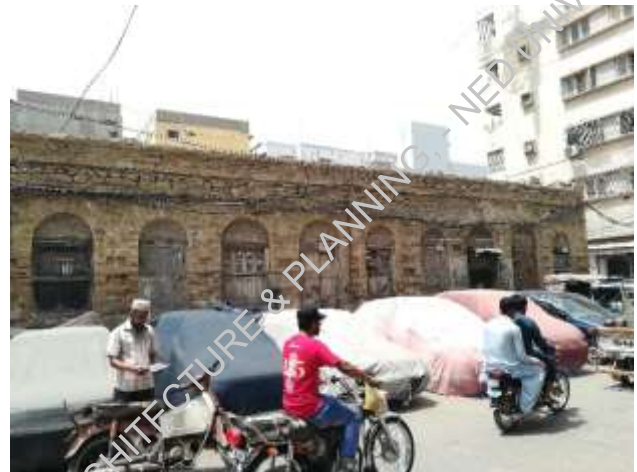
Plate-2 & 3: Wide cracks at the façade of the building

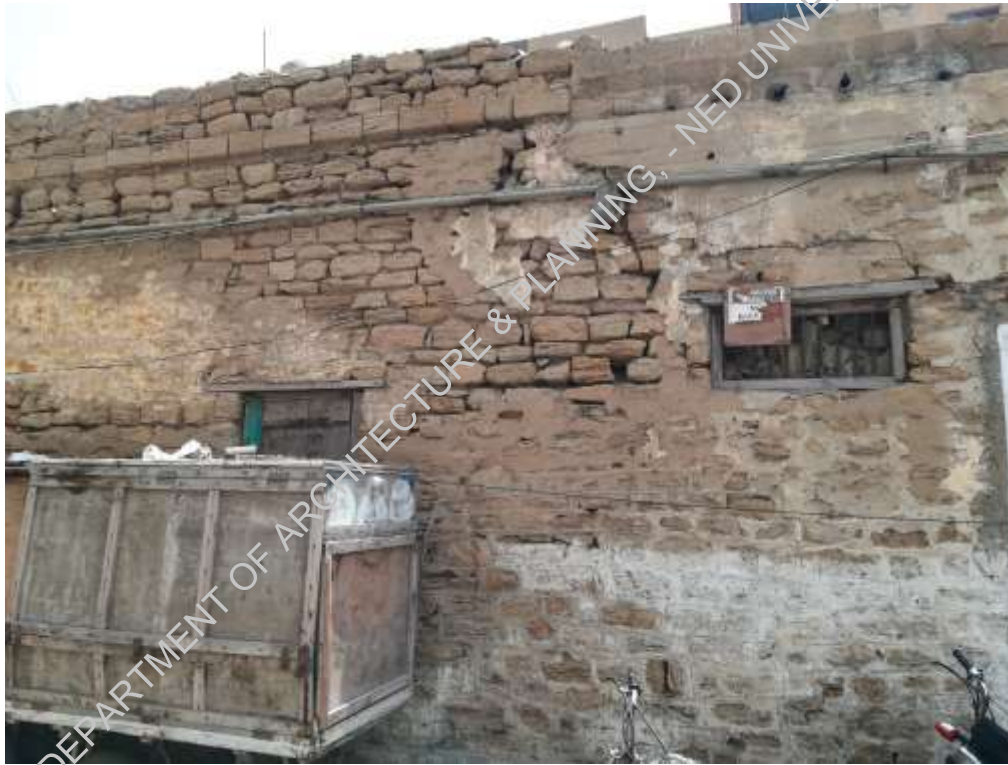
Plate-6: Loose stone masonry is visible

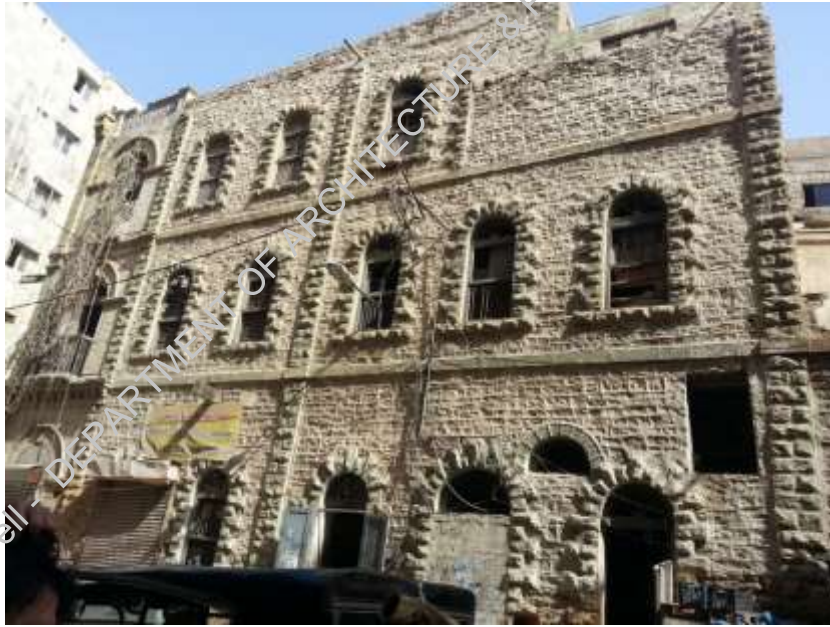
- The original building is ground plus two stories. Refer Plate-1.
- Front façade seems intact and in good location.
- The stair is collapsed so no access is available.
- Roots/vegetation are noticed to be protruding from the wall.

Plate-1: Front Façade-

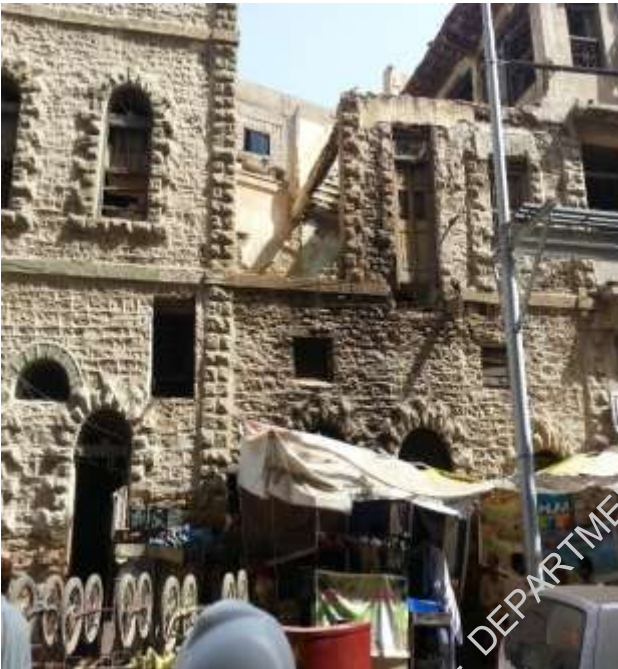
Plate-2: Masonry needs repair in few places

- In existing condition, building structure appears stable however, is in need of major repairs.
- Loose stone masonry should be repaired.
- Interventions if any should be removed.

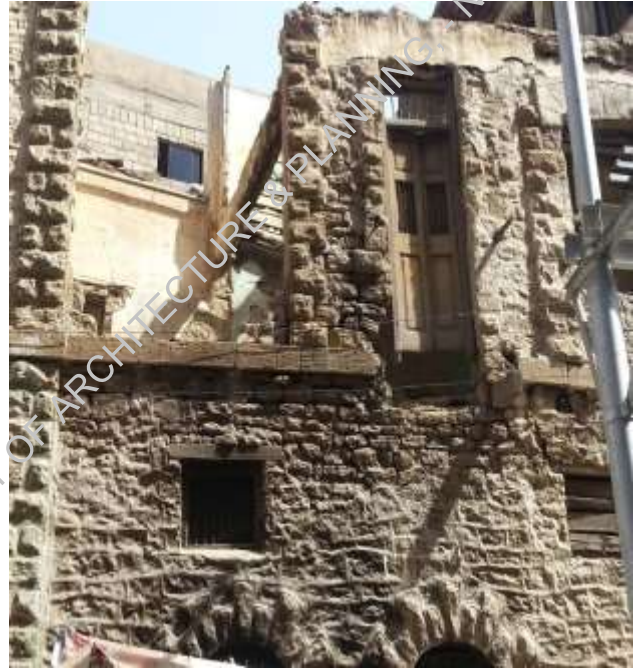
Plate-3: slab of portion seems collapsed

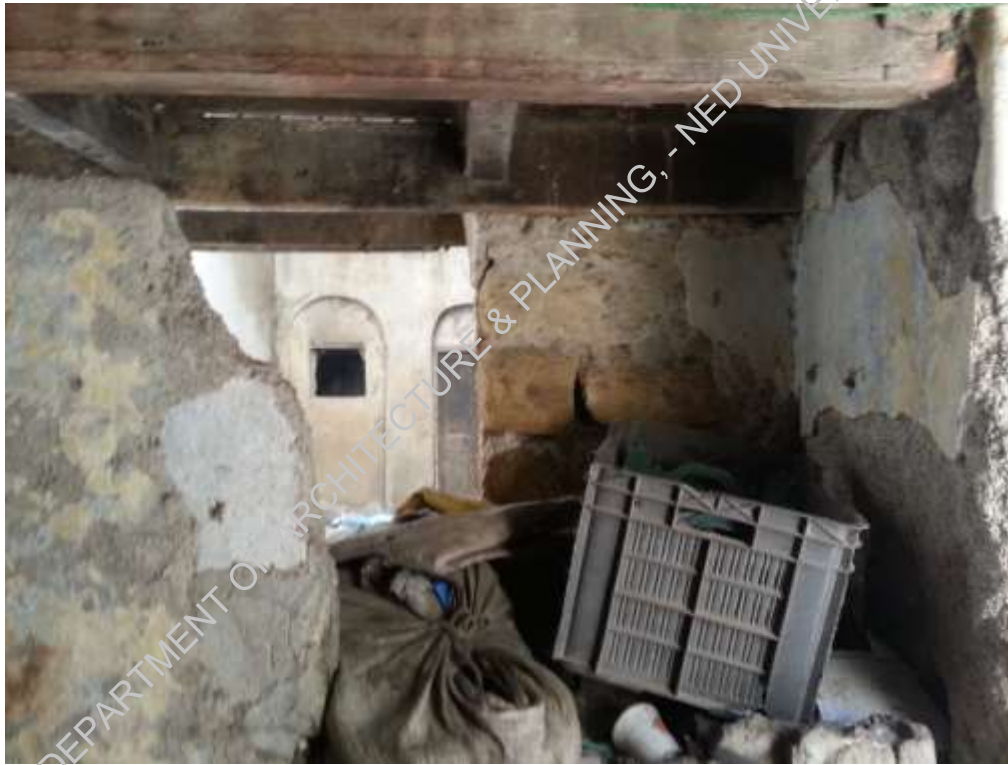
Plate-6: masonry wall in bad condition

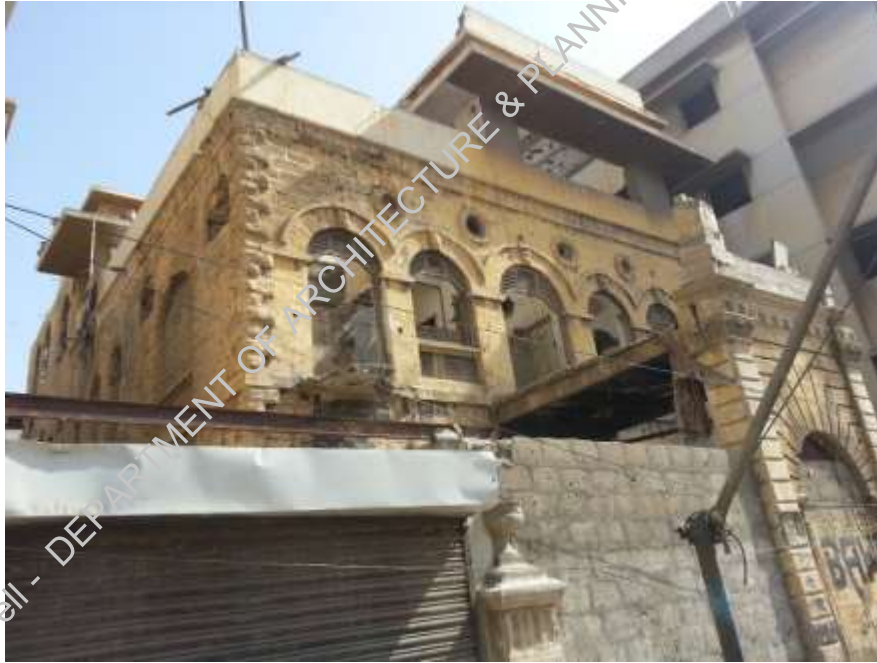
Plate-1: Front Façade- loose stone masonry can be noted at many places.

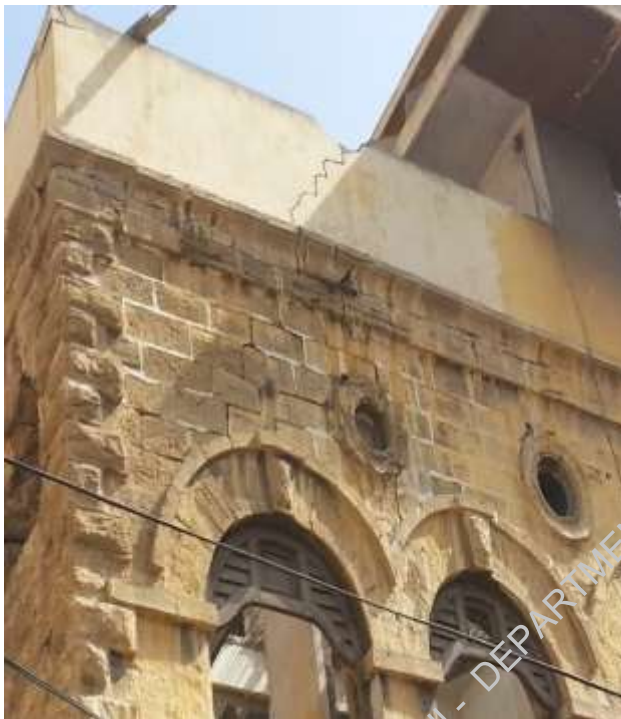
Plate-2: Wide cracks at the façade of building
