Condition Assessment of Heritage Buildings - Karachi Declared as “Dangerous”

JUNE 2018

Structural Consultant

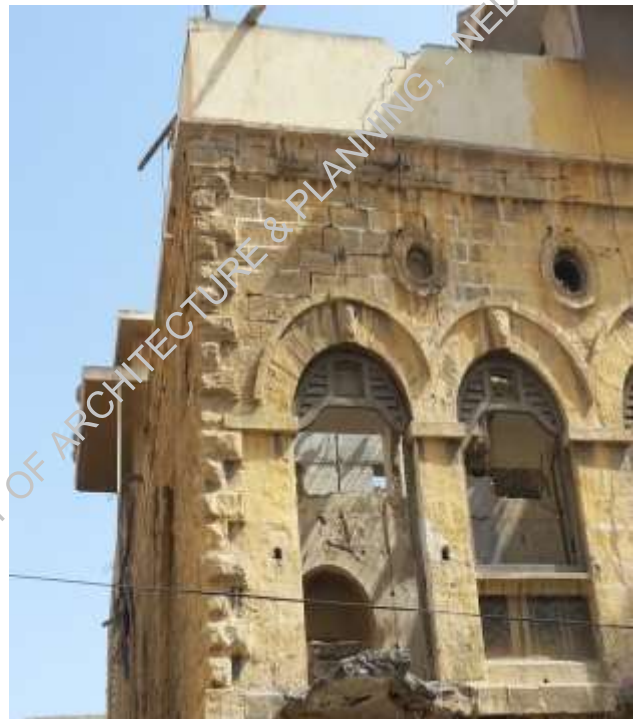
- The building exterior seems to be tilting and bulging with cracks at left.
- Front entrance slab is on steel girders but in bad shape.
- Intervention on roof with RCC beam frame.
- Rear façade part of building seems collapsed.
- There is a tree damaging the wall in the back.
- The OHWT is a future extension but in bad condition the building it-self feels tilting.

Plate-3: walls seems bulging

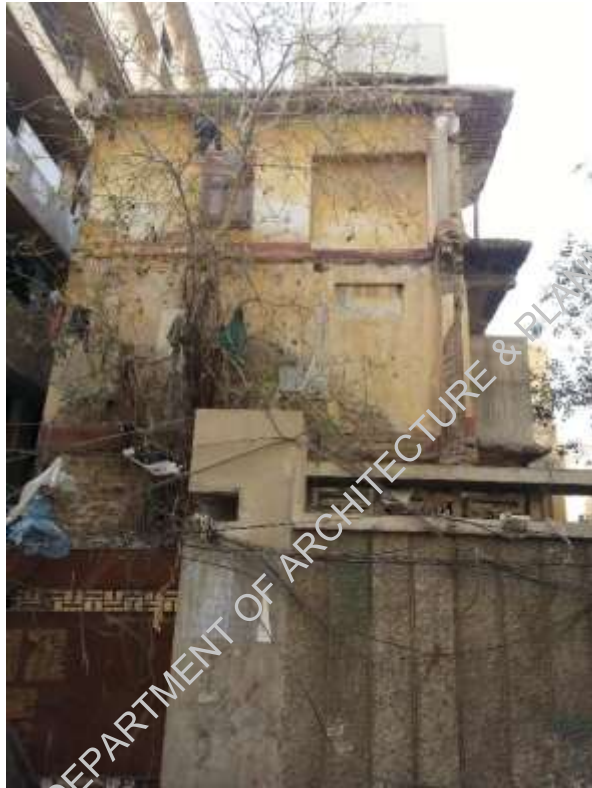
Plate-4: tree out grown from the wall tearing the wall apart

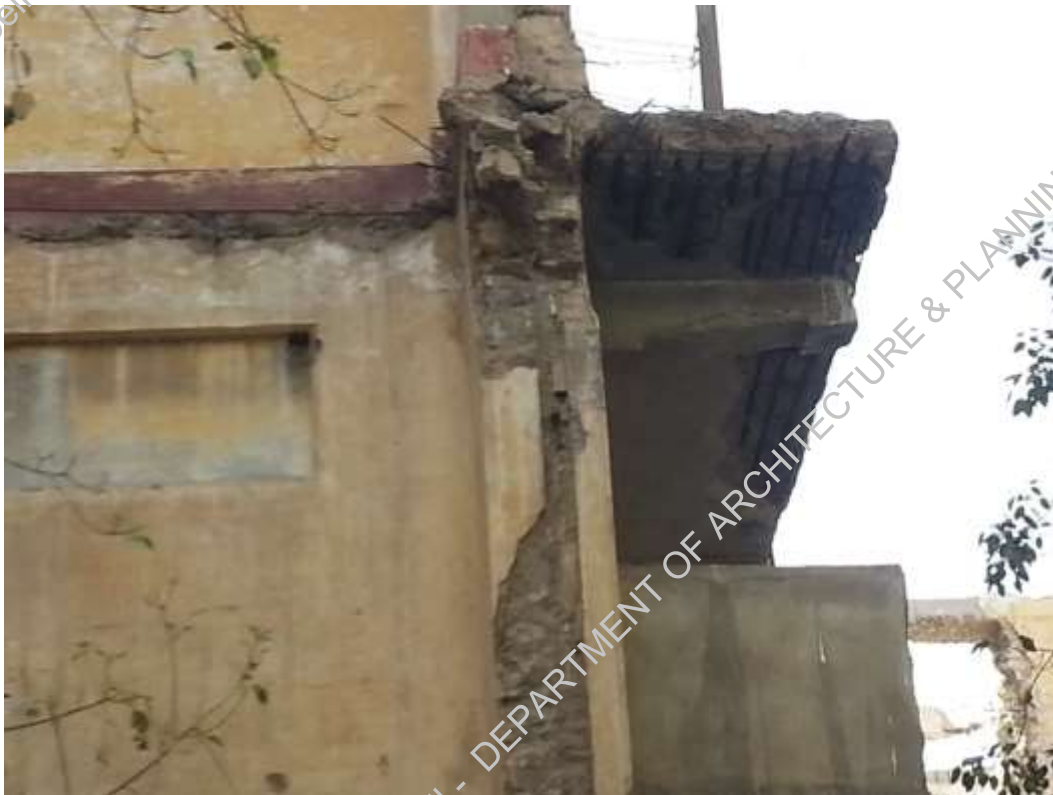
Plate-5: portion of building collapsed

- In existing condition, building structure is not stable and is not in useable condition.
- It appears that major strengthening works are required to make structure stable.

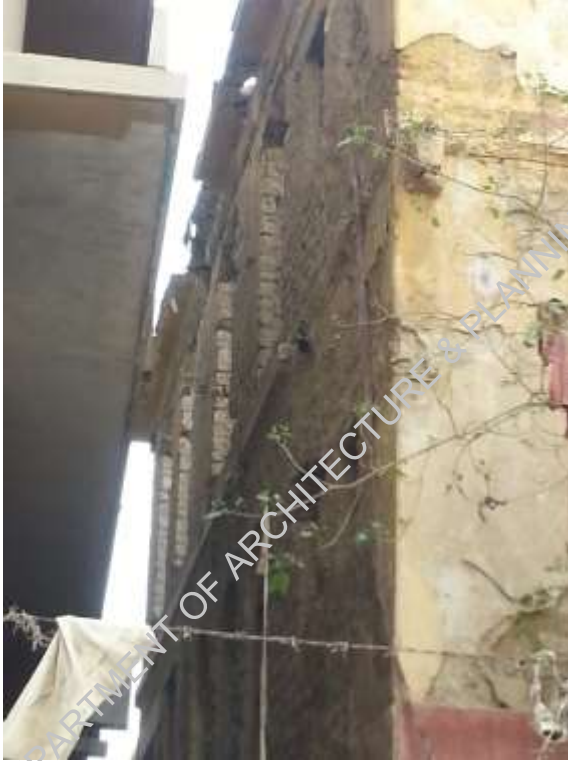
Plate-6: Loose stone masonry is visible

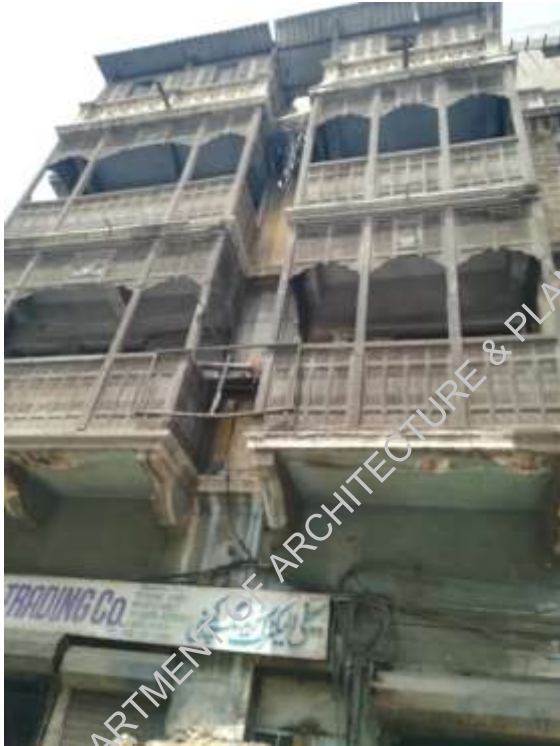
Plate-1: Front Façade-

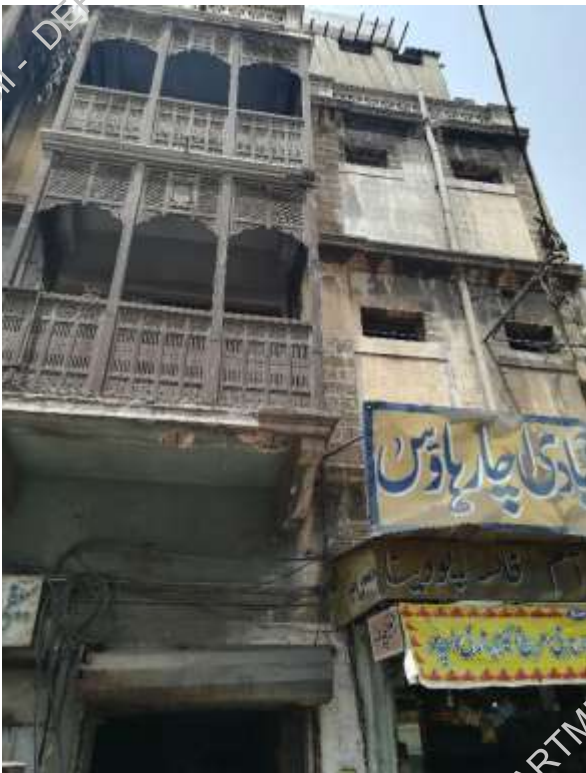
Plate-2: front elevation of building

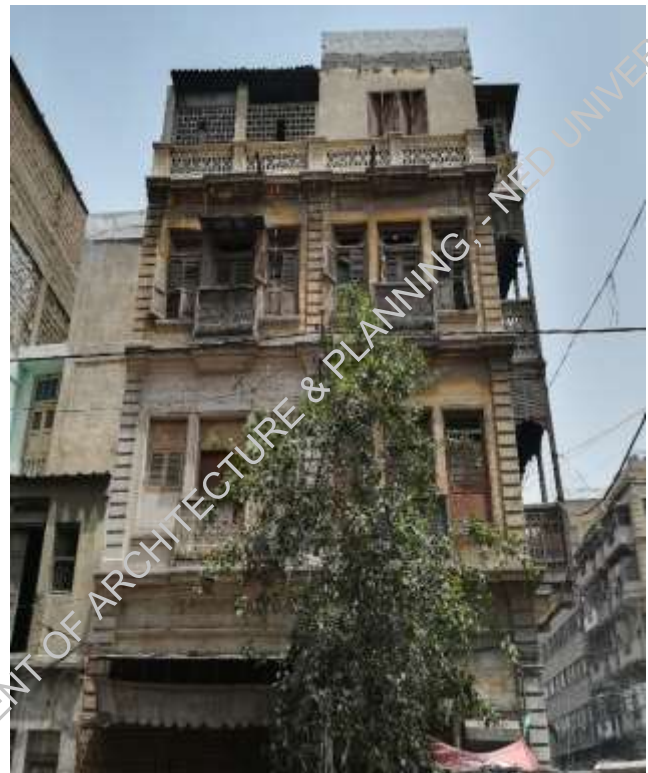
Plate-3: Side elevation

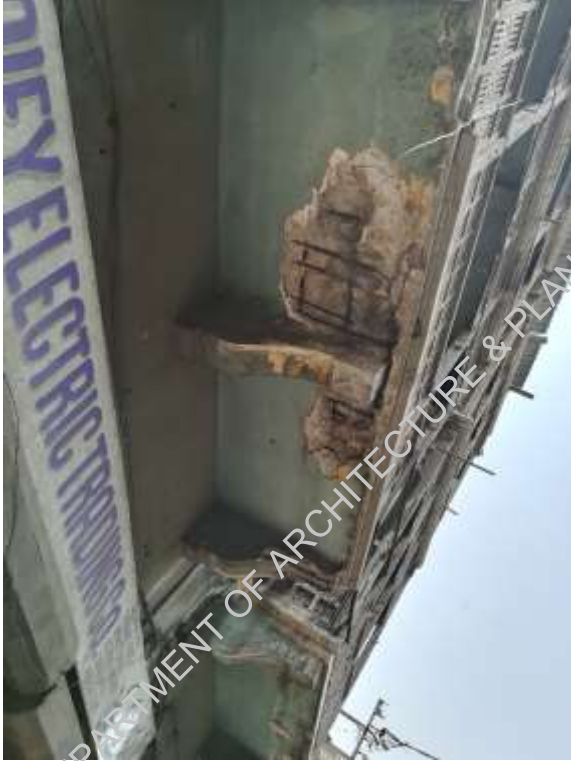
Plate-6: reinforcement of original projections exposed

- In existing condition, building structure appears to be in better condition.
- The balcony structures are in bad condition and are susceptible to collapse, as reinforcement of RCC projections have corroded and concrete cover has fallen.
- Internal side could not be observed hence, condition is unknown.

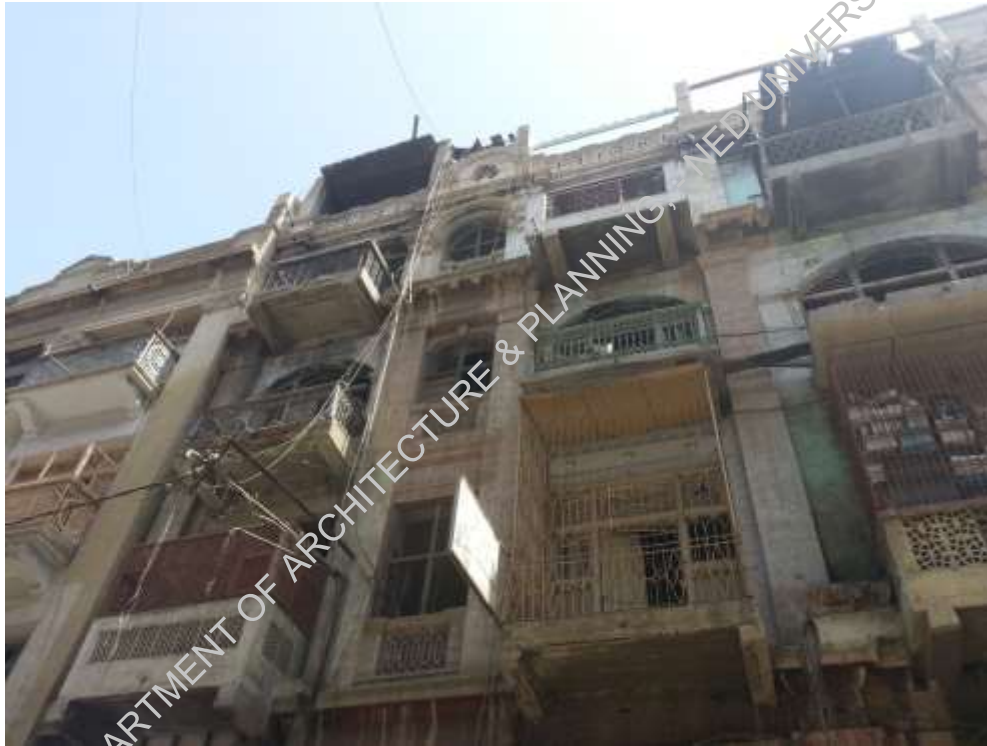
Plate-1: Front Façade-. Additional floor on top is also visible

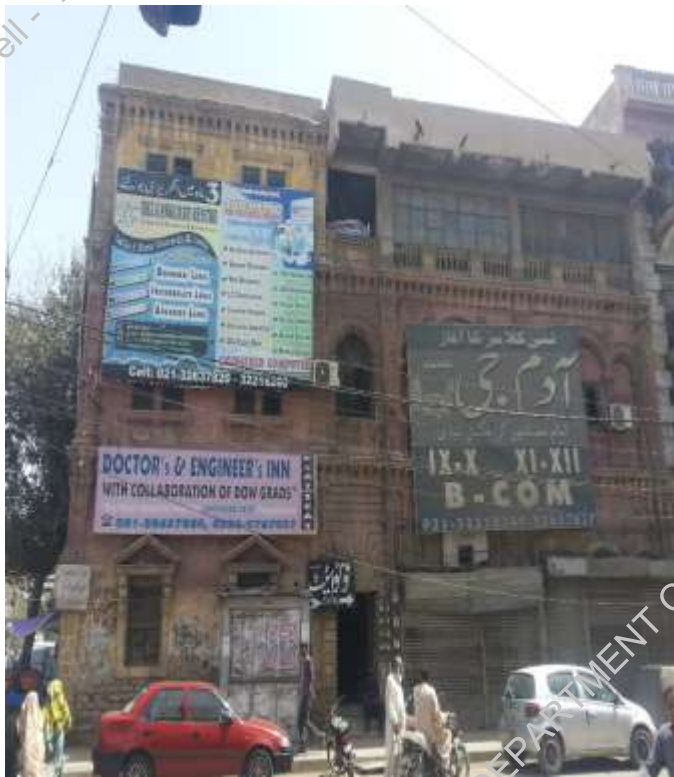
Plate-2: front façade

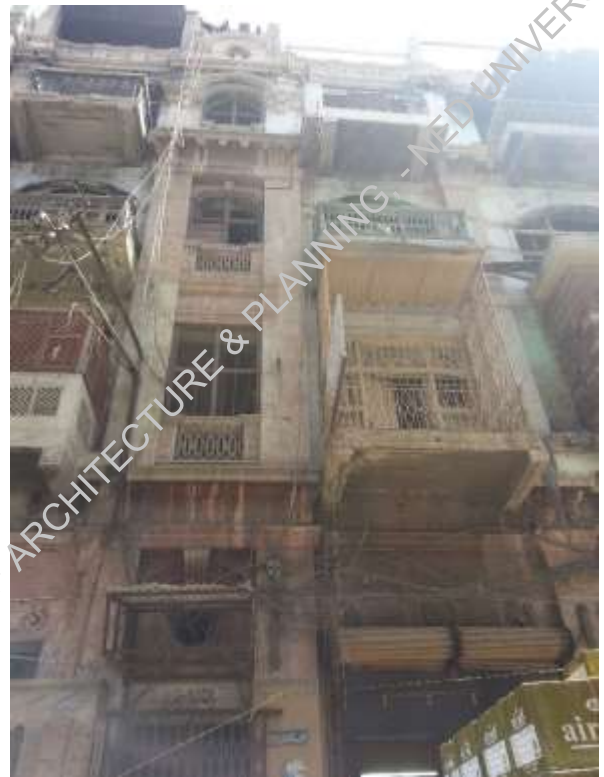
Plate-3: side elevation

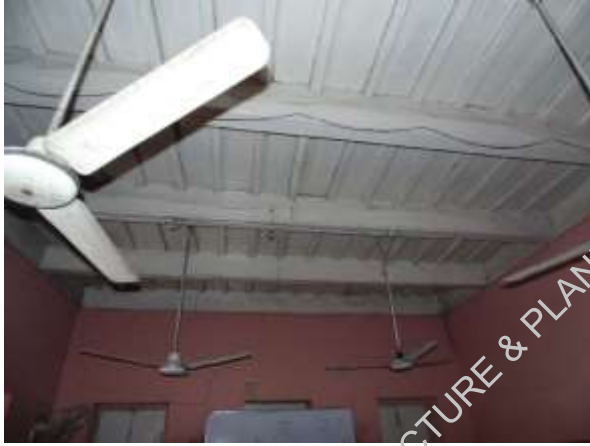
Plate-4: timber slab in good condition,

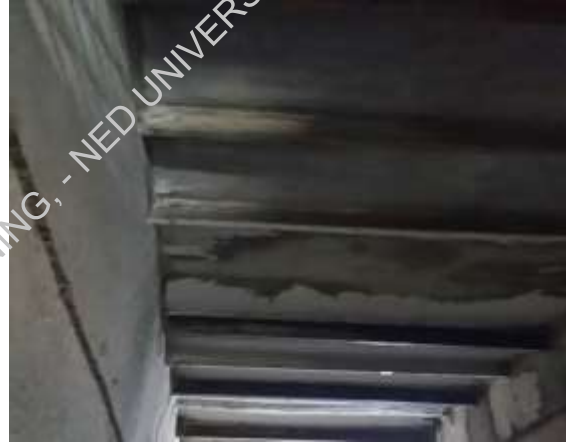
Plate-5: Concrete construction done later on, in bad condition

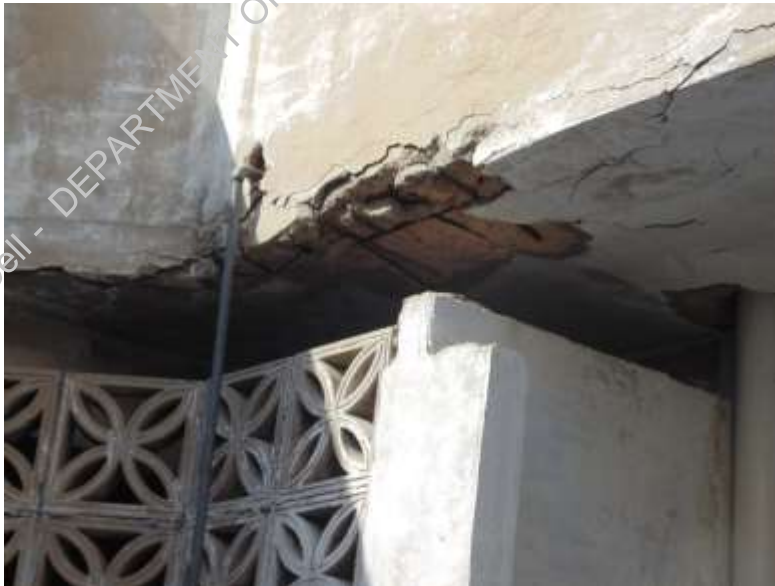
Plate-6: Concrete cover damage

- In existing condition, building structure appears to be in stable condition.
- No wide cracks were noticed in façade at the time of visit.
- Reinforced concrete construction at some places was in bad conditions and needed repair.

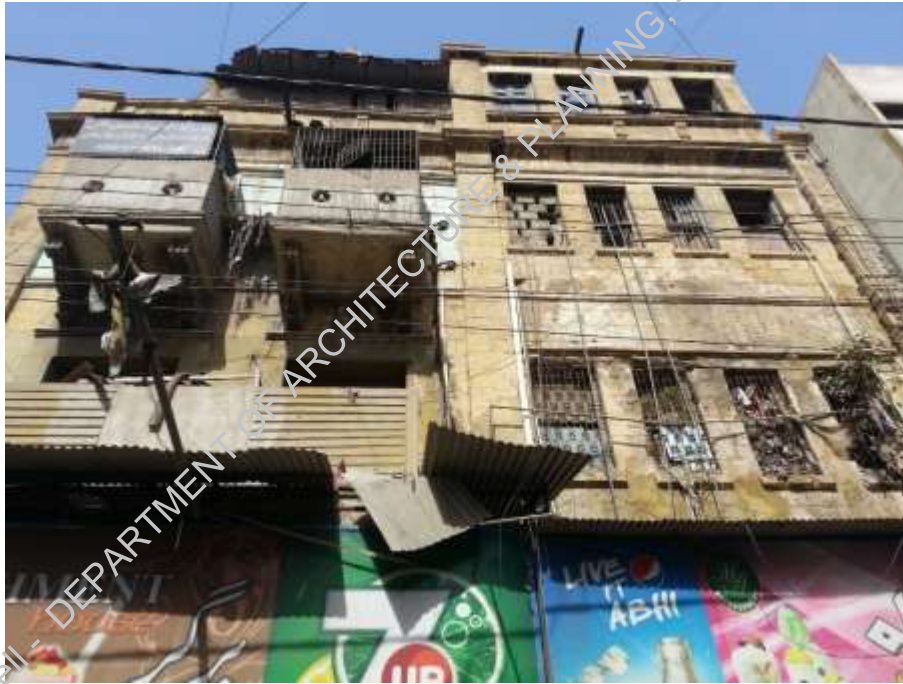
*Plate-1: Front Façade-
Additional floor on top is
also visible*

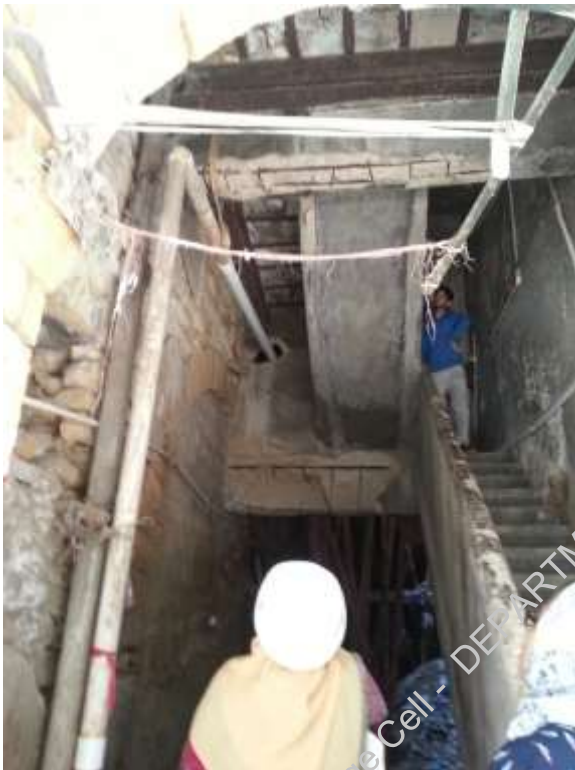
Plate-2: intervention on projection

- In existing condition, main building structure appears unstable and need major repairs, especially balconies.
- Reinforced concrete construction is in bad shape in many places and needs strengthening.
- Interventions at projections should be removed.

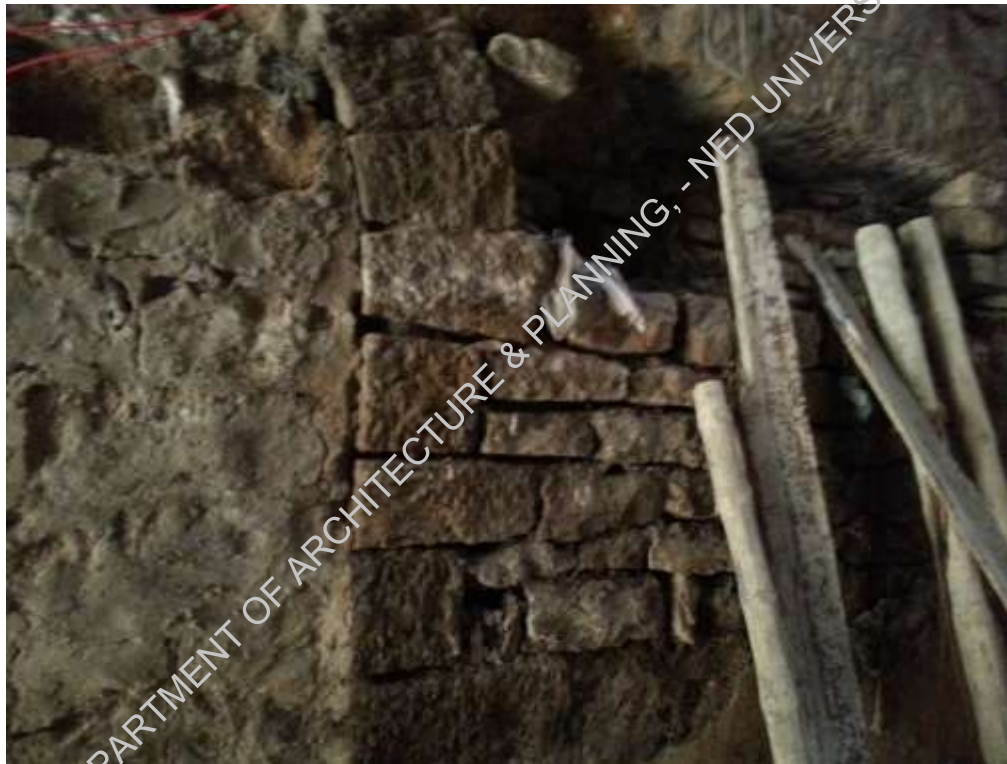
*Plate-6: Loose
stone masonry is
visible*

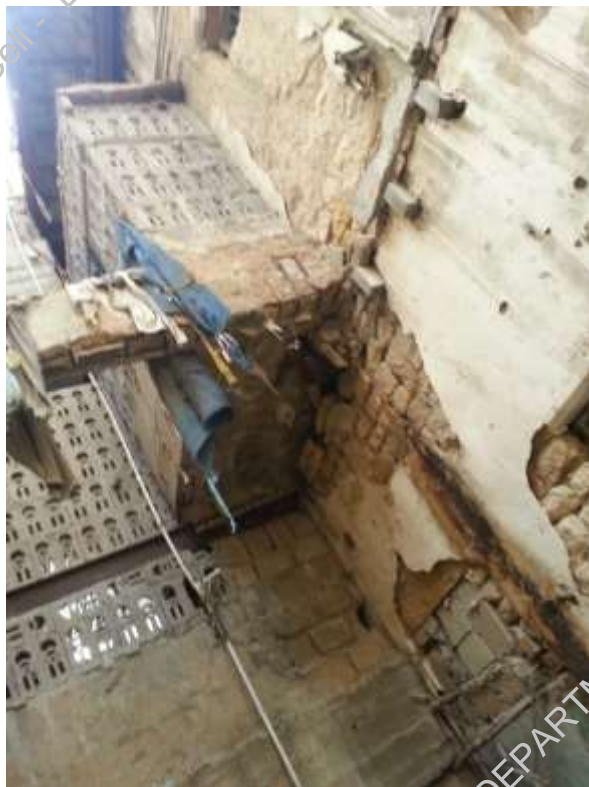
Plate-7: Interventions inside

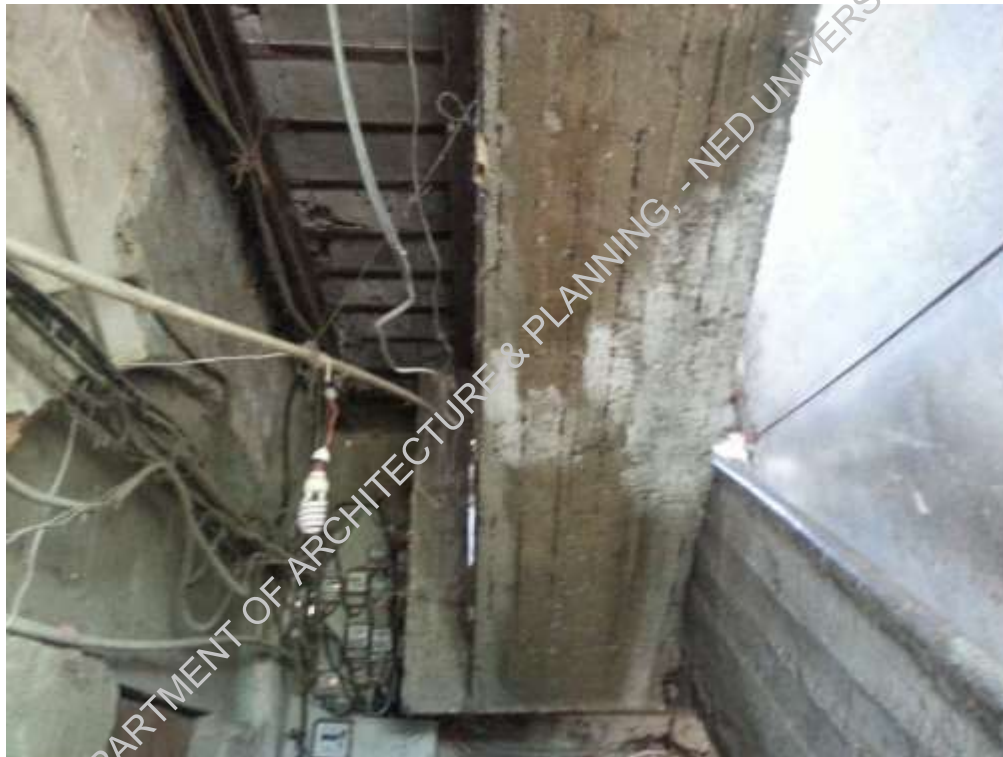
Plate-8: Stair at upper level

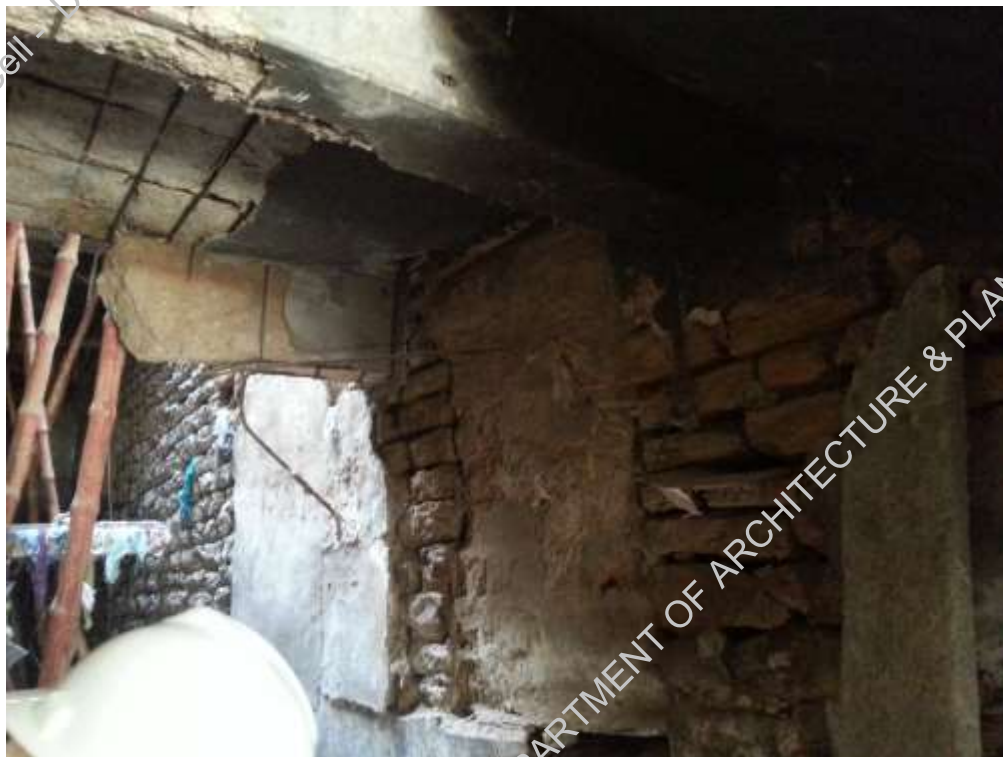
Plate-9: opening in stone walls needs to be filled

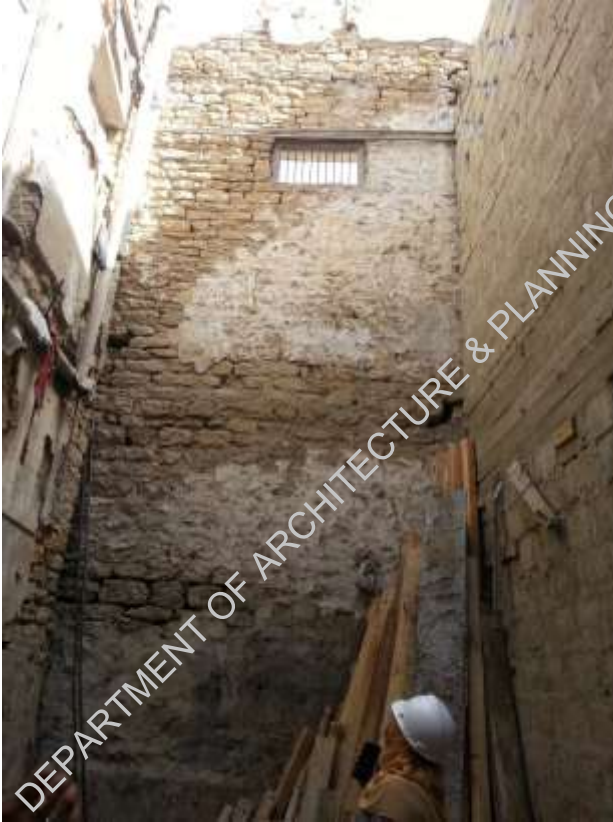
Plate-10: back side wall

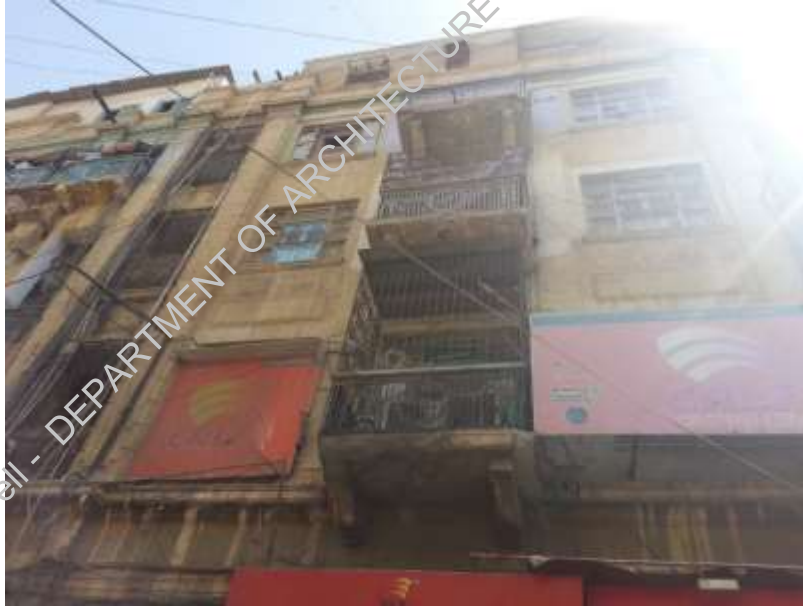
Plate-1: Front Façade- Additional floor on top is also visible

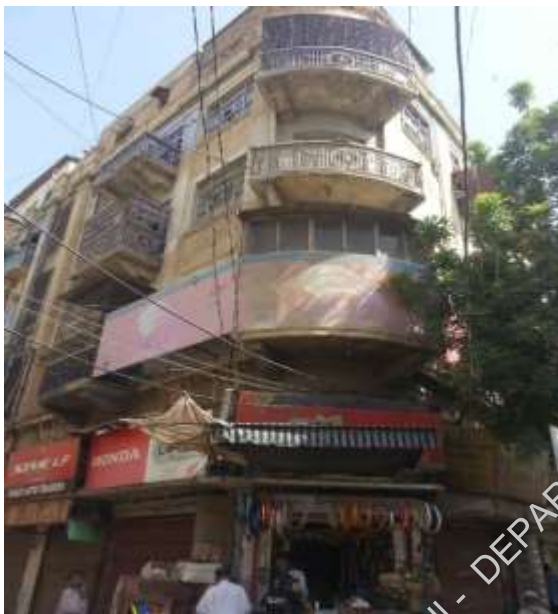
Plate-2: façade of building

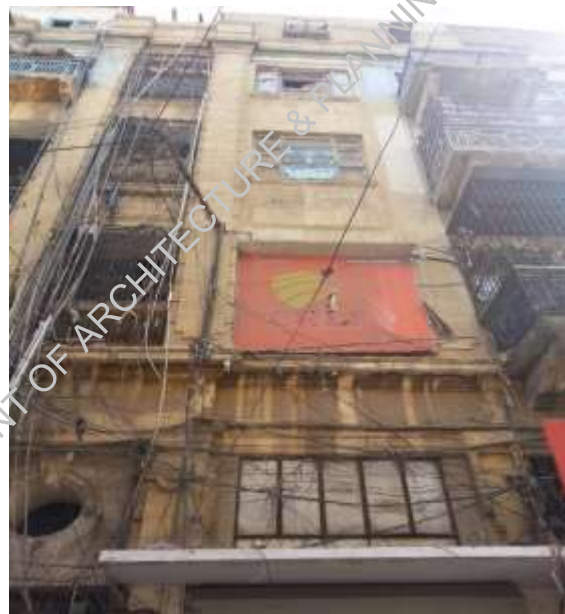
Plate-3: side elevation

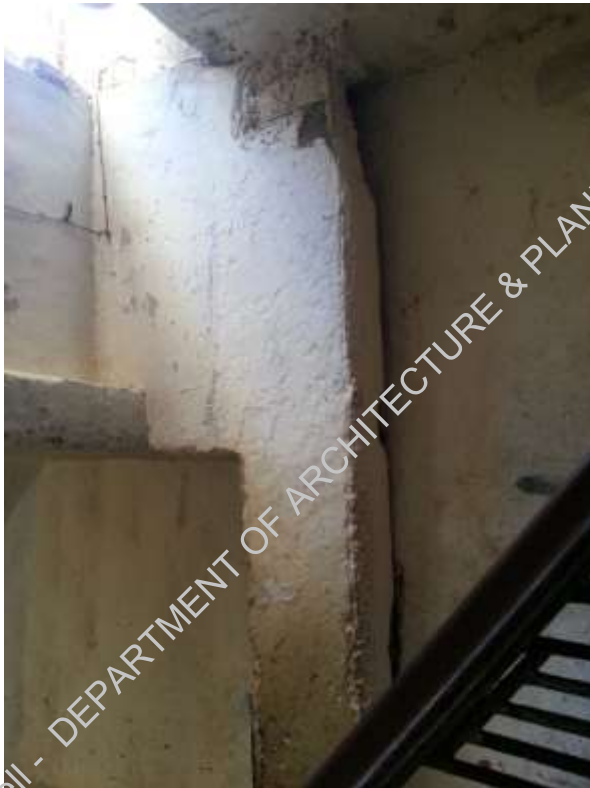
Plate-4: new construction inside

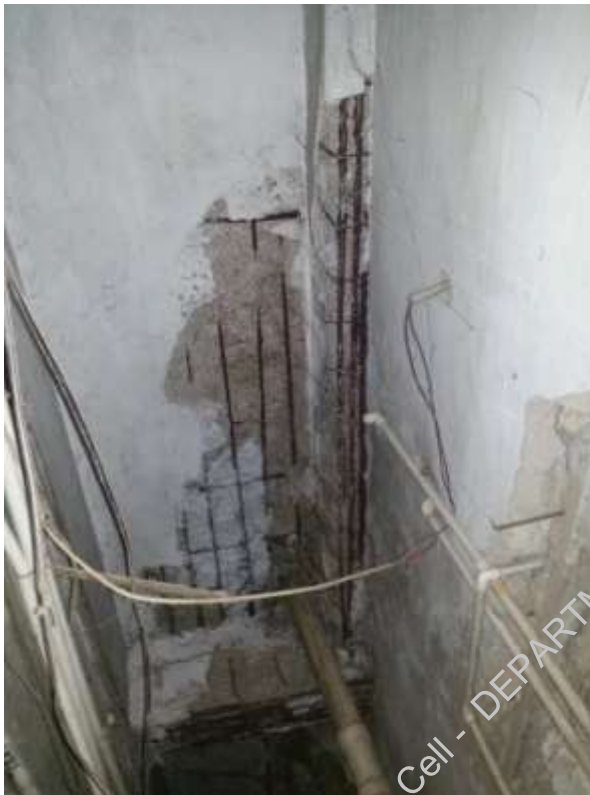
Plate-5: concrete cover damage

- In existing condition, building structure appears in stable condition.
- No major cracks or deterioration was noticed anywhere in stone masonry.
- Reinforced concrete construction needs repair at some places.

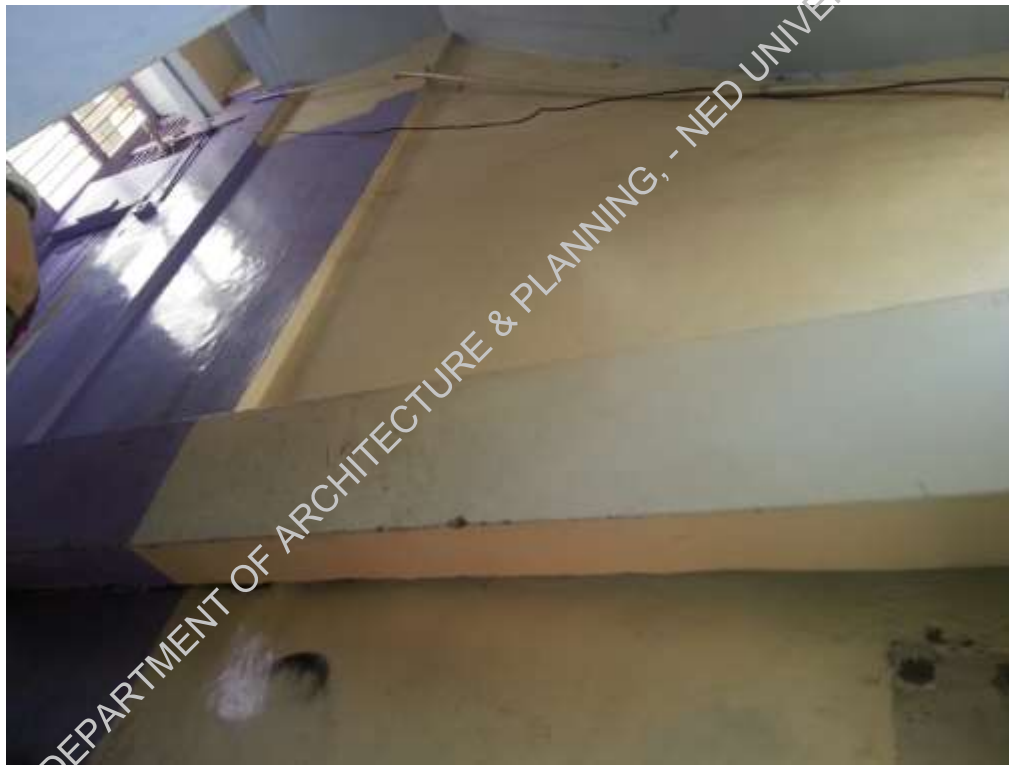
*Plate-6: RCC
beam intervention*

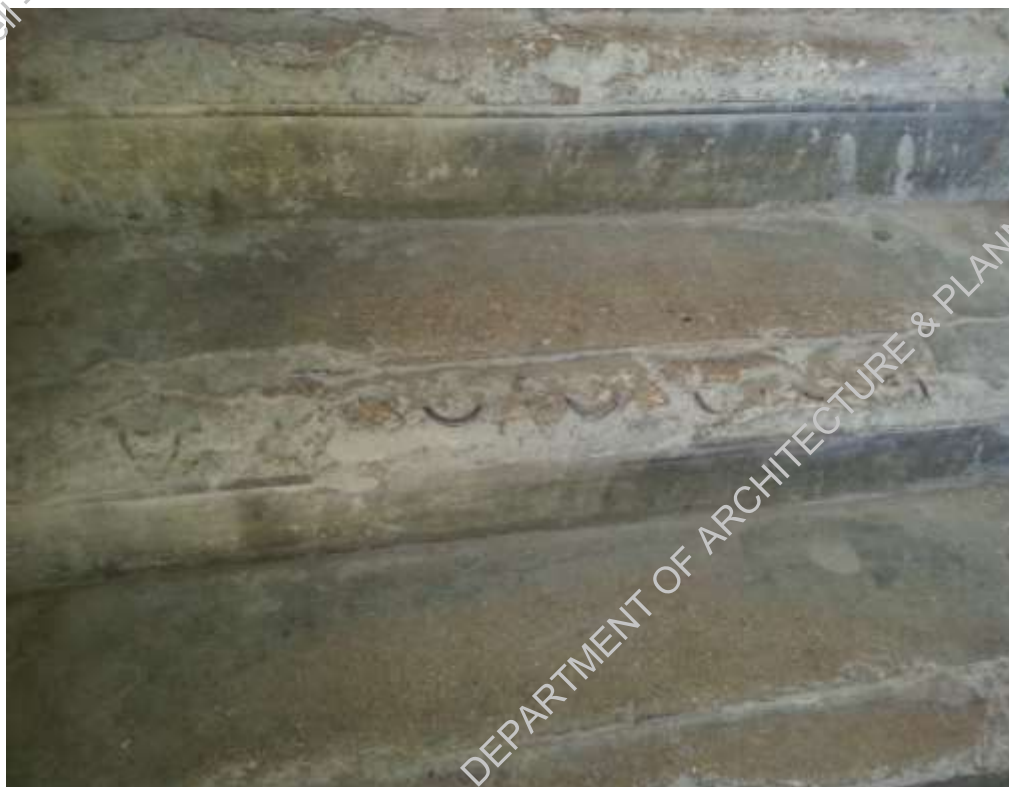
*Plate-7: RCC
steps in good
condition*

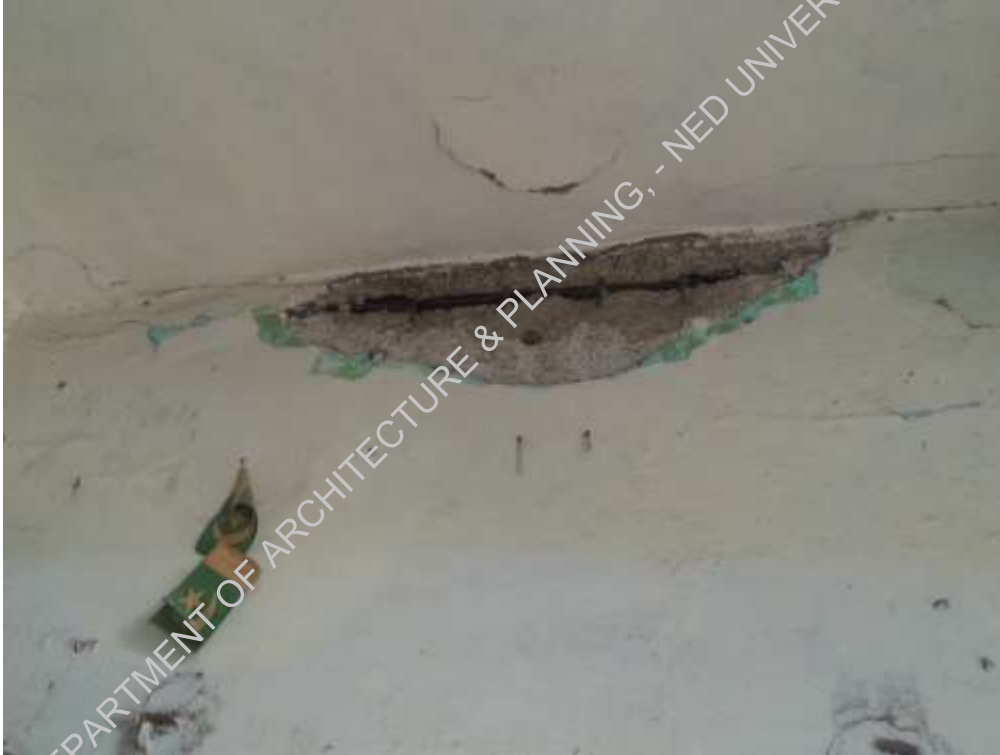
*Plate-8: damage
due to seepage*

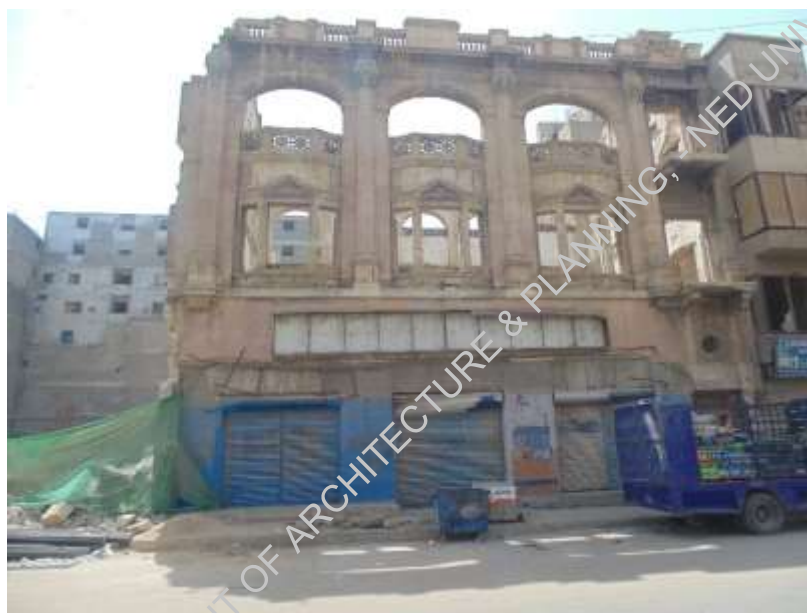
- The original building is ground plus two stories with no slab intact, only façade wall is free standing. Refer Plate-1.

Plate-1: Front Façade

- In existing condition, building structure is not stable and is susceptible to failure/collapse.
- Extensive strengthening is required to make the structure stable. Strengthening measures to be done with careful methodology which will include propping of existing walls/floors before proceeding with any strengthening technique.
- Interventions should be removed such as the additional floor on top and extra floor finishes where present, to decrease the dead load on existing walls,
- Strengthening techniques can be adopted, including but not limited to;
 - a. Pointing of mortar in existing stone masonry joints,
 - b. Application of mesh plaster
 - c. Introducing internal mild steel frame within the building to secure the occupants from fatal damages.

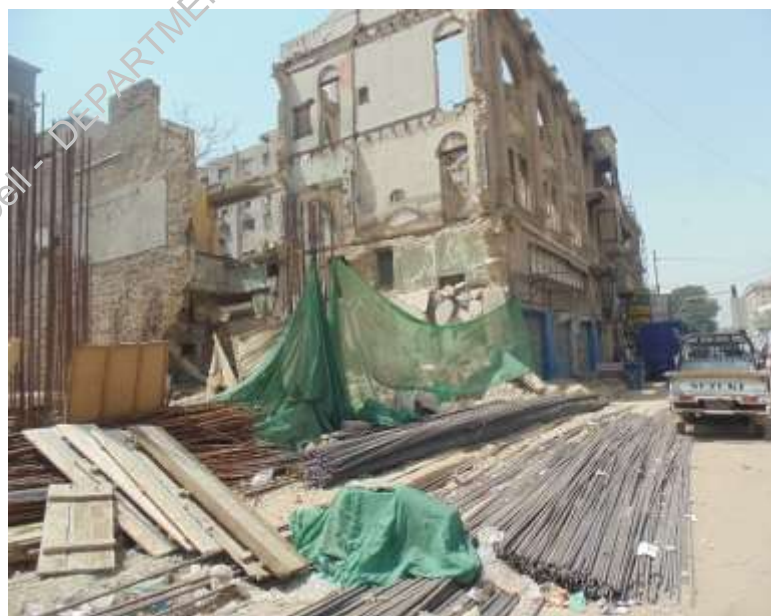
Plate-2: façade of building

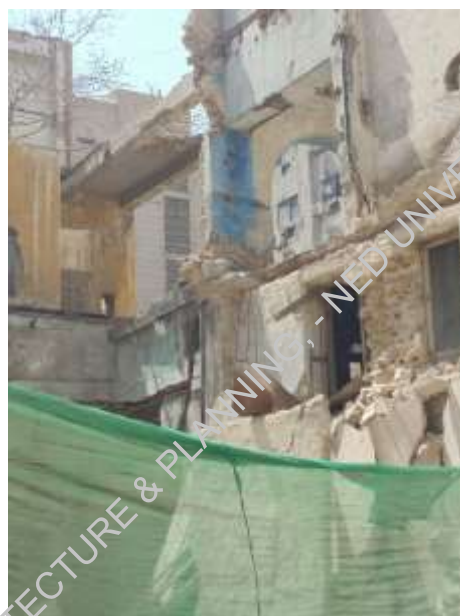
Plate-3: side elevation

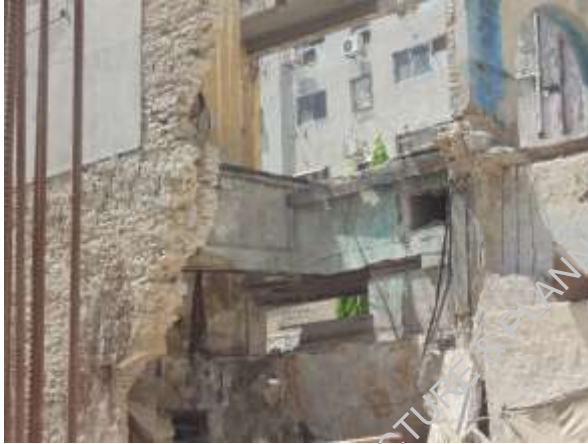
Plate-4: new construction inside

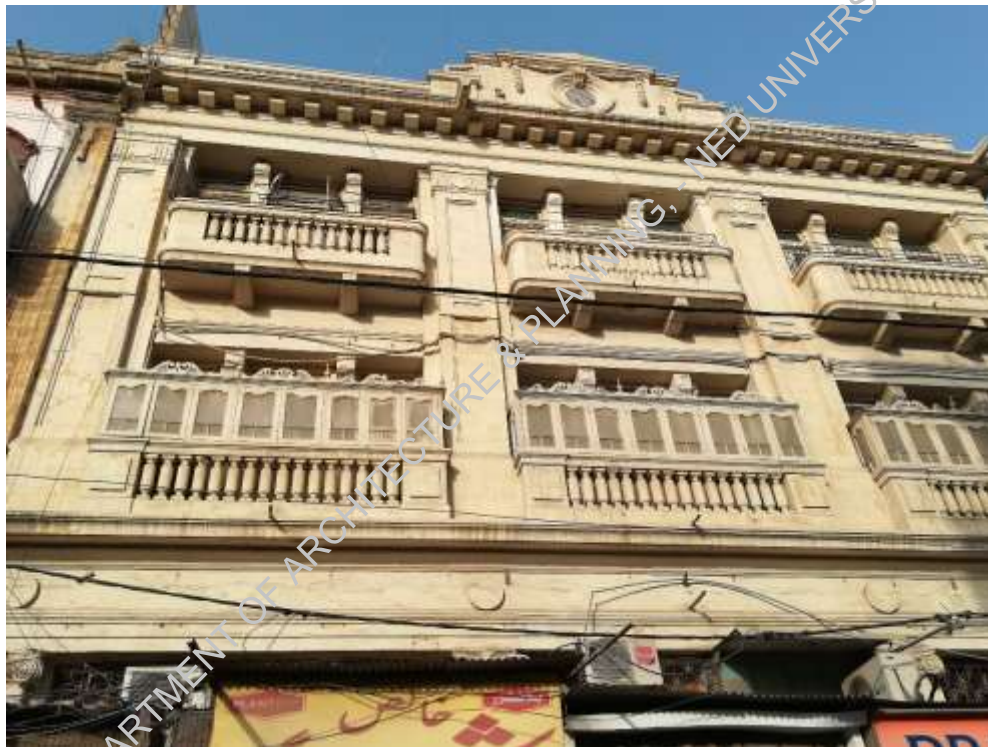
*Plate-1: Front
Façade-*

- The original building is ground plus two stories. Refer Plate-1.
- The building is itself in very good condition.
- Structure was inaccessible from inside but apparently, overall condition looks good from outside.

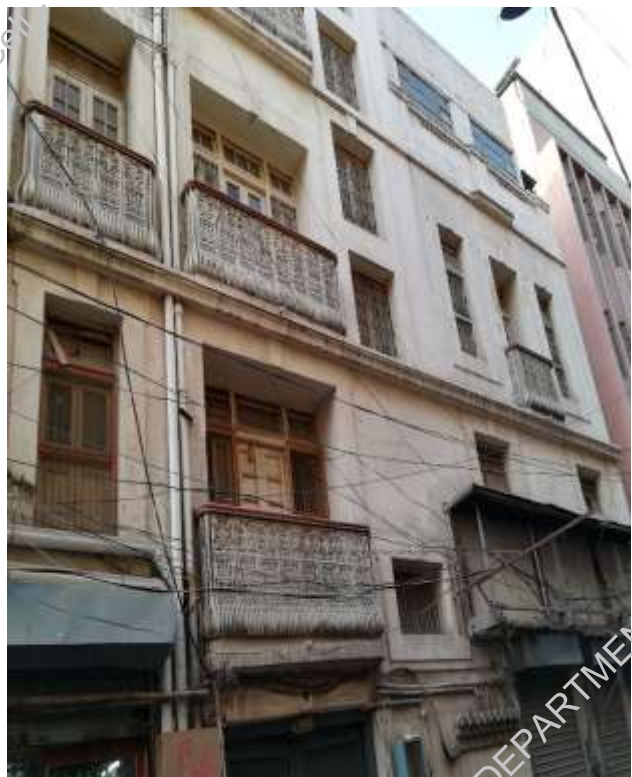
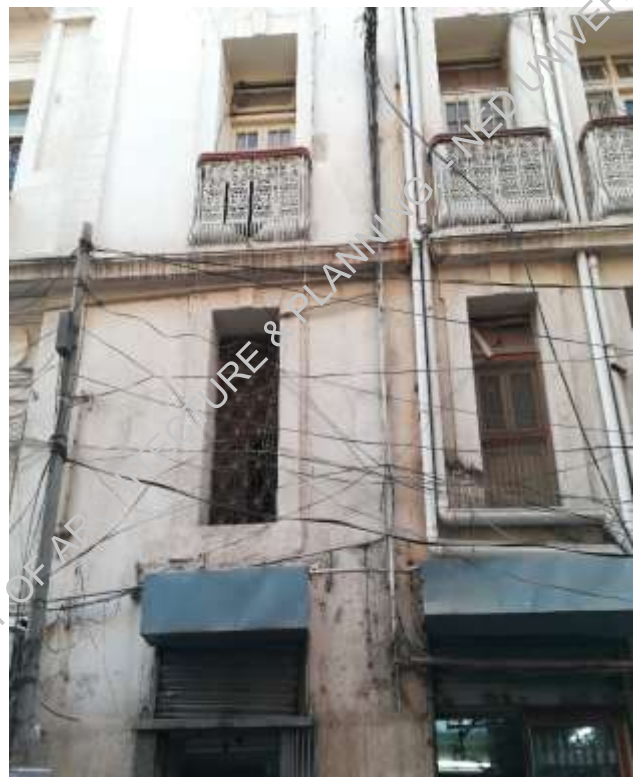
Plate-2&3: Different exterior views

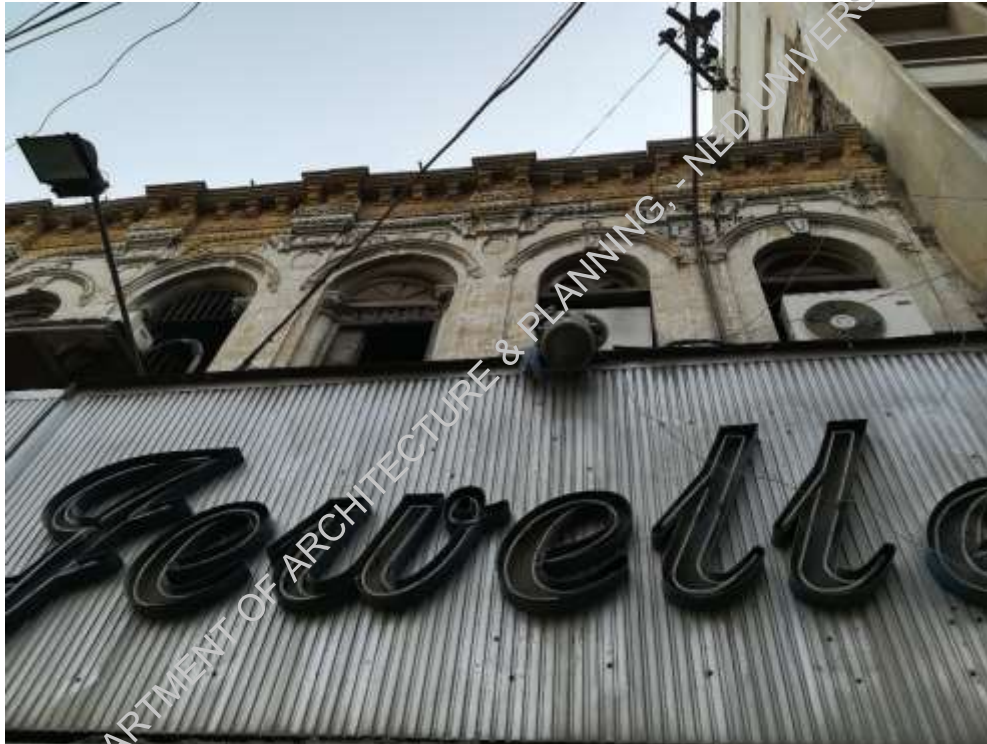
- The original building is ground plus one story. An additional story has been constructed on top. Refer Plate-1.
- Stone masonry visible on first level seems to be loose and plaster has fallen off.
- Building could not be accessed to observe from inside.

Plate-1: Front Façade- loose stone masonry can be noted at many places.

- In existing condition, it appears that building is stable, but needs repairs
- Building could not be observed from inside hence no comment can be made.

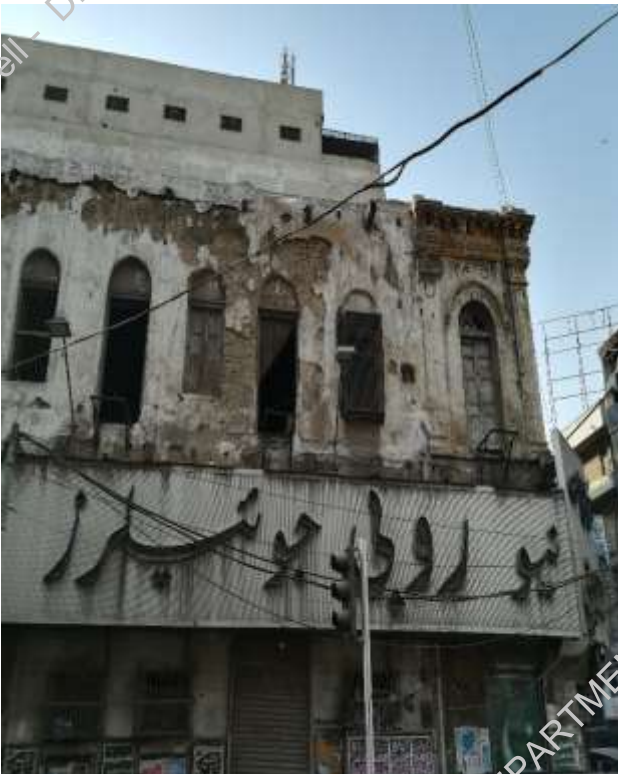
Plate-2 Plaster fallen off from the façade of building

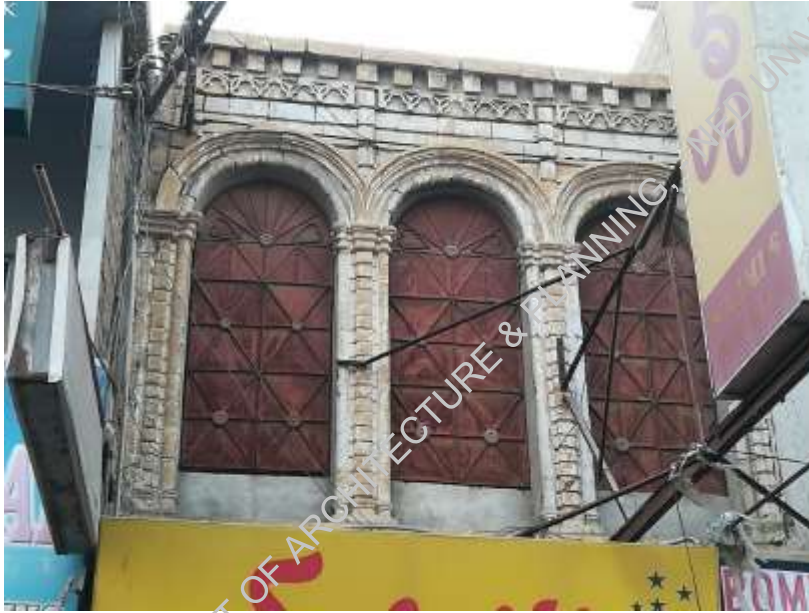
Plate-1: Front Façade-

- The original building is ground plus 1 story. Refer Plate-1.
- On front façade, stone masonry appeared to be in good condition with slightly loose condition of masonry at few locations.
- Rest building seems to be in good condition.
- The building was inaccessible for observation from inside.

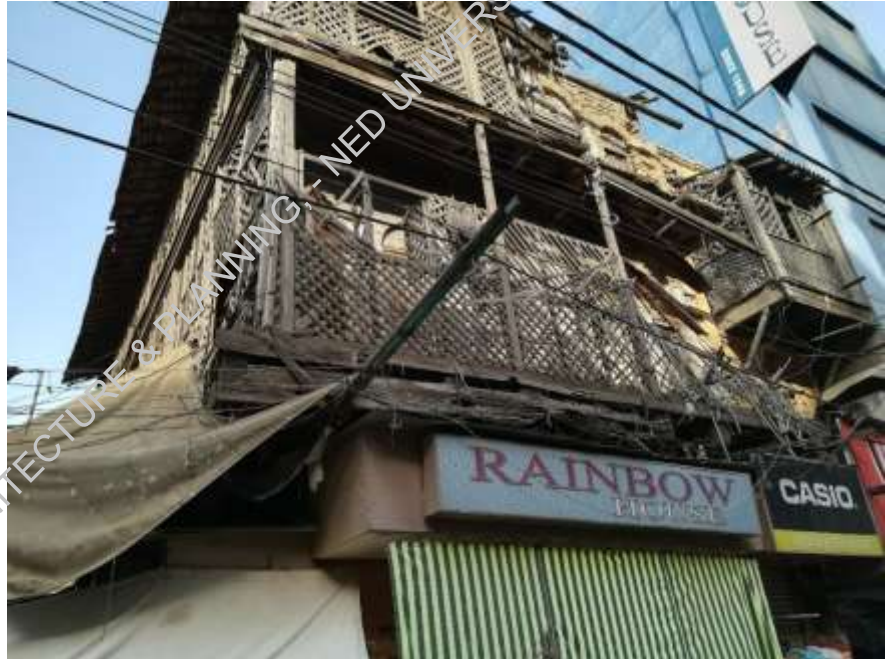
- The original building is ground plus two story. Refer Plate-1.
- The building is in bad condition over all, part of wooden Jali work collapsed and stone masonry in loose condition, especially at top floor.
- All timber beams and slabs are damaged and dislodged.
- The stone masonry is crumbling.

Plate-1: Front Façade- wooden jali work in bad condition.

- In existing condition, building structure is not stable and is susceptible to failure/collapse.
- Extensive strengthening is required to make the structure stable. Strengthening measures to be done with careful methodology which will include propping of existing walls/floors before proceeding with any strengthening technique.
- Interventions should be removed such as the additional floor on top and extra floor finishes where present, to decrease the dead load on existing walls,
- Strengthening techniques can be adopted, including but not limited to;
 - a. Pointing of mortar in existing stone masonry joints,
 - b. Application of mesh plaster
 - c. Introducing internal mild steel frame within the building to secure the occupants from fatal damages.

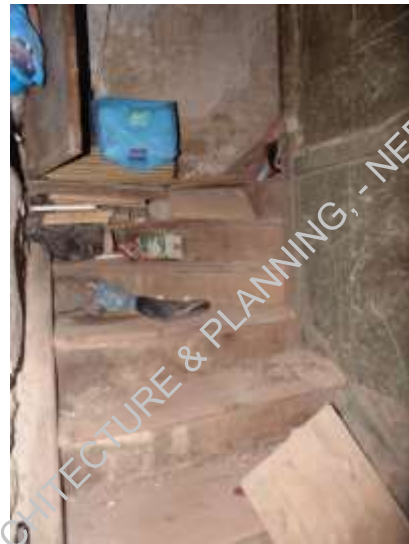
Plate-2: part of stair inside.
