Condition Assessment of Heritage Buildings - Karachi Declared as “Dangerous”

JUNE 2018

Structural Consultant

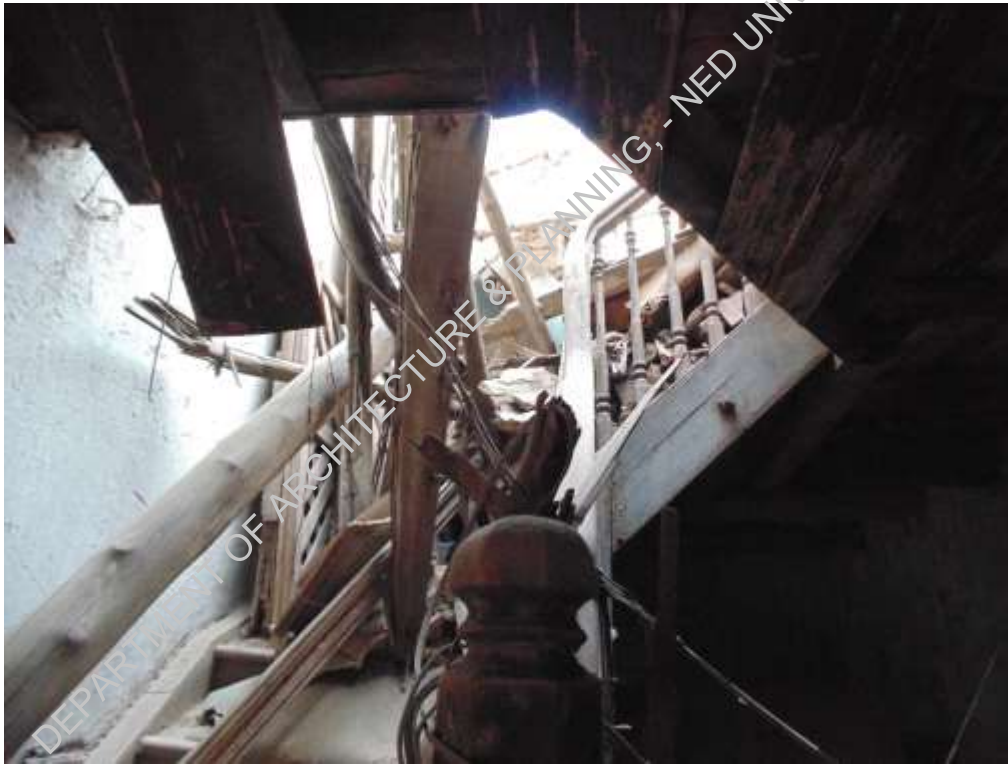
*Plate-3: stair
broken*

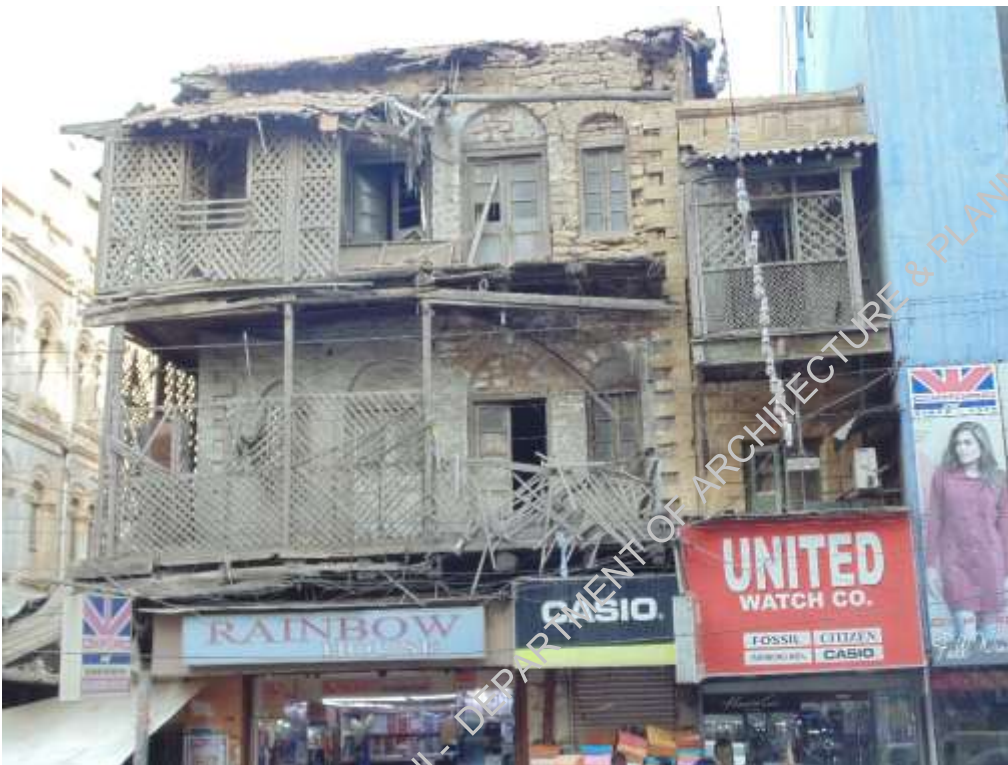
*Plate-4: Façade
in bad condition*

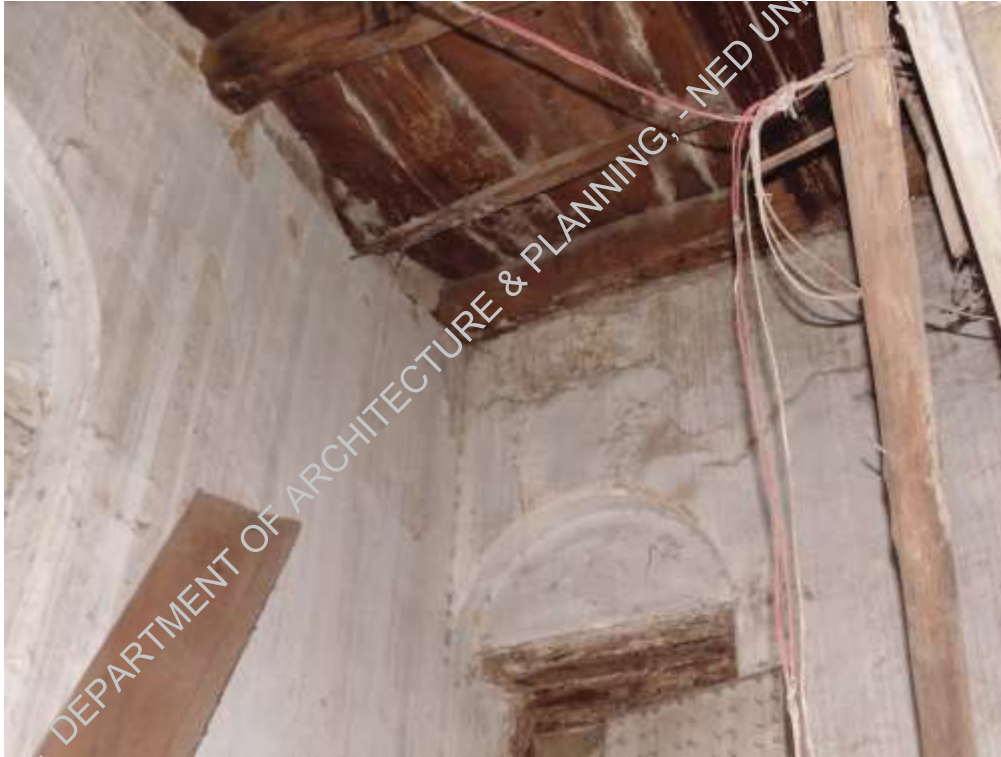
Plate-5: Condition of wooden floor from inside

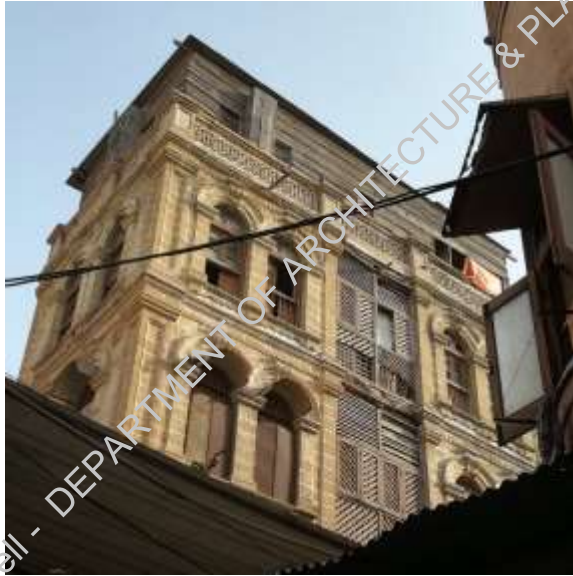
Plate-1: Front Façade-

- The original building is ground plus two stories with third story added sometime later. Refer Plate-1.
- Façade is in good condition but inside the structure is crumbling the slab and beams are deflecting.

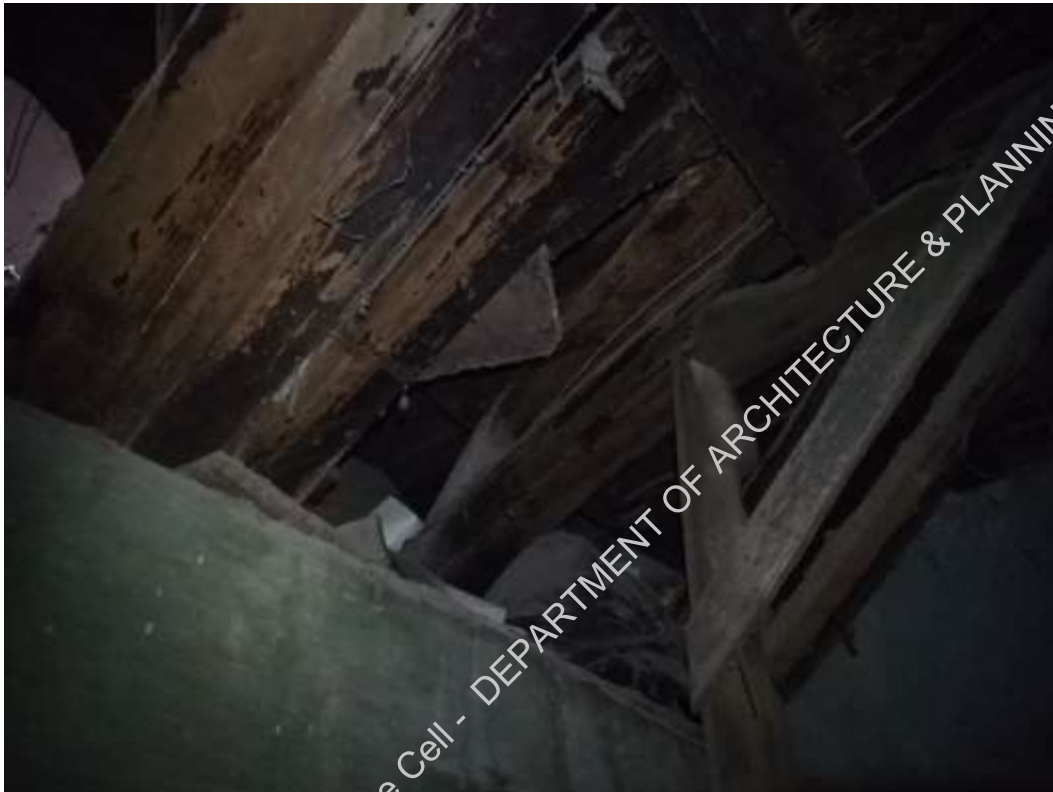
Plate-2: timber slab.

- Building appears to be in better condition from outside, however, deck/floor needs to be replaced/repared.

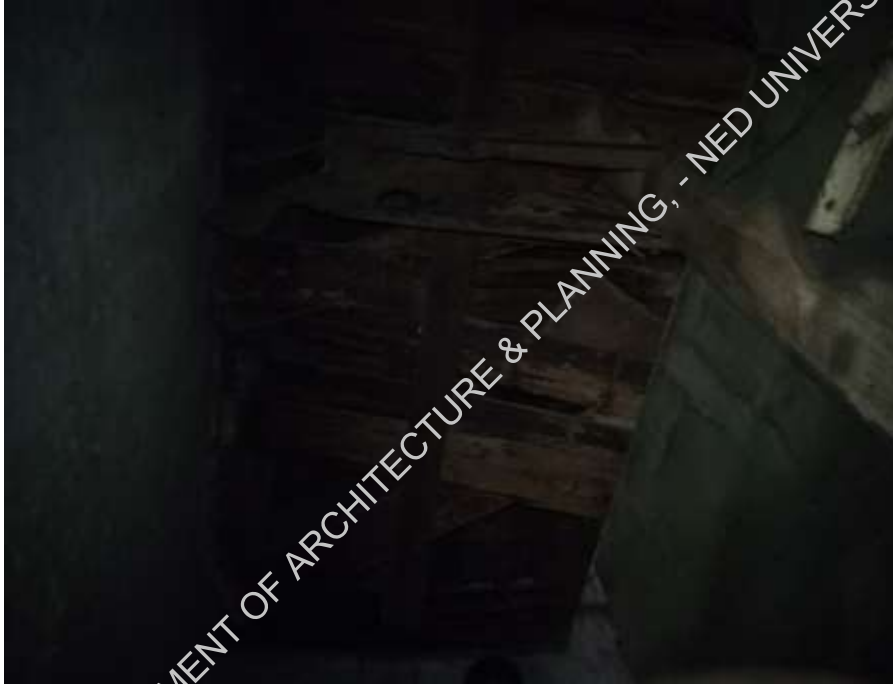
Plate-5: slab above stair

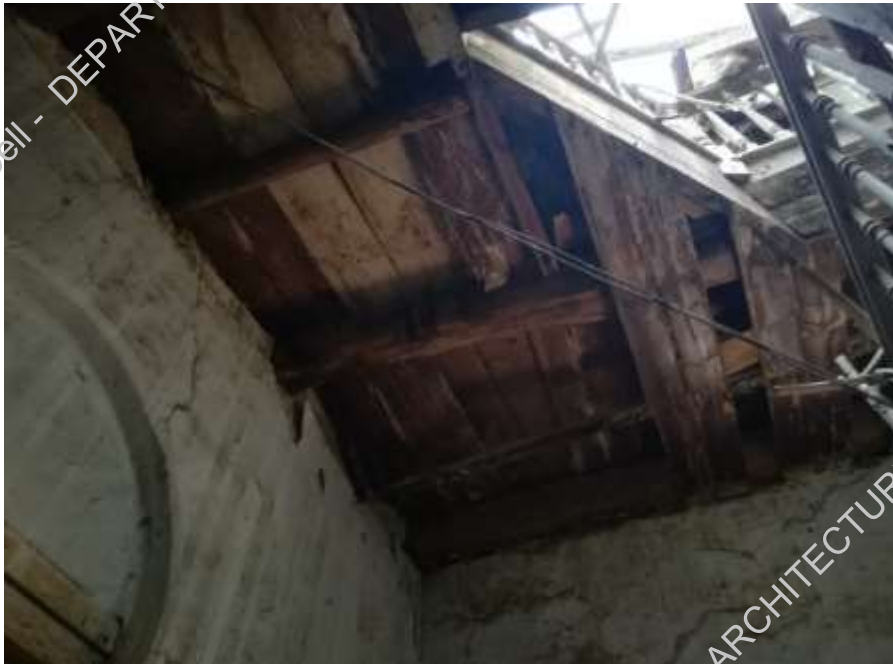
Plate-6: Loose planks

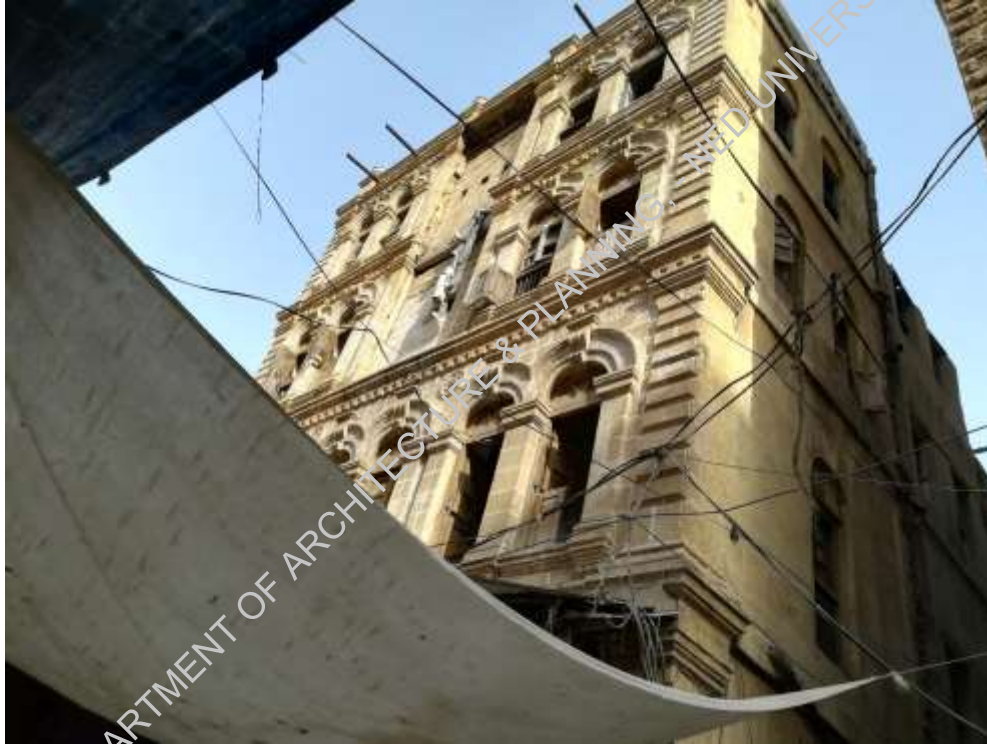
*Plate-1: Front
Façade-*

- The original building is ground plus 3 stories. Refer Plate-1.
- Front façade appears intact and in good condition.
- Side elevation has a crack and it seems the wall is bulging.
- Over all building is in very good condition minor repair works needed.

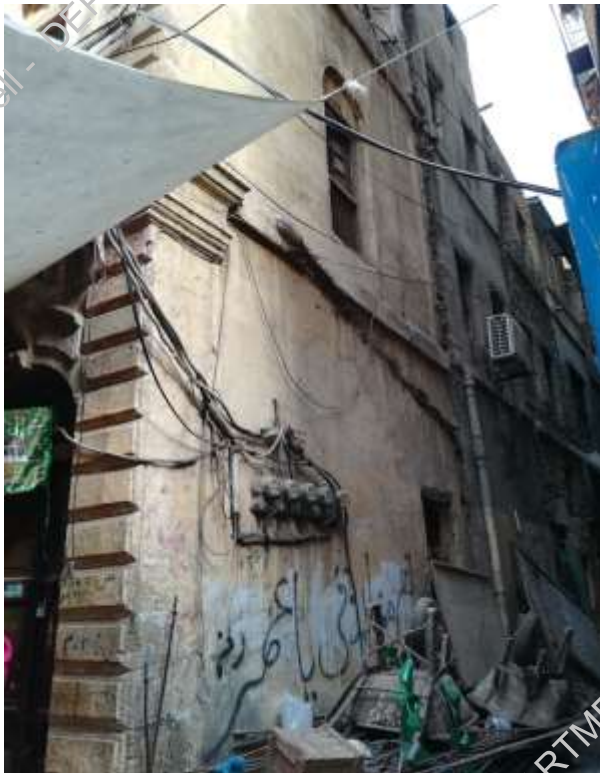
Plate-2: side elevation little wall seems bulging

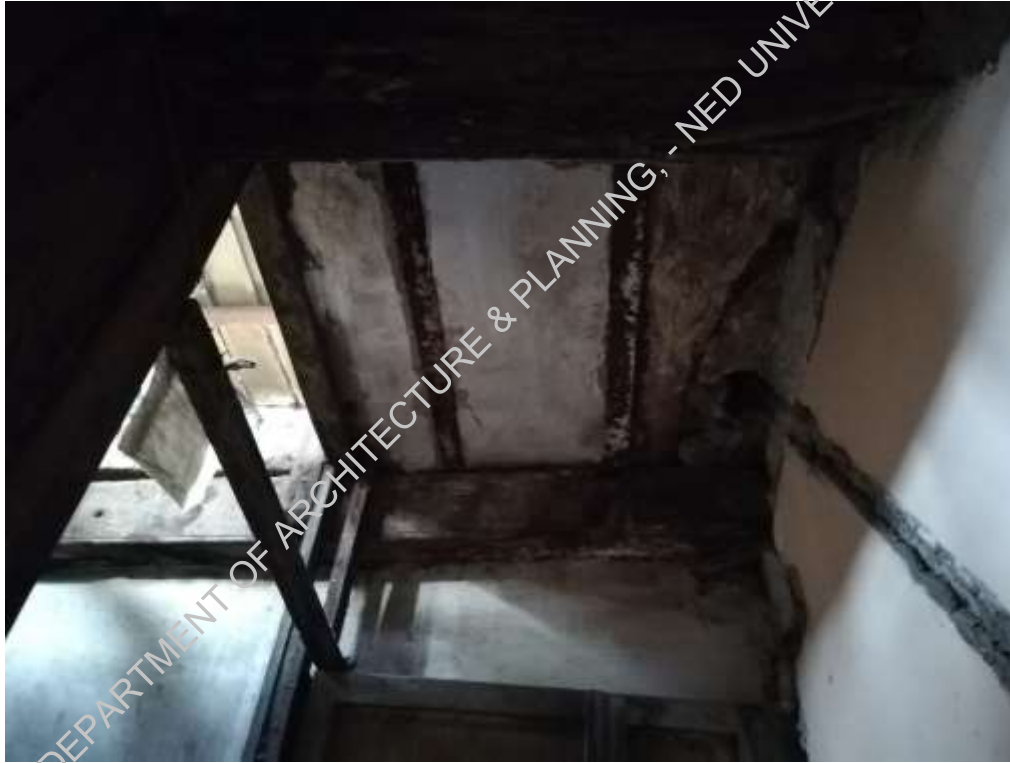
*Plate-6: slab
damage due to
seepage*

- Building appears to be in good condition from outside.
- From inside, stone walls appear intact, however, repair work is needed in floor decks and staircases.

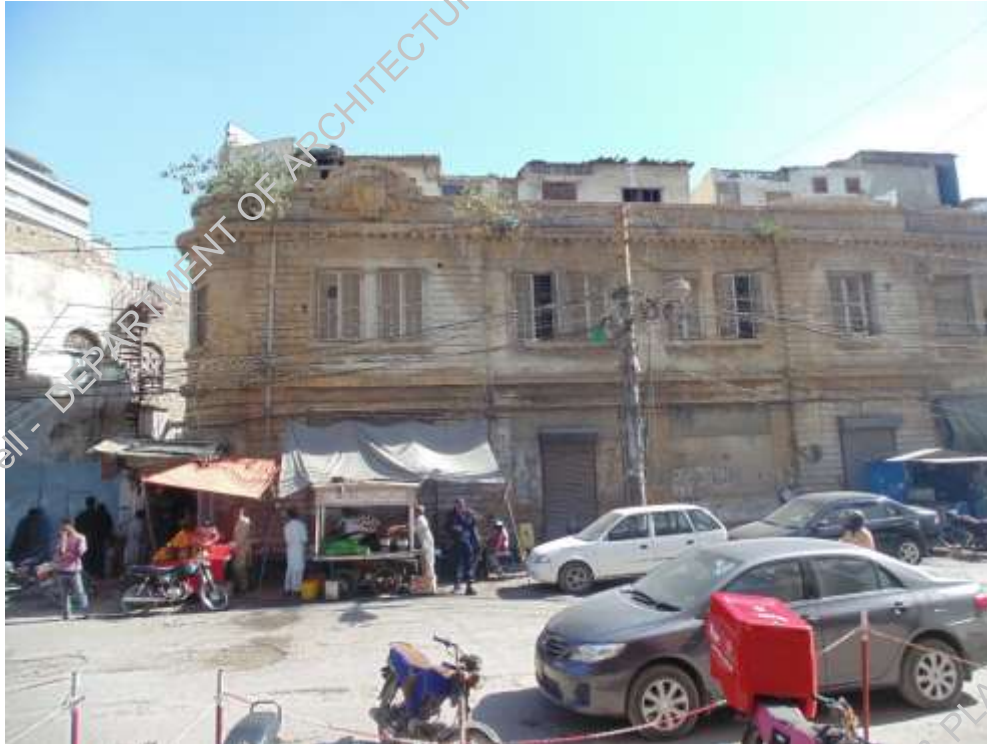
- The original building is ground plus two stories with partial third story, whereas additional third story on rest of the area has been added sometime later. Refer Plate-1.
- Part of the building was accessible which was cladded and plastered
- Diagonal cracks in the plaster of Face was observed in 2 locations.
- Rare side of the building which could only be observed from outside which as not plastered and loose stone masonry with weathered mortar was observed.

Plate-1: Front Façade- loose stone masonry can be noted at many places. Additional floor on top is also visible

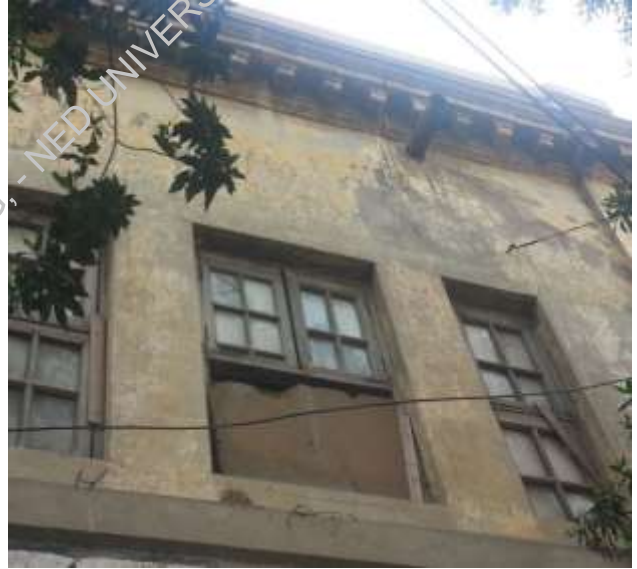
Plate-3: Crack on side of wall

- Part of the building where crack has appeared needs strengthening/repair immediately.
- Rest of the building appears in good shape and requires minor strengthening works to restore it.
- Building could not be observed from inside hence condition is not known

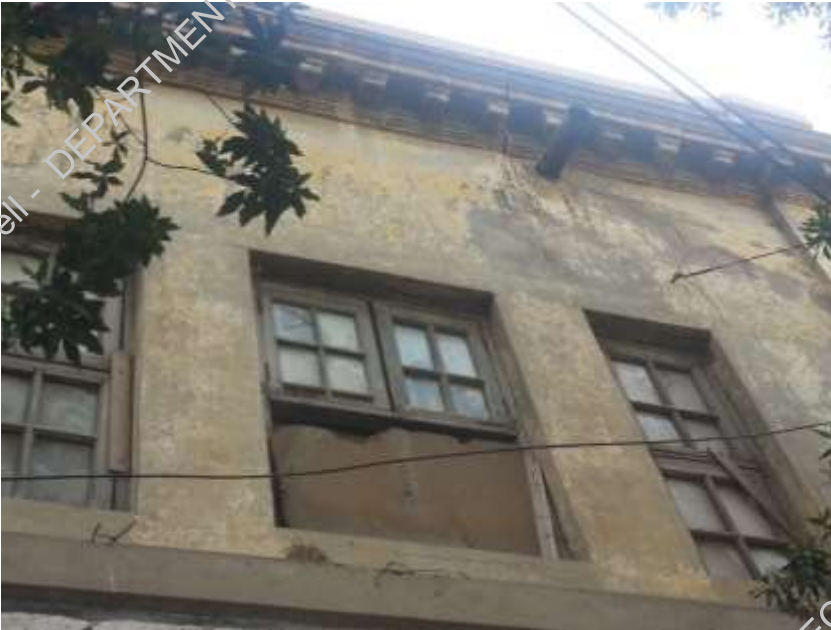
Plate-4: crack in stone masonry wall
