# DOCUMENTATION AND CONSERVATION REPORT

## Karachi Port Trust (KPT) Head Office Building

### STATE OF CONSERVATION REPORT

Prepared by: Heritage Cell, Department of Architecture & Planning  
NED University of Engineering & Technology, Karachi

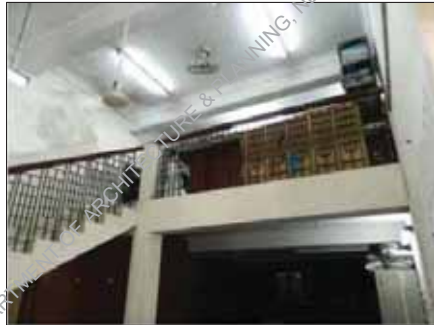
Figure 49. Added Loft

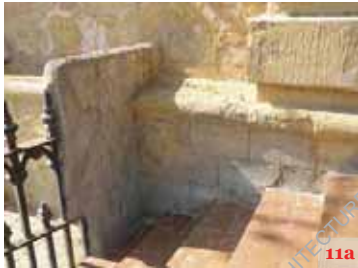
11a

TITLE: **FRONT ELEVATION (DAMAGES)**

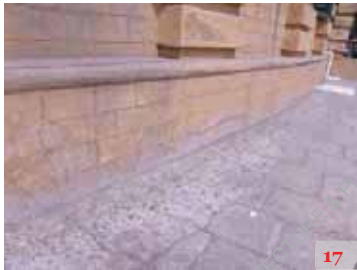
17

TITLE: **FRONT ELEVATION (DAMAGES)**

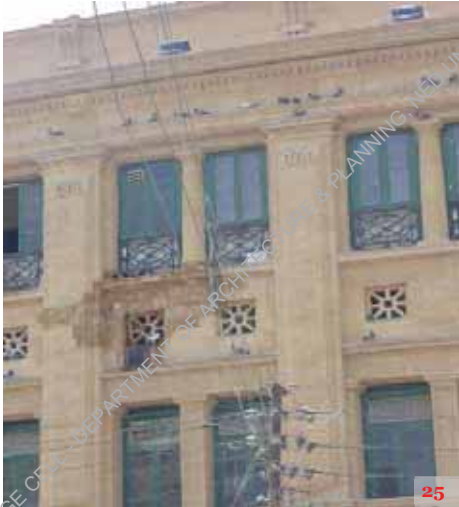
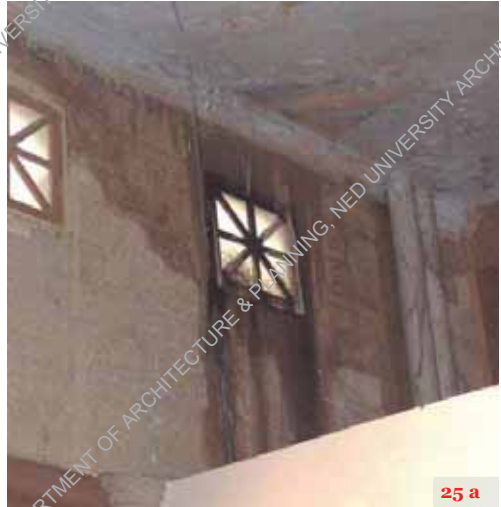
TITLE: **FRONT ELEVATION (DAMAGES)**
